**Salem Chapel, Bank Street, Rhos, Wrexham, LL14 1EN  
(National Grid Reference: SJ 2937 4688)**

**Inspection & Assessment in Relation to Bats & Breeding Birds  
Dusk Survey Results**

**Issued: 04<sup>th</sup> July 2017**

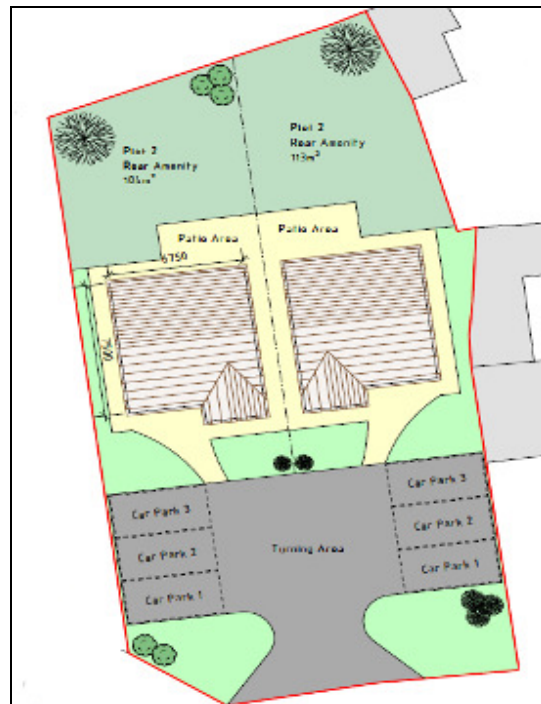
**Proposed site plan at Salem Chapel**

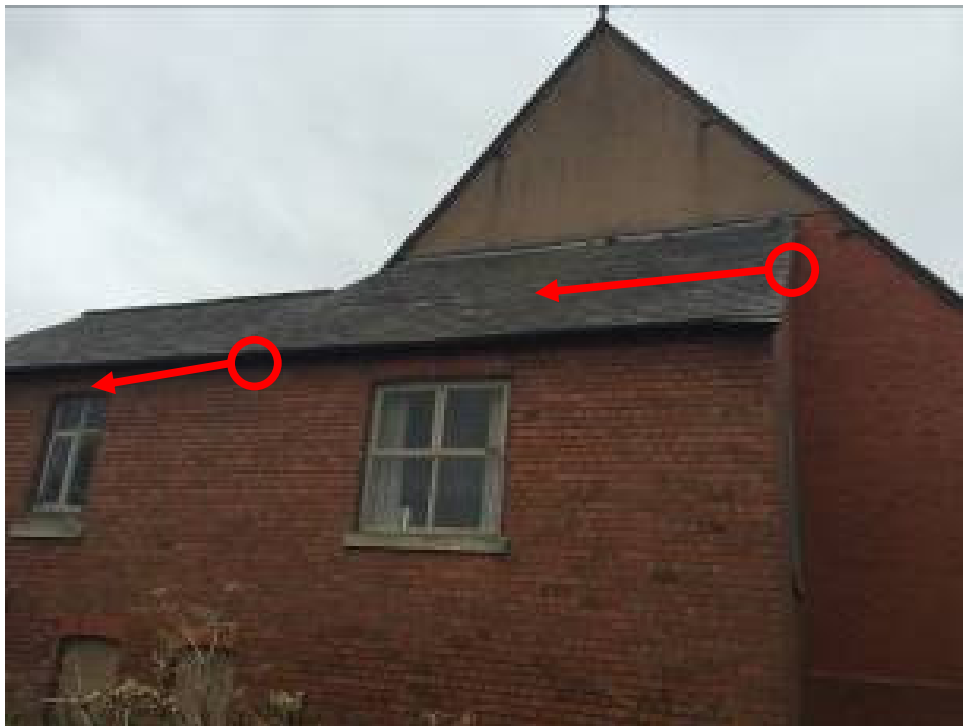
**Approximate emergence locations and subsequent flight line of Common Pipistrelle bat/s during dusk emergence surveys**

| Survey | Date | Results |
|---|---|---|
| Dusk survey | 16 <sup>th</sup> May 2017 | <b>Summary:</b> Emergence of two Common Pipistrelle bats from the building during observation period from two separate emergence points.<br><br>2120 hrs: Common Pipistrelle bat emerged from the building and proceeded to commute off site immediately in a northerly direction.<br><br>2135 hrs: Common Pipistrelle bat emerged from under the roof slate and proceeded to remain on site forage around the rear of the building throughout the survey duration. |

| Dusk survey | 22 <sup>nd</sup> June 2017 | <p><b>Summary:</b> Emergence of one Common Pipistrelle bat from the building during the observation period from under eaves at the rear of the structure.</p> <p>2216 hrs: Common Pipistrelle commuted onto site from the north to the south of the site.</p> <p>2217 hrs: Common Pipistrelle commuting onto site from the south to the north.</p> <p>2219 hrs: Emergence of one Common Pipistrelle bat from under the eaves of the structure to the rear elevation.</p> <p>Foraging activity on site was sporadic throughout the duration of the survey.</p> |

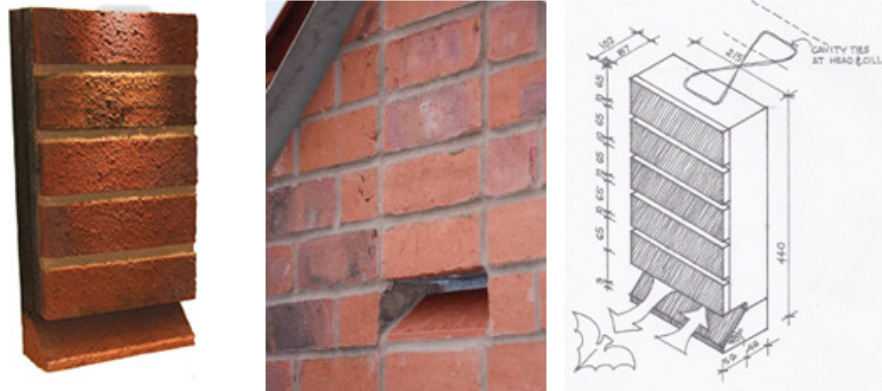
The integrated bat box can be installed to a gable elevation, it is a large, solid construction of insulating concrete with an internal roost space, which can be incorporated into the fabric of a building as it is built or renovated. A variety of facings can be fitted to suit any existing brick, and it is suitable for crevice dwelling species. The box is made to match the existing brickwork of the building

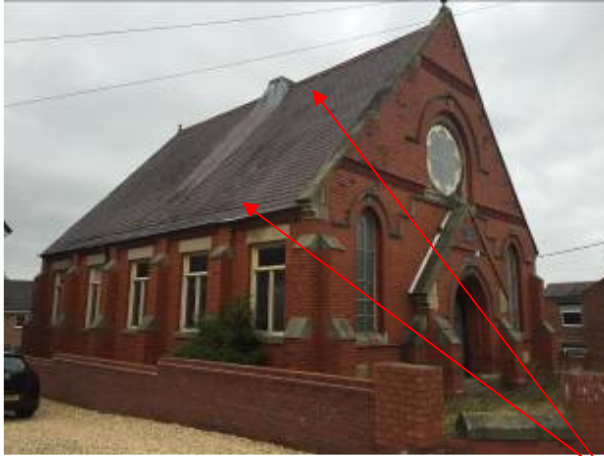
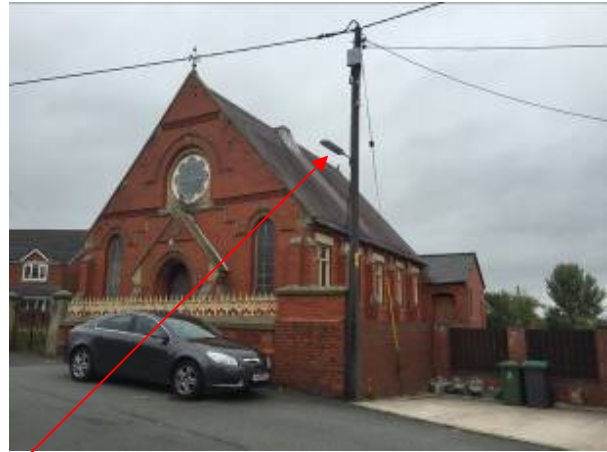
- 6.8 During the external inspection the decorative coping stones were found to be tight fitting to the front gable of the chapel as are the ridge tiles; the majority of the slate roof is further noted to be generally intact, notwithstanding this, a number of raised slates are observed at approximately 3 courses down from the ridge and 3 courses above the gutter, which would provide ingress for bats. The fascia boards to the east and west elevations were found to possess gaps that could be utilised by bats, however, they are not considered as being particularly favourable due to the large and generally exposed nature of the gap between the boards and external brickwork.

**Salem Chapel proposed for demolition – gaps under roof slates**

- 8.1 It is recommended that in order to establish if the identified features at the chapel and adjoining church hall are being used by bats dusk emergence or/and dawn surveys should be undertaken. The surveys will need to be conducted during the active season of bats i.e. between May – August as bats, particularly Pipistrelle bats often alternate between roosts and do not necessarily use one roost over their active season.

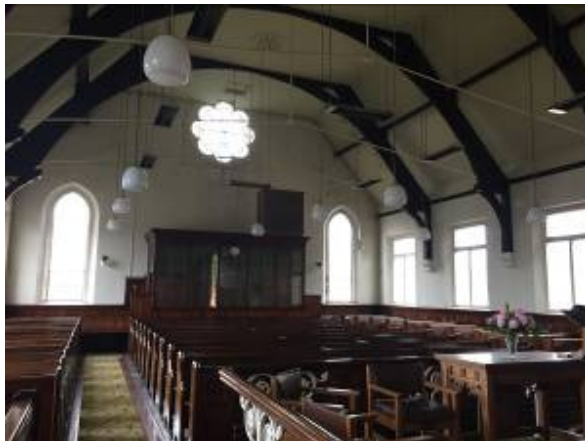
- 6.5 During the internal investigation a loft space is absent with the main chapel and the interior is open to the vaulted ceiling; internally, the area is open and extremely light filled, thus, as a result would not suit the basic requirements of loft dwelling bats, such as the Brown Long Eared bat (*Plecotus auritus*) as this is a species that favours a large, darkened and unrestricted loft spaces that allows free flight, with consistent warm and relatively stable temperatures. Furthermore, despite the extending habitat offering potential, the immediate environs are considered as not being entirely suitable to meet the specific foraging requirements of this species, and where possible to ascertain (see constraint 5.2) no recent or historic evidence to suggest the presence of void dwelling bats is located during the inspection, however, their presence can not be definitively ruled out.

**Light filled interior of chapel**

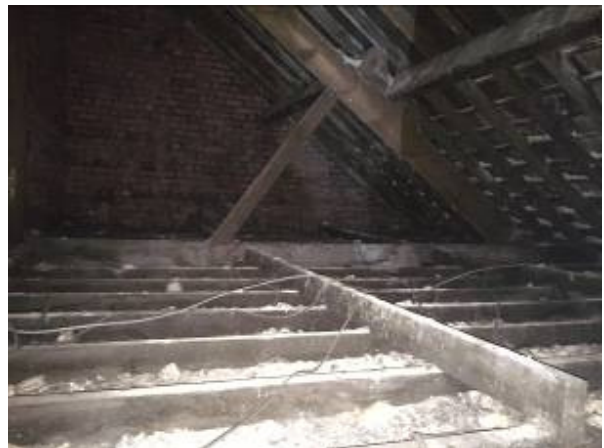
- 6.7 During the investigation from ladder level a loft space above the church hall was found to be to approximate dimension of 11 metres long x 5.5 metres wide x 2 metres (at highest point), which therefore would offer potential for void dwelling bats due to the reasons outlined within section 6.5, however, no obvious evidence was found to suggest their presence. Notwithstanding this, 2 historic droppings (deposited between 3 - 5 years) were identified and are indicative of the crevice dwelling Pipistrelle bat. Additionally, the bitumen underfelt beneath the roof slates increases potential for this species due to the factors discussed within paragraph 6.6. Further droppings may/may not be present within the loft however; this could not be fully established due to the health and safety constraints.

**Loft space above church hall to the north**

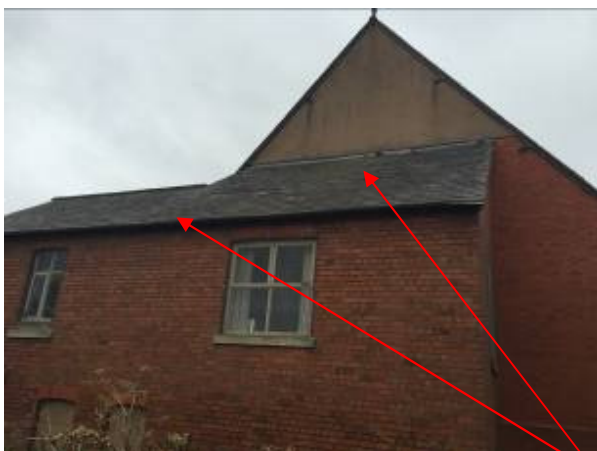
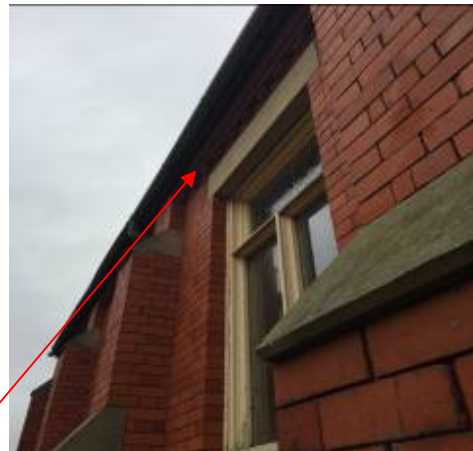
- 6.9 The mono pitched roof to the north of the chapel was found to offer a number of potential access opportunities for bats, notably, at eaves level, under roof slates and areas of lifted lead flashing whereby the structure meets the chapel.

**Gaps at lead flashing, under eaves and between fascia boards & external brickwork**
