*Phase 1 (Desk Study) Investigation Report*

**The Oaks, Oak Road  
Wrexham Industrial  
Estate, Wrexham,  
LL13 9RG**

**Cefn Park Developments Limited**

Reference: V-R6399.00

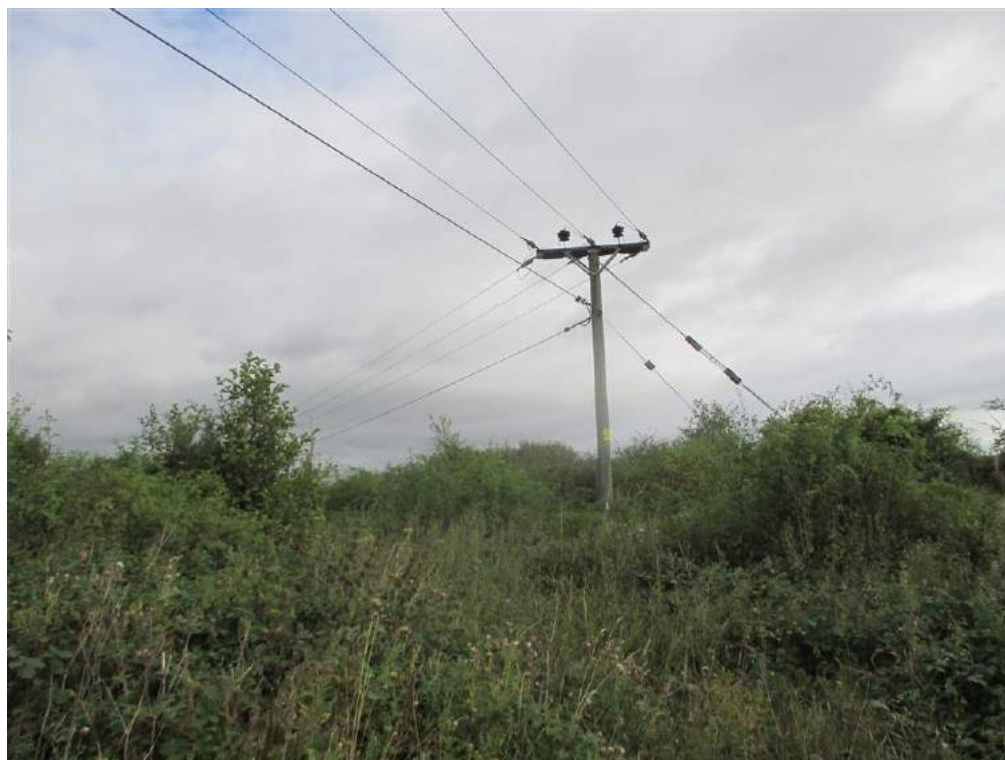
- 4 no. sets of overhead electricity lines were noted to exist on site, one of which roughly bisects the site running north to south and consists of large lattice tower pylons carrying 3 no. cables. The remaining lines are carried by wooden pylons;

**Plate 6:**  
**Typical wooden electricity pylon.**

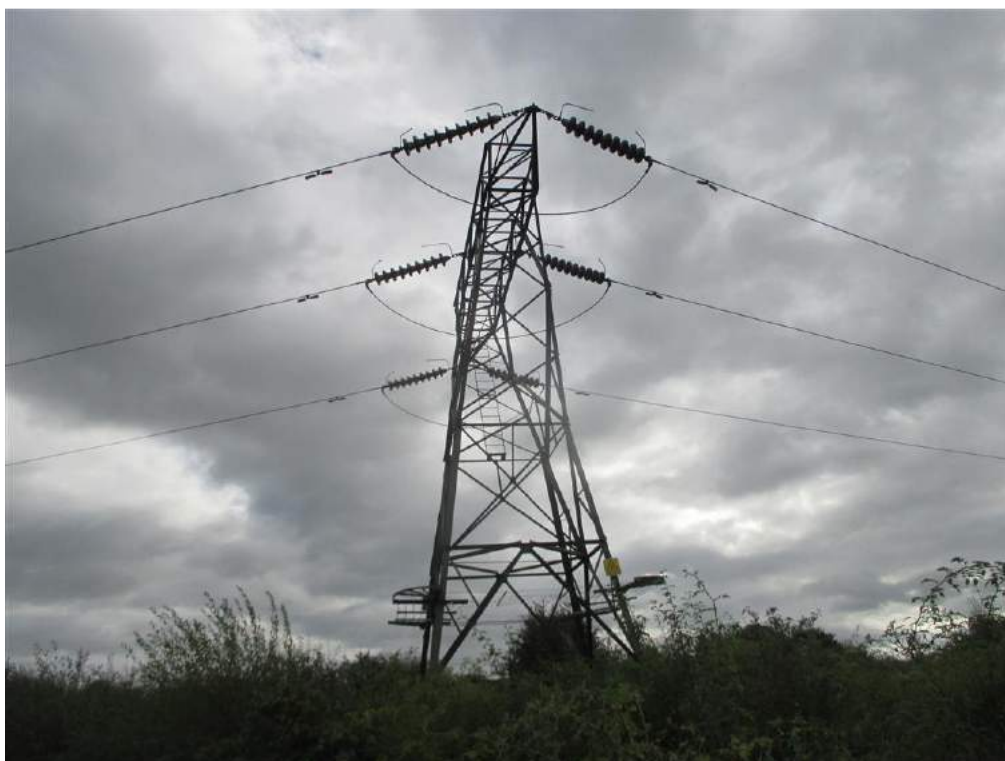
**Plate 7:**  
**Typical metal lattice electricity pylon.**

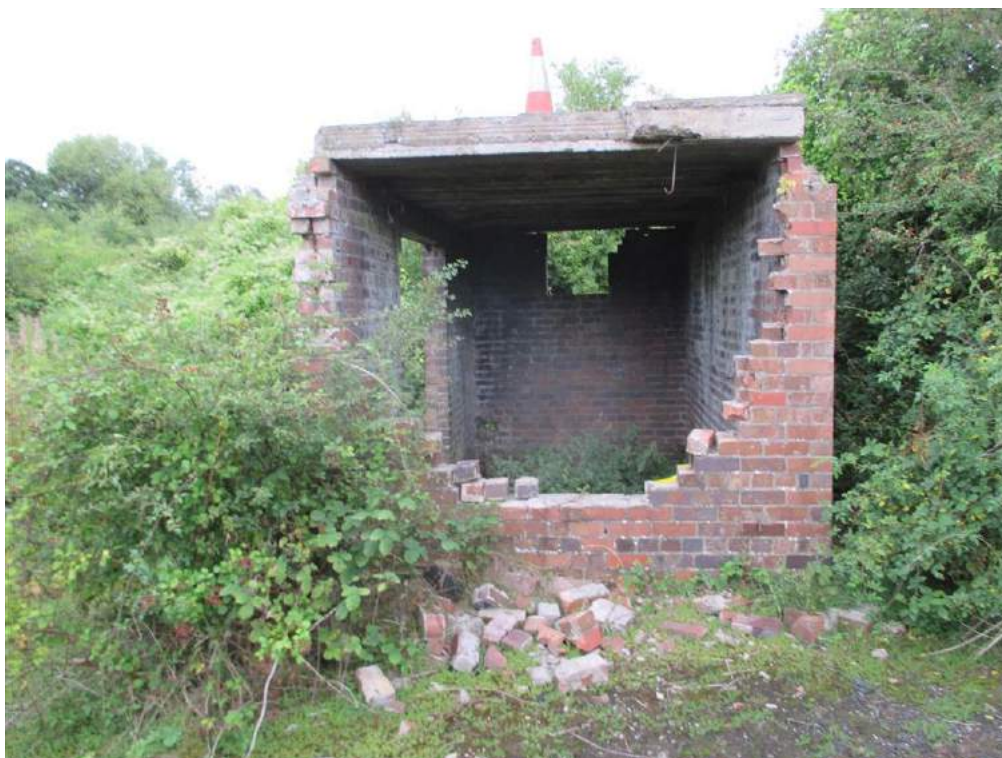
- Many small bricked buildings exist on the site, particularly in the southern and eastern areas. The structures were not entered during the walkover due to health and safety risks. The condition of some of the buildings is poor with missing and spalling brickwork noted;

**Plate 10:**  
**Example of a damaged building in the north east area of the site.**

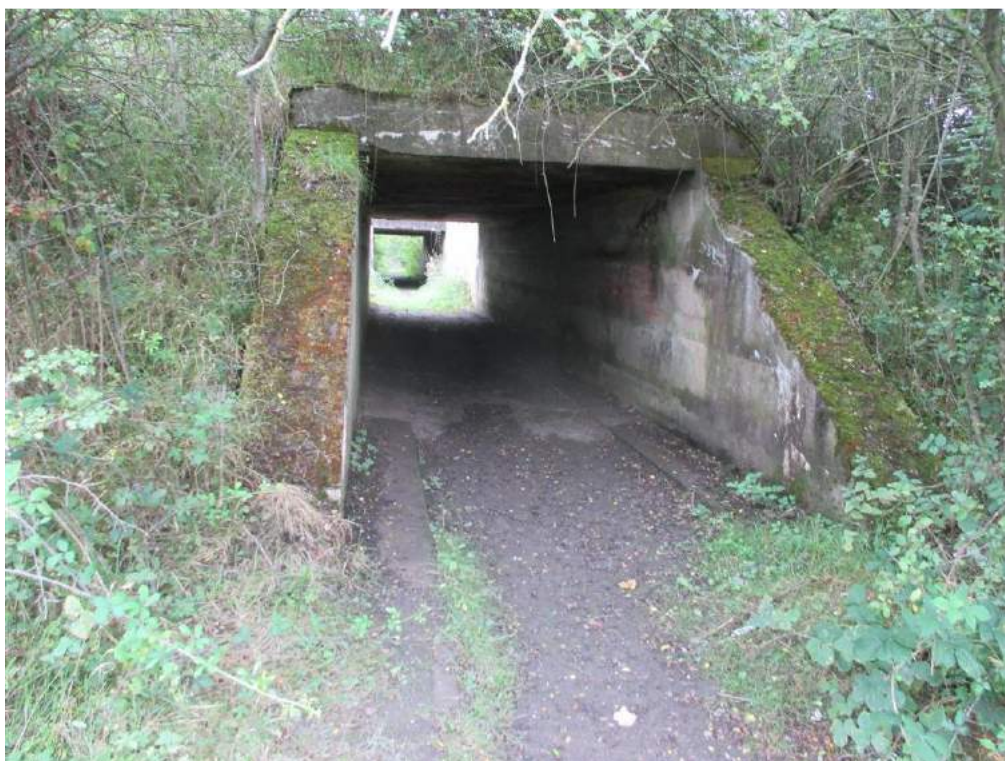
- 
- Other structures of note include a set of concrete tank cradles located in the north eastern part of the site. Several concrete tunnels were also found on site. An open manhole was noted to the east of the central area of the site;

**Plate 11:**  
**Typical example of concrete box tunnels on site.**

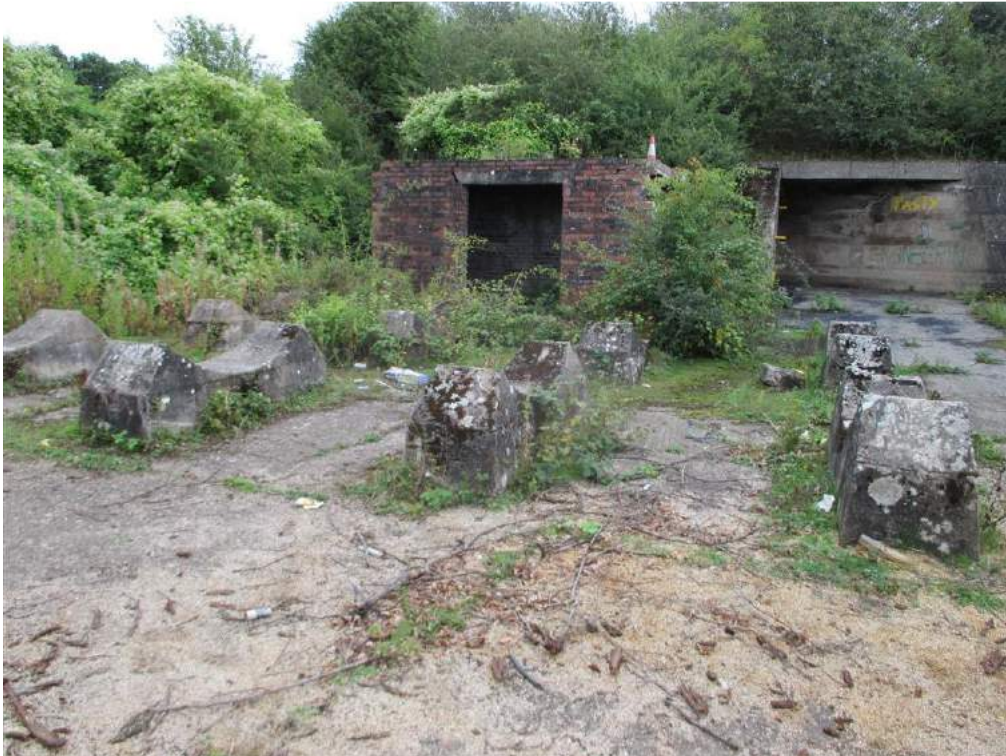
**Plate 13:**  
**Tank cradles located in the north east area of the site.**

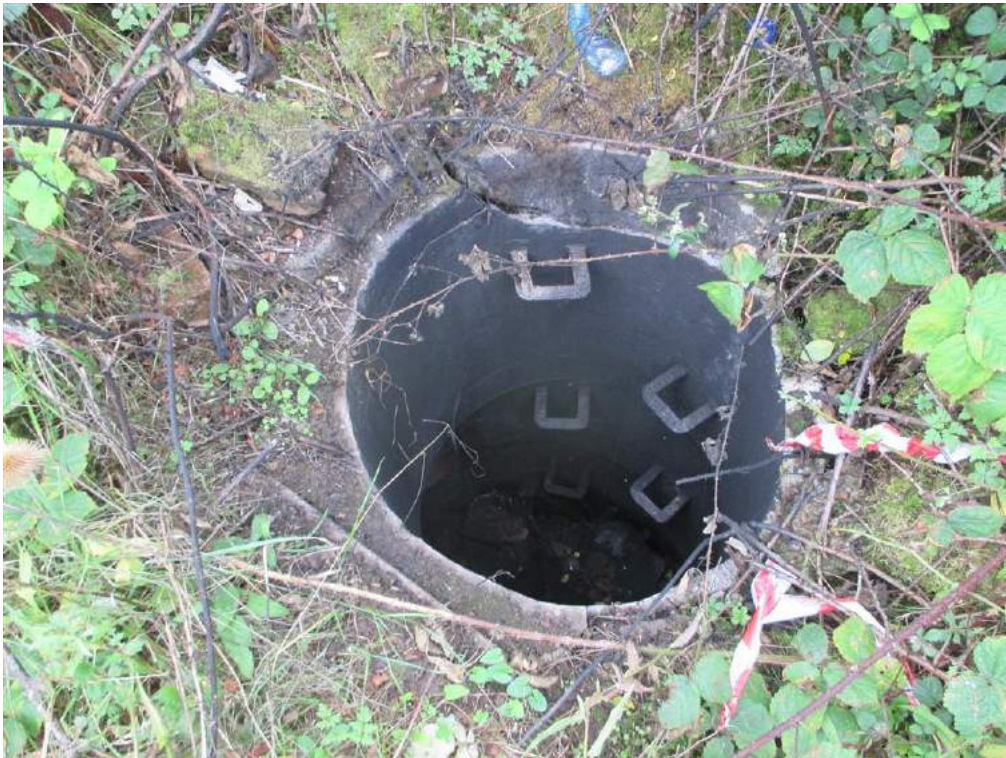
**Plate 14:**  
**Detailed view of an open manhole located in the central area of the site.**

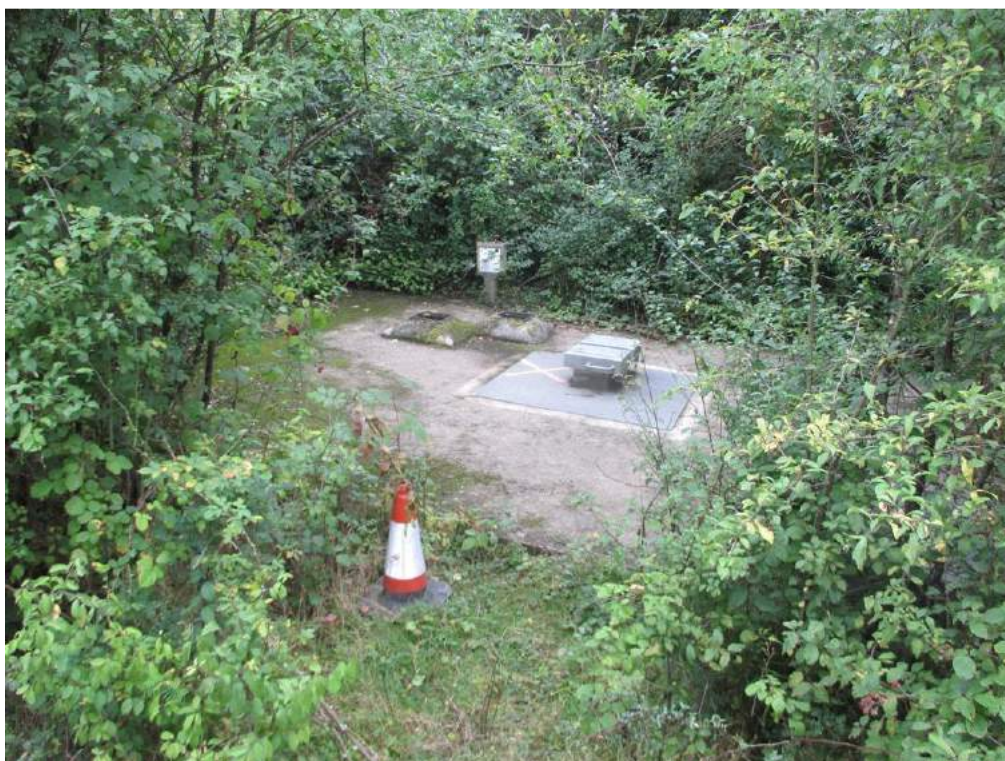
- Evidence of water services were noted during the walkover. 2 no. below ground chambers were noted in the north eastern part of the site beside the concrete track running south from Oak Road. Missing covers made it possible to see that one of the chambers contains standing water; and,

**Plate 15:**  
**View of the water chamber covers located in the north east area of the site looking north west.**

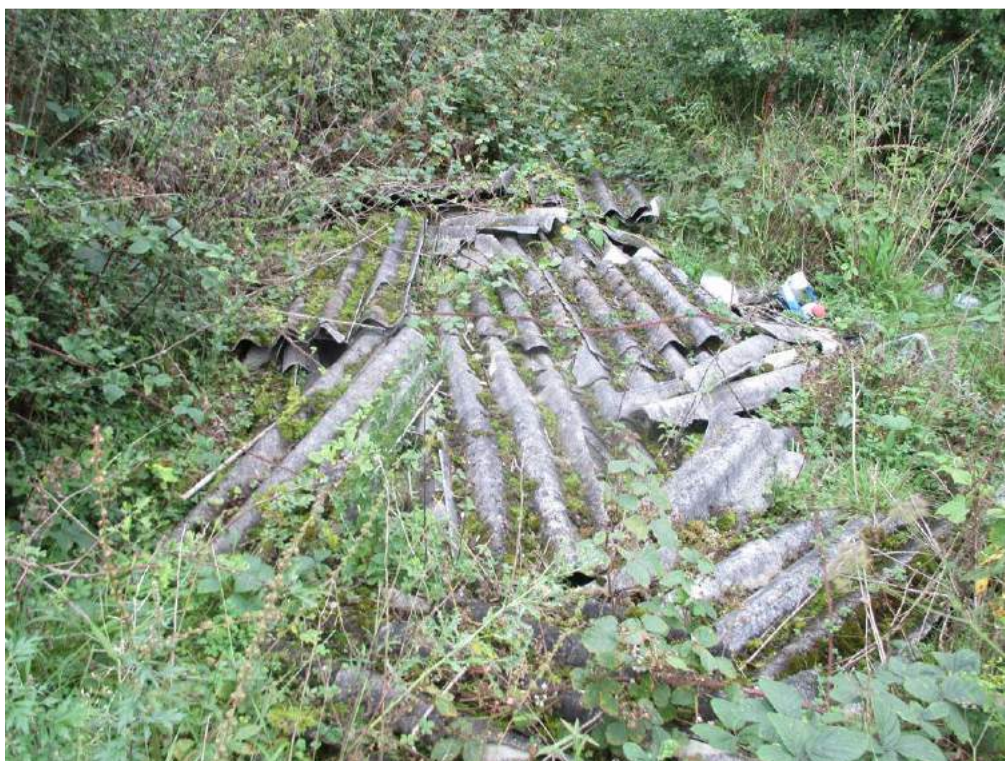
- Potential Asbestos Containing Materials (ACMs) were noted in the north eastern part of the site beside the concrete track running south from Oak Road. Large corrugated cement sheets were found, together with smaller fragments at the site boundary with Oak Road. It is considered that they are the result of fly tipping;

During the site walkover on Tuesday 6<sup>th</sup> September 2016, potential Asbestos Containing Material (ACM) was noted in the north eastern area of the site. Several large fragments of corrugated cement sheeting were found beside the concrete track running south west from Oak Road and some smaller fragments were found at the end of the track on Oak Road itself. These are believed to be a result of fly tipping.

**Plate 24:**  
**Possible ACM found in the north east area of the site near Oak Road.**

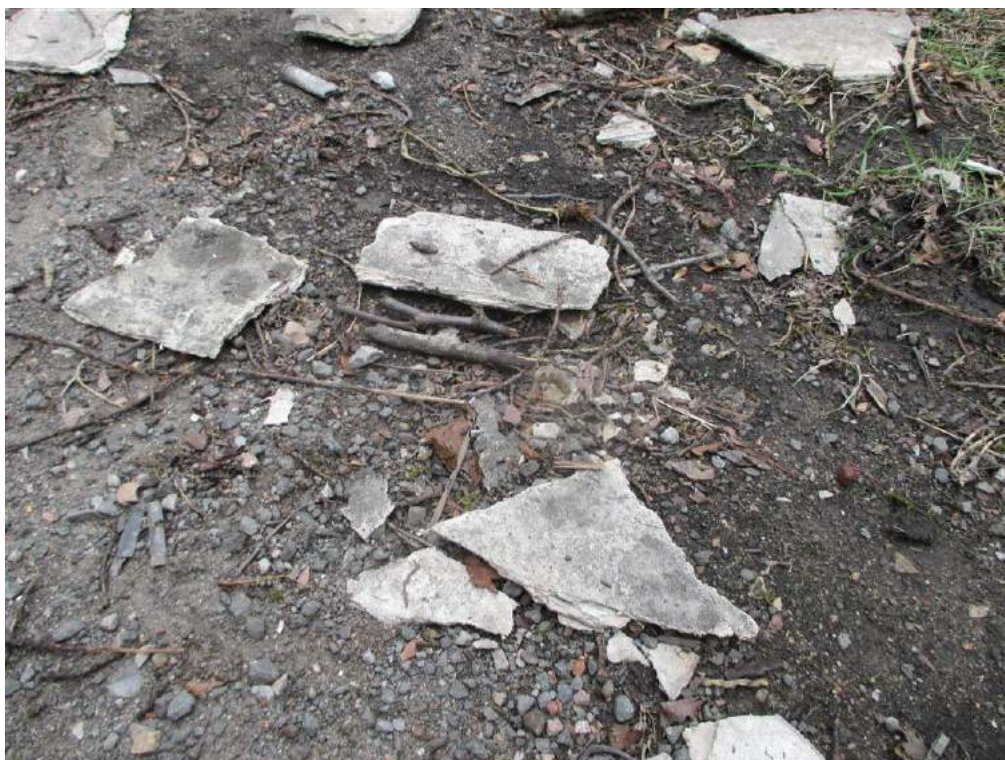
**Plate 25:**  
**Fragments of possible ACM by the north eastern site boundary with Oak Road.**

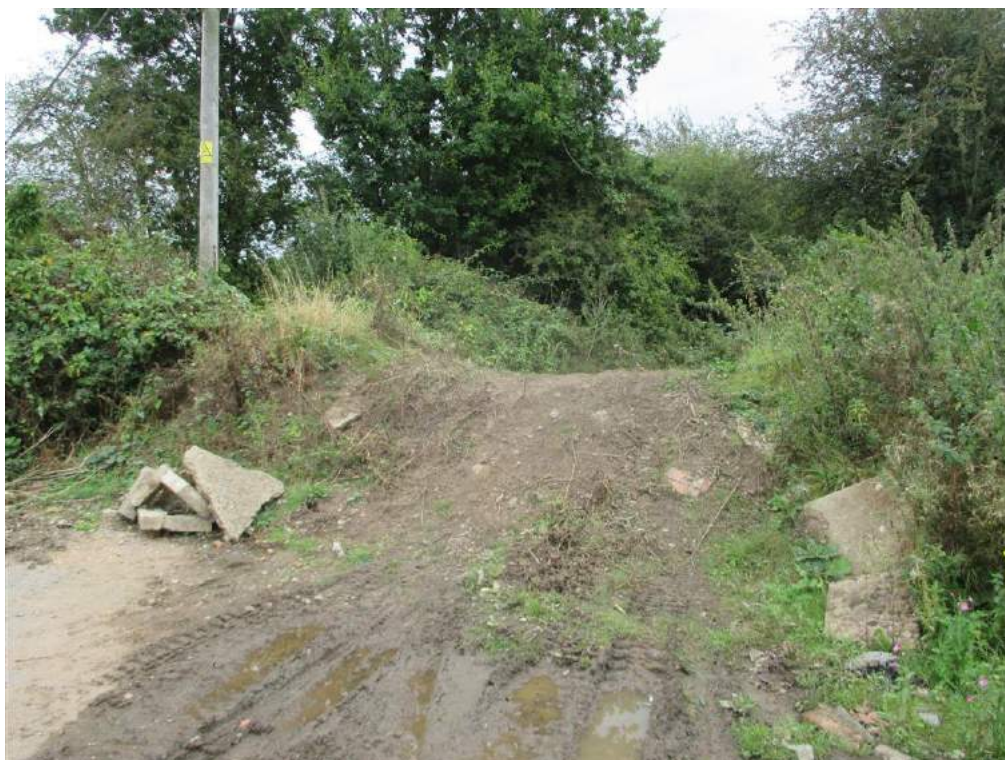
- The site boundary is defined for the most part by Oak Road to the north, and Redwither Brook and the River Clywedog to the south. The boundary deviates around several smaller plots of land to the west and the north east resulting in its irregular shape. A bund was noted at the site boundary on the concrete path leading onto the site from the west.

**Plate 27:**  
**Bund located at the south western site boundary.**
