**PROPOSED DEVELOPMENT AT HOLT ROAD, WREXHAM BY BLOOR HOMES NORTH  
WEST AND BARRATT HOMES**

**SUDS STRATEGY STATEMENT IN SUPPORT OF OUTLINE PLANNING APPLICATION  
REF. P/2019/0005**

**Ground Investigation Report**

**Holt Road, Wrexham**

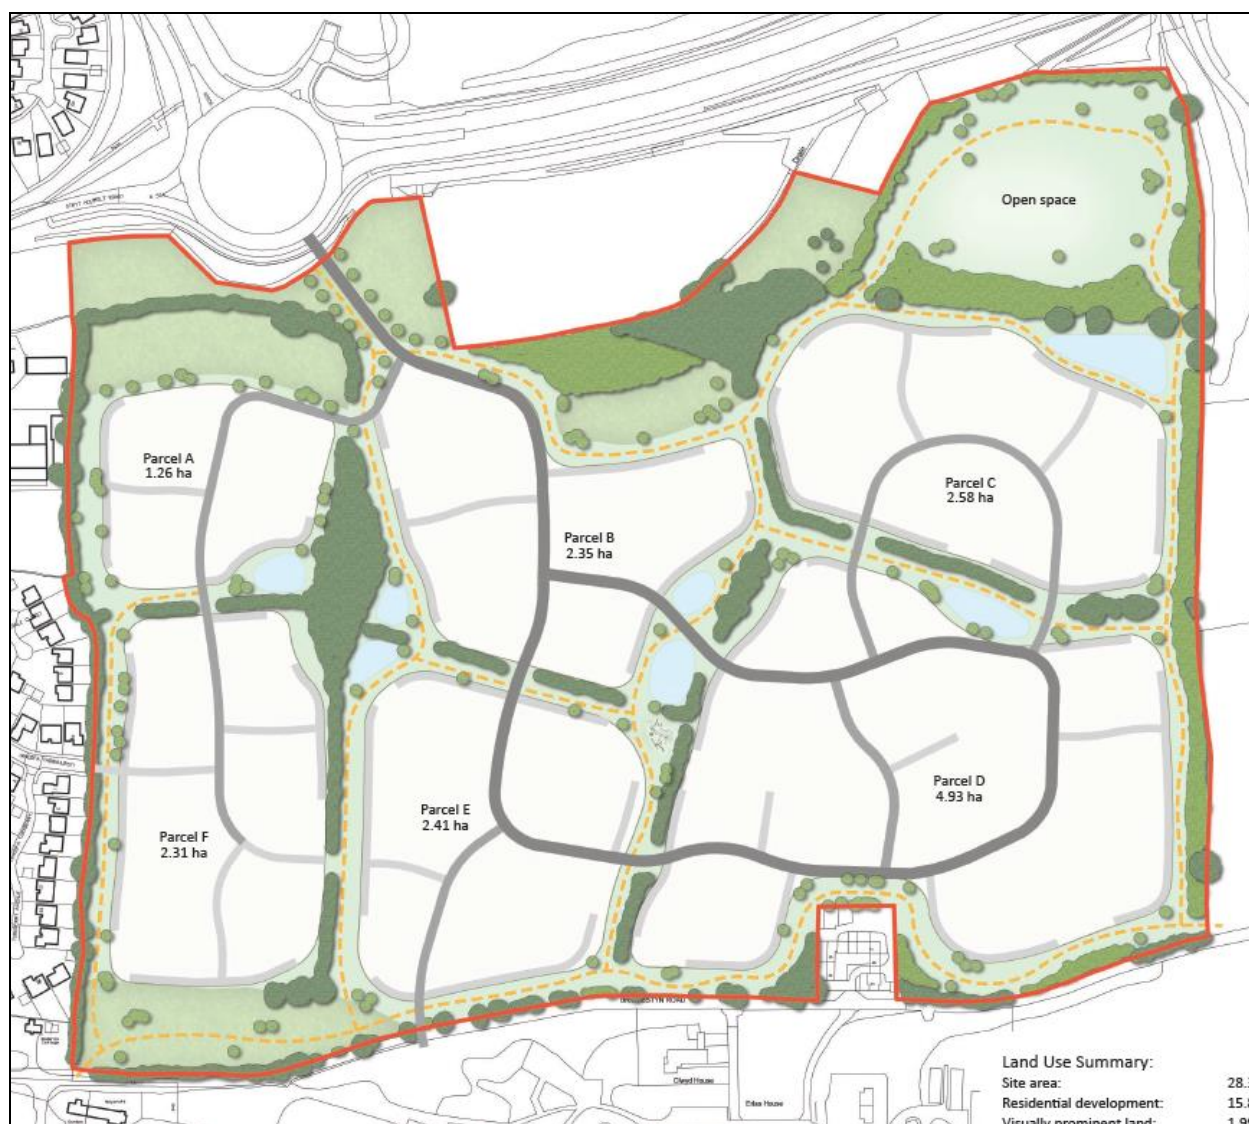
Concept Layout, drwg No. 661B-01, dated 18/08/17, by Randall Thorp.

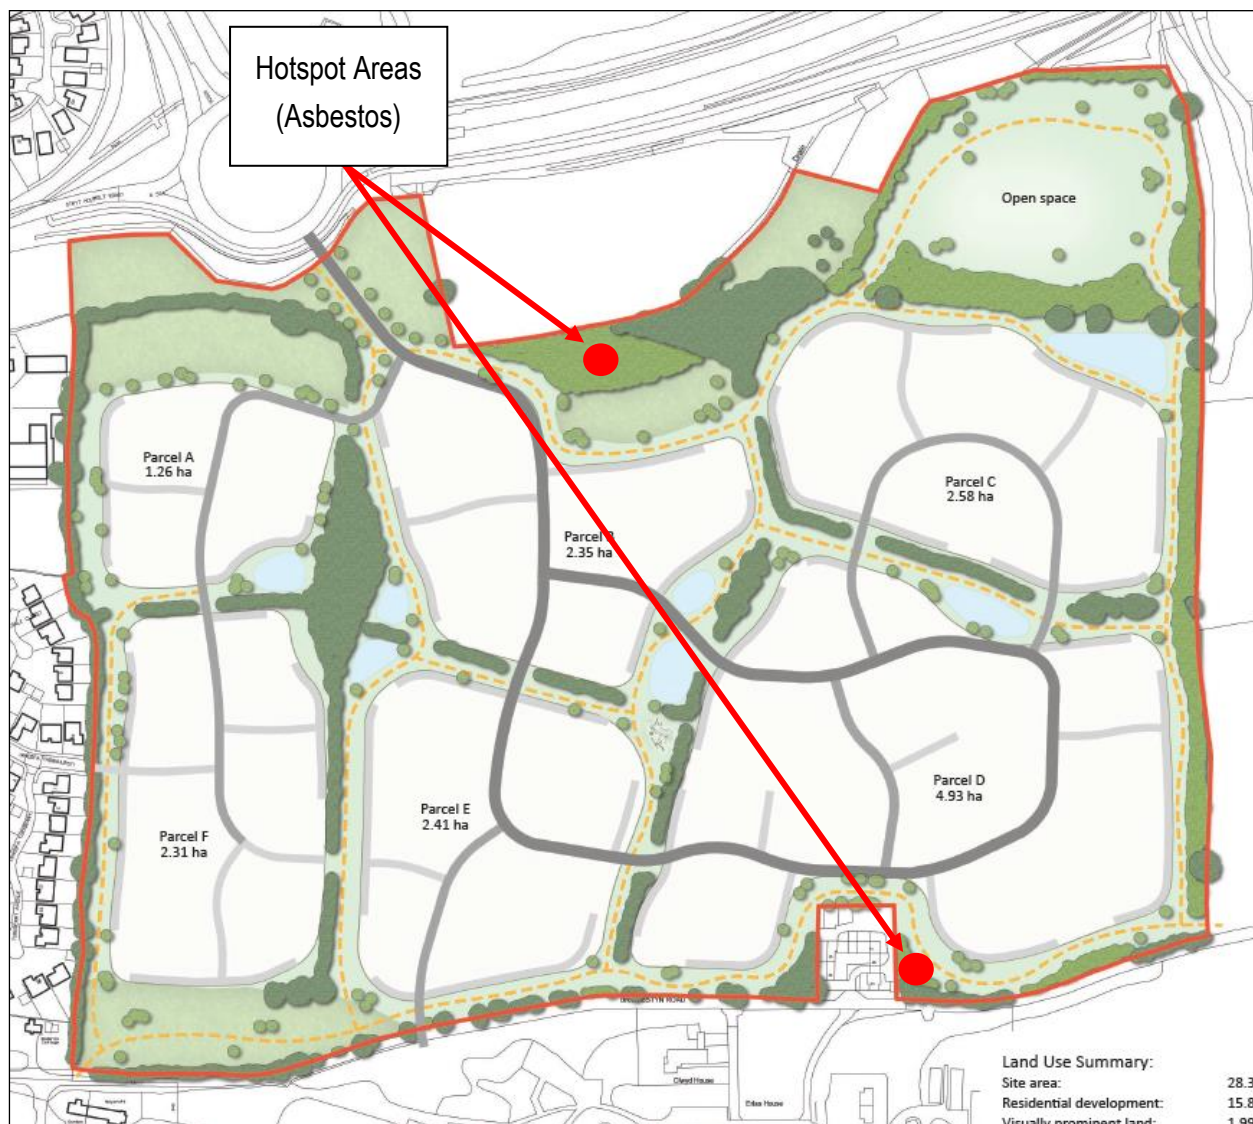
location areas are shown as a red dots on the extract below.

No significantly elevated contamination was encountered across the remainder of the site. It is therefore likely that a minimum thickness of 300mm of debris-free soil within garden areas to provide a growing medium will be required as per NHBC guidance; this is likely to be made up of site-won subsoil and topsoil.

If the development layout changes further delineation may be required in the vicinity of TP29, with either the following likely to reduce the risk to proposed end users:

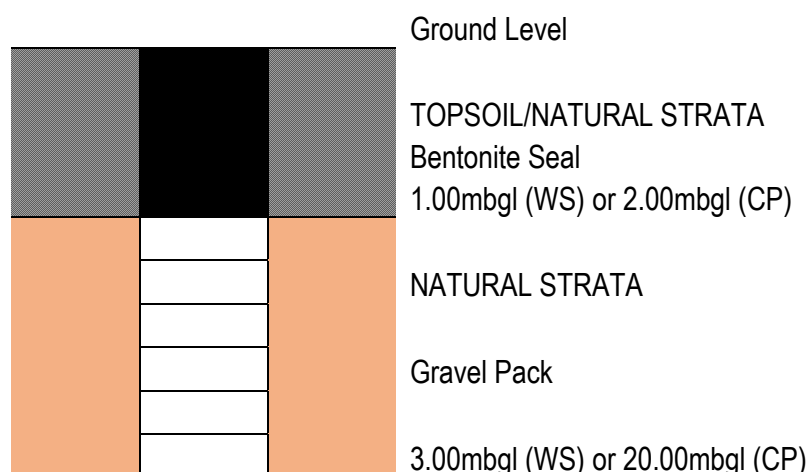
The eleven (11 No.) window sample boreholes and five (5 No.) cable percussive boreholes were all installed to 3.00mbgl and 20.00mbgl respectively with 1.00m or 2.00m of plain pipe and 2.00m or 18.00m of slotted pipe into the Natural Strata below. A typical installation is shown below;

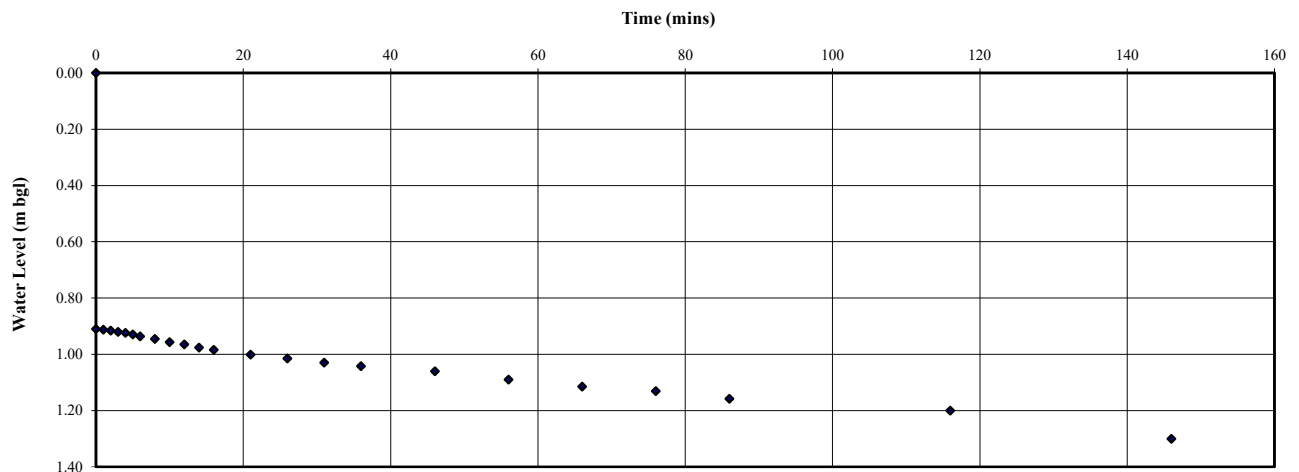
| Time<br>(mins) | Depth of water<br>(m bgl) | Time<br>(mins) | Depth of water<br>(m bgl) | $V_{(p75-25)}$ = Effective storage volume in trial pit between effective depths 25% to 75%. = 0.35 m <sup>3</sup> |
|---|---|---|---|---|
| | | | | Soil infiltration rate = 2.0E-05 m/sec |

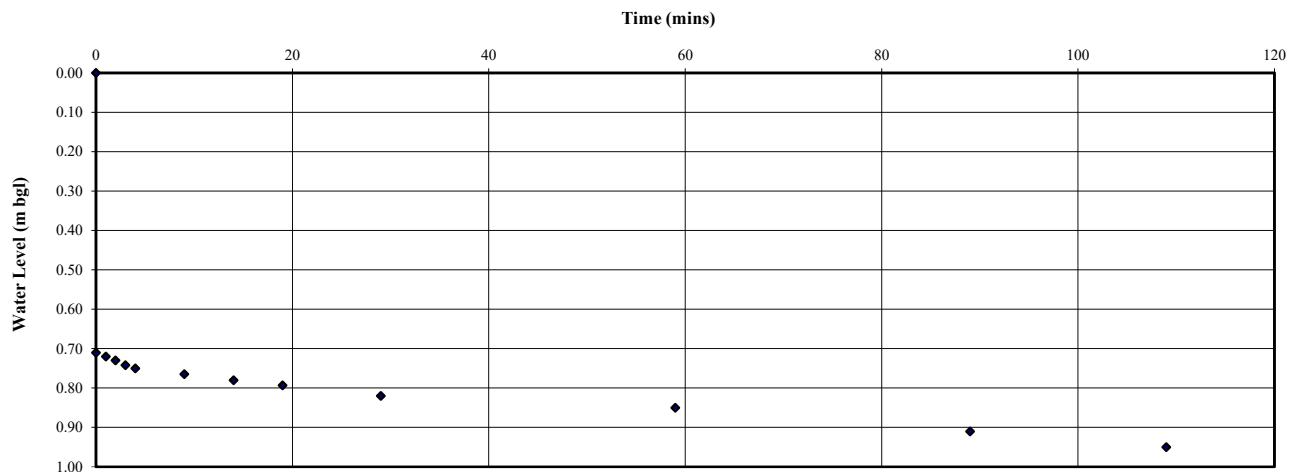
| Time<br>(mins) | Depth of water<br>(m bgl) | Time<br>(mins) | Depth of water<br>(m bgl) | Effective storage volume in trial pit<br>$V_{(p75-25)}$ = between effective depths 25% to 75%. = 0.35 m <sup>3</sup> | |
|---|---|---|---|---|---|
| | | | | Soil infiltration rate = 1.8E-05 m/sec | |

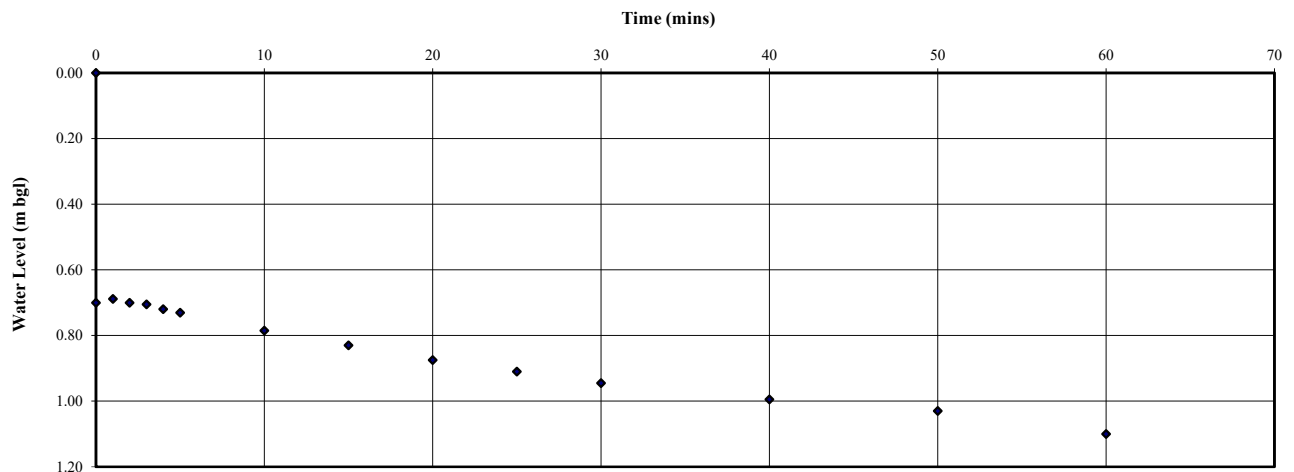
| Time (mins) | Depth of water (m bgl) | Time (mins) | Depth of water (m bgl) | Effective storage volume in trial pit between effective depths 25% to 75%.<br>$V_{(p75-25)} =$ = 0.27 m <sup>3</sup> | |
|---|---|---|---|---|--|
| | | | | Soil infiltration rate = 6.9E-05 m/sec | |

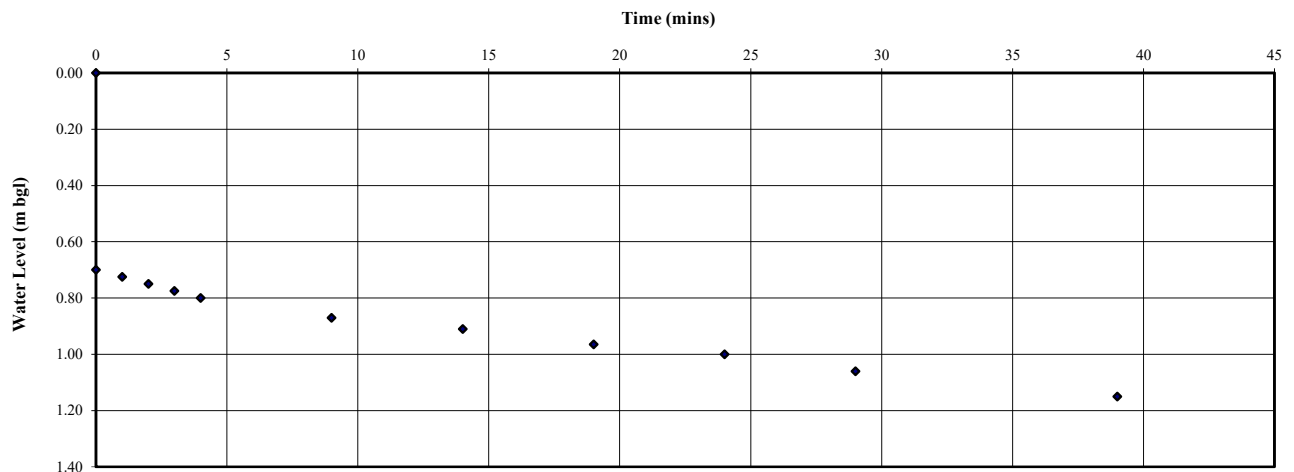
| Time<br>(mins) | Depth of water<br>(m bgl) | Time<br>(mins) | Depth of water<br>(m bgl) | $V_{(p75-25)}$ = Effective storage volume in trial pit between effective depths 25% to 75%. = 0.27 m <sup>3</sup> |
|---|---|---|---|---|
| | | | | Soil infiltration rate = 8.3E-05 m/sec |

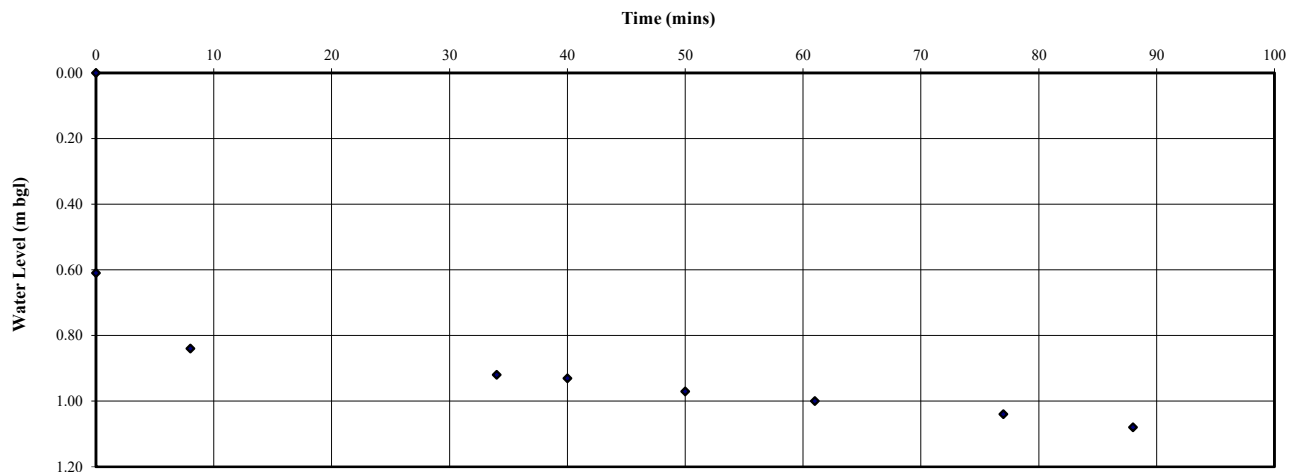
| Time<br>(mins) | Depth of water<br>(m bgl) | Time<br>(mins) | Depth of water<br>(m bgl) | $V_{(p75-25)}$ = Effective storage volume in trial pit between effective depths 25% to 75%. = 0.32 m <sup>3</sup> |
|---|---|---|---|---|
| | | | | Soil infiltration rate = 3.2E-05 m/sec |

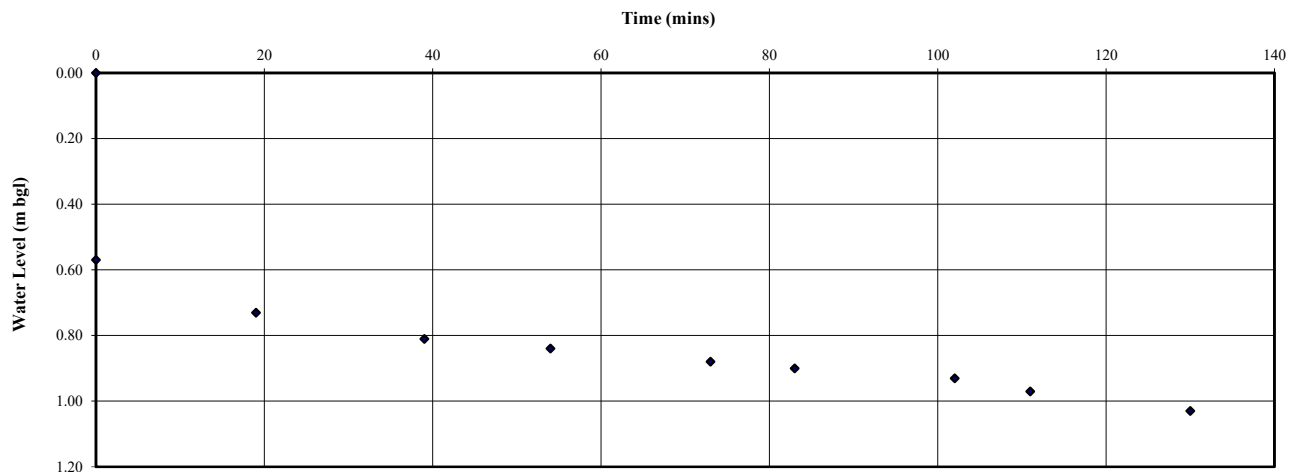
| Time (mins) | Depth of water (m bgl) | Time (mins) | Depth of water (m bgl) | Effective storage volume in trial pit between effective depths 25% to 75%.<br>$V_{(p75-25)} =$ = 0.31 m <sup>3</sup> | |
|---|---|---|---|---|---|
| | | | | Soil infiltration rate = 2.1E-05 m/sec | |

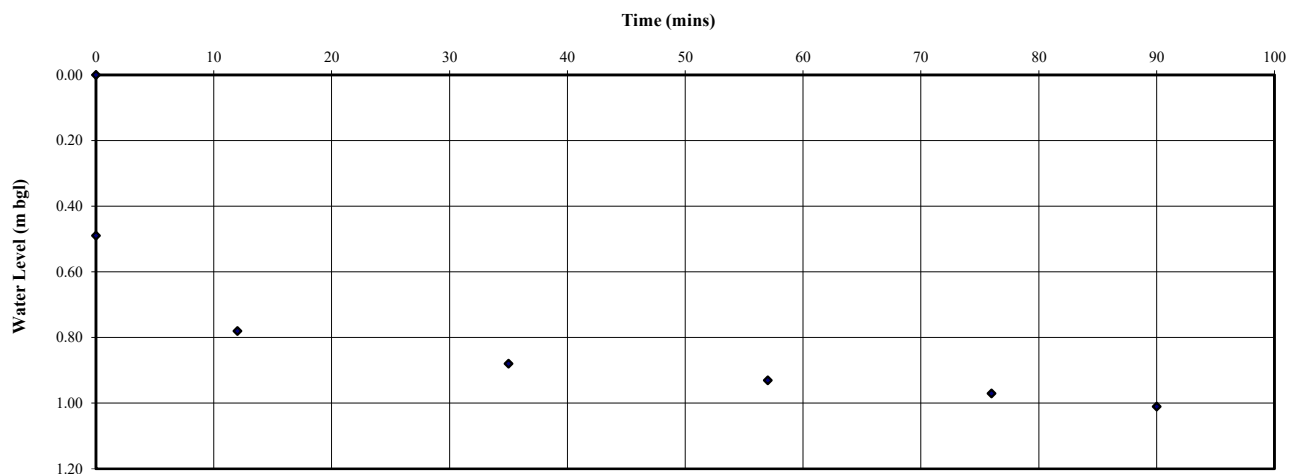
| Time (mins) | Depth of water (m bgl) | Time (mins) | Depth of water (m bgl) | Effective storage volume in trial pit between effective depths 25% to 75%.<br>$V_{(p75-25)} =$ = 0.46 m <sup>3</sup> | |
|---|---|---|---|---|---|
| | | | | Soil infiltration rate = 4.5E-05 m/sec | |

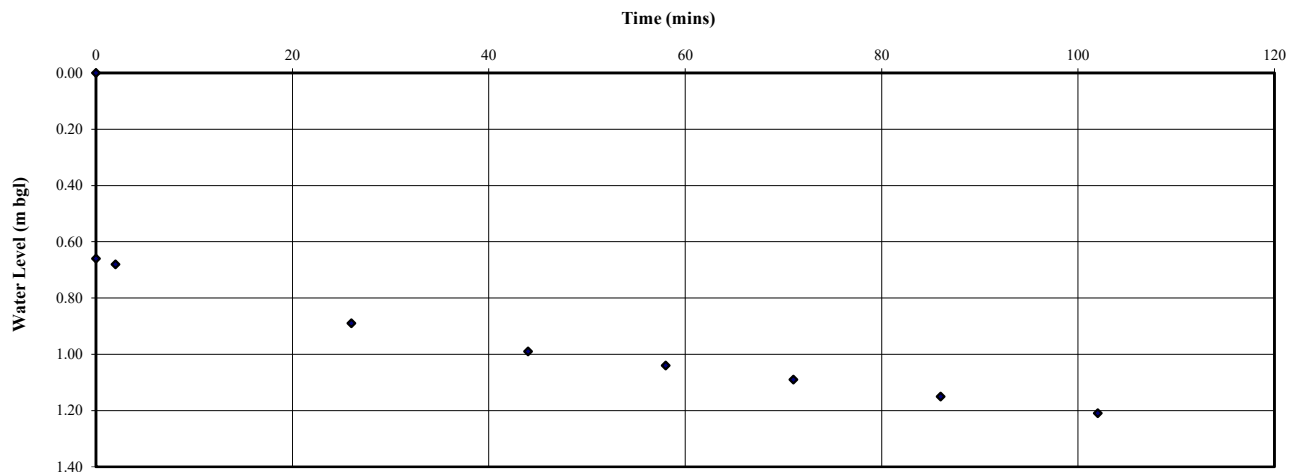
| Time (mins) | Depth of water (m bgl) | Time (mins) | Depth of water (m bgl) | $V_{(p75-25)}$ = Effective storage volume in trial pit between effective depths 25% to 75%. = 0.25 m <sup>3</sup> |
|---|---|---|---|---|
| | | | | Soil infiltration rate = 3.2E-05 m/sec |
