# Bat Survey Report

Rose Hill Lodge, Erbistock, Wrexham

May 2021

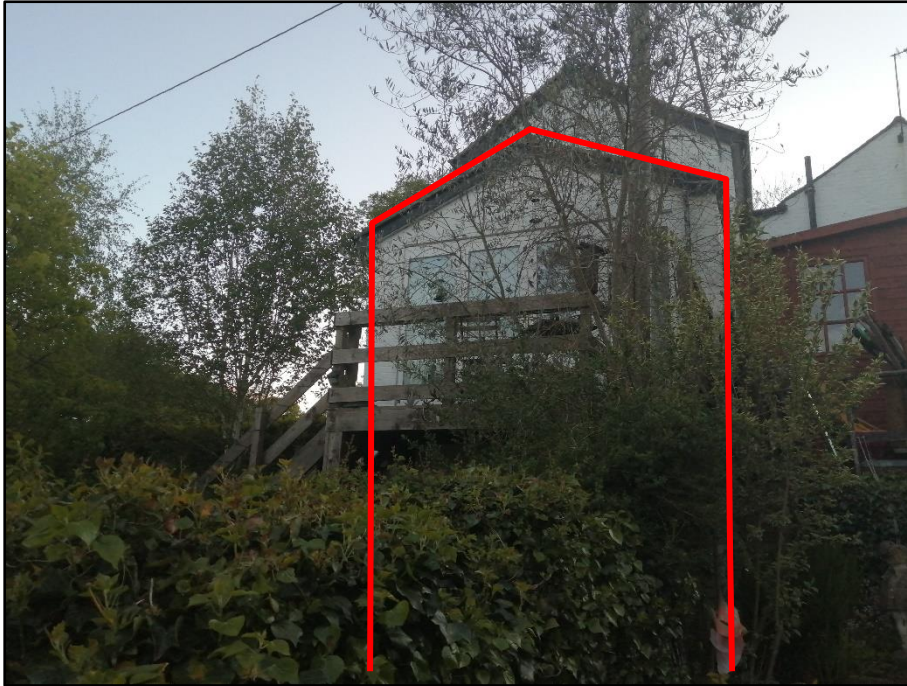
A1.1 Plate 1: View of the extension to be replaced

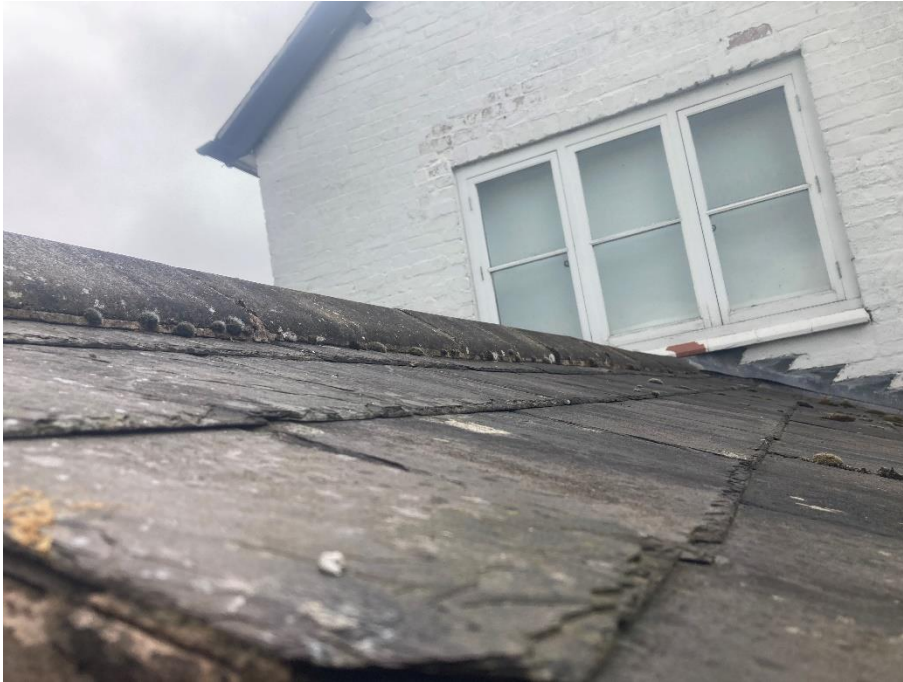
A1.3 Plate 3: View showing ridge tiles well sealed and slate roof in good condition

3.2.2 The structure is a brick built two-story extension attached to a two-story residential property. The walls are brick with mortar being in good condition; however, gaps are present within walls through weep vents (Plate 4) and a large crack associated with subsidence away from adjacent property. The subsidence large vertical crack, most of the crack is filled with expanding foam and is unsuitable for bats; however, at the top of the crack a small void is present providing potential roosting opportunities for bats. Barge boards and soffit boxes are present; gaps between wall plate and soffit providing access on top of wall plate. The roof structure is in good condition: few gaps were present within in the verge; slate roof and ridge tiles were in good condition with little lifting (Plate 3).

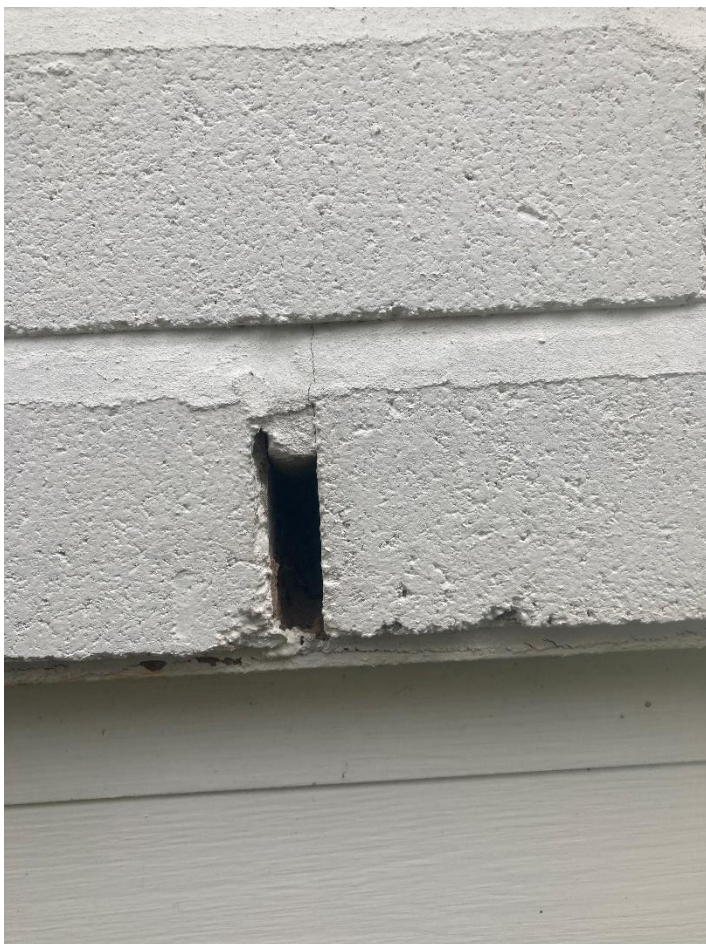
A1.4 Plate 4: Weep hole within brick work providing potential bat access to roof

3.2.3 Potential roosting features are limited to: access points between soffit and wall plates crawling access into the roof void could be possible at these points; loss of weep vents allowing access into cavity wall; and a small area within the large crack between buildings due to subsidence. No free flight access is possible at any point into the loft space. All of these access points were checked using a borescope and no signs of bat activity were noted
