# Demolition of Chapel for two Residential Dwellings

**Report Title:** Updated Dusk Survey Results

**Address:** Salem Chapel, Bank Street, Rhos, Wrexham, LL14 1EN

**Issued:** 15<sup>th</sup> October 2019

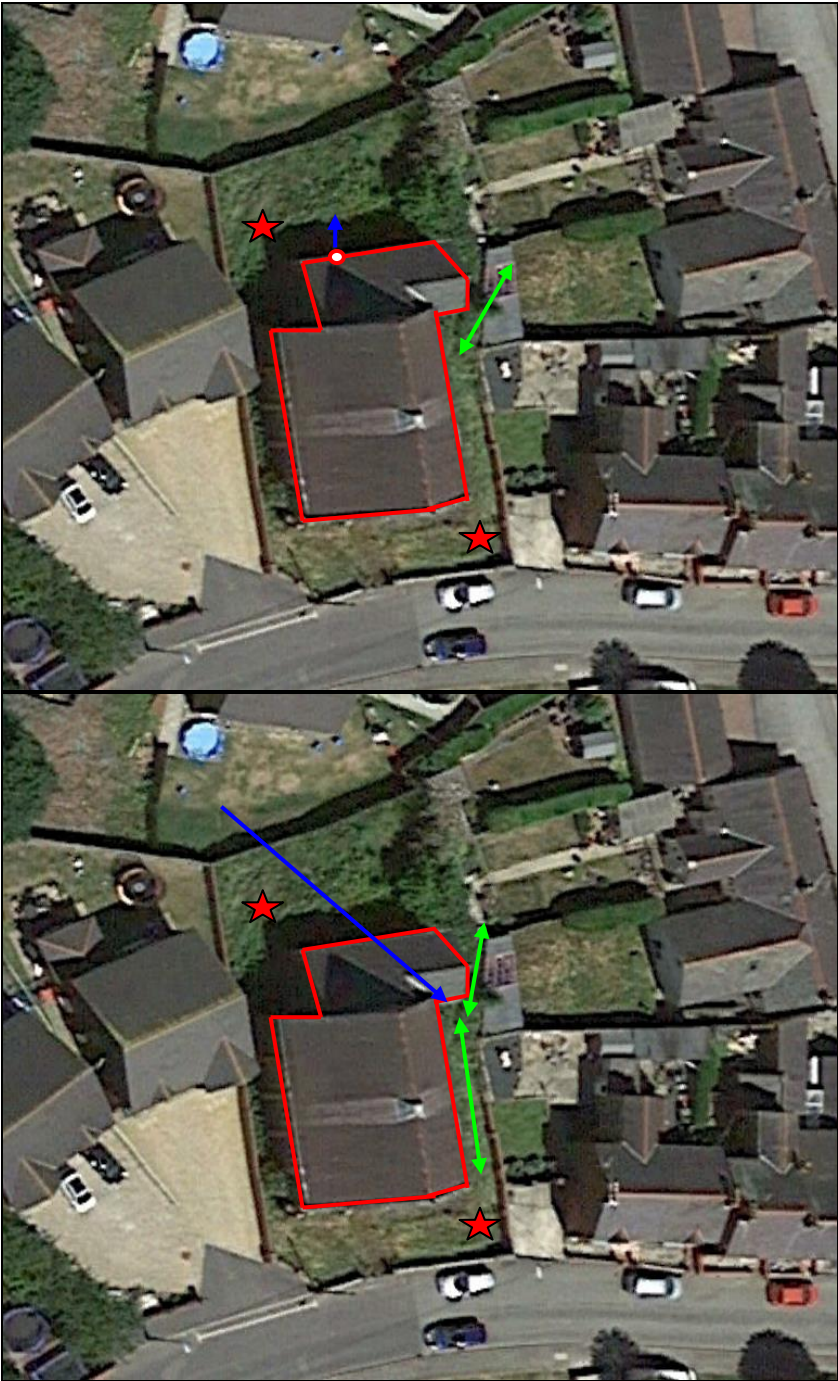
**Figure 3:** Summary of dusk results 2019

| Survey | Date | Results |
|---|---|---|
| Dusk survey<br>1949-2112 | 28 <sup>th</sup> August 2019 | <p><b>Summary: Emergence of a single common pipistrelle bat from the northern elevation from wall plate.</b></p> <p>2026 hrs: Common pipistrelle emerged from the wall plate on the northern elevation.</p> <p>2047-2058 hrs: Common pipistrelle bat sporadically foraging to the east of the building on the eastern elevation.</p> <p>2048 hrs: Noctule bat commuted overhead.</p> <p>Foraging activity on the site was sporadic with minor common pipistrelle foraging during the dusk survey observations.</p> |
| Dusk survey<br>1900-2025 | 16 <sup>th</sup> September 2019 | <p><b>Summary: No bat emergence for the duration of the observation period.</b></p> <p>1942-2024hrs: Common pipistrelle bat commuted on to site commuting in a southerly direction then occasionally foraged along the eastern elevation.</p> <p>Foraging activity on site was occasional with a singular common pipistrelle foraging during the dusk survey observations.</p> |

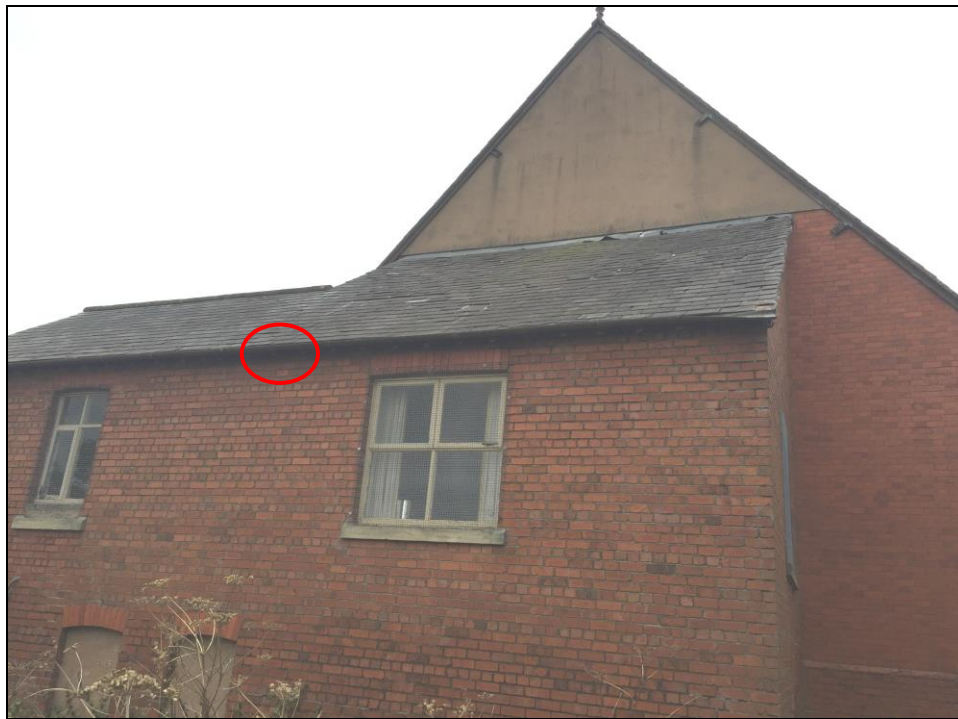
**Figure 4:** Common pipistrelle emergence point at wall plate indicative.

- 4.1 From the updated dusk survey, it is concluded that the results confirm the continued presence of a single common pipistrelle bats (peak count of one) out of the wall plate on the northern elevation. Salem Chapel is thus concluded to still be host to a day roost of a common pipistrelle bats (*Pipistrellus pipistrellus*), consistent with dusk results from the 2017 survey effort.
- 4.2 The damage/destruction of a bat roost/s will need to be addressed from both a conservation and legal/planning perspective along with the application of appropriate mitigation. A European Protected Species Mitigation Licence (EPSML) will be required to legally damage/destroy a place that is used for rest or shelter (roost) by bats; in this case the roost identified at building at Salem Chapel.

- 4.3 Relative to bat roost mitigation, proposals that entail a scheme of mitigation are contained within section 11.0 of the Tyrer Partnership (now Tyrer Ecological Consultants Ltd) dusk report remain applicable.
