### Sion Chapel Bat Method Statement

**Required by Wrexham County Borough Council, consent P/2019/0828 dated 11/12/19 - Condition 20**

| <b>Site Address:</b> | <b>Sion Chapel</b><br>Pontfadog, Wrexham, LL20 7AR |

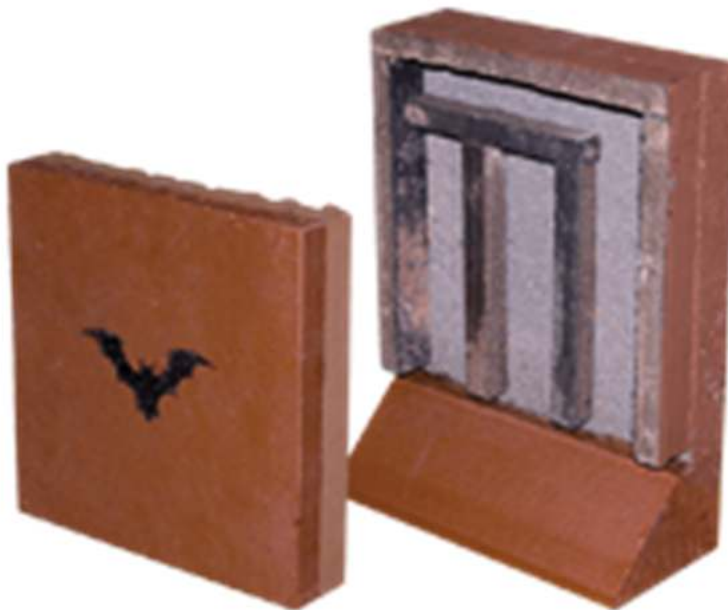
- (i) Provide two wall constructed purpose designed bat boxes of the Ibstock brick make using their design C, (see details <https://ibstockbrick.co.uk/kevington/eco-products/>), one each on the southwest and northwest elevations at over 3m height.

| <b>Timetable of Works</b> | | | |
|---|---|---|---|
| 01 | Provide two wall constructed purpose designed bat boxes of the Ibstock brick make using their design C, one each on the southwest and northwest elevations at over 3m height. | Need a range of dates e.g. fitted between 01 Oct 2020 and end April 2021 | Ronald Smith |

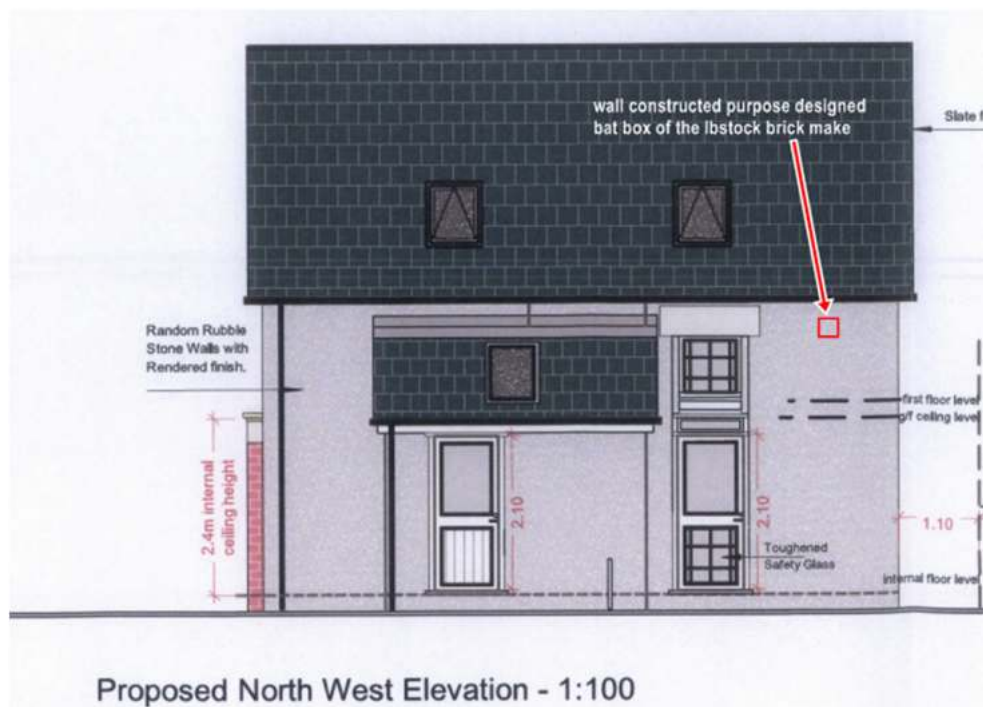
The boxes will be installed in the locations indicated on the plans below:

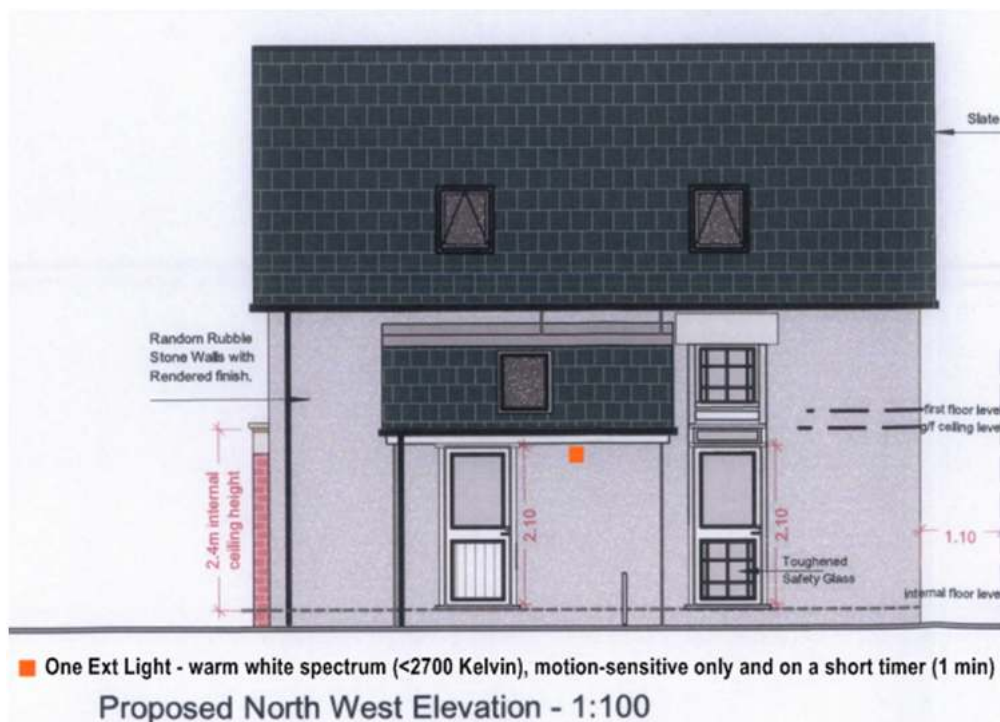
**2 exterior lights will be installed. One on the NW elevation by the back door on the new extension.**
