TAN-Y-CLAWDD BARN ON HIGH ST.  
JOHNSTOWN  
PHOTOGRAPHIC RECORDING REPORT

June 2021

CLIENT: Gower Homes Ltd, Wrexham

**Document Type: PHOTOGRAPHIC RECORDING REPORT**

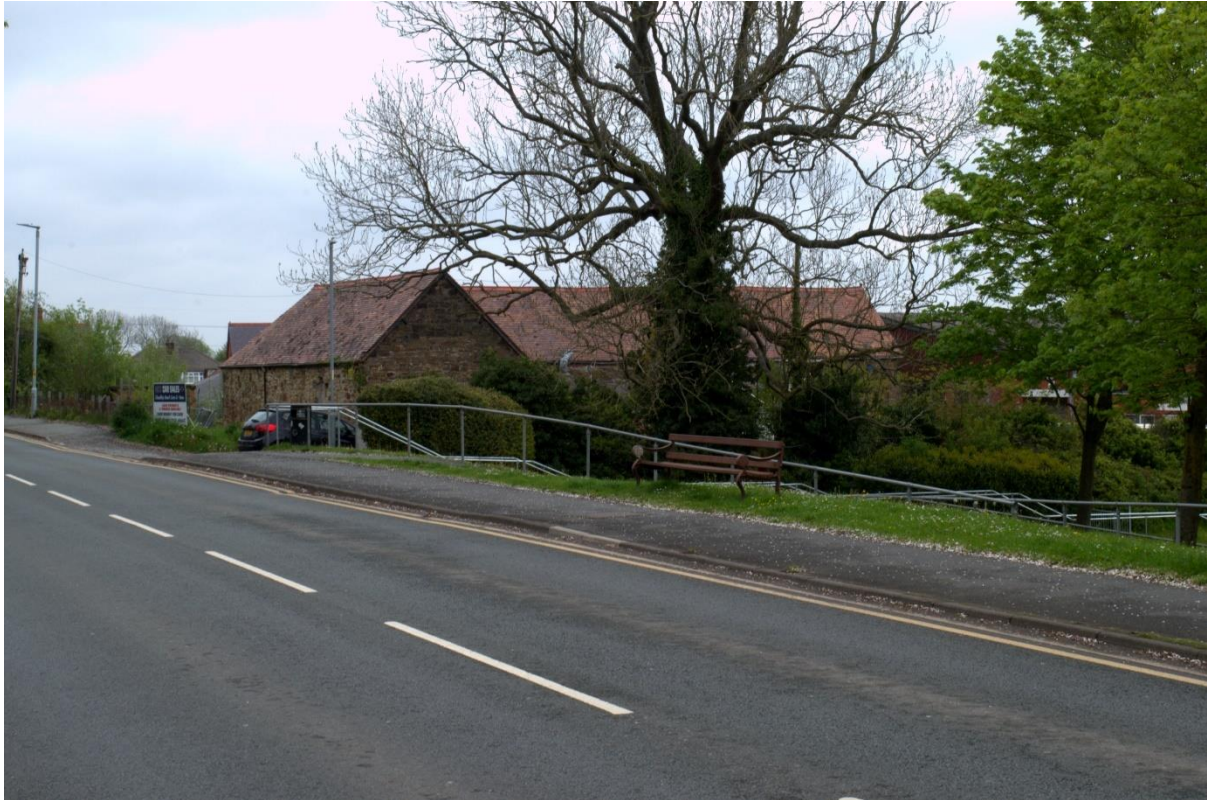
**Figure 5 Site from SW view of the site**

The site covers 0.35 ha. with modern industrial buildings, the former farm building (being the only one of heritage interest) and areas of hard standing and some developing scrub vegetation. The site slopes from W – E with a fall of c. 1m between the west and east sides of the West range and of c 1.75 m between the west elevation of the west range and the east gable of the North Range. The modern road level of the B 5605 is c 1.5m above the ground level adjacent to the west elevation of the West Range. The buildings were used for light manufacturing until recently (Figures 5 - 7).

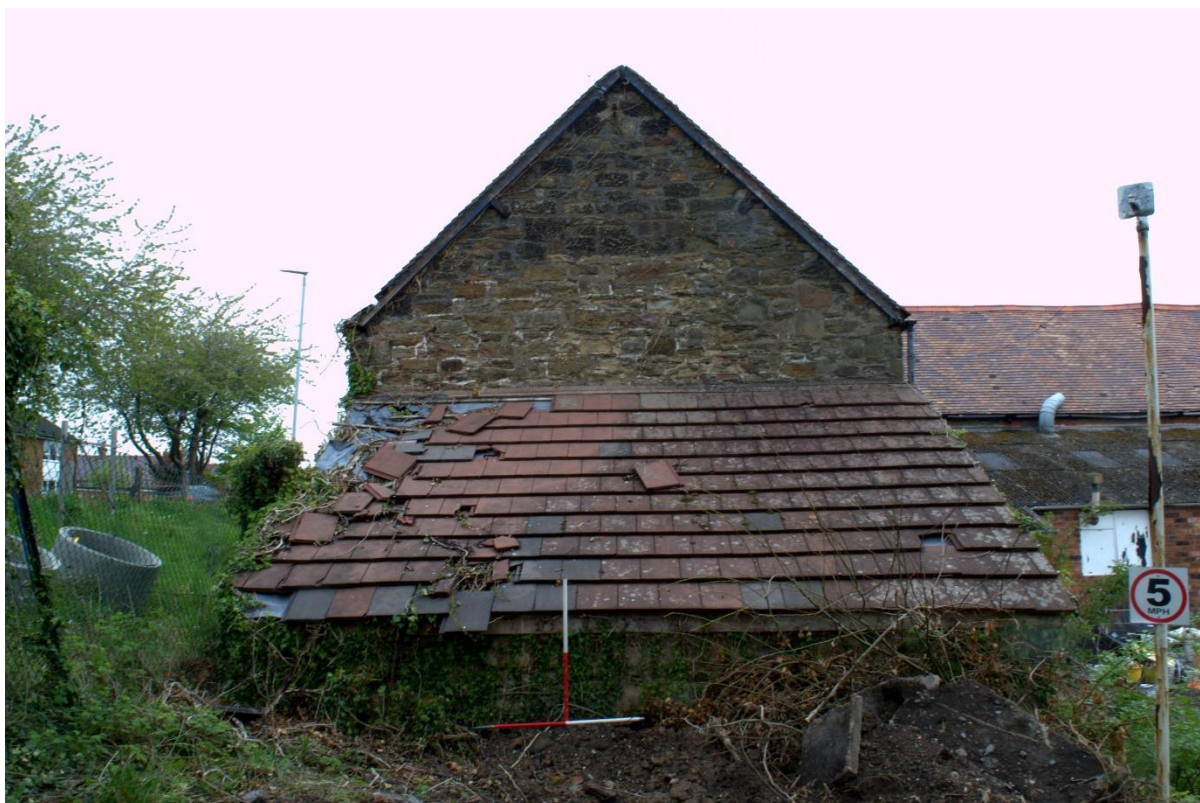
3.1.3.A stone-built lean-to has been added to the southern end of the West range, a brick built lean to along most of the southern elevation of the North range and a brick built, single story shed added to the north elevation of the North range, running S-N from the eastern end (Figures 10 - 12).

**Figure 10 West range South gable and South lean-to**

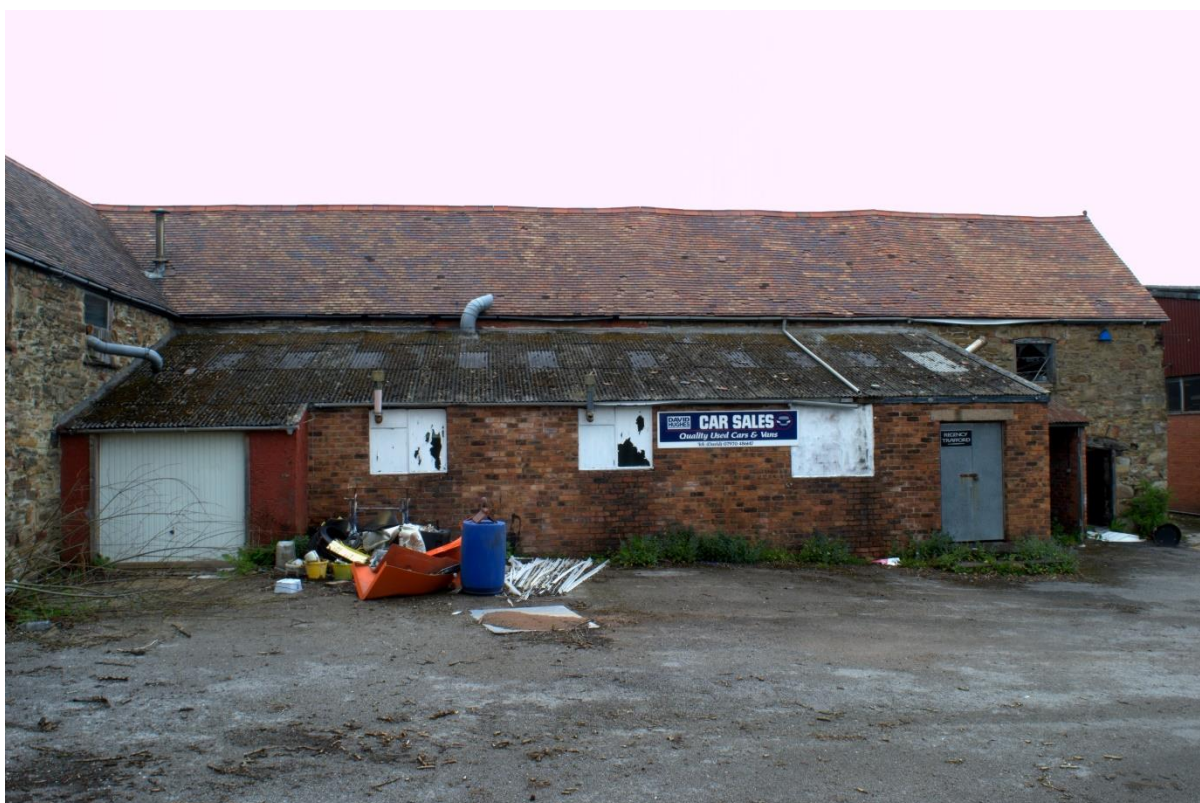
**Figure 11 North range South elevation with added brick lean-to**

- 3.1.9.1. The south elevation of the lean to has a pedestrian door, three windows which are currently boarded up and a garage door of the “up and over” type on the outshot abutting the West Range wall (see Fig. 11 above).

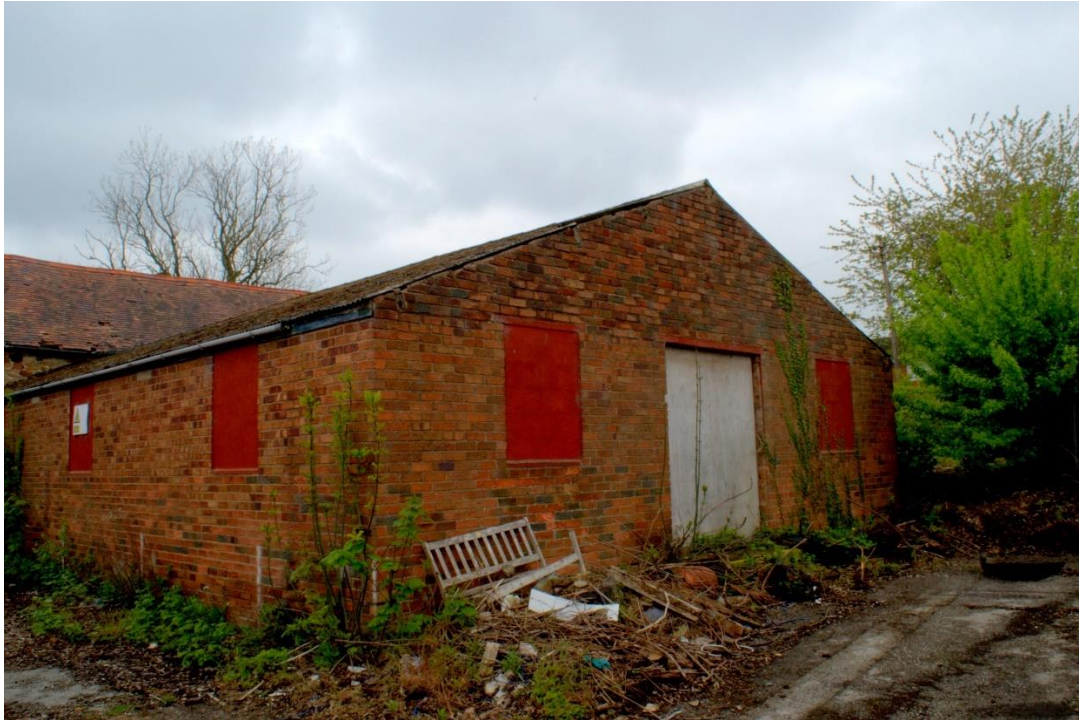
**Figure 12 Brick shed added to North elevation of North Range**

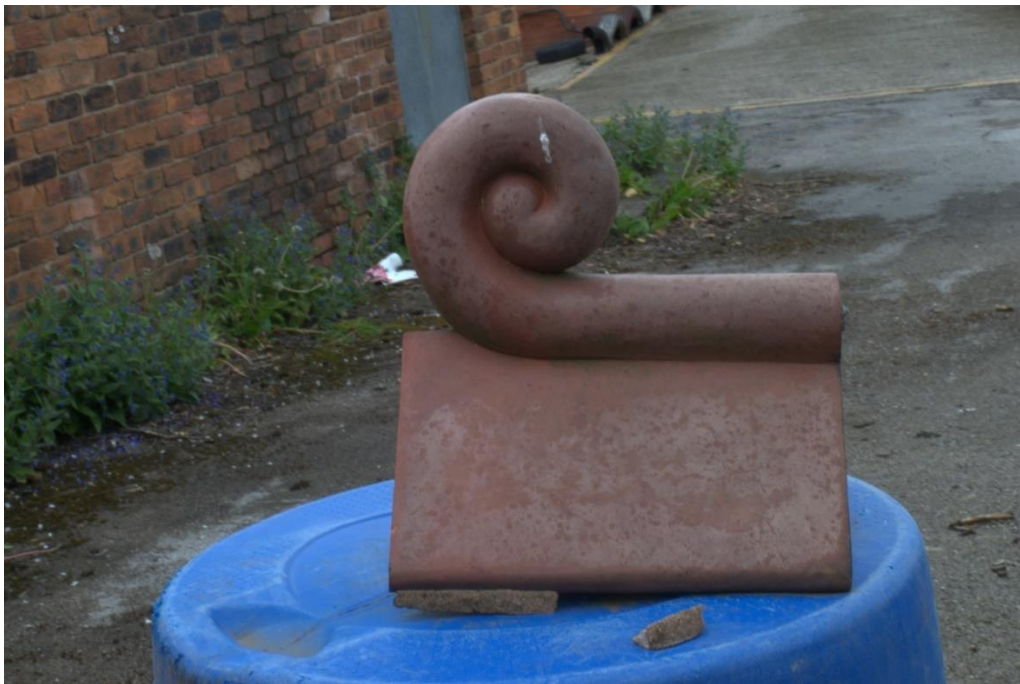
3.1.4. The main building and southern lean to are covered with red, unglazed, ceramic tiles (probably locally produced from one of the brick and tile works centred around Ruabon) with spiral decorated finials one of which was loose and which is stamped “Dennis Ruabon” and with the letters S T and 90° graffitied onto the underside, along with rows of triple prick holes which may be to help key the tiles to mortar or to speed the drying process (Figures 13 and 14). The brick built lean-to, and the brick single story range are both roofed with corrugated, fibrous cement sheet.

**Figure 13 Ridge finial tile side view**

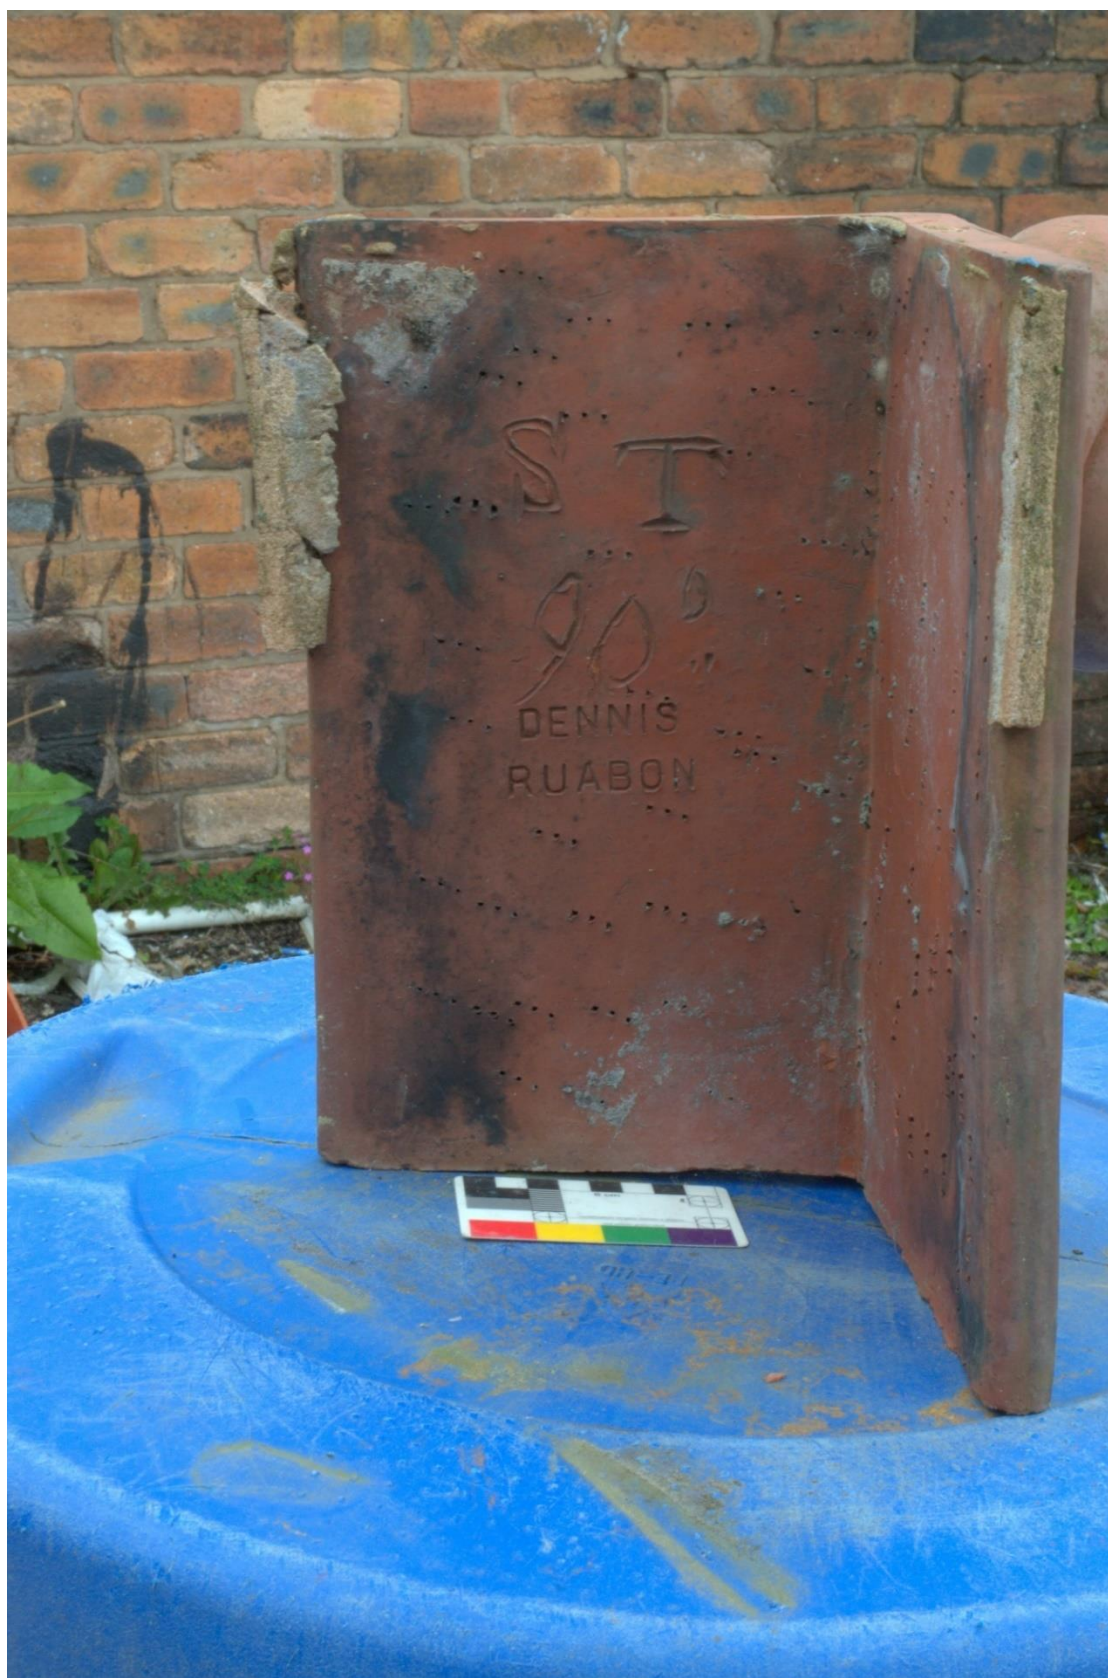
**Figure 14** Roof finial tile, underside

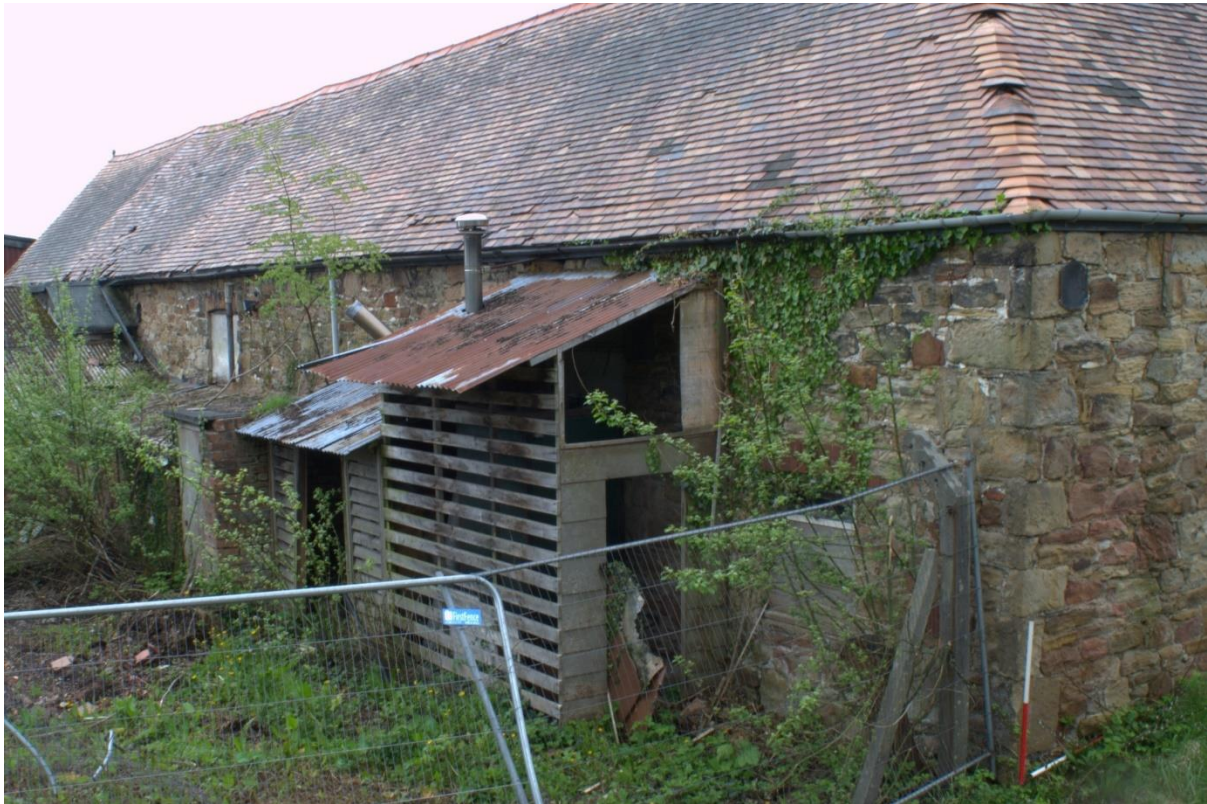
- 3.1.5.1. The north elevation has the later brick range attached towards its eastern end and two small lean-to structures of timber and corrugated iron sheet towards the western end. The latter are probably related to the 20th C industrial uses of the building, and both have ventilator pipes protruding through their roof (Figure 15)

**Figure 15 North range, north elevation, later lean to structures.**

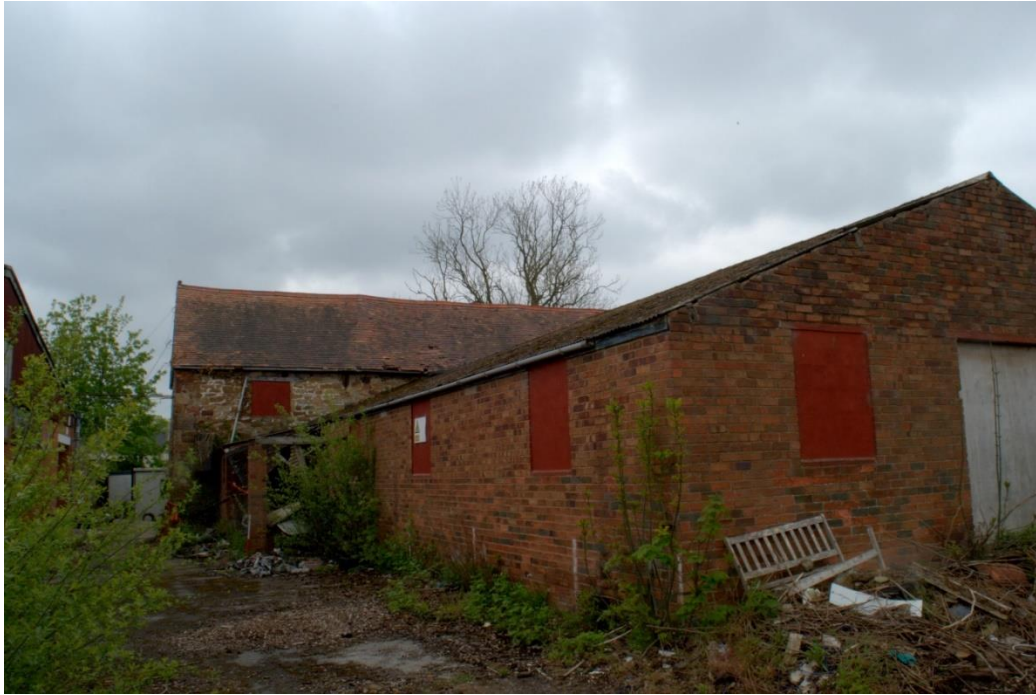
- 3.1.6.1. The single storey brick shed was built towards the eastern end of the north elevation of the North Range. The shed has a small enclosure formed by brick pillars and a flat roof at the southern end of its east elevation (Figure 16).

**Figure 16 Brick shed addition to E end North elevation of North range from NE**

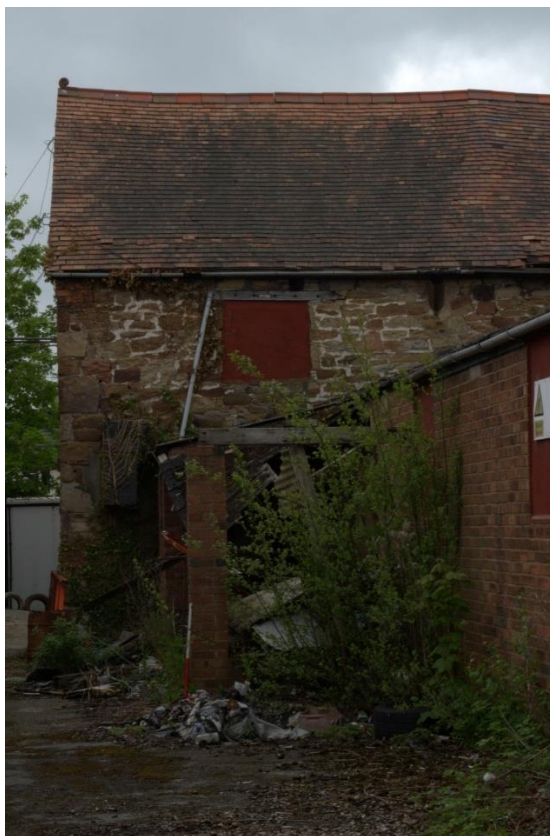
3.1.6.2. Above the level of the eaves of the brick shed is a square window into the upper level of the North Range. This has a flat timber lintel, with several circular holes possibly indicating it is reused from an earlier building. Below the current cill joints in the stonework suggest the cill of the window has been raised slightly (Figures 17 and 18).

**Figure 17 North range North elevation Eastern end**

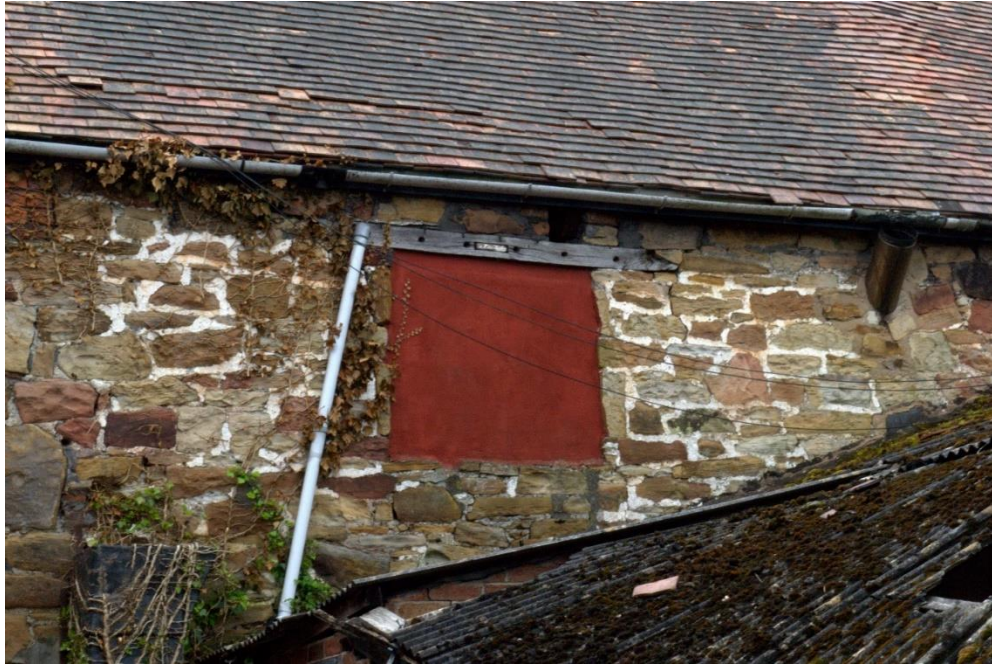
**Figure 18 North range North elevation eastern end upper window detail**

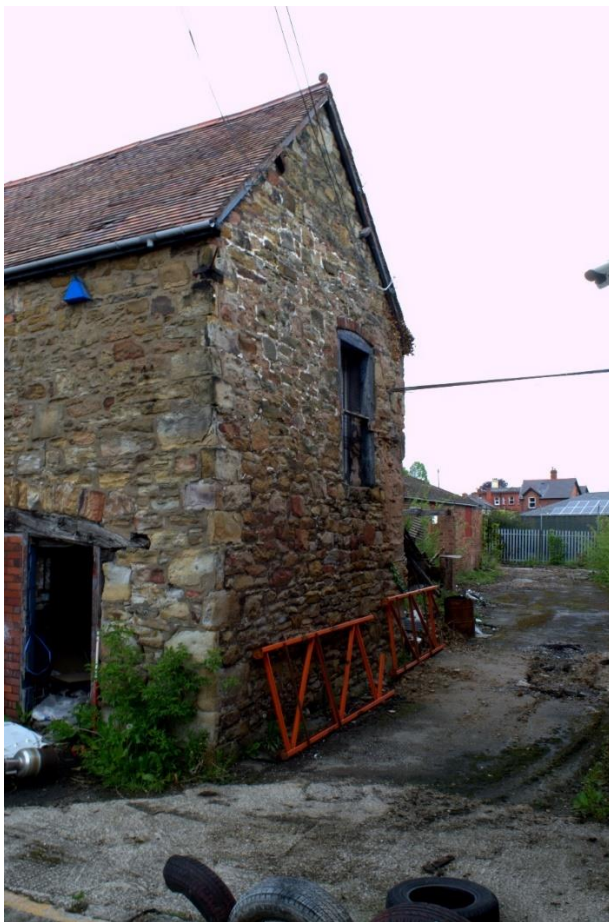
- 3.1.7.1. The eastern elevation of the north range is a gable end with a window, possibly originally a pitching window for a hayloft, in the upper part (Figures 19 and 20).

**Figure 19 East gable of North Range from SE**

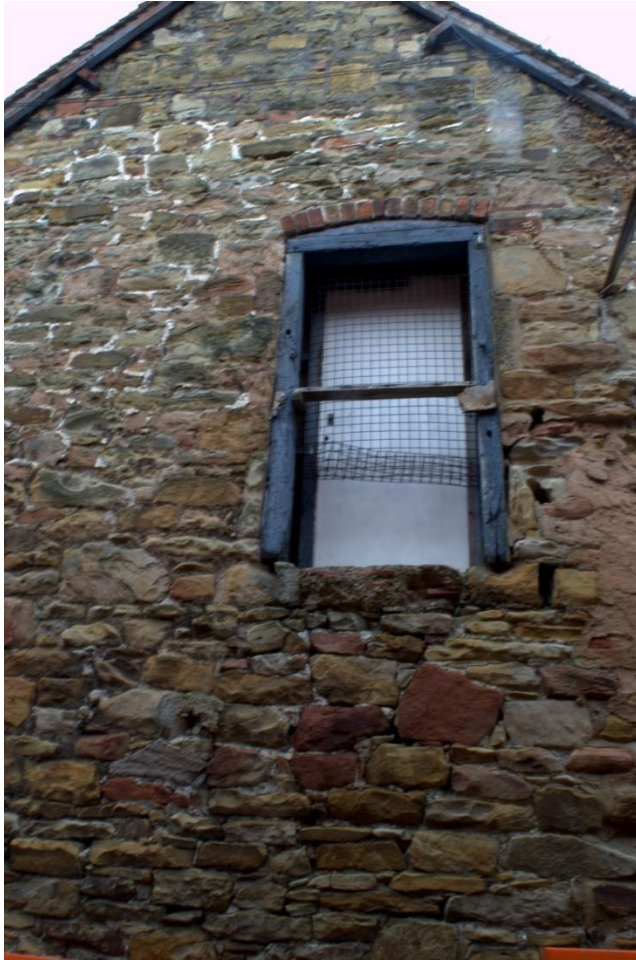
**Figure 20 East gable window**

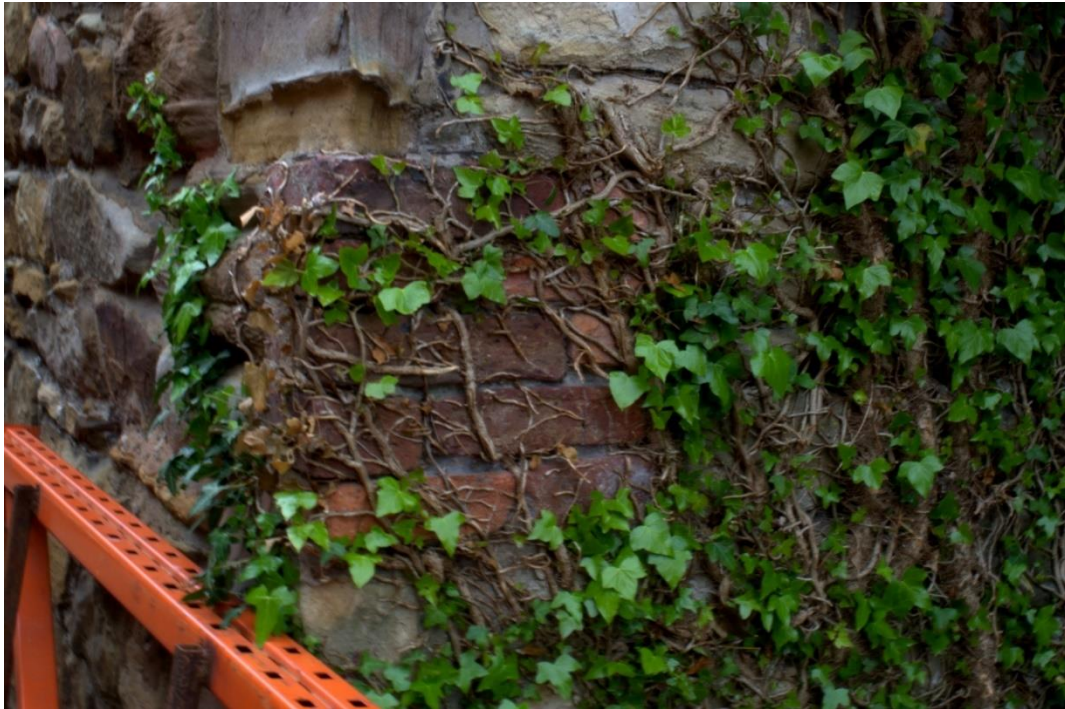
- 3.1.7.2. One of the original stone quoins appears to have been lost and replaced with brickwork (Figure 21).

**Figure 21** Brick patch replacing stone quoin NE corner of North range

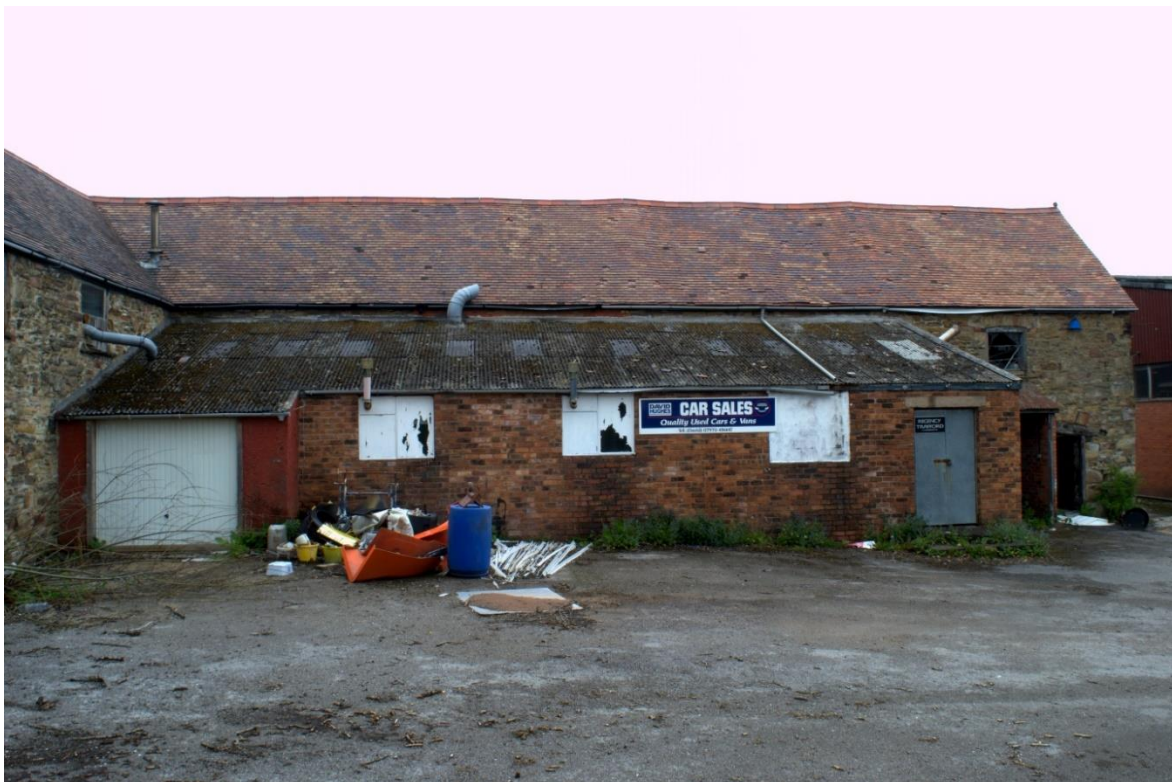
- 3.1.8.1. The south elevation of the North Range of the stone barn is largely obscured by the brick lean-to that has been built against the original buildings wall (Figure 22). This has an additional brick outshot at the western end, butted against the eastern face of the West Range (figure 23).

**Figure 22** Lean-to on South elevation of North Range

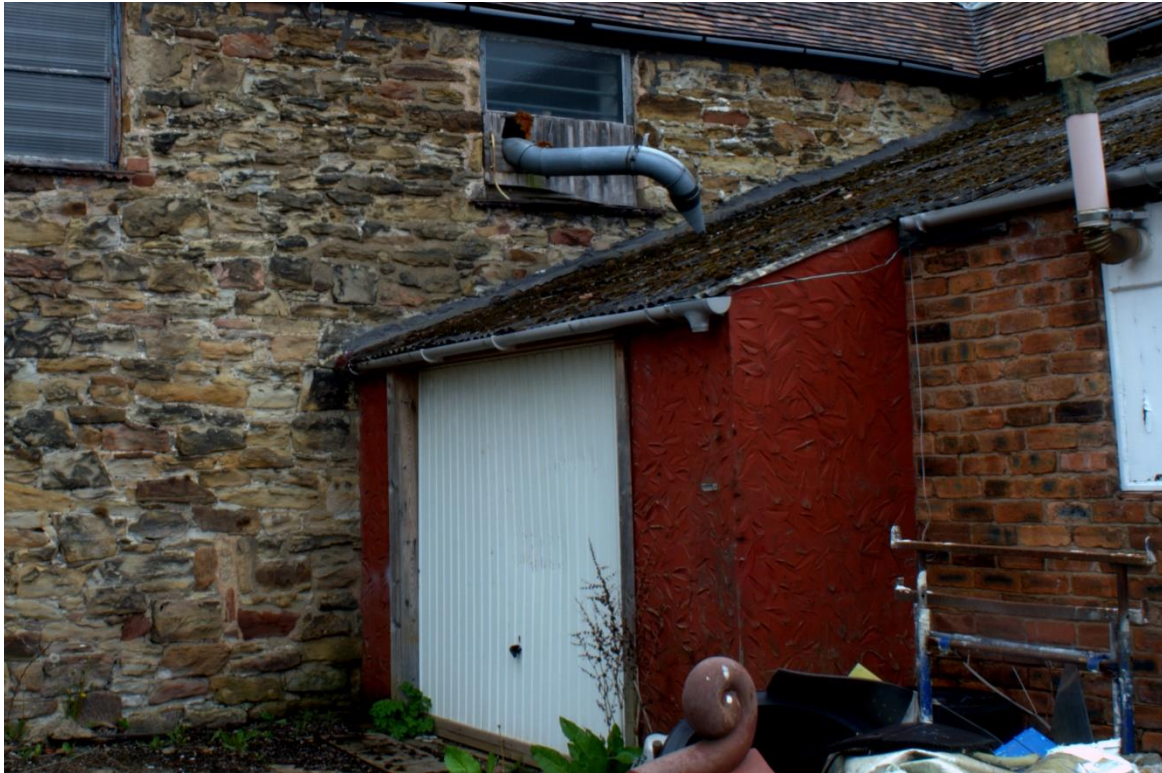
**Figure 23 East elevation of West range with lean-to outshot**

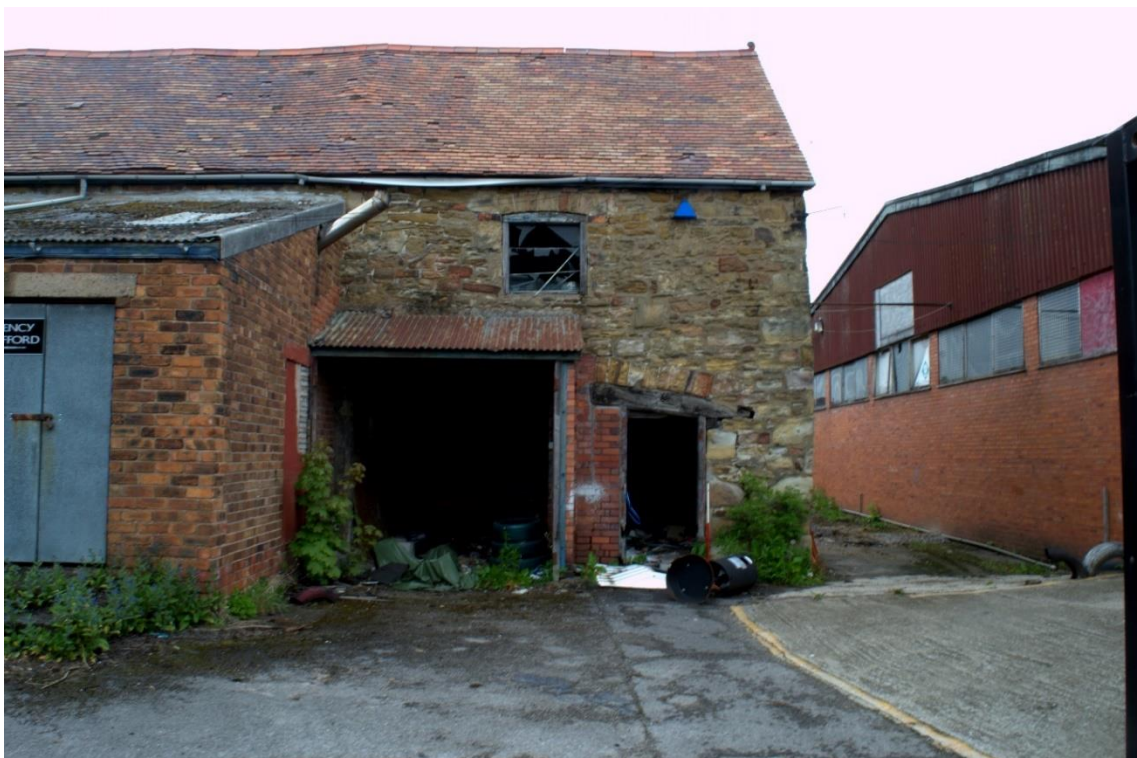
- 3.1.8.2. At the eastern end there is a pedestrian doorway with a substantial, curved, wooden, lintel below a segmented arch of dressed stone adjacent to the western end of the brick lean to (Figure 24).

**Figure 24 North range East end of South elevation**

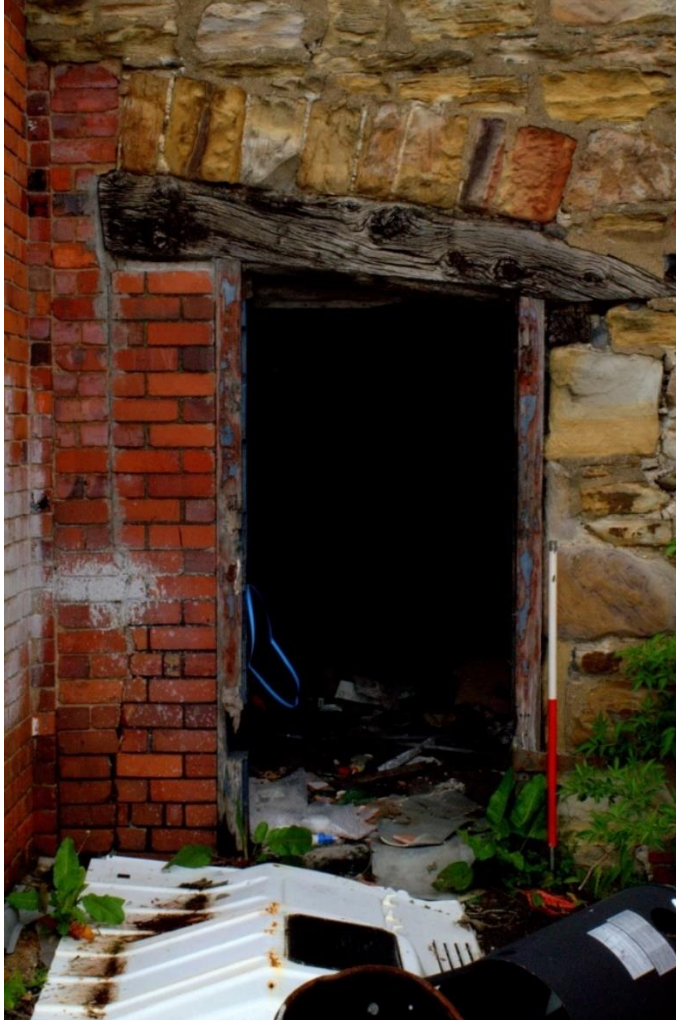
- 3.1.8.3. This appears to be the surviving remnant of a wider arched opening, perhaps for a wagon or cart shed. The original opening has been altered by cutting away the left-hand half of the lintel, underbuilding it and creating a new opening to the left of the remodelled doorway which has removed the other part of the original opening (Figures 25 and 26).

Figure 25 Detail of remaining part of original doorway West end South elevation North range.

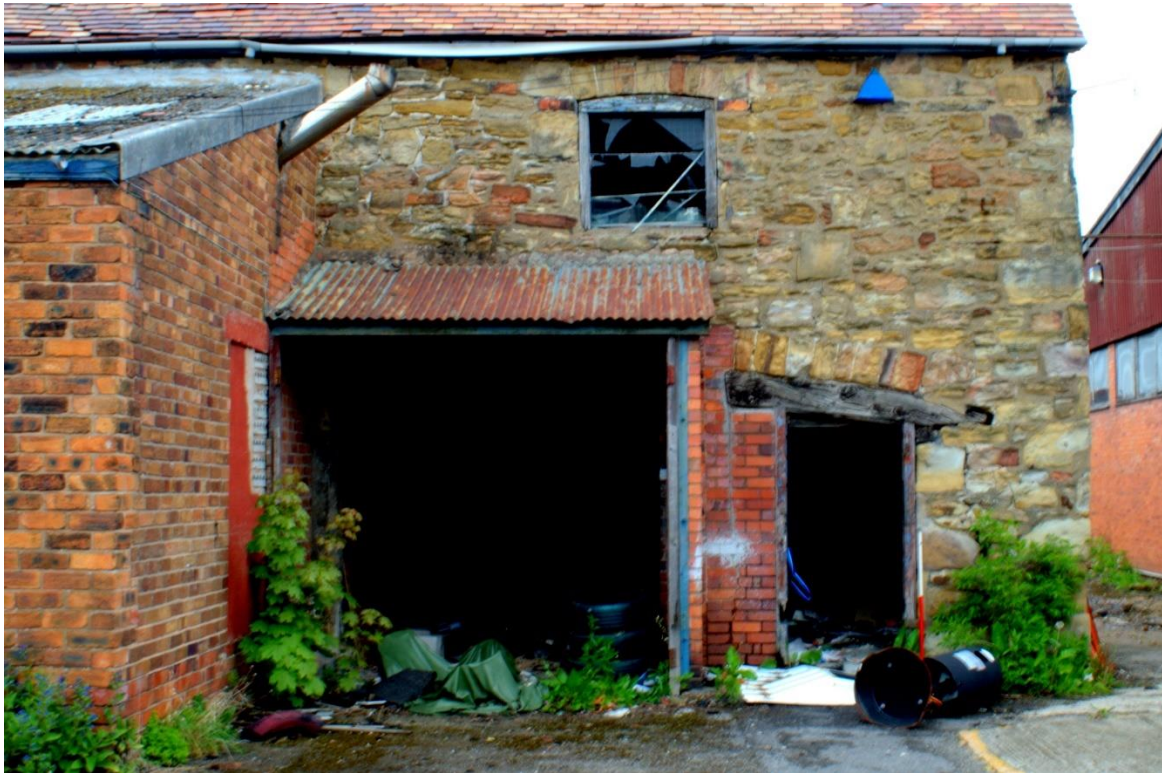
**Figure 26 Altered original and later inserted openings at Western end, South elevation North Range**

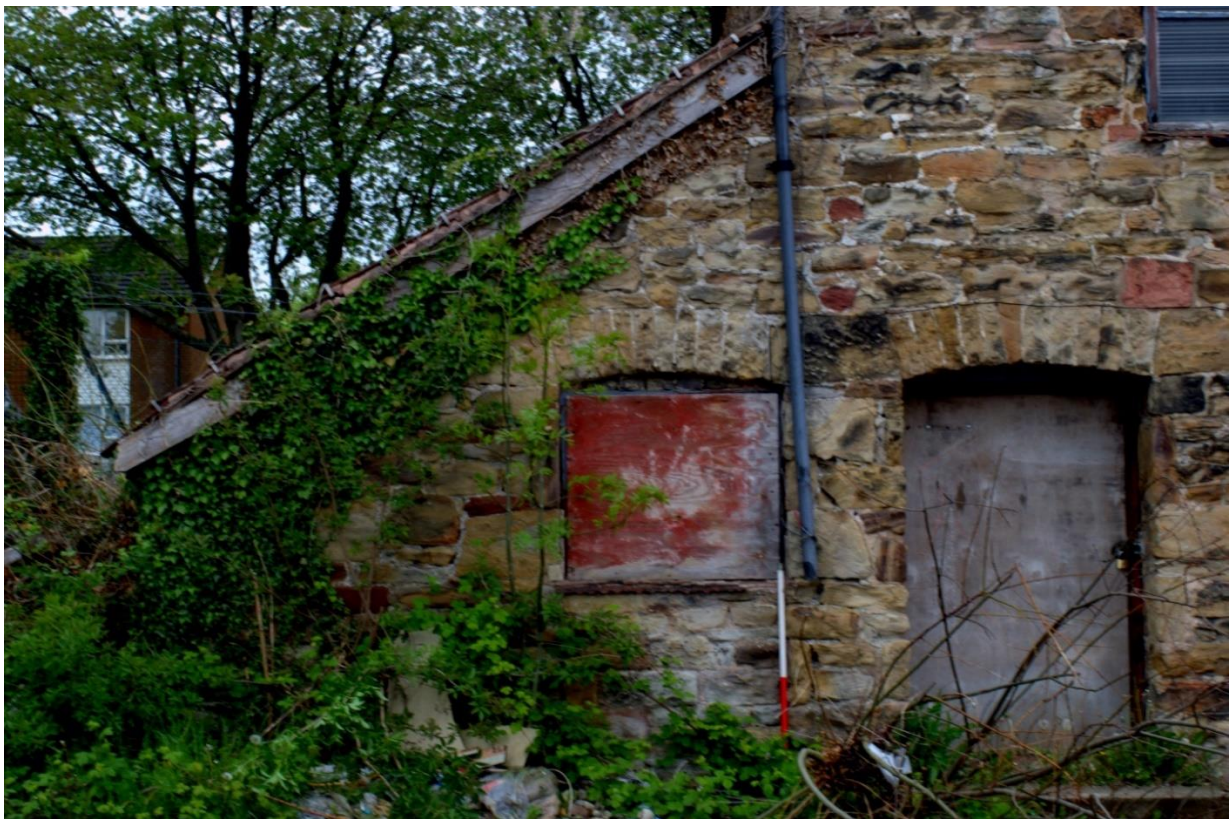
- 3.1.10.1. The southern elevation of the West Range is obscured on its northern part by the North Range and the lean to. The southern end (left when facing) is the east elevation of the single-story lean to on the south gable end. This has a window, currently boarded up, under a segmented stone arched lintel and with the with the right-hand jamb formed by the primary phase building’s quoins. The cill is composite, made up of mortared, flat, red ceramic tiles (Figure 28 and 29).

**Figure 28 East elevation of lean to on South gable of West range**

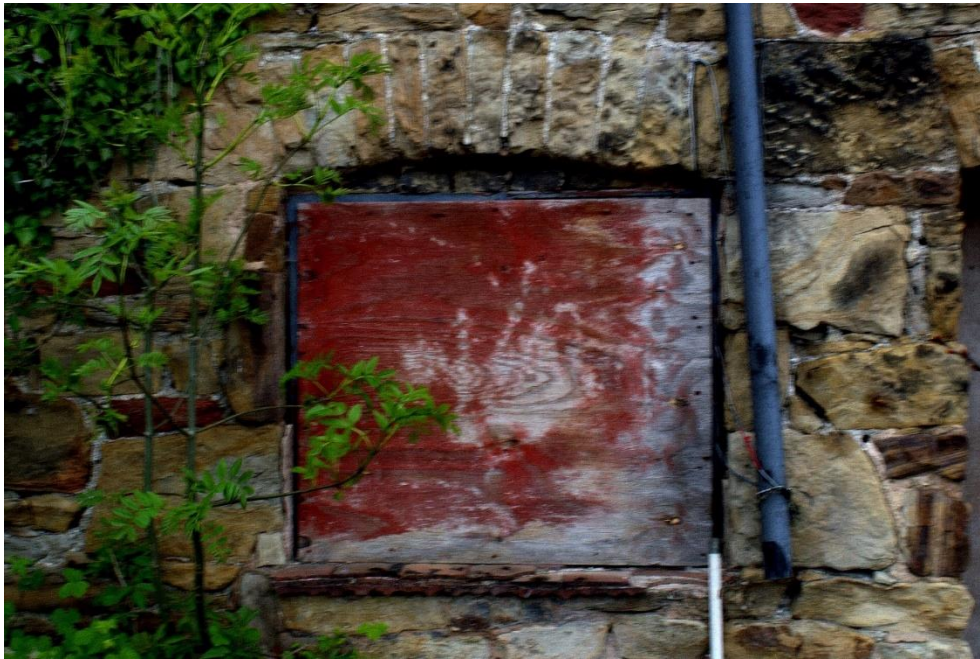
**Figure 29 Window detail**

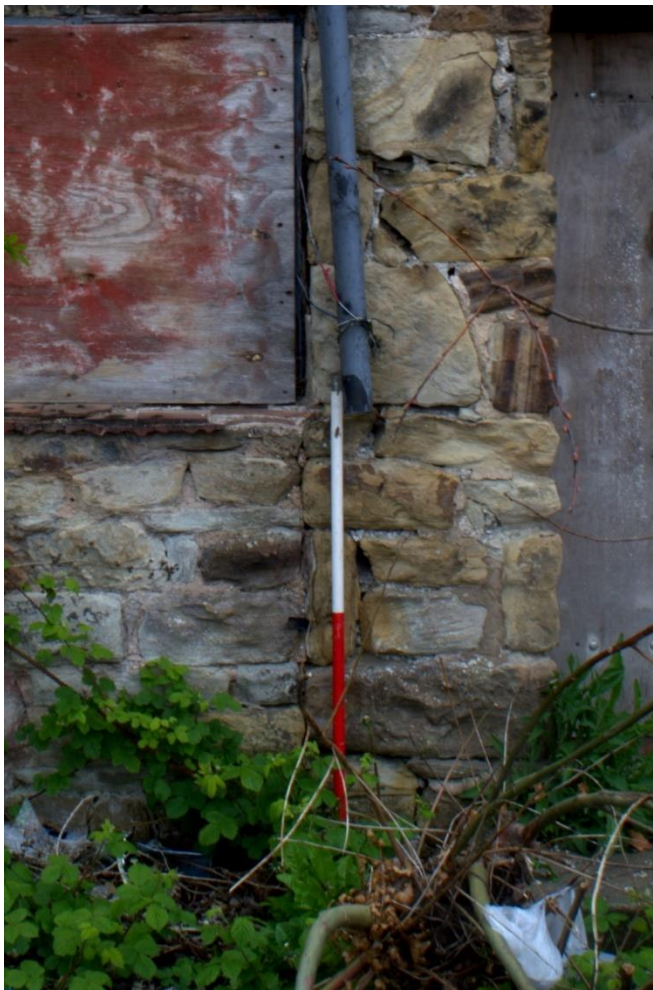
3.1.10.2. Straight joints below the window jambs show that this was originally a doorway (Figure 30)

**Figure 30 Straight joint below lean-to window**

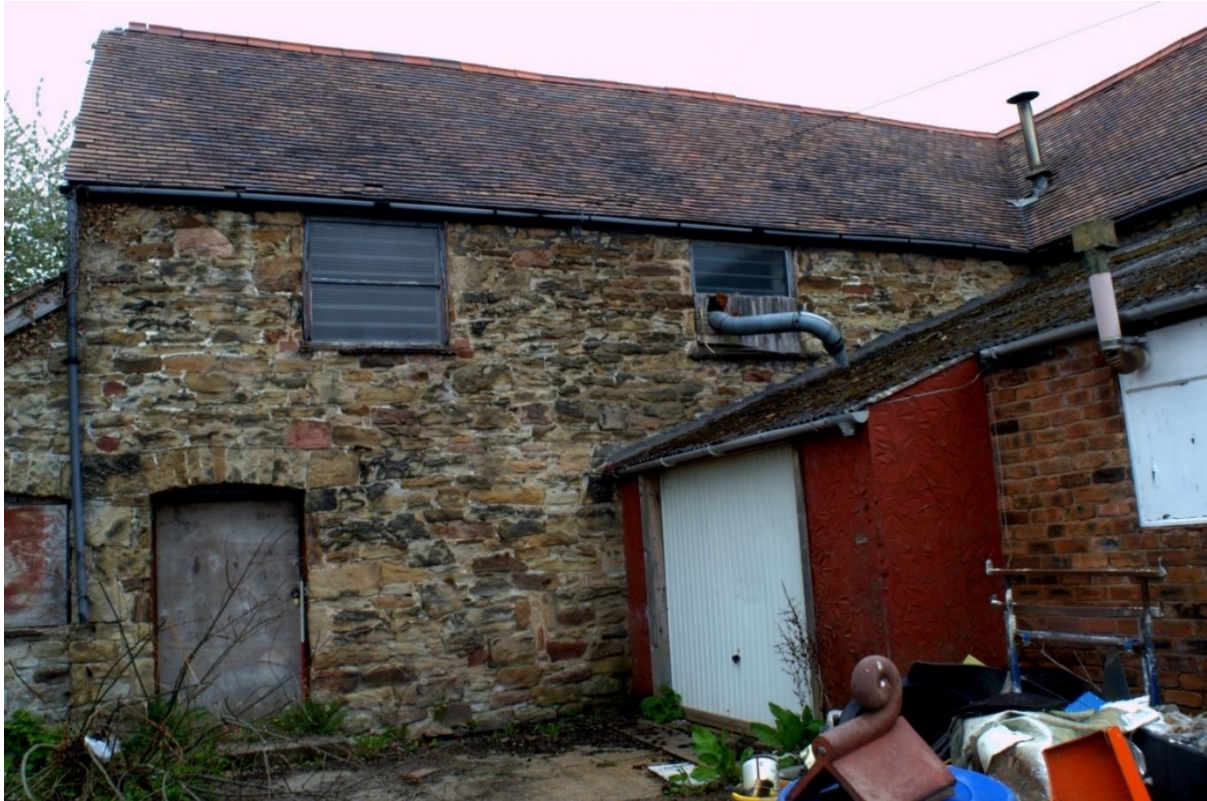
- 3.1.11.1. The eastern elevation of the West Range has a door at the southern (left hand) side, the left jamb of the door being against the gable wall of the barn (Figures 31 and 32)

**Figure 31 Eastern elevation of Southern end of West Range**

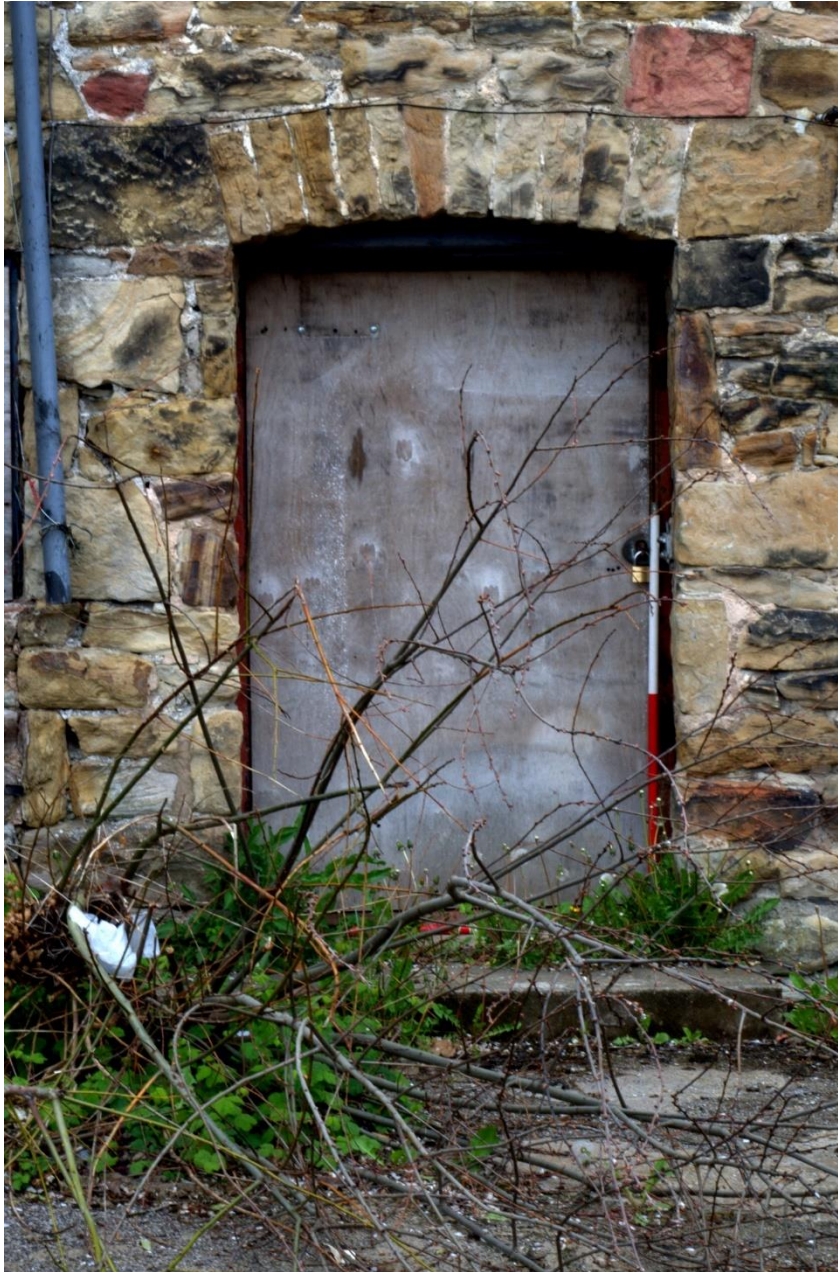
**Figure 32 Detail of door at South end East elevation of West Range**

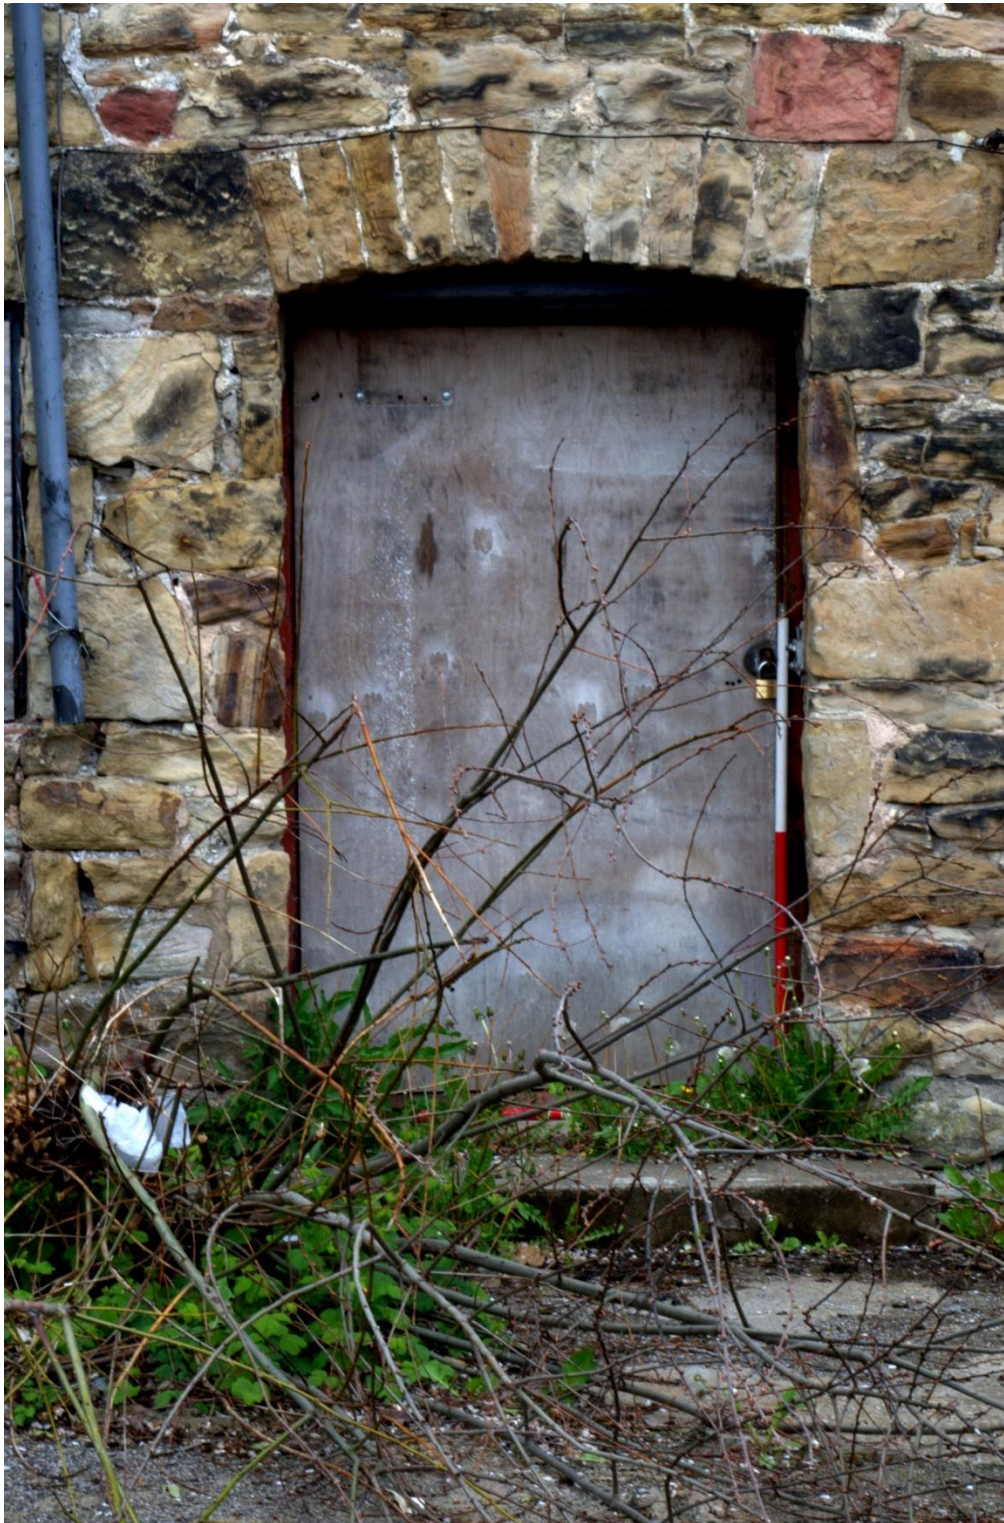
- 3.1.11.2. To the right of the door, and approximately 400 mm above current ground level is a blocked ventilation slit. This is approx. 500 mm high and 75mm wide (Figure33).

**Figure 33 E elevation of barn blocked ventilator**
