TAN-Y-CLAWDD BARN ON HIGH ST.  
JOHNSTOWN  
PHOTOGRAPHIC RECORDING REPORT

June 2021

CLIENT: Gower Homes Ltd, Wrexham

**Document Type: PHOTOGRAPHIC RECORDING REPORT**

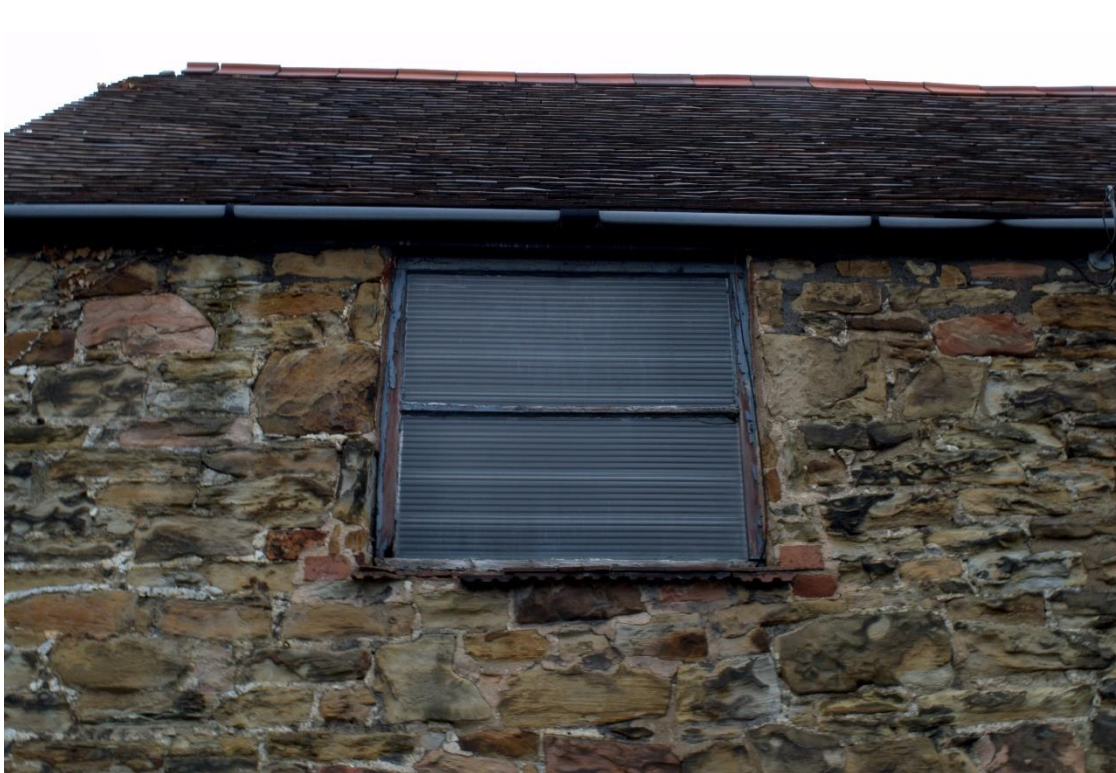
- 3.1.11.3. It is not known if the interior of the ventilators splay into the interior of the building as the interiors have been plastered (see below Fig. 45)
- 3.1.11.4. The upper floor has a pair of windows immediately below the eaves. Both are blocked with modern shuttering. The timber frame of the southern window is visible and the cill appears to be a composite of red, ceramic tiles and cement. The northern window has a large ventilation pipe protruding (Figures 34 and 35).

**Figure 34 West Range, upper floor's window with metal sheet blocking**

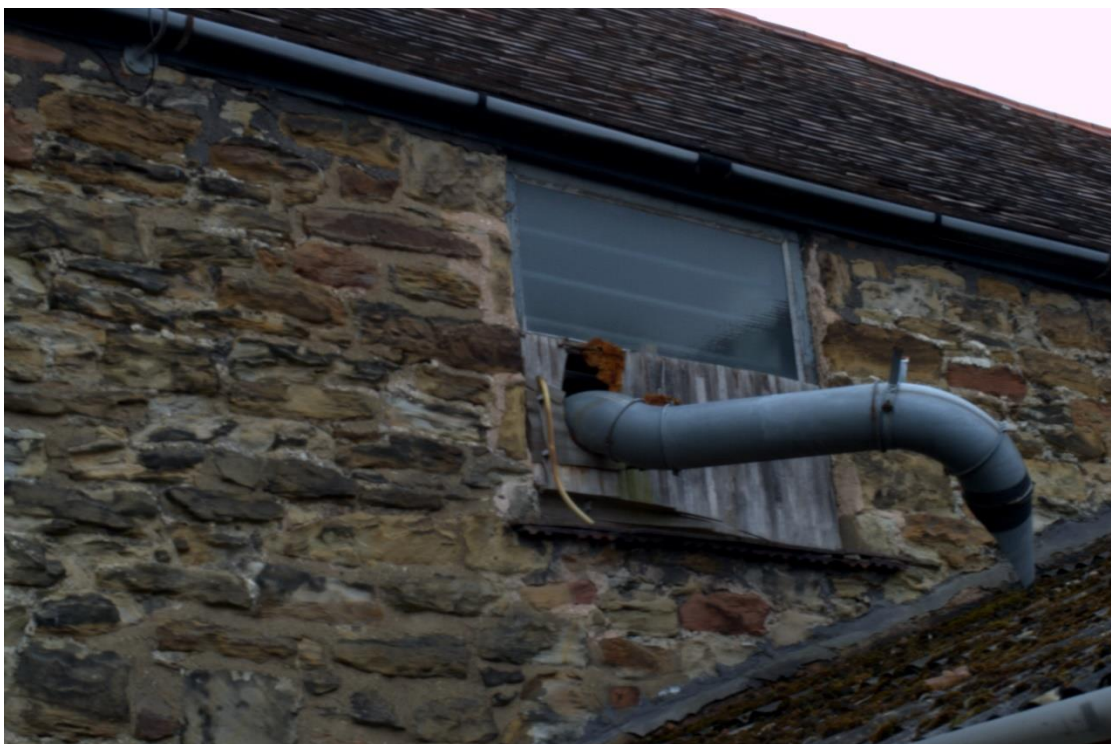
**Figure 35 West Range, upper floor n window with ventilator pipe**

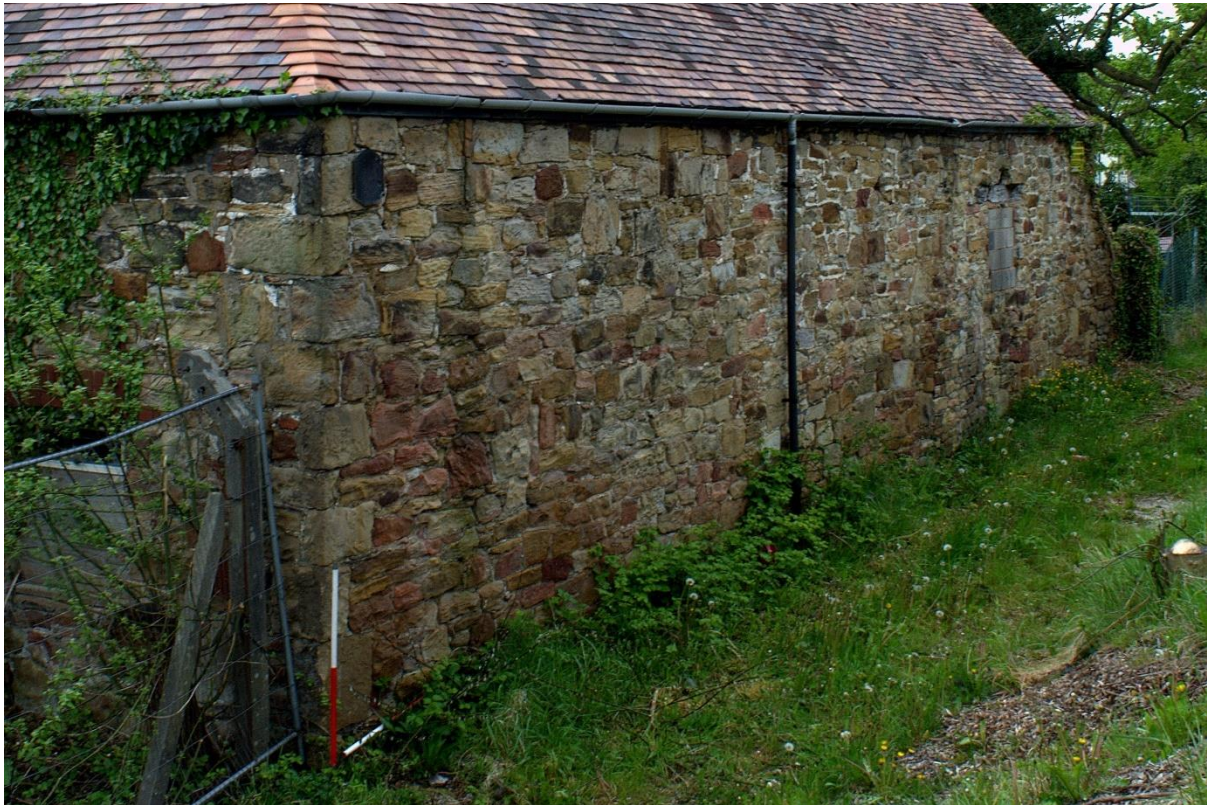
- 3.1.12.1. The western elevation of the West Range faces onto the B5605 and currently presents a superficially rather blank face (Figure 36).

**Figure 36 Western elevation of West Range from NW**

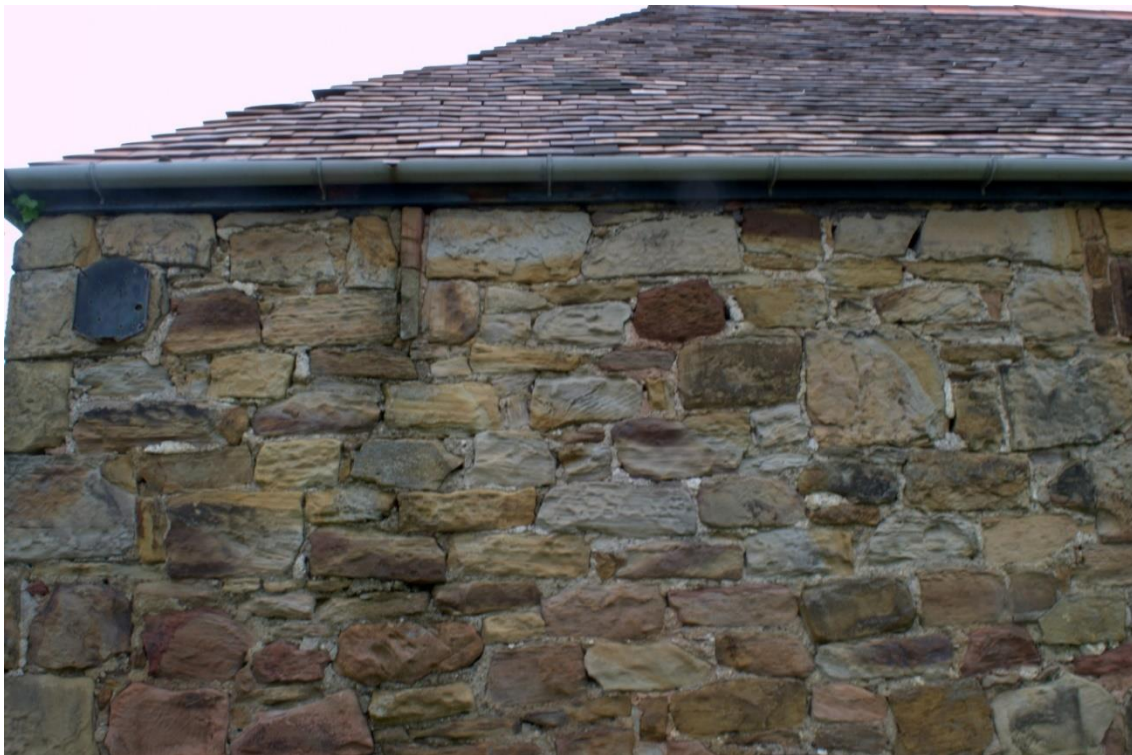
- 3.1.12.2. Originally the elevation had a row of vertical ventilation slits just below eaves level and another row approximately a metre above current ground level (Figures 37 and 38)

**Figure 37 West elevation West Range Blocked ventilator slits below eaves**

4.1.2. Their original function was probably a combination of livestock housing with lofts above the stalls for storing fodder, the former vents being to allow hay or straw stored in the loft to be ventilated and livestock in the lower level of the building to get fresh air.

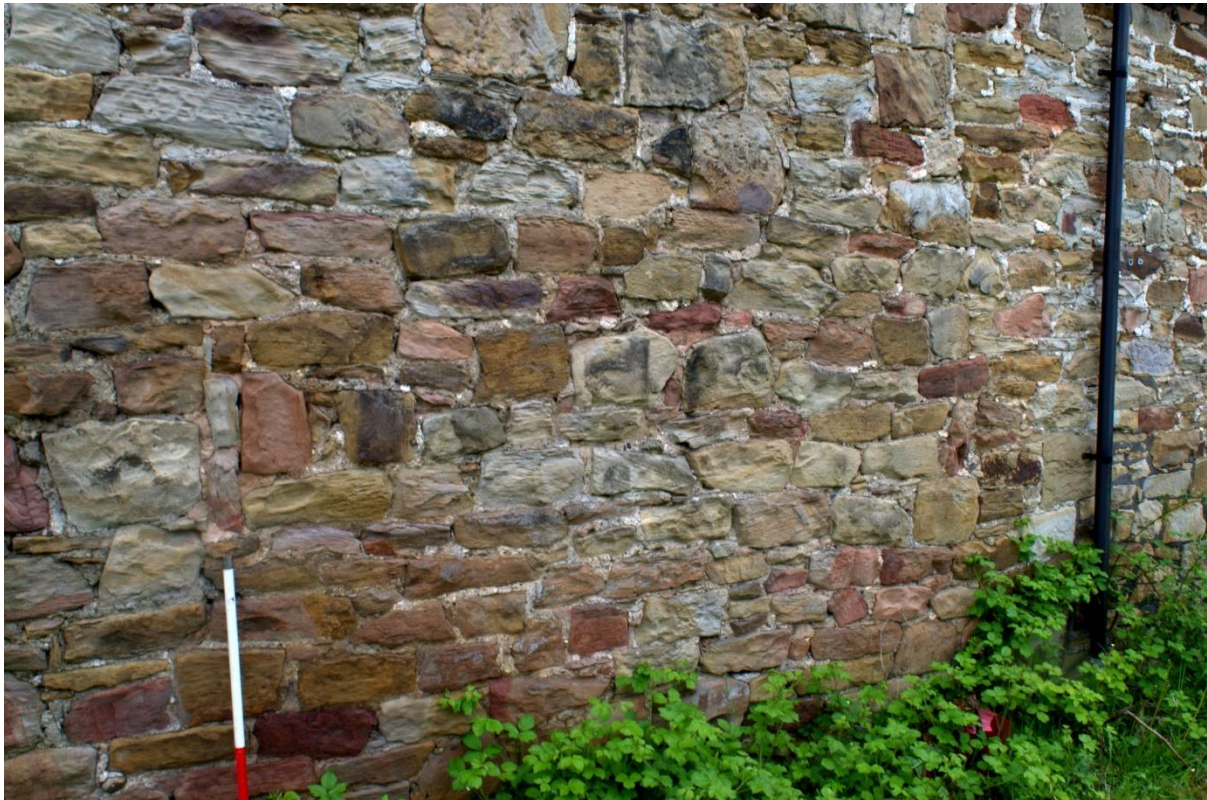
**Figure 38 West elevation West Range Blocked ventilator slits at lower level**

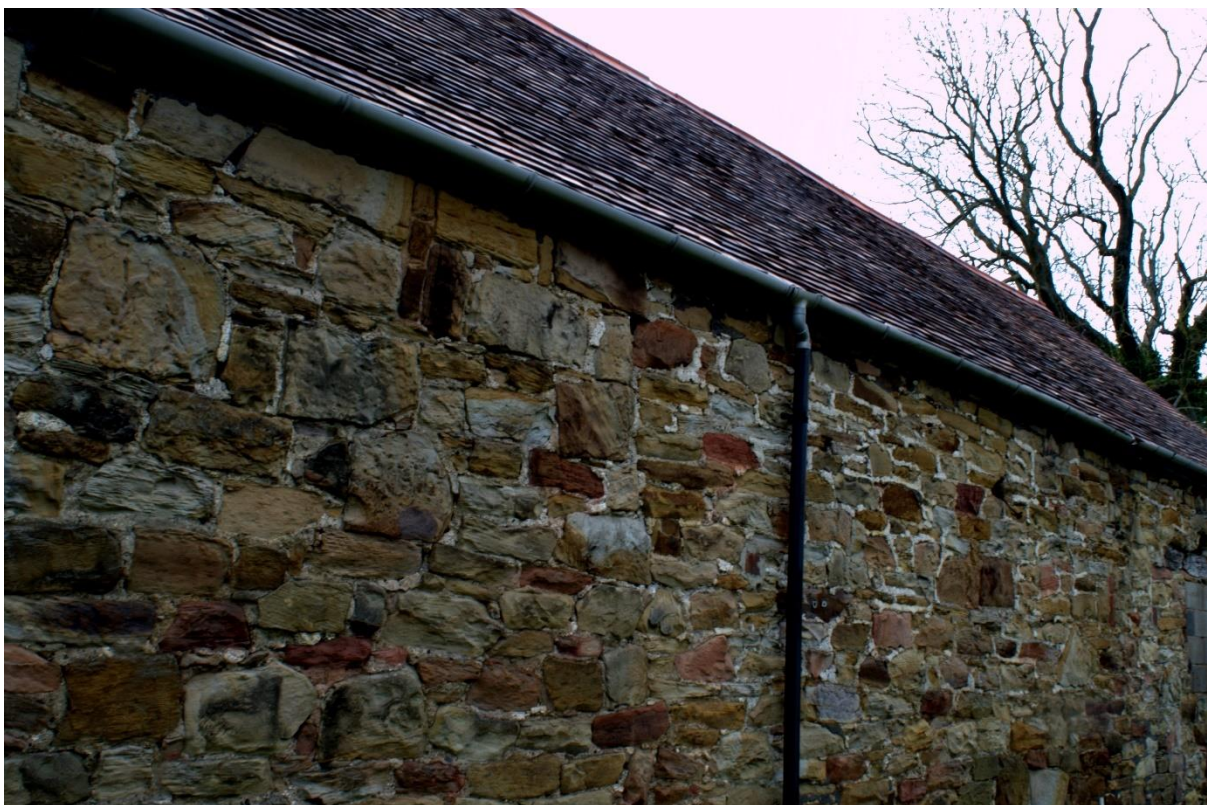
To the left (north) of centre is a vertical straight joint in the masonry. This does not run down to ground level and may indicate a remodelling of a building with an enclosed yard prior to the surveying of the 1st edition O.S.

**Figure 39 West elevation West Range Vertical straight joint**

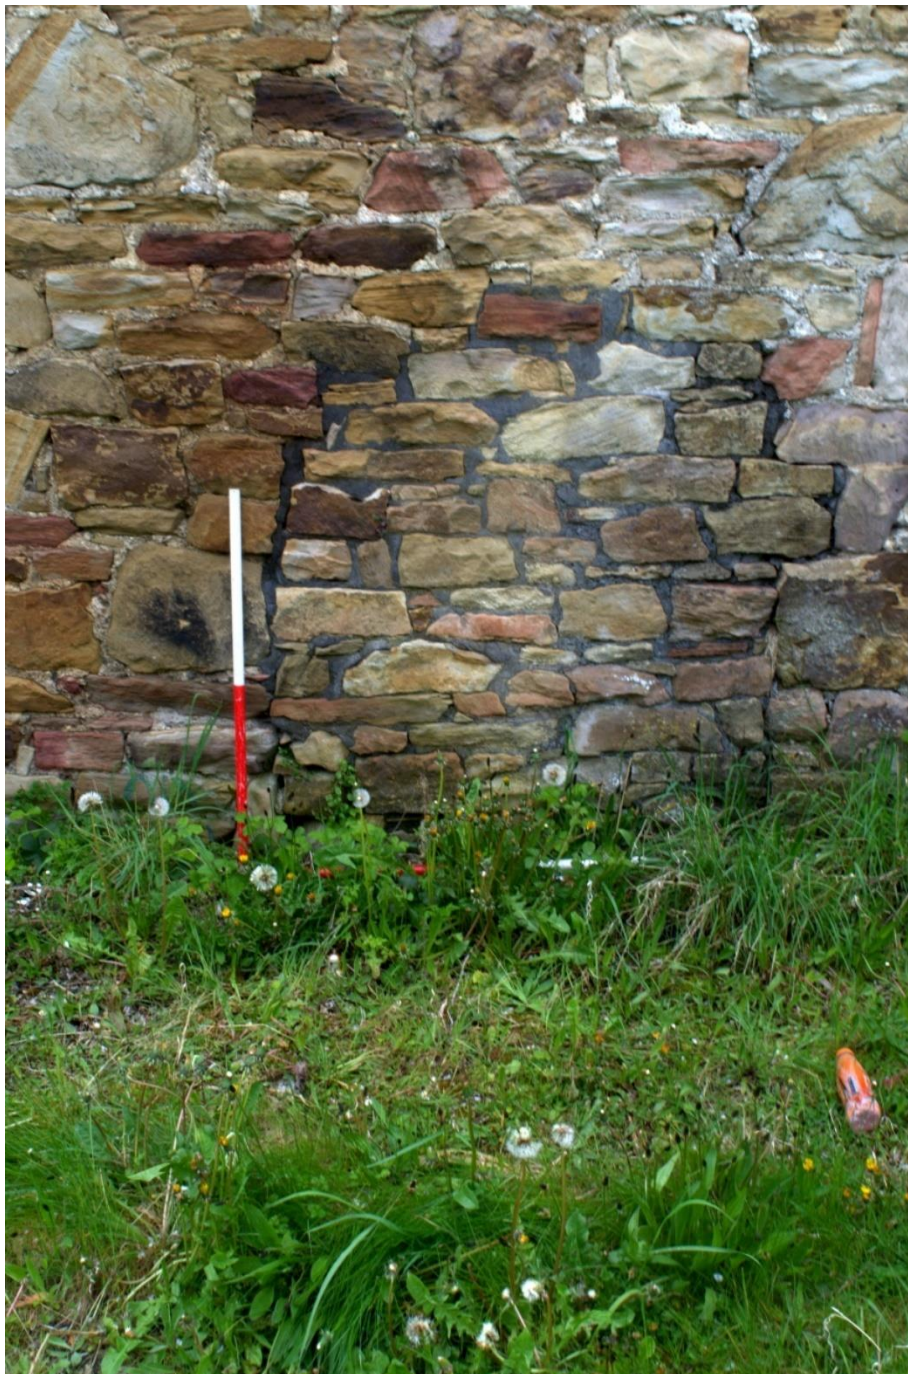
- 3.1.12.3. To the right of centre of the elevation is a blocked opening at ground level, the slightly curved upper edge perhaps indicating that the original lintel was curved (Figure 40).

**Figure 40 West elevation West Range blocked former opening**

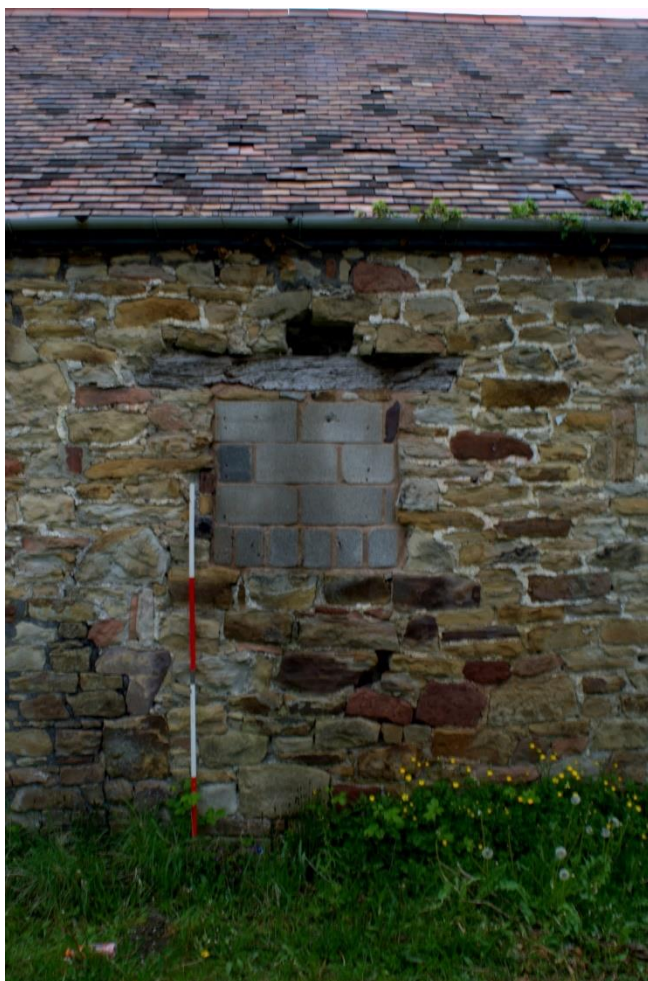
- 3.1.12.4. To the right of the blocked ground floor opening is a blocked opening to the upper part of the building. This has a surviving timber lintel and is blocked with modern concrete blocks and may be a former pitching door (Figures 41 and 42).

**Figure 41 West elevation West Range blocked pitching door**

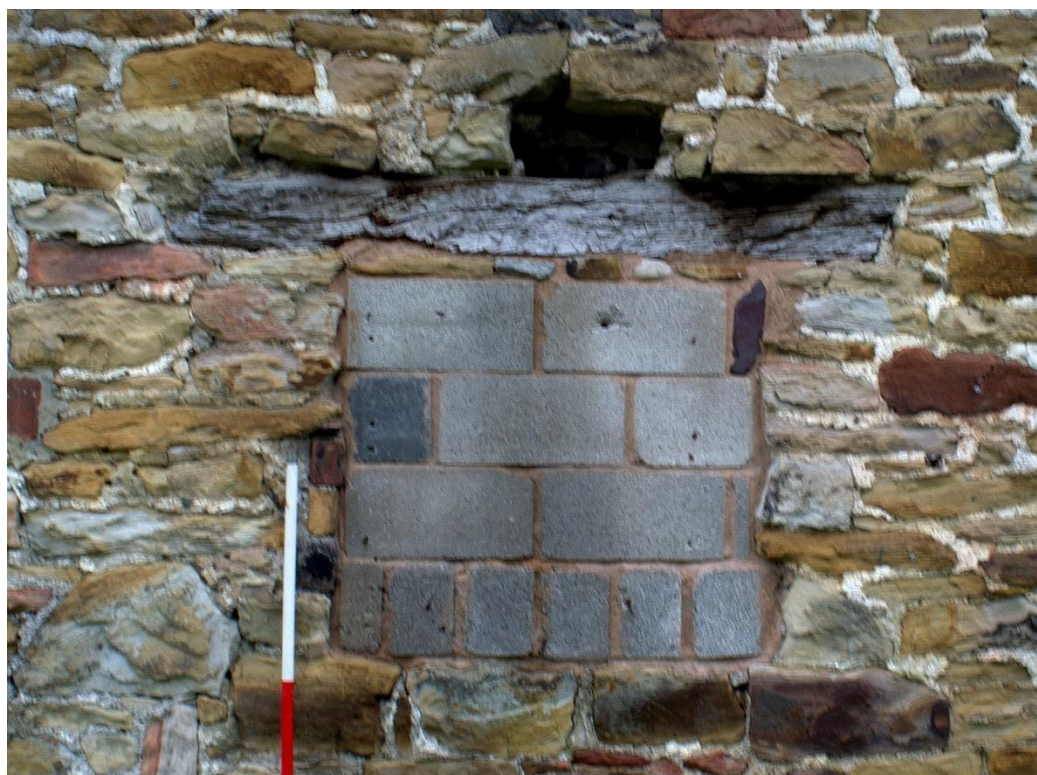
**Figure 42 West elevation West Range blocked opening detail**

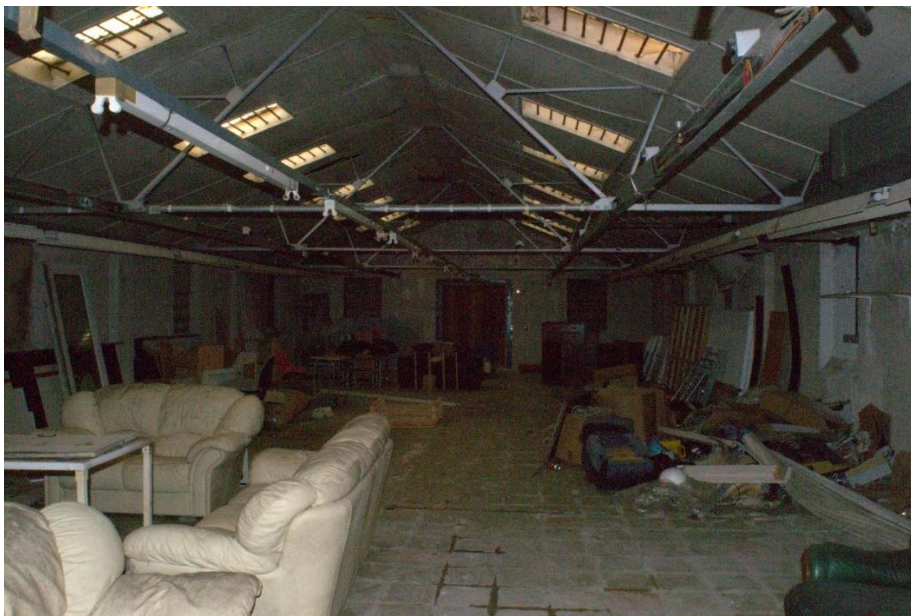
3.2.2.1. The interior of the north brick shed is a single open space with tubular steel roof trusses and roof lights. There are several blocked windows in the walls and a door in the northern gable, the main access to the building is from the south (Figures 43 and 44).

**Figure 43 Brick shed Interior view to North**

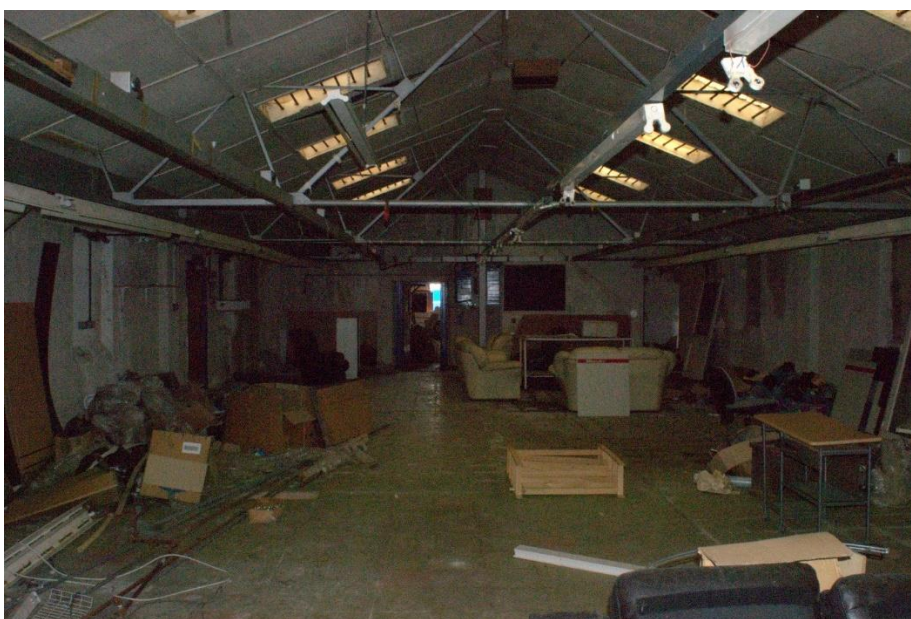
**Figure 44 Brick shed Interior view to South**

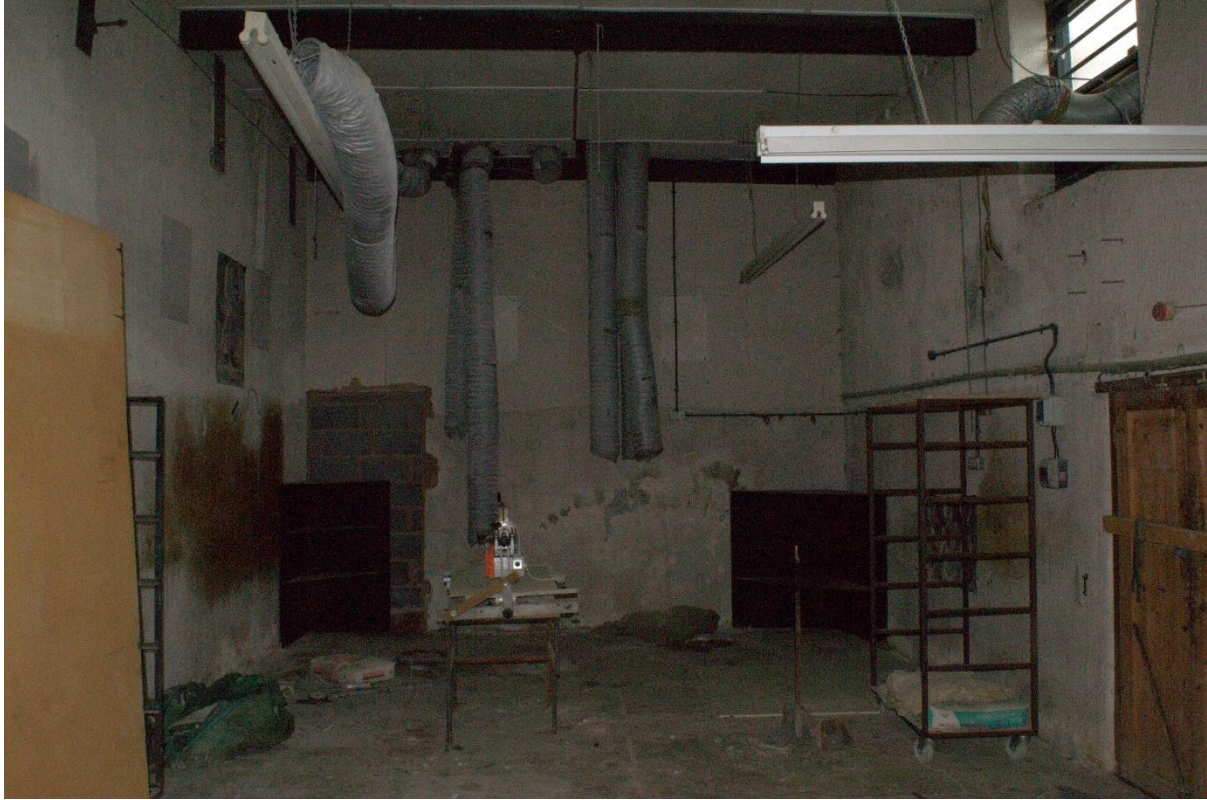
- 3.2.3.1. The West Range has features relating to its latest, light industrial uses. There is a doorway blocked with concrete blocks. doorway at the northern end. It was not possible to determine if this was an original feature for the agricultural uses or inserted for industrial use (Figure 45).

**Figure 45 West range interior from Southern end**

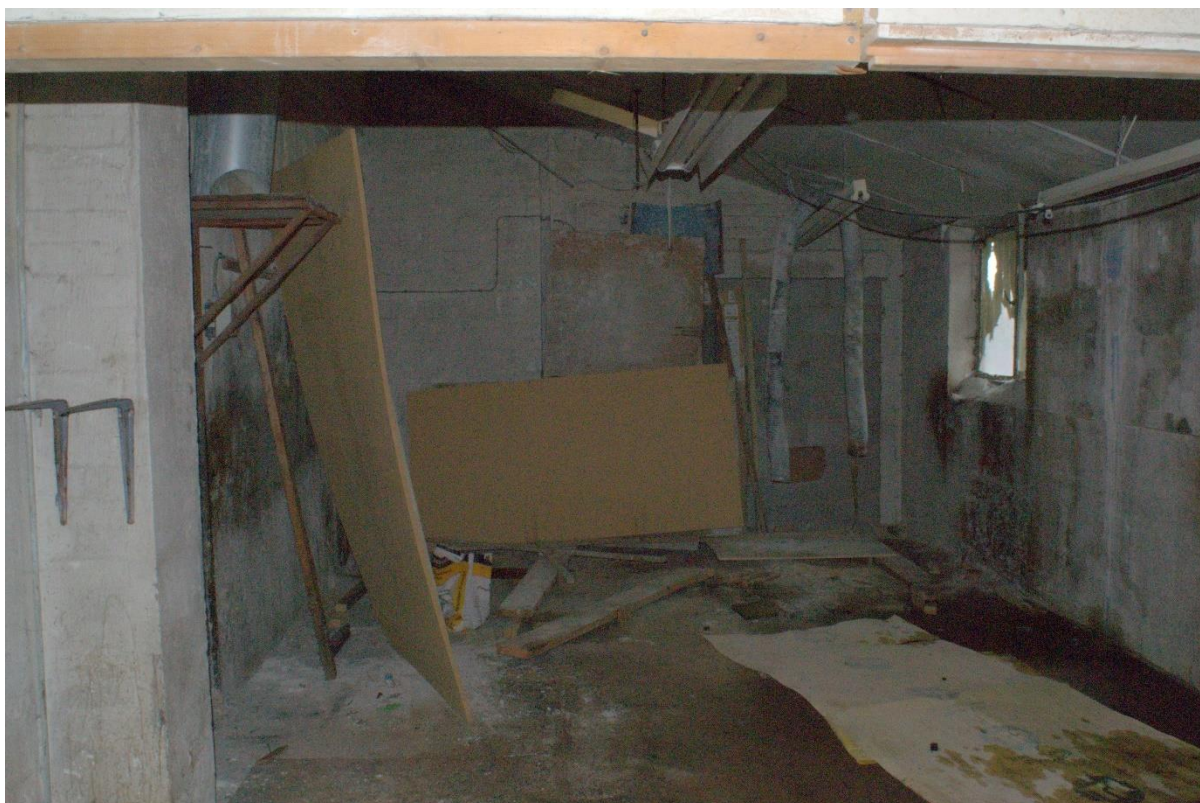
- 3.2.4.1. The lean to attached to the North Range is subdivided by an internal brick partition. The south wall of the original barn has been taken down in places to create open space to the barn building. Any historical features relating to the barns agricultural use are masked by plaster finishes (Figures 46-48)

**Figure 46 Lean-to West room interior looking East Middle window on Right**

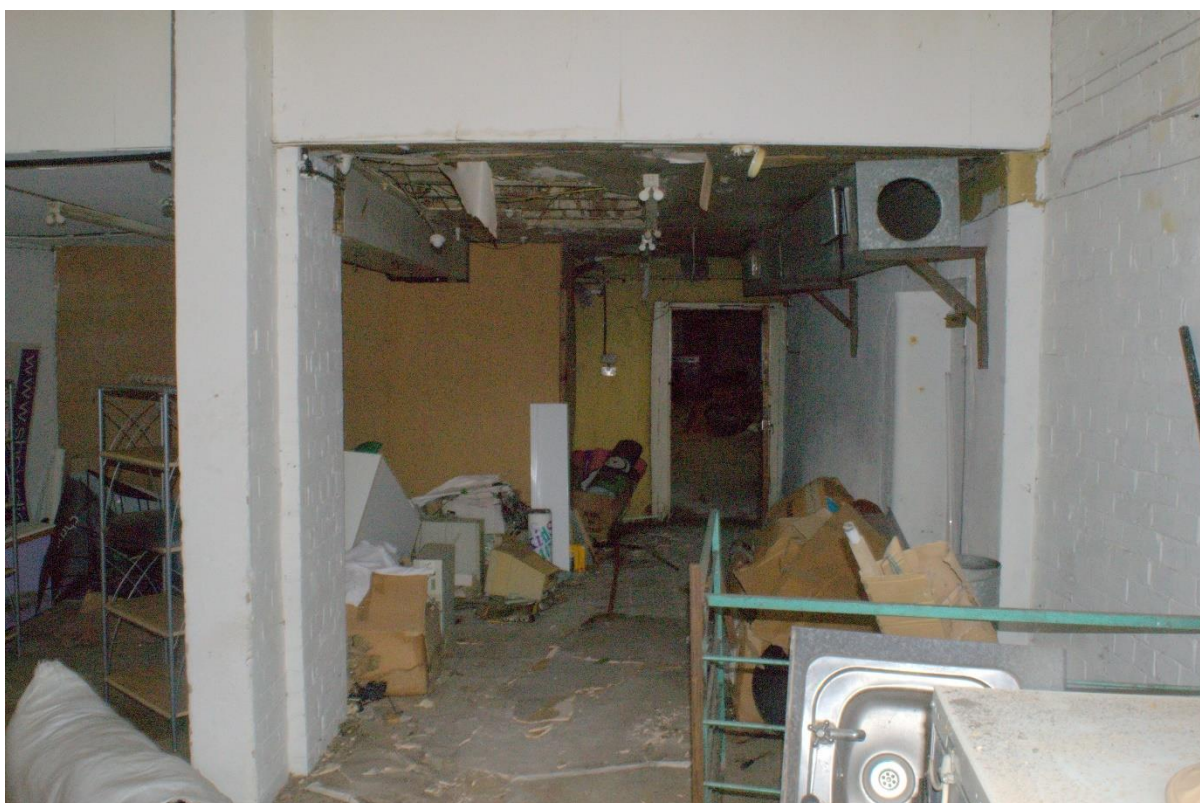
**Figure 47 North range barn interior from lean-to**

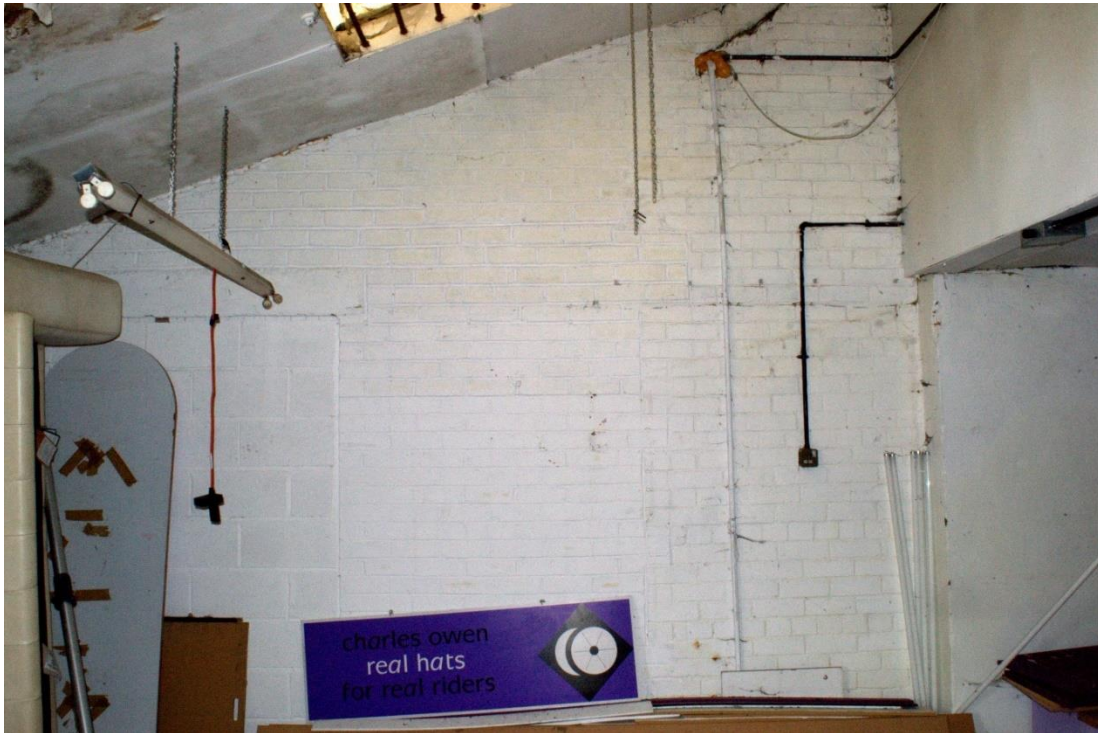
**Figure 48 North range lean-to East room West elevation partition wall**

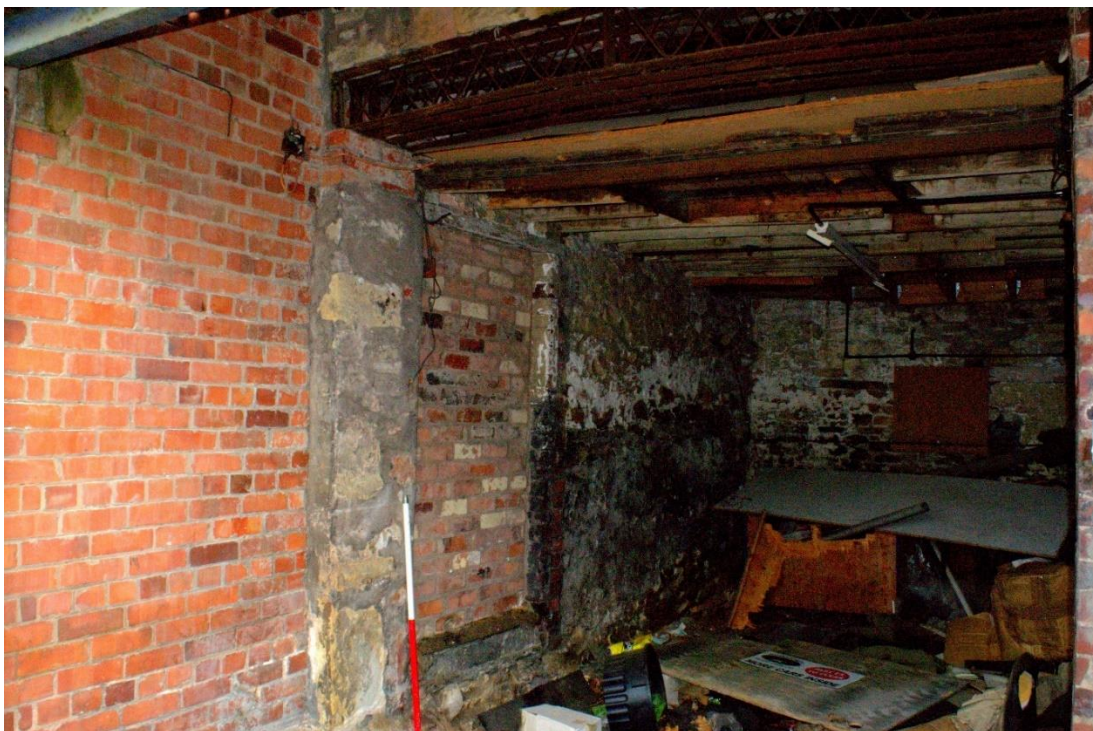
- 3.2.4.2. The two rooms at the east end of the North Range are those which may originally have been accessed from the yard by the timber-linteled doorway which has been reduced with a partition inserted to subdivide the space. On the west elevation of the left-hand room (West East Room) is a blocked doorway with brick blocking in a stone dividing wall of the original barn (Figure 49).

**Figure 49 North Range room behind large opening at Eastern end West elevation with blocked doorway**
