# The Elms, Darland Lane Rossett

## Ecology Scoping Report

6<sup>th</sup> April 2021

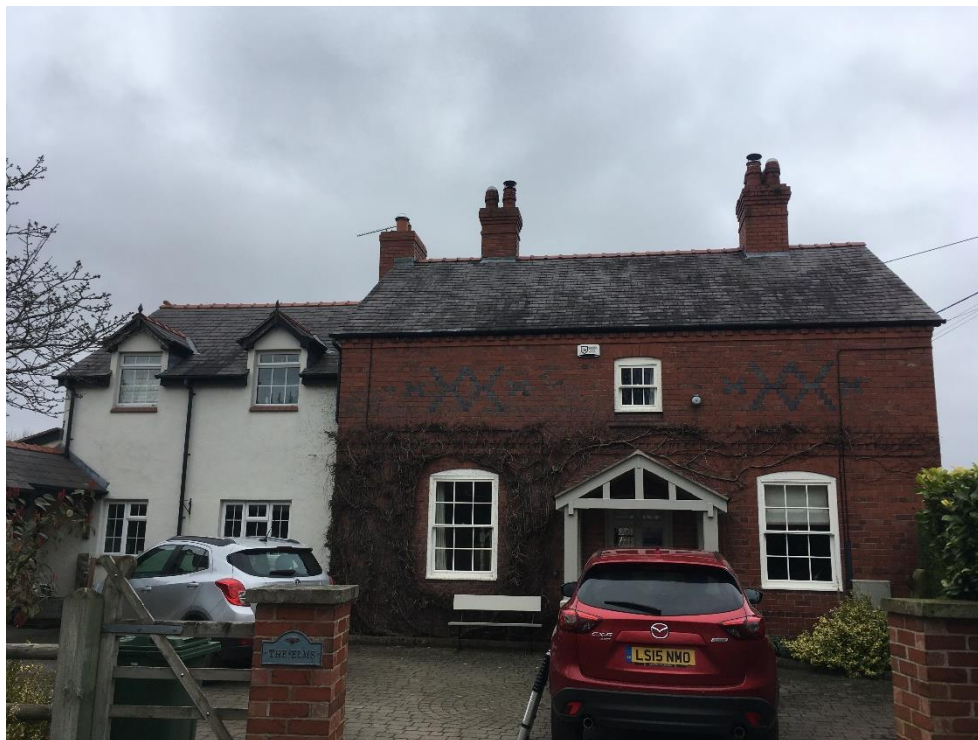
Externally, the building is generally in good condition with roof slates and ridge tiles largely intact and well sealed. However, the building was found to have several potential bat roosting features located at the building's eaves and around the dormers and verges of the newer extension. These features are numbered and shown on Figure 2.

There are occasional crevices located at the east and west facing eaves of the original section of house (Bat Target Notes 1 on Figure 2). These crevices comprise of narrow gaps (0.5cm-3cm in width) between a horizontal wooden beam and the external brickwork located immediately below the guttering of the house. These features offer suitable bat roosting habitat with bats potentially able to squeeze under the wooden beam and some of the larger gaps offer suitable nesting habitat for birds.

There are additional potential roosting crevices associated with the roof of the newer extension, these are located under areas of loose lead flashing at the corners of the building's north and west facing dormer windows (Bat Target Notes 2 on Figure 2).

*Photograph 1- West face of house*

In order to further assess the potential bat roosting features associated with both buildings, it is recommended that at least two dusk/dawn bat activity surveys are carried out during the active bat survey season (May-September inclusive with at least one survey completed between early June and the end of August).

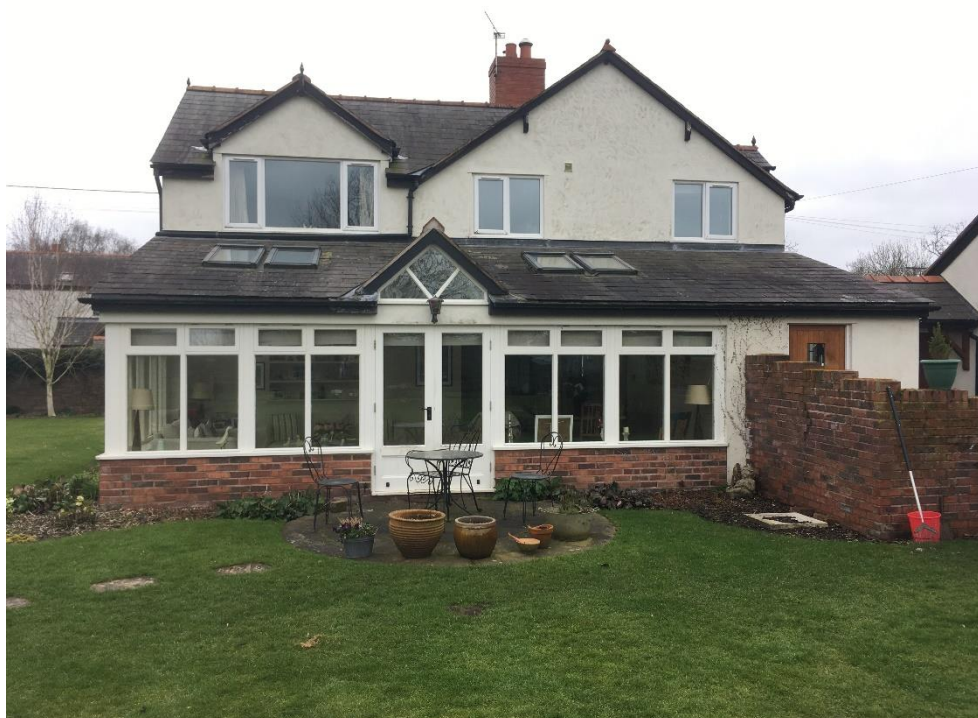
The northern half of the house comprises of the newer extension. This section of the building is constructed of rendered brick and has gable ended roofs with dormer windows at its west and north faces.

*Photograph 2- North face of house*

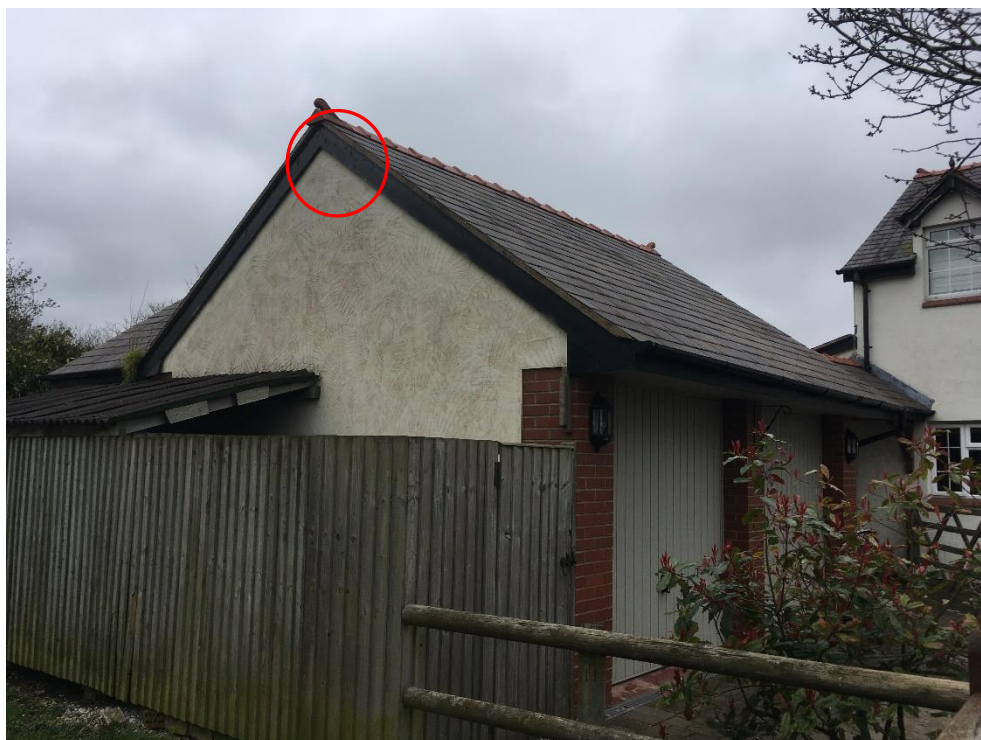
Externally, the garage is generally in good condition but there are some limited areas of potential bat roosting habitat. These are located at the north facing gable where there is a gap in the verge mortar (approximately 10cm x 2.5cm in size) providing potential bat access between the slates and the roofing felt (Bat Target Note 4). The garage has wooden fascia boarding at each gable. This was observed to have a narrow crevice between the walls and the boarding. This crevice is cobwebbed over at the building's east and north faces but at the west face there is an approximately 1.5cm wide crevice which was not cobwebbed. A single old bat dropping was recovered from behind this section of fascia boarding. No other droppings could be found.

It is considered likely that the fascia boarding has been used as a pipistrelle day roost by low numbers of bats in the recent past.

*Photograph 3- West and south face of garage (Target Note 5 circled)*

Even if no evidence of roosting bats is found during further surveys, it is recommended that additional bat roosting habitat is provided at the site. This should comprise of bat boxes which can be built into the proposed new garage building and the new extension. The model and location of bat boxes should be determined by an appropriately qualified ecologist.

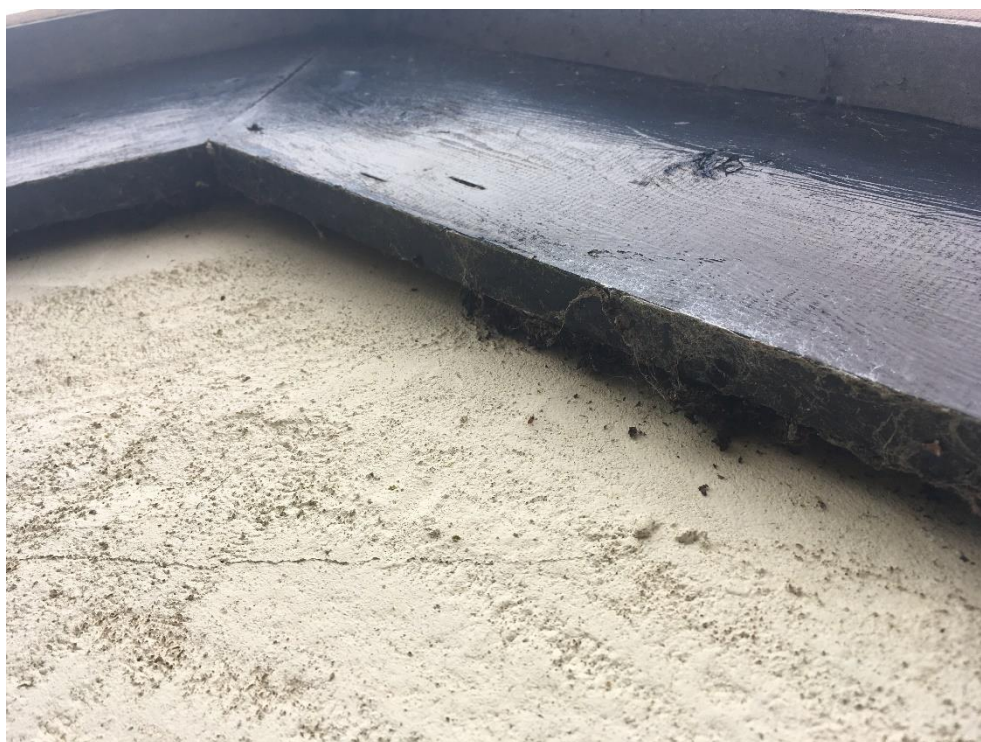
There is also a double garage building at the site. This is a relatively modern structure and is generally well sealed. However, there are some potential bat roosting features offered at the building's north facing gable where decayed verge mortar offers potential access between the roof slates and underfelt; and at the building's west facing gable where there is a narrow crevice between a length of fascia boarding. A single bat dropping (likely from a pipistrelle bat species) was found behind the fascia boarding. This dropping confirms that the gap has been used by roosting bats in the past.

*Photograph 4- Crevice at Tare Note 5*

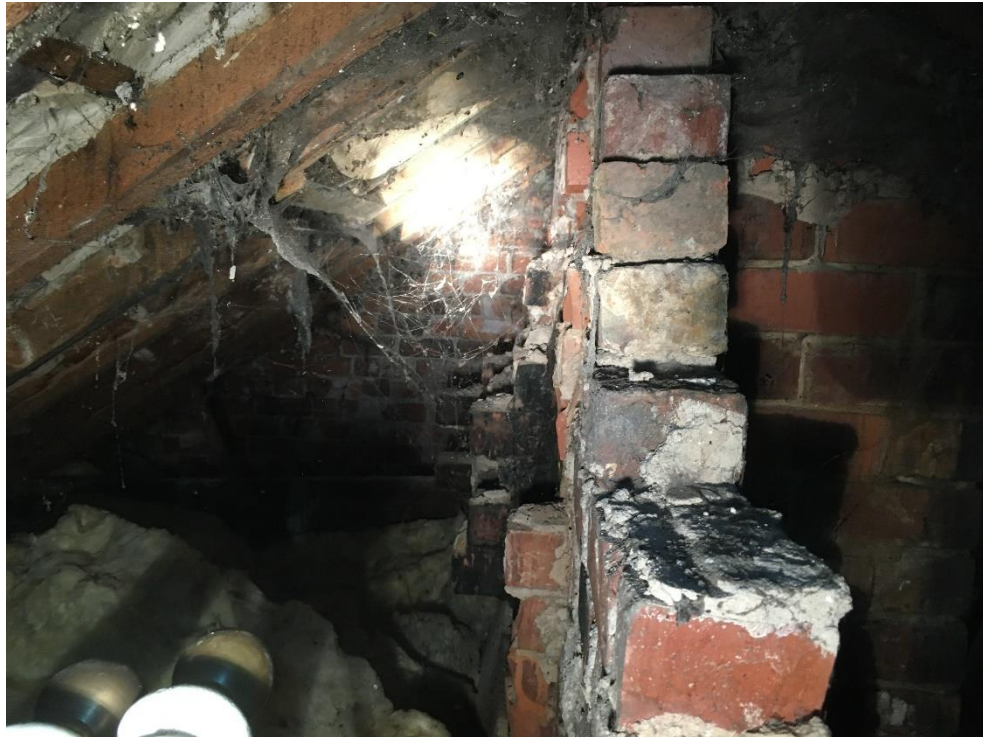
The southern half of the house has a small loft space. The loft is approximately 1.5m in height and is approximately 9m x 7m in area and is used for storage.

The loft space is lined with fibrous insulation felt and the internal face of the roof has been torched with lime mortar. The mortar has begun to decay and so the loft space is relatively dusty.

The loft space was found to be heavily cobwebbed with extensive cobwebbing at the gable ends, along the ridge and spanning the void space.

No evidence of bat activity was found within the loft space. No obvious potential bat access points to the loft space interior were found.

*Photograph 5- Loft space of house*

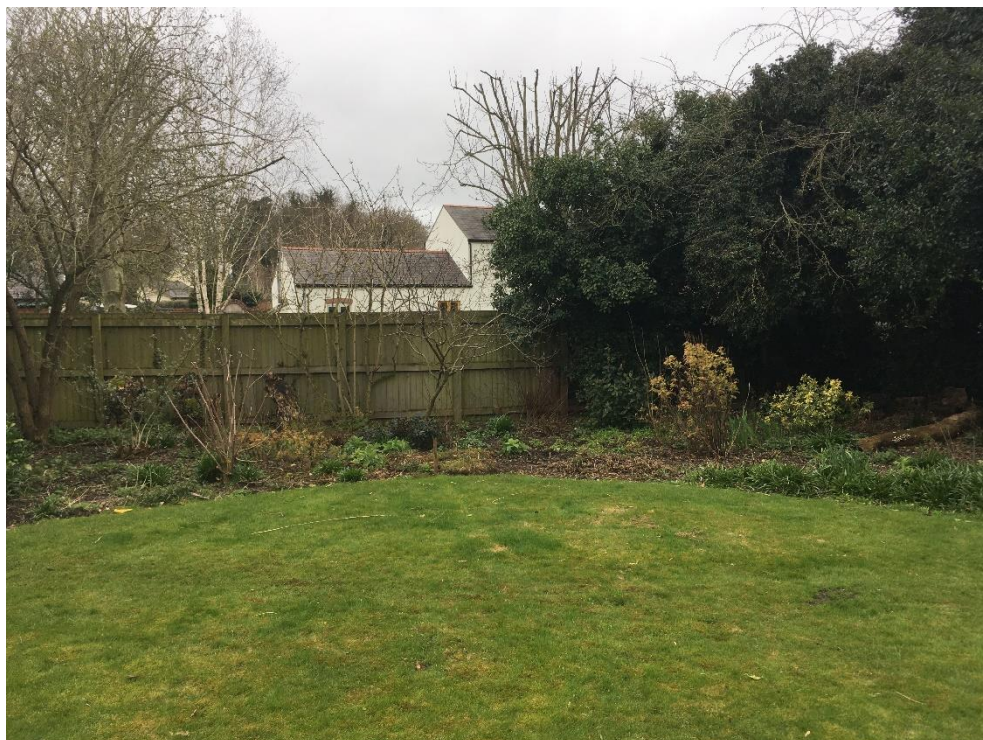
The house has established gardens to the side and rear comprising of mown lawn with ornamental shrubbery and young trees including maple, elder, hawthorn and holly. None of the trees are considered to offer suitable habitat for roosting bats.

*Photograph 6- Garden habitats at proposed new garage location*

Although the site is generally of low conservation value it is recommended that opportunities to enhance the biodiversity value of the proposed development are taken. This could include the replacement of removed garden trees and hedging with native species or species which offer valuable foraging resources to wildlife (through either fruits or nectar sources).

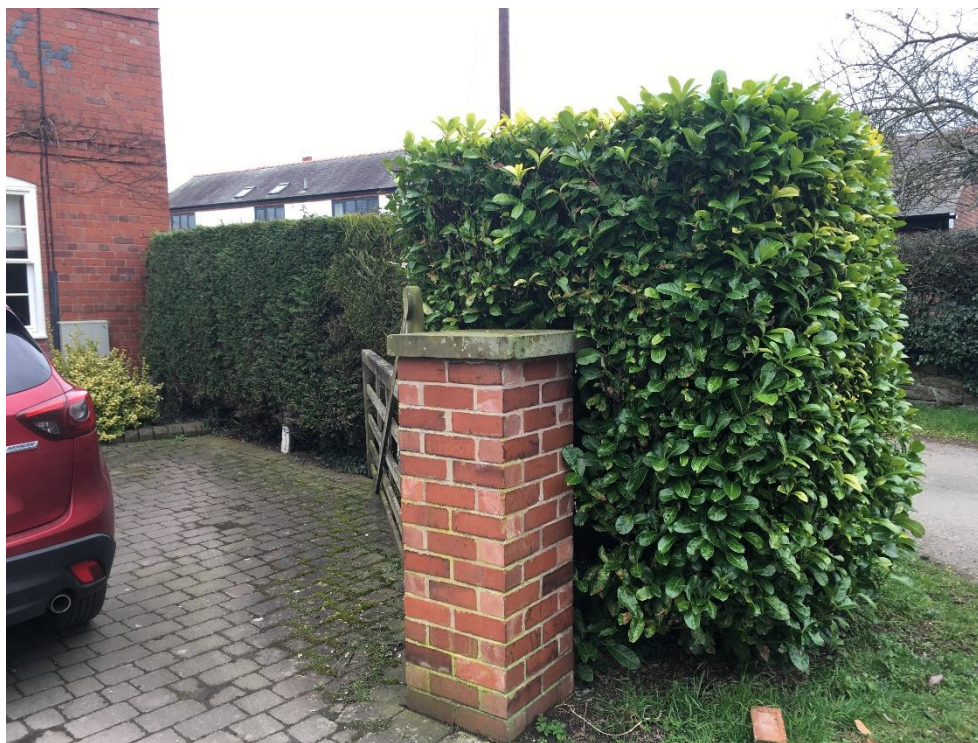
There is a garden hedgerow along the site's boundary with Darland Lane. The hedgerow comprises of laurel and cypress.

There is a garden hedgerow located along the southern boundary of the site. This comprises of laurel and privet and is also considered to be of limited biodiversity value. A section of this garden hedge may need to be removed to facilitate the development.

*Photograph 7- Hedge on Darland Lane*

It is therefore recommended that any works to remove/manage tall vegetation and works to the house roof avoid taking place during the breeding bird season (March-August inclusive). Where this is not possible, a check for nesting birds should be completed immediately prior to removal by an appropriately qualified ecologist.

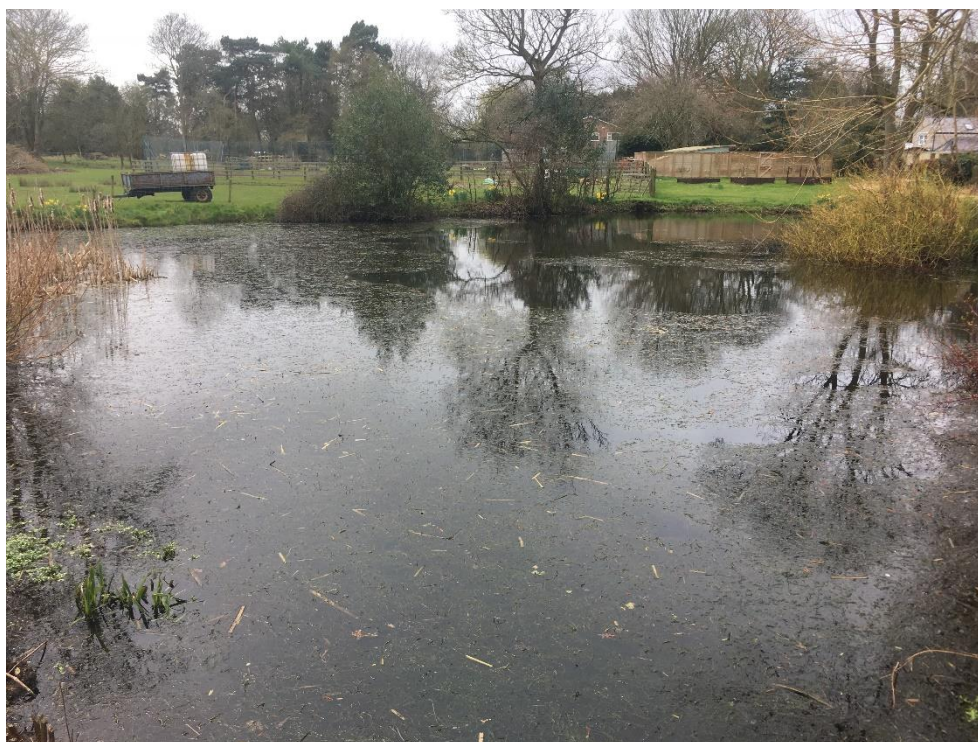
There is a moderately sized pond located approximately 30m to the southwest of the site on the opposite side of Darland Lane. The pond measures approximately 700m<sup>2</sup> in area and is unlikely to dry out.

The pond supports a good coverage of aquatic vegetation comprising of extensive areas of *Elodea* waterweed, with fringes of fools' watercress, brooklime and bulrush. The pond is partly shaded by willow with some open unshaded banks. There is a reasonable likelihood of the pond supporting fish.

The pond appears to offer high quality great crested newt breeding habitat however this suitability would be significantly reduced if the pond supports fish.

*Photograph 8- Pond located opposite the site*

In order to further assess the site for great crested newt, it is recommended that great crested newt presence/absence surveys are undertaken of the nearby pond. The great crested newt survey season runs from mid-April until the end of June (for eDNA presence/absence surveys).
