**COMBINED STAGE I AND STAGE II LAND  
CONTAMINATION ASSESSMENT**

**Bryn Foty, Gwynfryn**

**R2492-R01-v1**

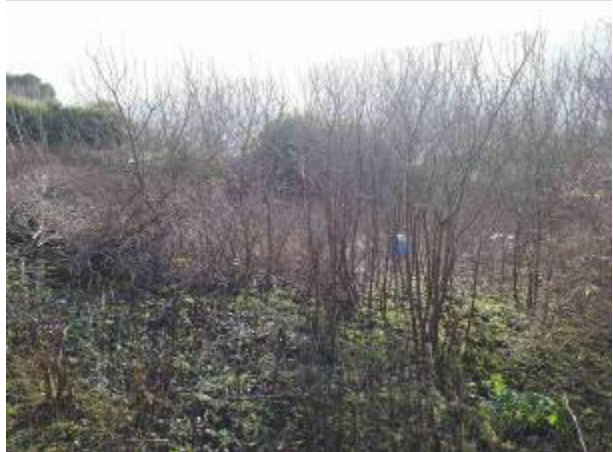
2.

12.01.18 – View southwest across site from northeast corner; dense vegetation in northeast of site obscuring visibility.

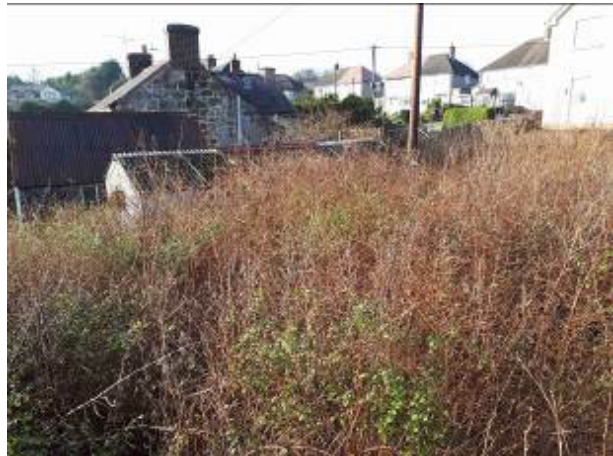
10.

12.01.18 – View northwest across site from centre of southern boundary; dense vegetation in south of site obscuring visibility.

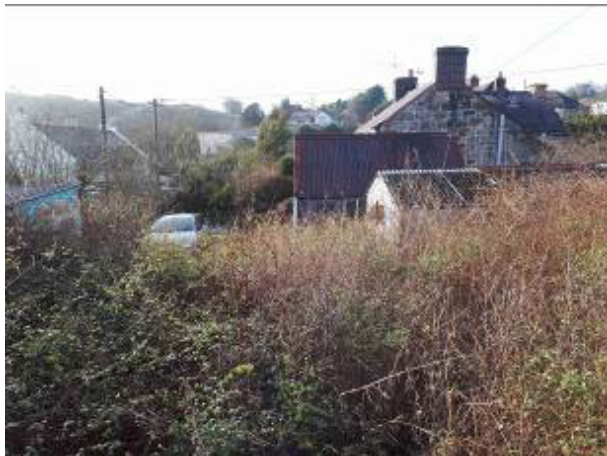
11.

12.01.18 – View west along southern boundary from centre of southern boundary; dense vegetation in south of site obscuring visibility (garage building in southwest corner of site just visible in left of photograph).

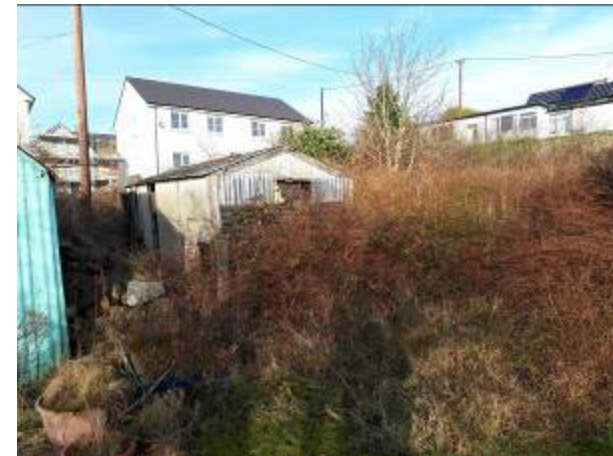
12.

12.01.18 – View north along southern part of western boundary from area to the southwest of site; no distinct boundary (very dense vegetation).

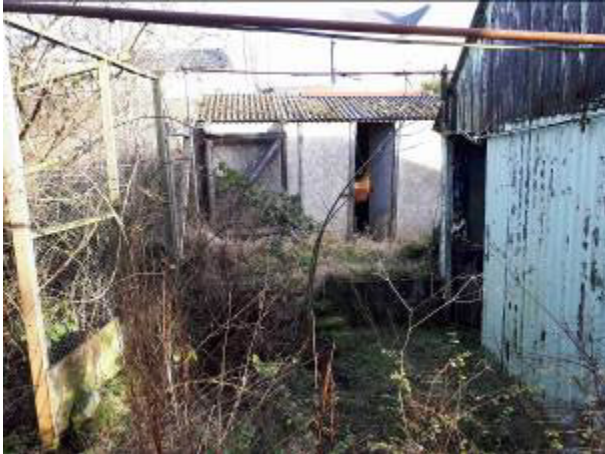
13.

| <b>Structures</b> | Two structures were identified on site, a shed located in the centre of the western boundary and a garage which straddles the southwest corner of the site. The former appeared to be constructed from a combination of wood and suspected asbestos cement sheeting, the latter mainly from brick, but also suspected asbestos cement roofing. |

12.01.18 – Shed located along centre of western boundary; suspected asbestos cement sheet cladding and roof.

| | validation of the chemical quality will be necessary, the results of which should be reported to WCBC. The depth of placed materials will also need to be independently verified by an environmental consultant. The quality and depth testing frequency should be detailed in a Remediation Strategy and agreed with the WCBC Contaminated Land Officer prior to the commencement of development. Full radon protection measures should be provided for the planned dwelling. An asbestos survey and removal of confirmed ACM will be required for the site buildings in advance of any demolition. |

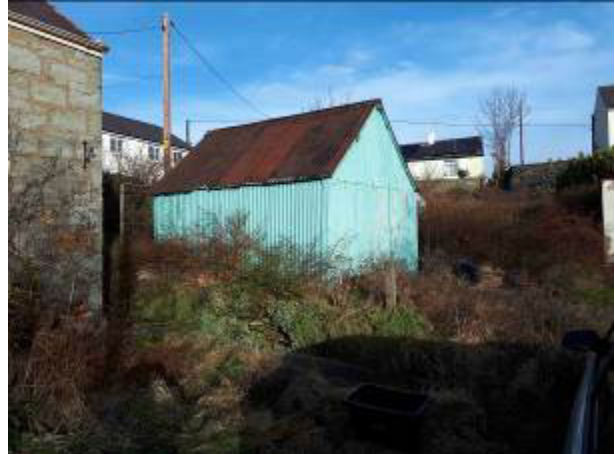
14.

12.01.18 – Outbuilding directly adjacent to west of site; constructed from corrugated metal.

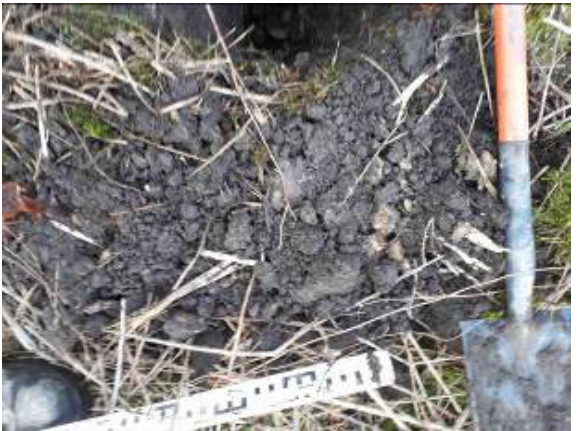
5.4.1. Topsoil consisting of a blackish brown very slightly sandy silty clay with fine to coarse angular to sub-rounded gravel, occasional cobbles and frequent organic matter (roots) was present in all entries from the surface to depths of between 0.25m bgl to unproven at 0.6m bgl. The only anthropogenic material noted within the topsoil was a cobble of red brick observed in trial pit 3 at a depth of 0.2m bgl suggesting that this material was either reworked or has possibly been imported onto site.

TP4: Arisings (topsoil) – 12.01.2018
