**PHASE 2 BAT ACTIVITY SURVEY**

**WOLVESACRE HALL**

**Project name:** Wolvesacre Hall, Iscoyd, Whitchurch SY13 3AS

**Date:** 22/10/2020

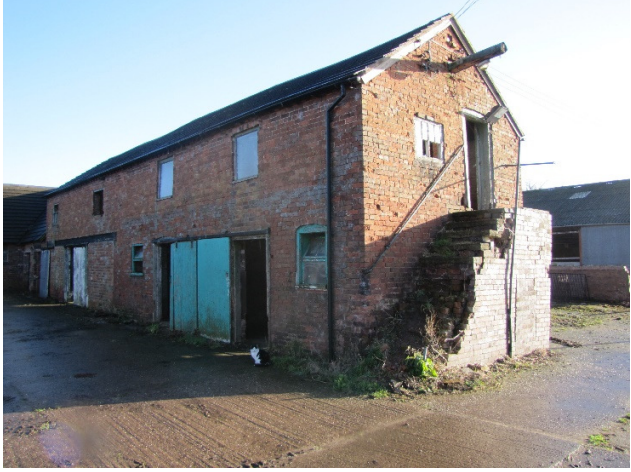
The building under consideration is a two storey brick building clad with a concrete tile roof and clay ridge tiles. The verges of the roof are mortared and there are timber barge boards in place at the south west facing gable end. Internally the roof is not lined and the first floor is open to the rafters. There is no enclosed loft space and there are several window and door apertures which are permanently open. The timbers within the roof are mostly original with some newer replacements present.

| | Building |

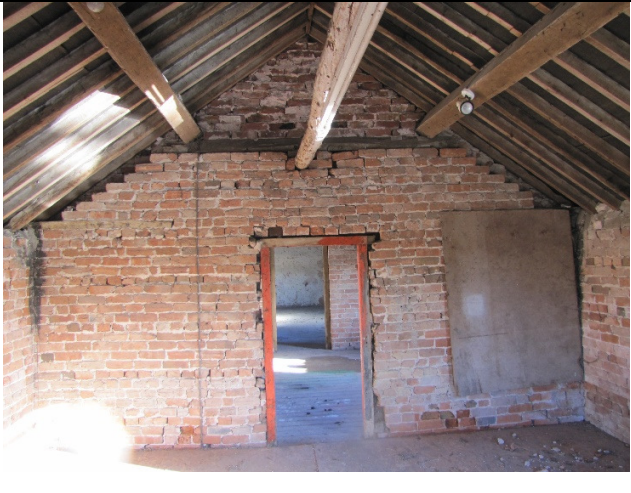
An internal inspection of the building revealed no evidence of feeding or roosting and the building has deteriorated in condition since 2017.

The building holds 'low' potential as a bat roost, given the open and light conditions. Some small crevices are available on the exteriors of the building e.g. beneath loose tiles.

| | First floor interior |
