# Arboricultural Report

**Glebe House Farm  
Horsemans Green  
Whitchurch  
SY13 3DY**

David Bailey  
*BSc(hons), M.Arbor.A, cert. Arb(RFS)*

21<sup>st</sup> October 2020

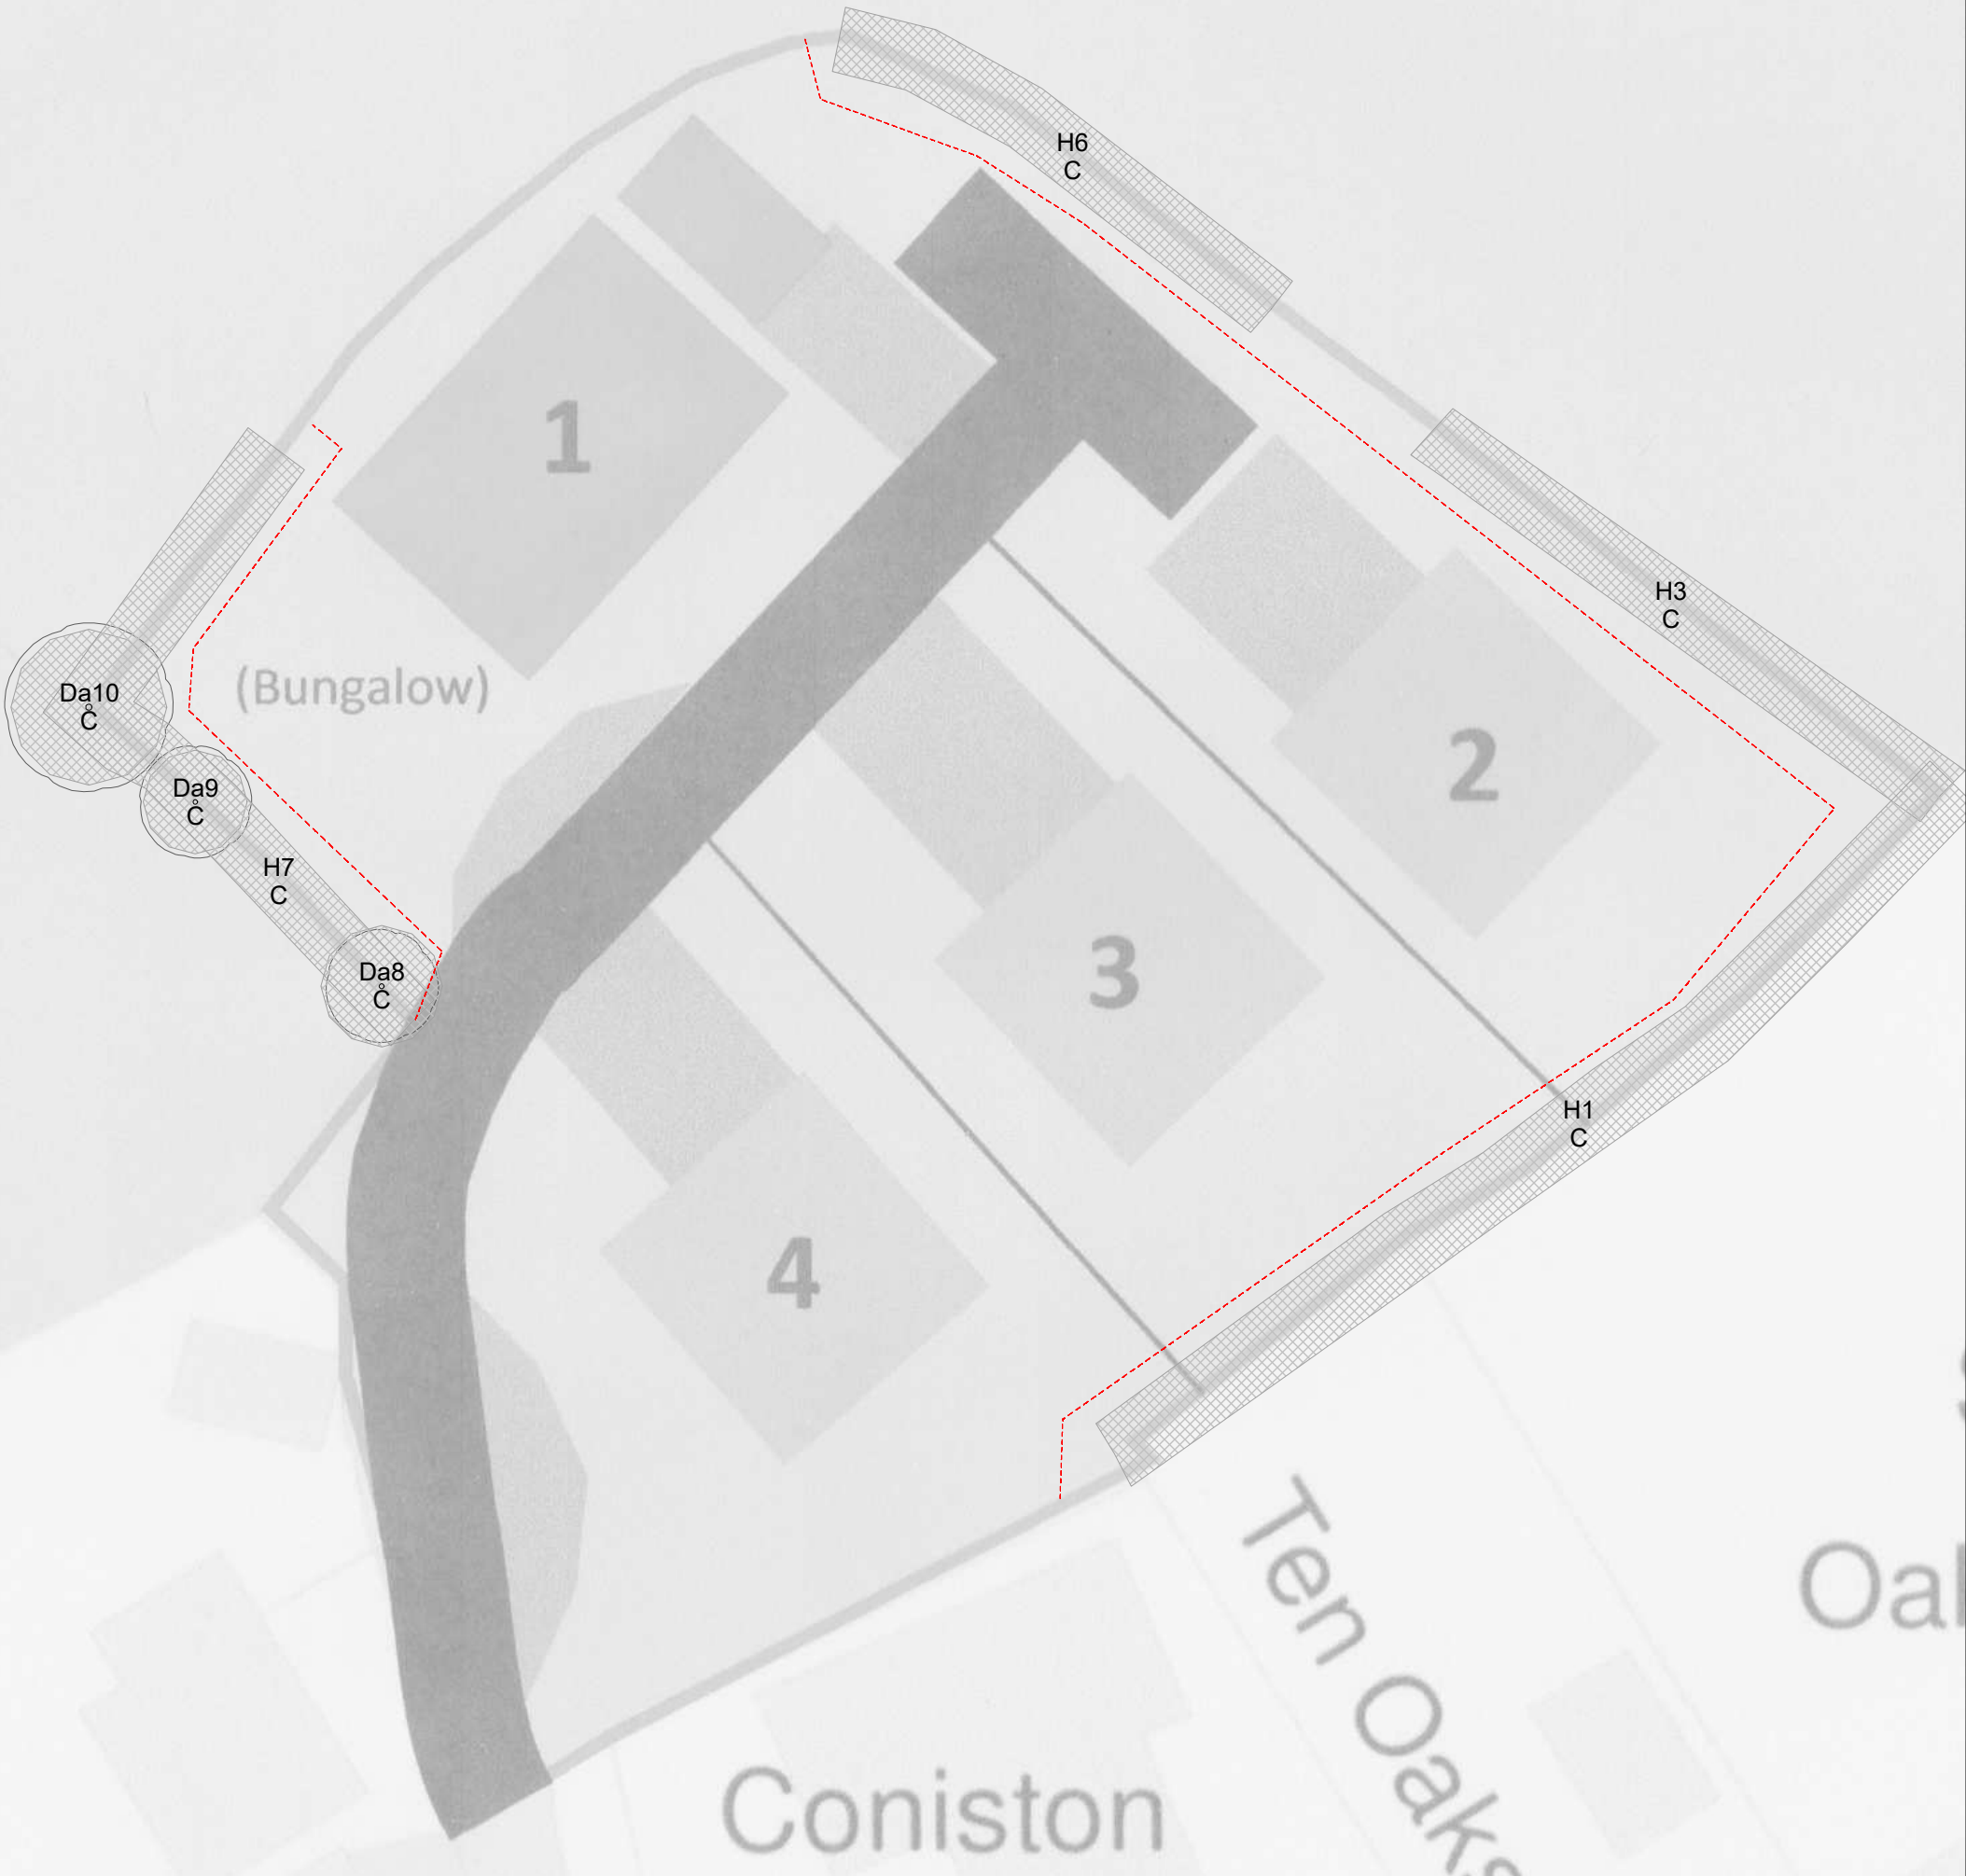
**Map reference:**  
**PC20/421/TCP**

**Tree Protection Plan**  
Showing all retained trees, crown dimensions, tree  
categories, RPAs and protective fencing

- 8.5 The tree protection plan TPP shows adequate space is provided for the development. Distances in purple are shown to ensure protective fencing is suitably positioned around retained trees.
