**DESIGN & ACCESS STATEMENT**

**NEW ACCESS DRIVE**

**ODDI-AR-Y-TWMPATH, GARTH, GLYN CEIRIOG, LL20 7LY**

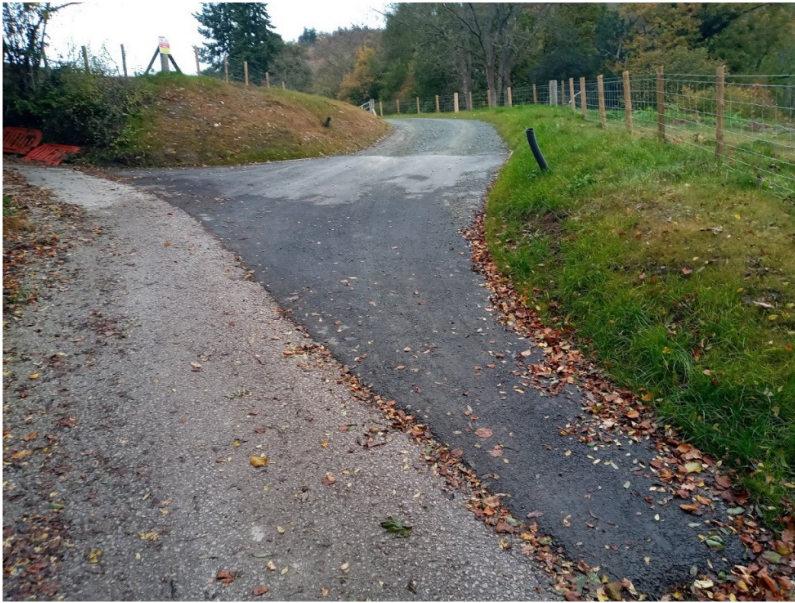
Access drive entrance off existing road

A new access road is provided off the lower end of the road through the site and to the dwelling constructed in permeable stone with no edge treatment and timber post and sheep net fencing to retail the rural appearance. The first 5m of the access drive is surfaced in macadam to tie into the road.

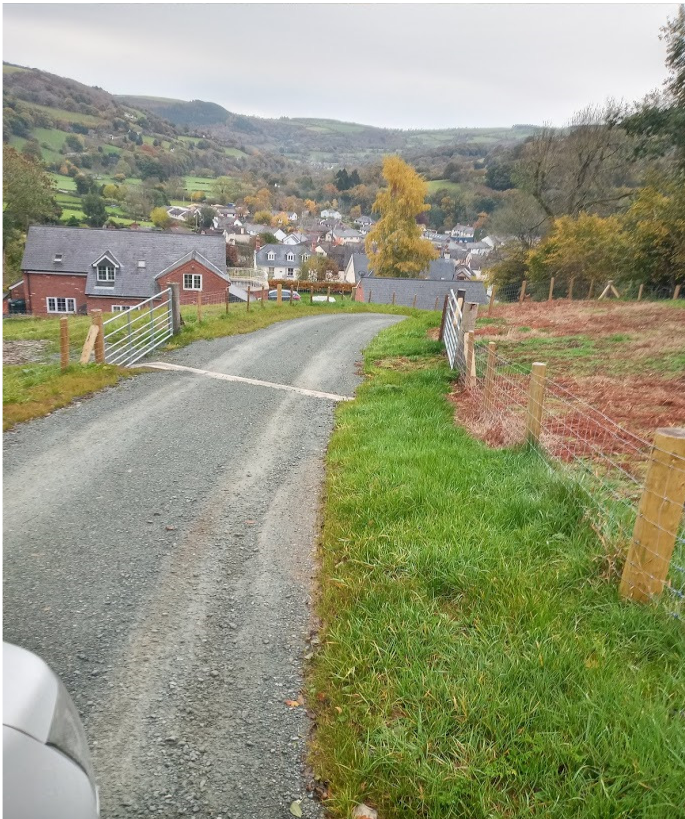
View of access drive showing surface and fencing looking down towards junction with road.

The access drive has been constructed to allow access to renovate the dwelling and photographs are included of the finished surface and also of the existing road.

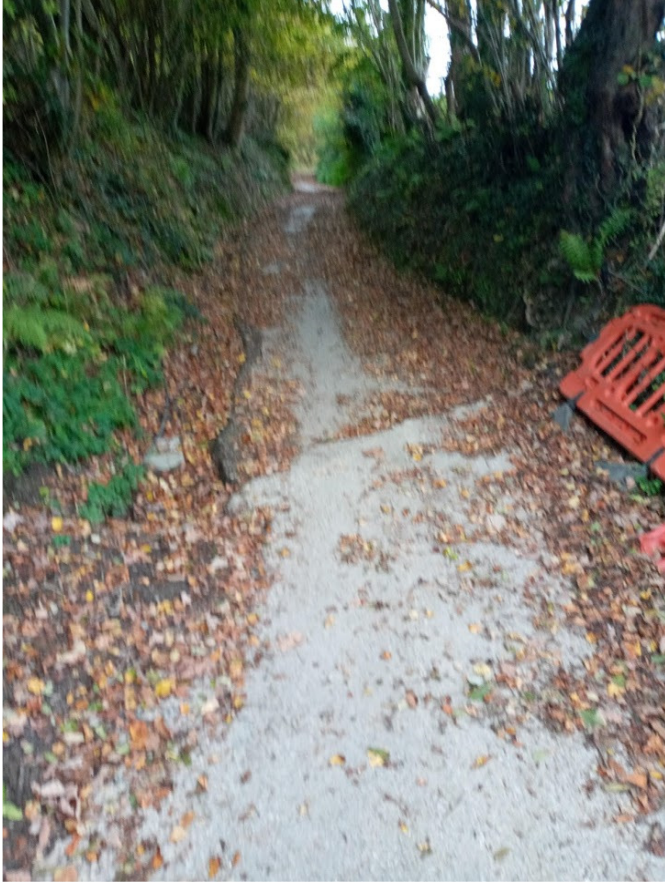
Existing road with narrow width and steep, dense embankments

The road is steep and the surfaced width is approximately 2m with the sides of the road suffering from significant erosion from surface water from the hill to the south and west which has formed channels at the road sides. Following rainfall the water flows at speed down these channels, it also covers the road between them and in winter it can be particularly hazardous, the property becomes inaccessible following frost and snow.

The embankments at each side are steep and densely populated with trees at the higher end.

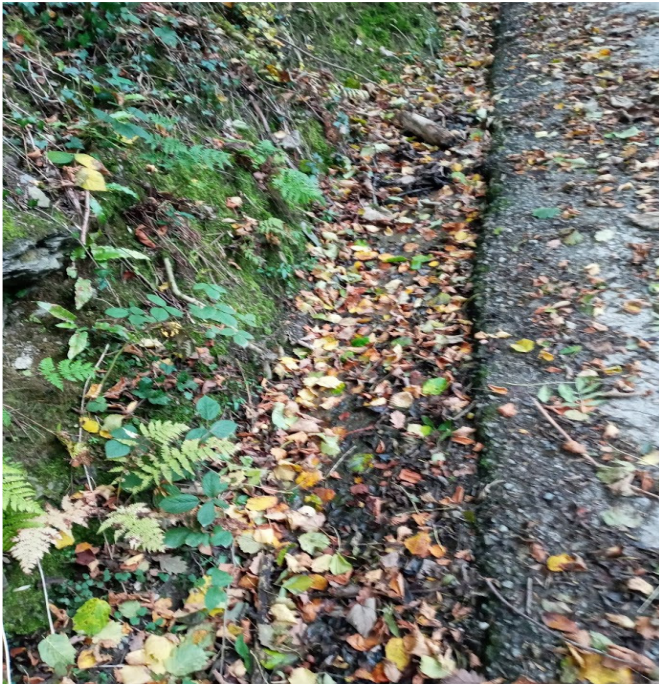
Channel formed by water erosion at LH side of road

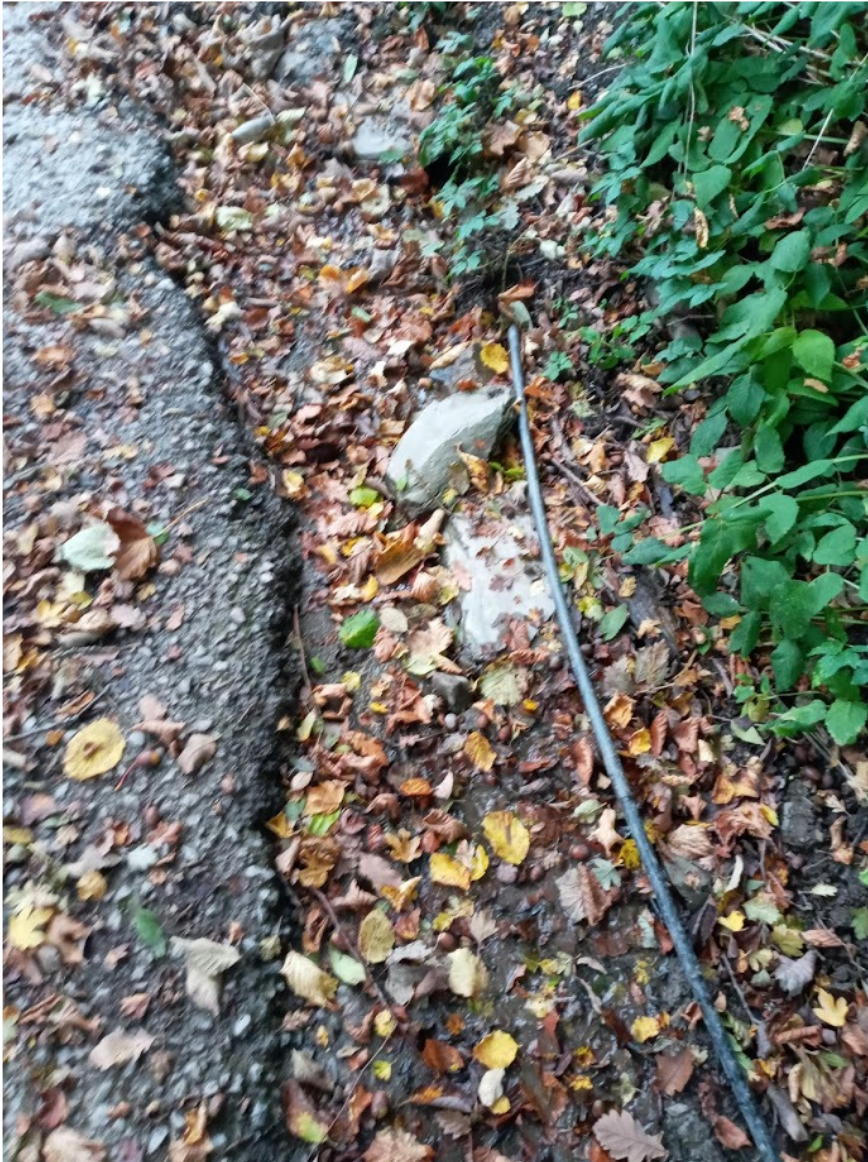
Channel formed by water erosion at RH side of road
