## Summary

Yorke Associates Ecological Consultants was instructed by Cadnant Planning Ltd to undertake a protected species survey at James Farm, Ruabon. The survey was commissioned in connection with a planning application for the conversion of outbuildings.

## James Farm, Ruabon Protected Species Survey

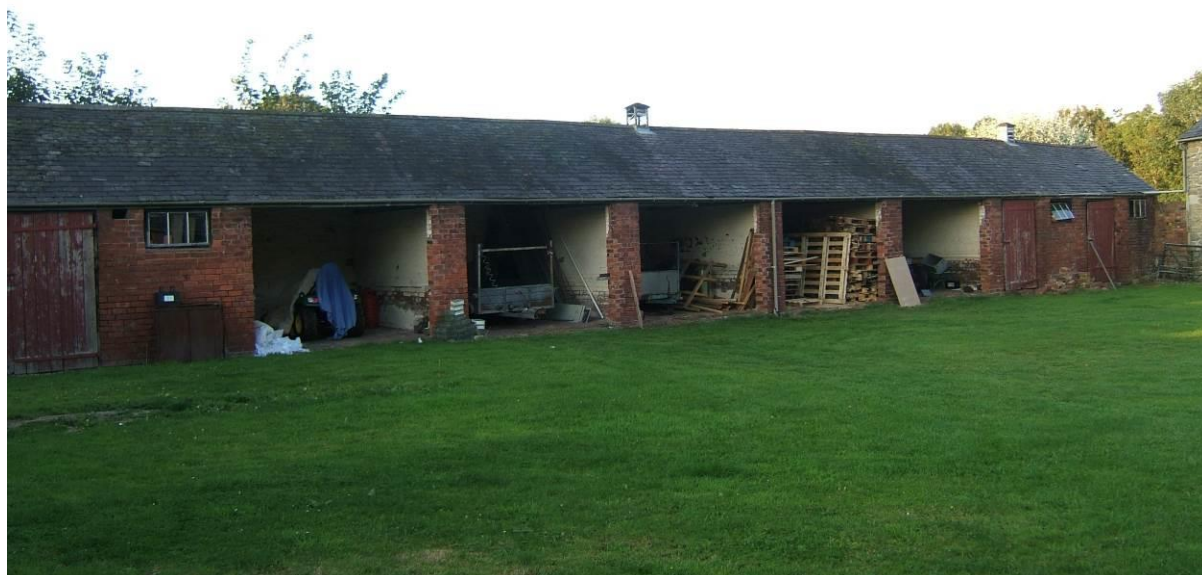
**Figure 1:** South elevation of Building 1.

**Building 1** – This single-storey building is constructed from brick and has a pitched slate roof (see Figure 1 below). Potential fly-through access for bats and birds consists of 4 large openings on the south elevation and also louvered vents on the roof ridge. A few old bat droppings were found internally, in addition to old swallow nests.

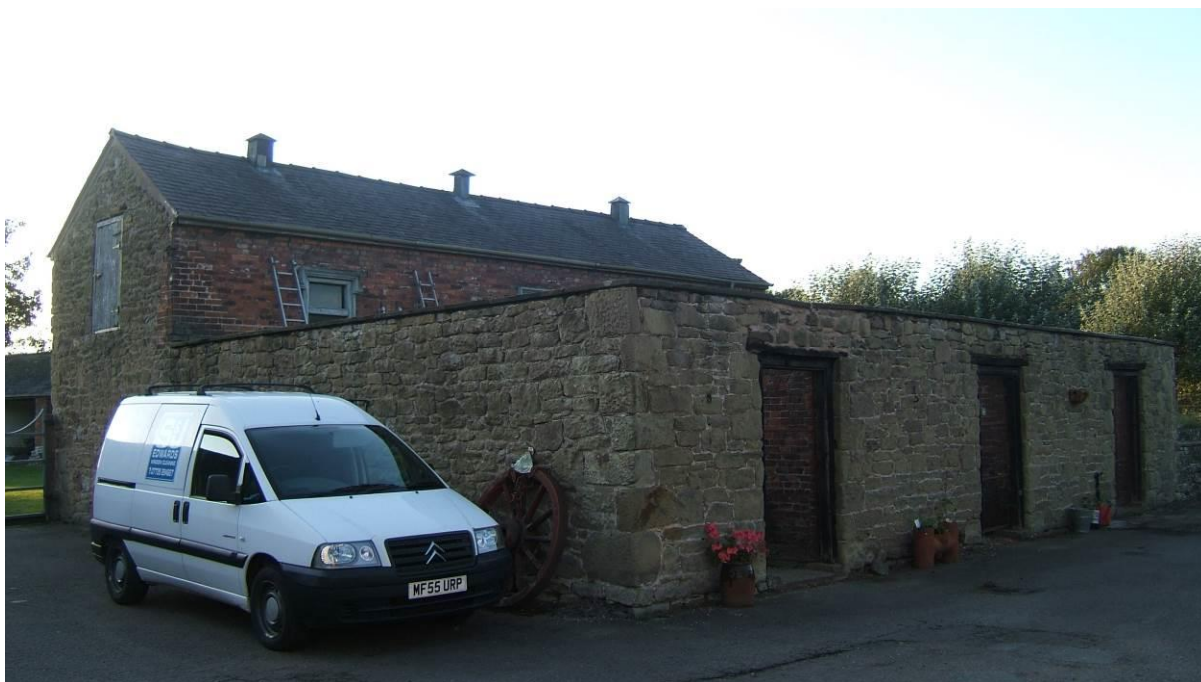
**Figure 2:** Eastern elevation of Building 2.

**Building 2** – The south and west elevations of this two-storey building are constructed from stone and the north and east elevations from brick. The roof is pitched slate supported by timber trusses and purlins and internally is open to the ridge (Figures 2 – 4). Potential fly-through access points for bats and birds consist of door openings on the east elevation. Potential roosting features on the exterior consist of a few gaps in mortar joints on the south
