**RE: P/2020/0636 – Discharge of Condition 7 (Contamination) of Planning Permission P/2018/0675**

In response to your memorandum dated 13th November 2020 & conversation with my colleague Greg Jones we understand that you require a 'lines of evidence' approach with regard to the:

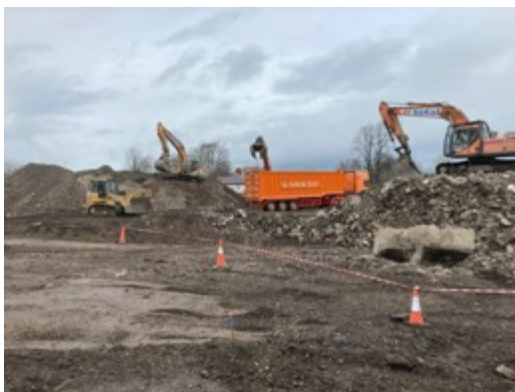
**Photo 1:** View eastwards across the site on 4th December 2020, with the former position of the tank being located underneath the demolition material stockpile on the right (as indicated by Braithwaites). A stockpile of crushed material is present to the left of the orange metal skip in the background.

In the New Year and following removal of the stockpile in the photo above we will take two samples of the soil in the location of the former tank. The samples will be scheduled for the analysis of TPHCWG, PAH16 and BTEX.

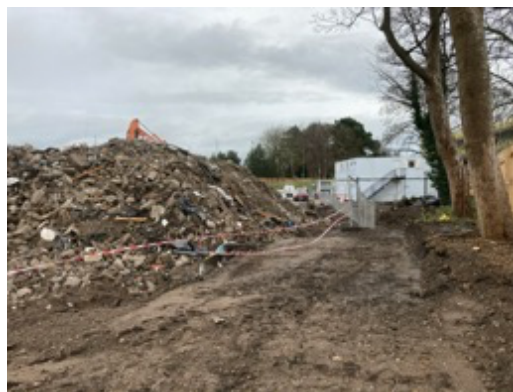
**Photo 2:** View southwards across the site on 4th December 2020, with the former position of the tank being located in the left foreground.
