REF: 2165/BGR/MRA/mjs

**RE: BRYN GLAS RHOS: MINING STUDY**

This letter report presents the findings of the desk study, shaft searches and site investigations. It discusses the risks posed by shallow abandoned mine workings and gives geotechnical recommendations for the site.

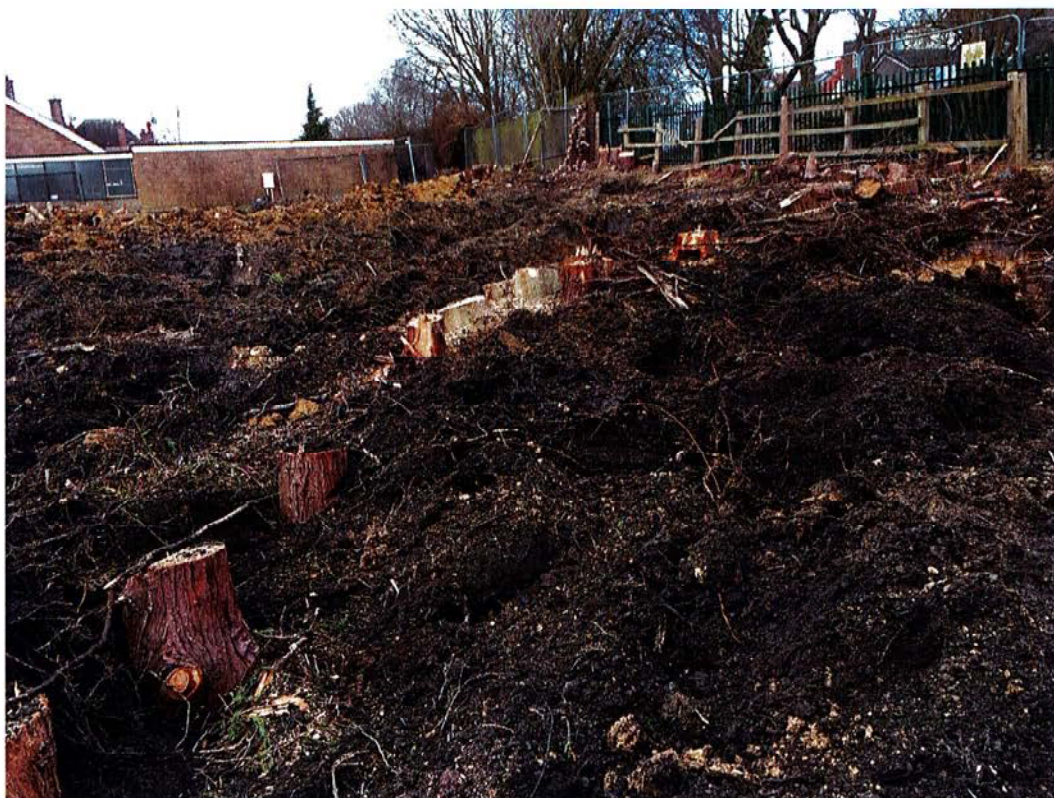
Photograph 3 looking north post demolition

Recently the bungalow has been demolished and many of the trees have been felled.

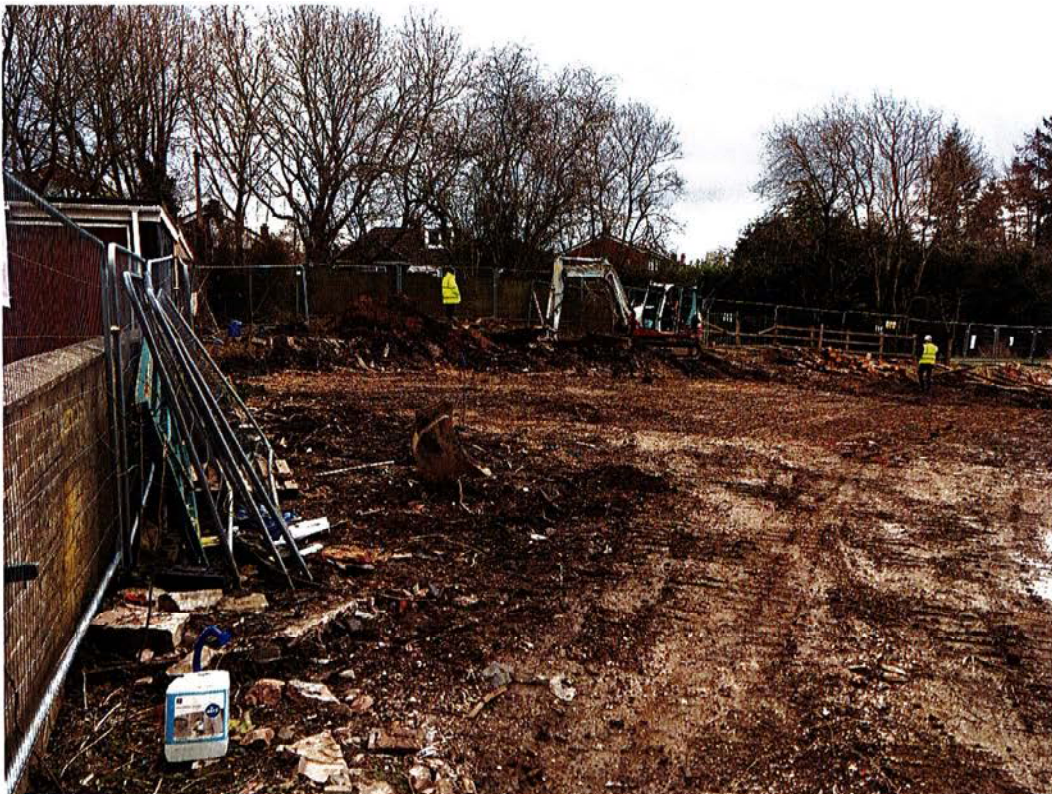
Photograph 12 north east corner of site at plotted shaft location

In addition, the site investigation failed to reveal any evidence for the shaft, with all of the fill being demolition debris and placed following construction of the property. No colliery spoil or evidence of any other mining fill was encountered.

The site investigation has also confirmed that the development area is free of unrecorded shafts.

Therefore, the shaft is not considered to be present on site. However, the potential for the shaft to exist has to be considered within the wider mining context to allow an assessment of the potential for shallow unrecorded mine workings.

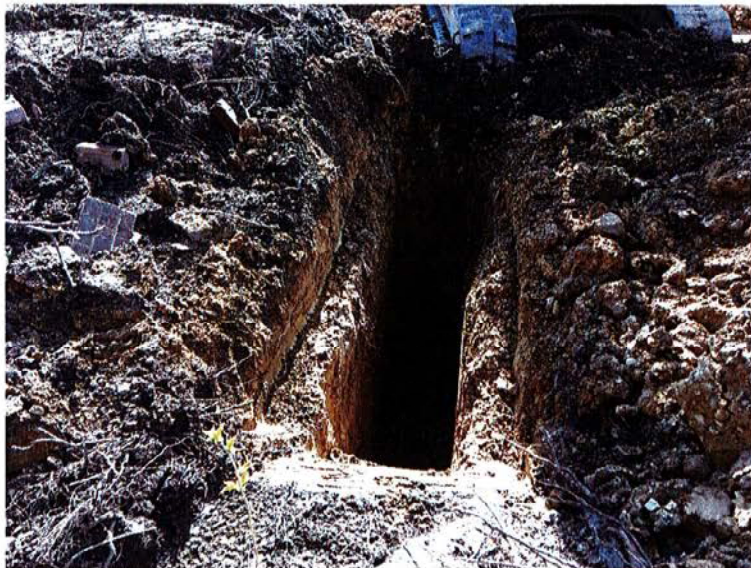
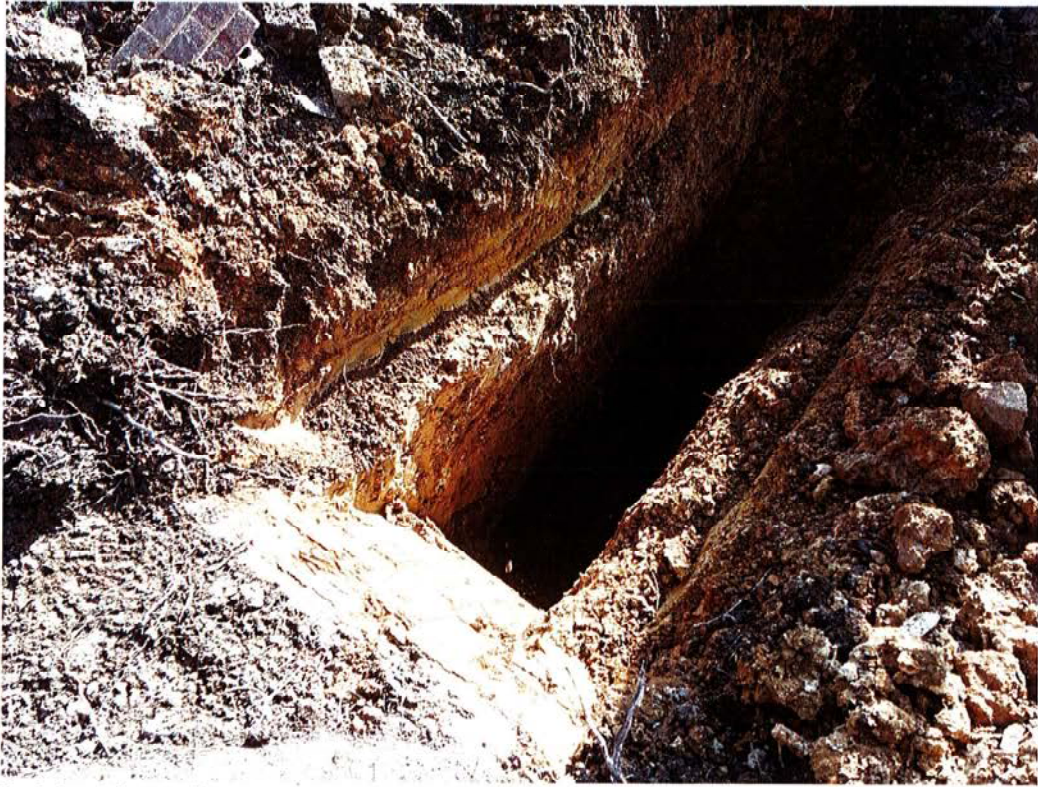
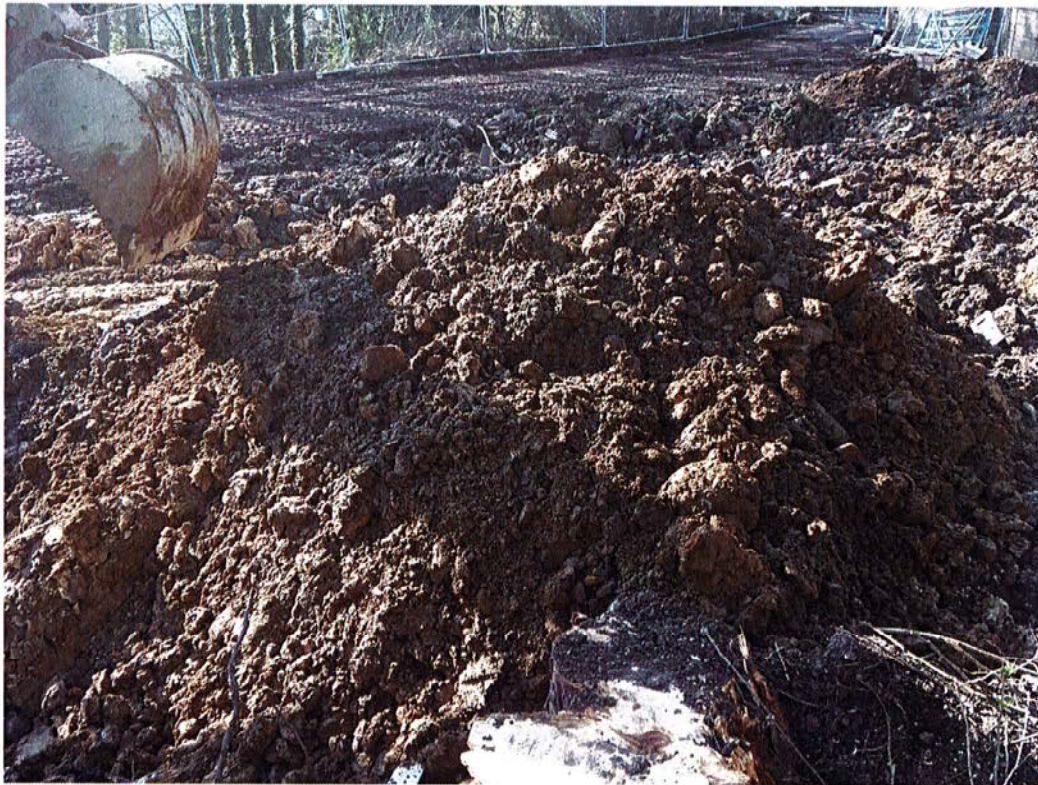
Trial Pit 06

| Depth (m) | Strata |
|---|---|
| 2.50 – 3.00 | Loose locally medium dense yellowish-brown SAND and GRAVEL in a sandy clay matrix (GLACIAL DEPOSITS) |

1. Pit walls slightly unstable from 2.50m depth.
2. Water strike encountered at 2.50m depth.
3. Physical sample taken between 1.00 – 1.10m depth for pH, Water Soluble Sulphate and Atterberg limit testing.
4. Physical sample taken between 2.00 – 2.10m depth for Atterberg limit testing.

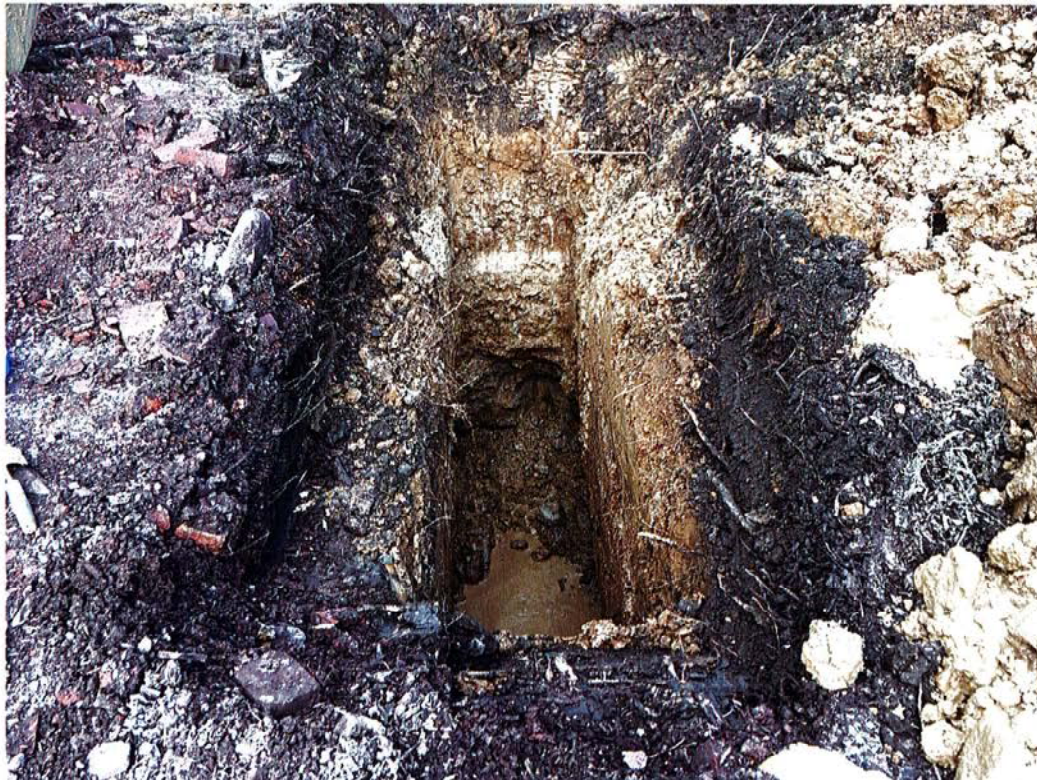
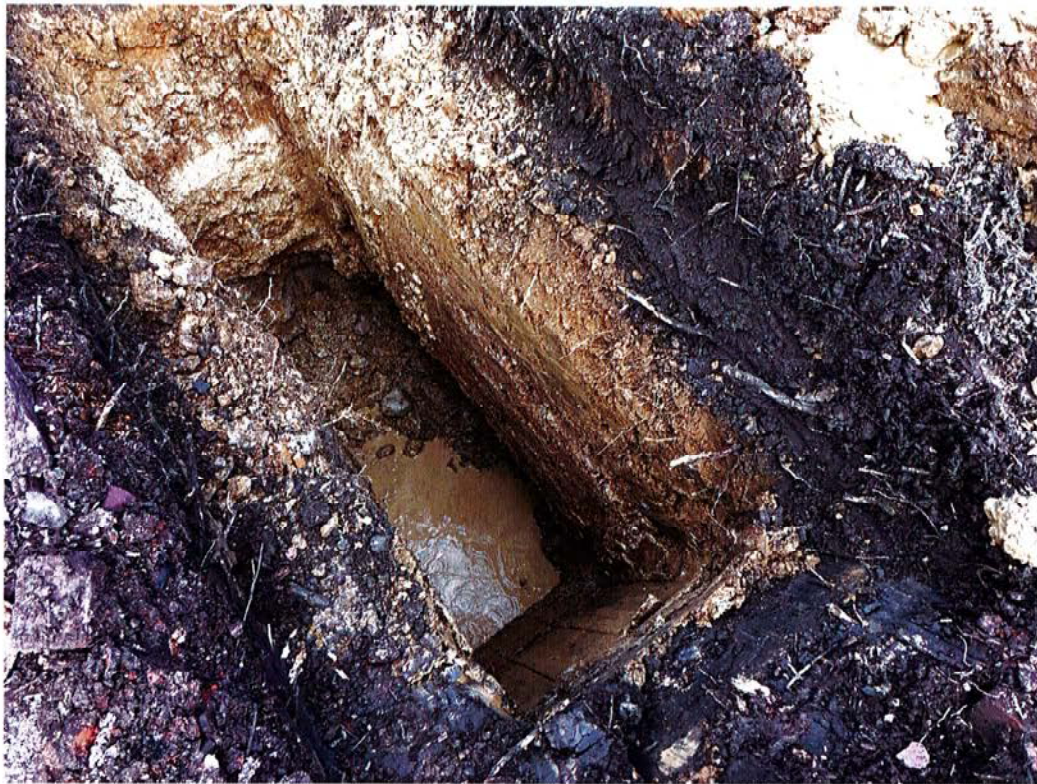
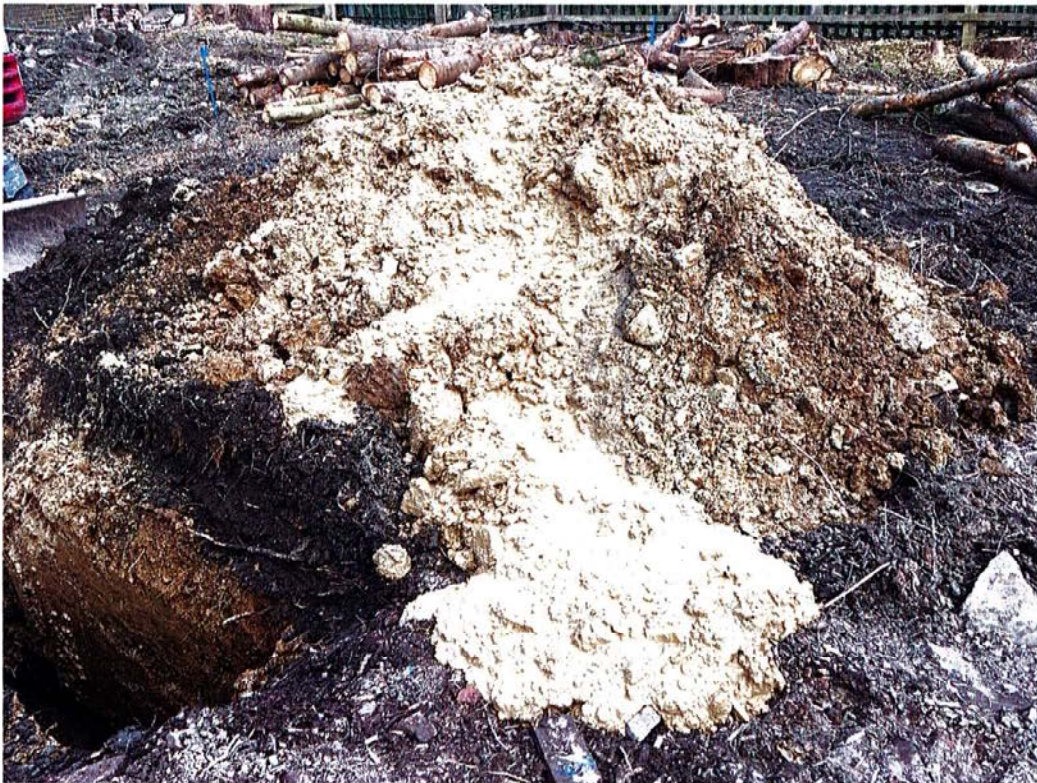
Trial Pit 07

| Depth (m) | Strata |
|---|---|
| 1.90 – 2.80 | Loose yellowish-brown SAND and GRAVEL in a sandy clay matrix<br>(GLACIAL DEPOSITS) |

1. Pit walls unstable from 1.90m depth.
2. Water strike encountered at 1.90m depth.
3. Physical sample taken between 1.00 – 1.10m depth for pH, Water Soluble Sulphate and Atterberg limit testing.
