MILL HOUSE, MARCHWIEL HALL, MARCHWIEL, WREXHAM

## **BAT MITIGATION STRATEGY**

Rev B – October 2020

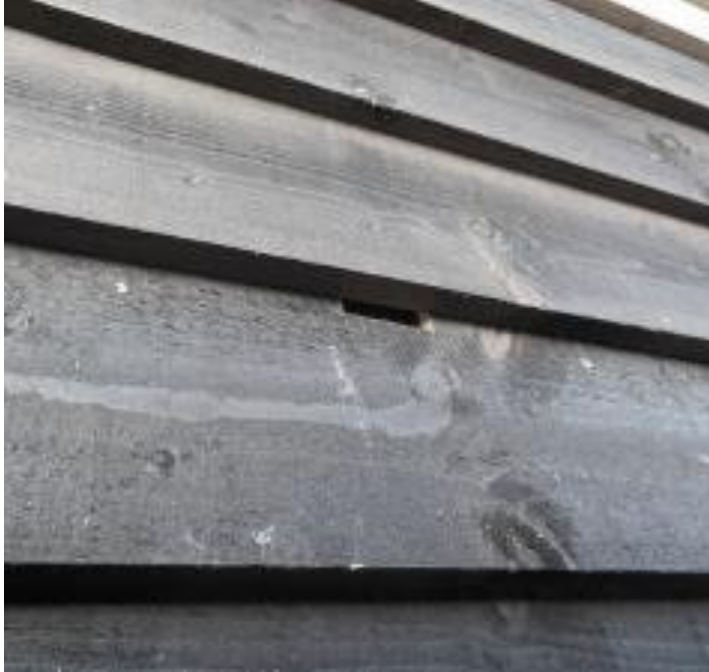
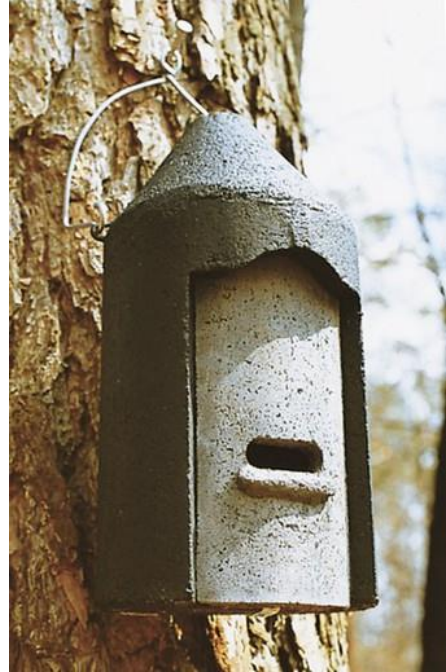
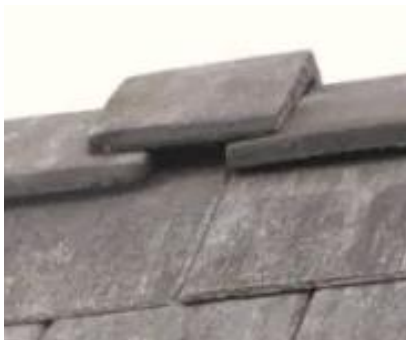
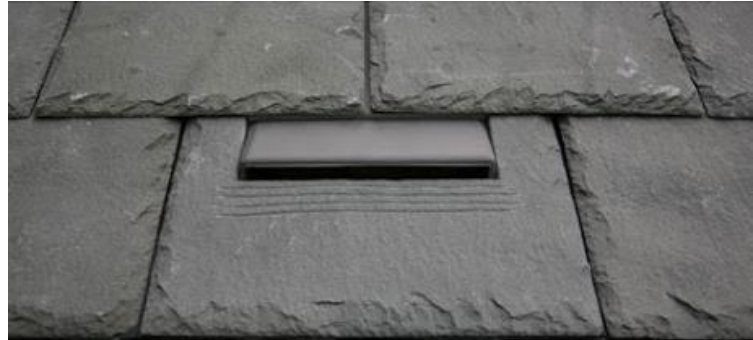
Common Pipistrelles, Soprano Pipistrelles and Brandt's/Whiskered bats have all been identified on site and so crevice dwelling opportunities need to be maintained. Disturbance to the Mill Cottage roof, eaves and soffits will be minimal if at all, with the existing materials and access points retained where possible, and Bitumen 1F underfelt used rather than breathable membrane. Where slate tiles have slipped on the roof and need replacing, access tiles will be provided to maintain access for crevice dwelling bats, as well as ridge access tiles (a minimum of 4).

Soffit and barge access shall be re-instated across areas currently used by Pipistrelles, Whiskered/Brandt's and Brown Long-eared bats and will allow access into existing loft voids at Mill cottage.

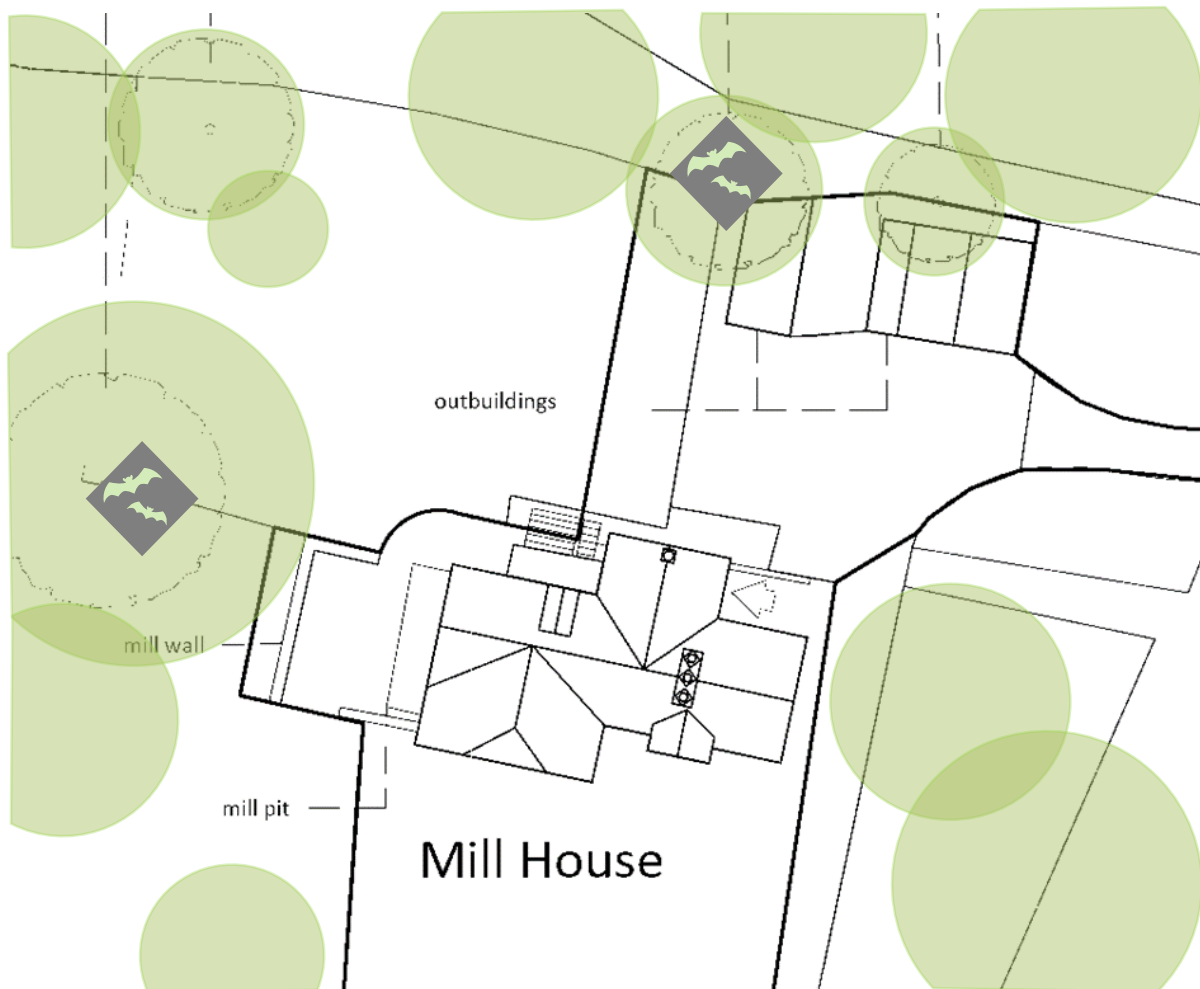
Indicative positions of receptor boxes:

To ensure that bats are not left without a roost while the redevelopment work at the cottage and outbuilding structures takes place, five Schwegler 2F bat boxes (or equivalent) will be erected onto mature trees to the west and north of the site; they will be indefinitely retained during and after the work schedule and will also act as a receptor if bats have to be captured during the work schedule.

To ensure that bats are not left without a roost while the redevelopment work at both structures takes place, five Schwegler 2F bat boxes (or equivalent) will be erected onto mature trees to the west and north of the site; they will be indefinitely retained during and after the work schedule and will also act as a receptor if bats have to be captured during the work schedule (see Figure 6).

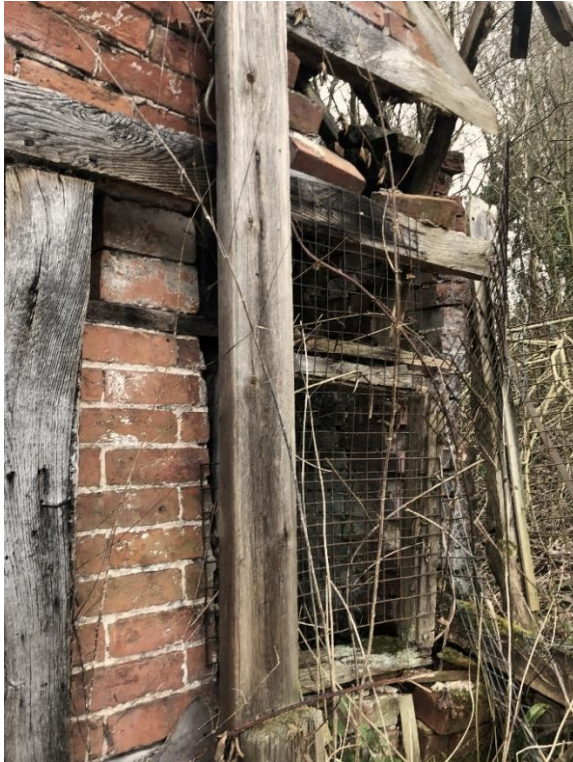
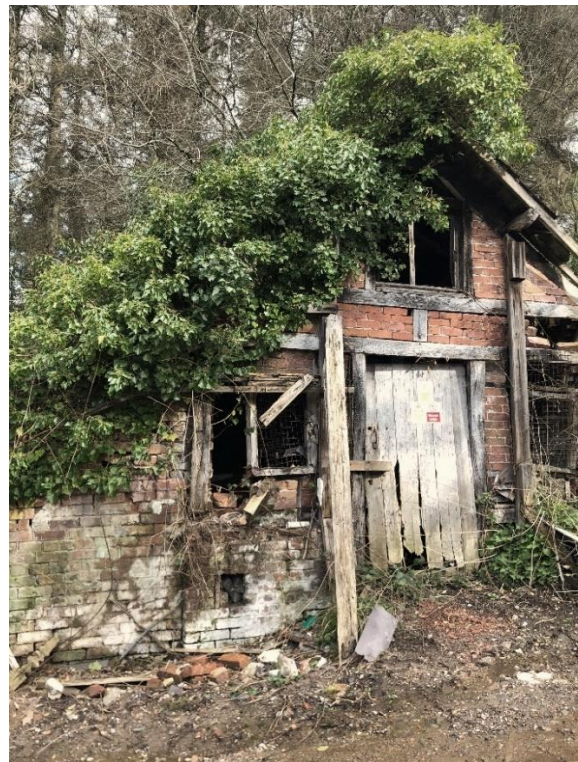
## LESSER-HORSESHOE BAT MITIGATION

The dilapidated outbuilding is being used as a roost for a lesser-horseshoe bat as well as some pipistrelle bats. A replacement roost will be incorporated into the proposals for a replacement outbuilding to the north of the site, in the same location, which will replicate the existing dimensions and form of the current building, which will ensure the same aspect, size, access points and vegetation links are maintained. No lighting will be directed toward or placed within proximity of the new roost/outbuilding.

The new walls will be timber clad, backed with Bitumen 1F underfelt, and some of the original timber materials will be re-used where possible. Gaps of 15-18mm minimum width and 75mm length will be provided along the cladding. On the roof of the stand-alone roost to the south-east will be dedicated access for Lesser Horseshoe bats which will provide open access for bats to fly directly into the loft space, whilst not allowing for illumination in the loft space. The roof of the stand-alone roost will comprise slates backed with bitumen 1F underfelt as opposed to breathable membrane or any other underfelt material. The insulation and enclosed construction should improve the current internal temperatures for the bats and encourage them to stay.

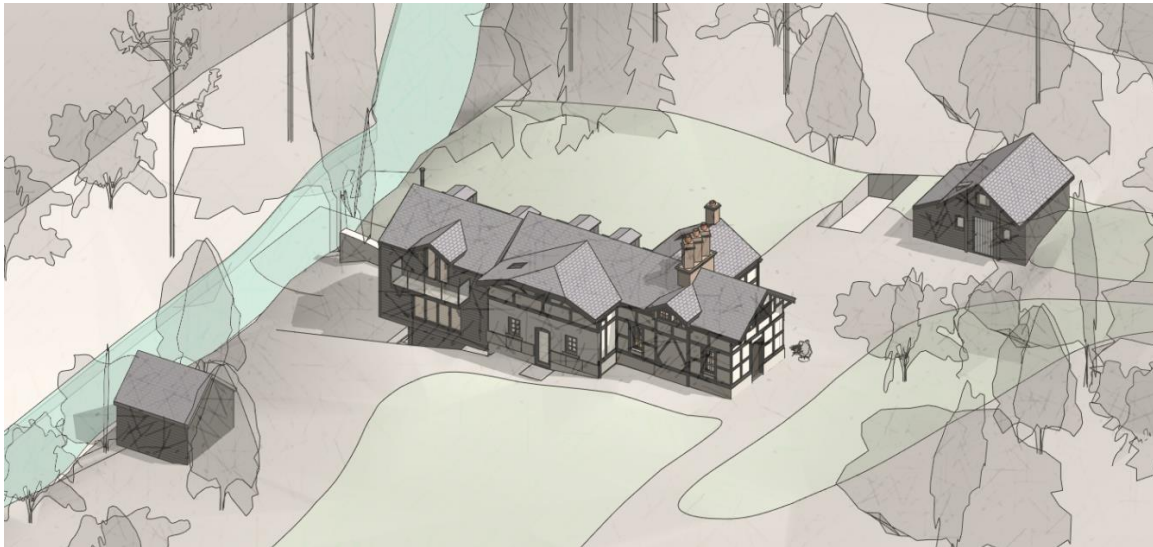
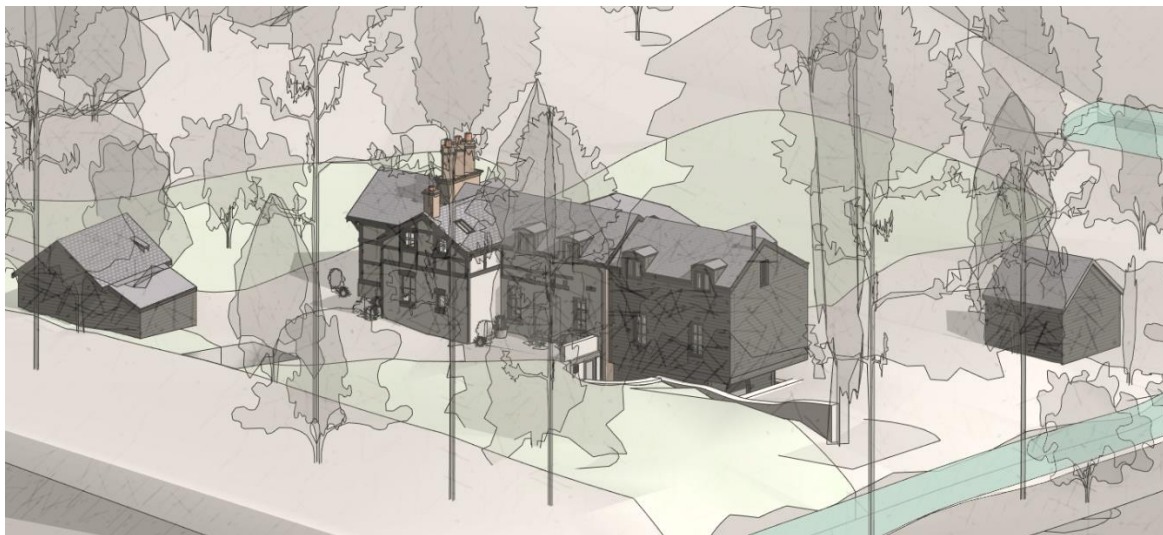
Proposed brown long-eared bat roost:

The new purpose-built Brown Long-eared bat roost will feature a partitioned loft space measuring 4.2 x 4.2m in footprint and will be 2.0m in height from floor to ridge (42 degree slope). It will be located 2-3m distance from the bank of the Gefeilliau Brook (as the bank is too steep to support construction), where it will receive solar gain to support a maternity colony, and will be built using reclaimed timber frame, with blackened cladding to match the extension and outbuilding, 100mm insulation and Bitumen 1F felt underlay. The roof will be slate tile to match the existing roofs with Bitumen 1F felt underlay.

At intervals along the ridge beam and along the roof slope the bitumen roof felt will have 30 x 100mm slots cut out for crevice access between the felt and tiles. A double ridge board will be created with a gap of 20mm between boards to provide crevice situations. Elm cladding will be fixed on vertical 18mm battens over bitumen underfelt at the gable ends, with gaps of 15 - 20mm in the cladding for additional crevice opportunities. A 500 x 500mm hatch on the rear underside of the loft will provide access for monitoring.

The roost is positioned alongside the brook (as close as possible, and set back no more than 3m), where feeding and foraging takes place. It is positioned at a distance of around 12.5m from the proposed extension and the nearest light source (which would be indirect, internal light emitting from within the rear windows of the extension, which would likely be low level and be significantly dimmed by curtains/blinds).
