**PHASE II GEO-ENVIRONMENTAL  
ASSESSMENT  
PROPOSED INDUSTRIAL DEVELOPMENT  
SITE 4  
WREXHAM INDUSTRIAL ESTATE**

**Client:** FI Real Estate Management Ltd

**Report Number:** S1671- 4

**June 2020**

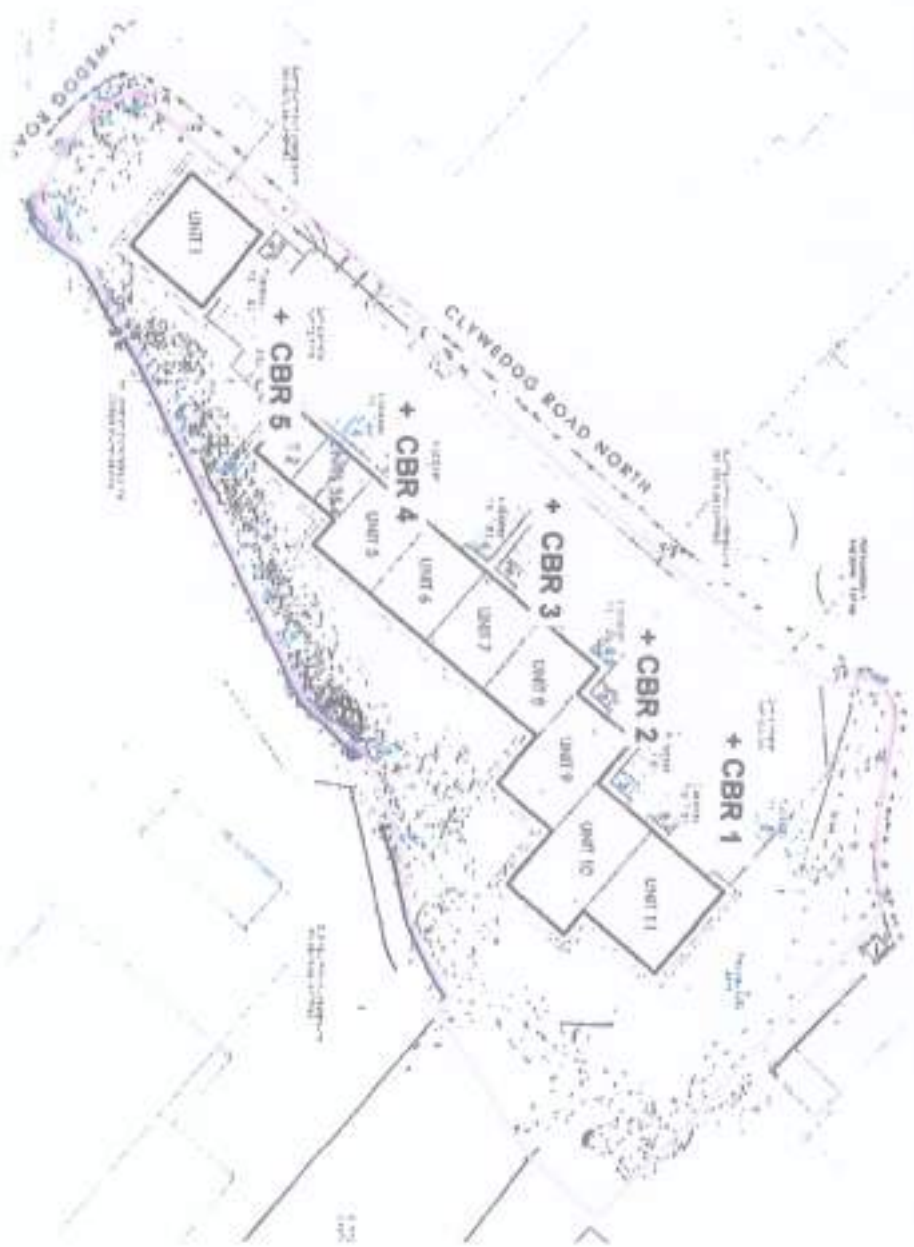
| <b>SP</b><br><b>ASSOCIATES</b> | <b>Report No.</b><br><b>S1671 - 4</b> | <b>Project:</b><br><b>Wrexham Industrial Estate, Site 4</b> | <b>Figure:</b><br><b>3</b> |

**In-situ CBR Test Location Plan**

Some of the CBR values achieved are lower than would be expected for a firm to stiff clay. The CBR value for a give soil depends upon its dry density and its moisture content and the higher the latter value the lower the CBR value tends to be as illustrated in the above summary table. The in-situ testing took place in February during and after a spell of very high rainfall and the near surface soils were very soft as demonstrated by the fact that the four wheel drive test vehicle had to be winched off the site as it was 'bogging down'.

The Plasticity Index range for the clay formation based upon Index test data is 25% to 35% which, based upon the recommendations of Interim Advice Note 73/06 Revision 1 (2009), equates to a CBR of about 3%. On the grounds that the formation level for the proposed pavements is likely to be somewhat deeper than the test level and that corresponding natural moisture contents will be somewhat lower than those listed above, it is recommended that a design CBR value of 2.5% is adopted for a thin layered pavement construction.

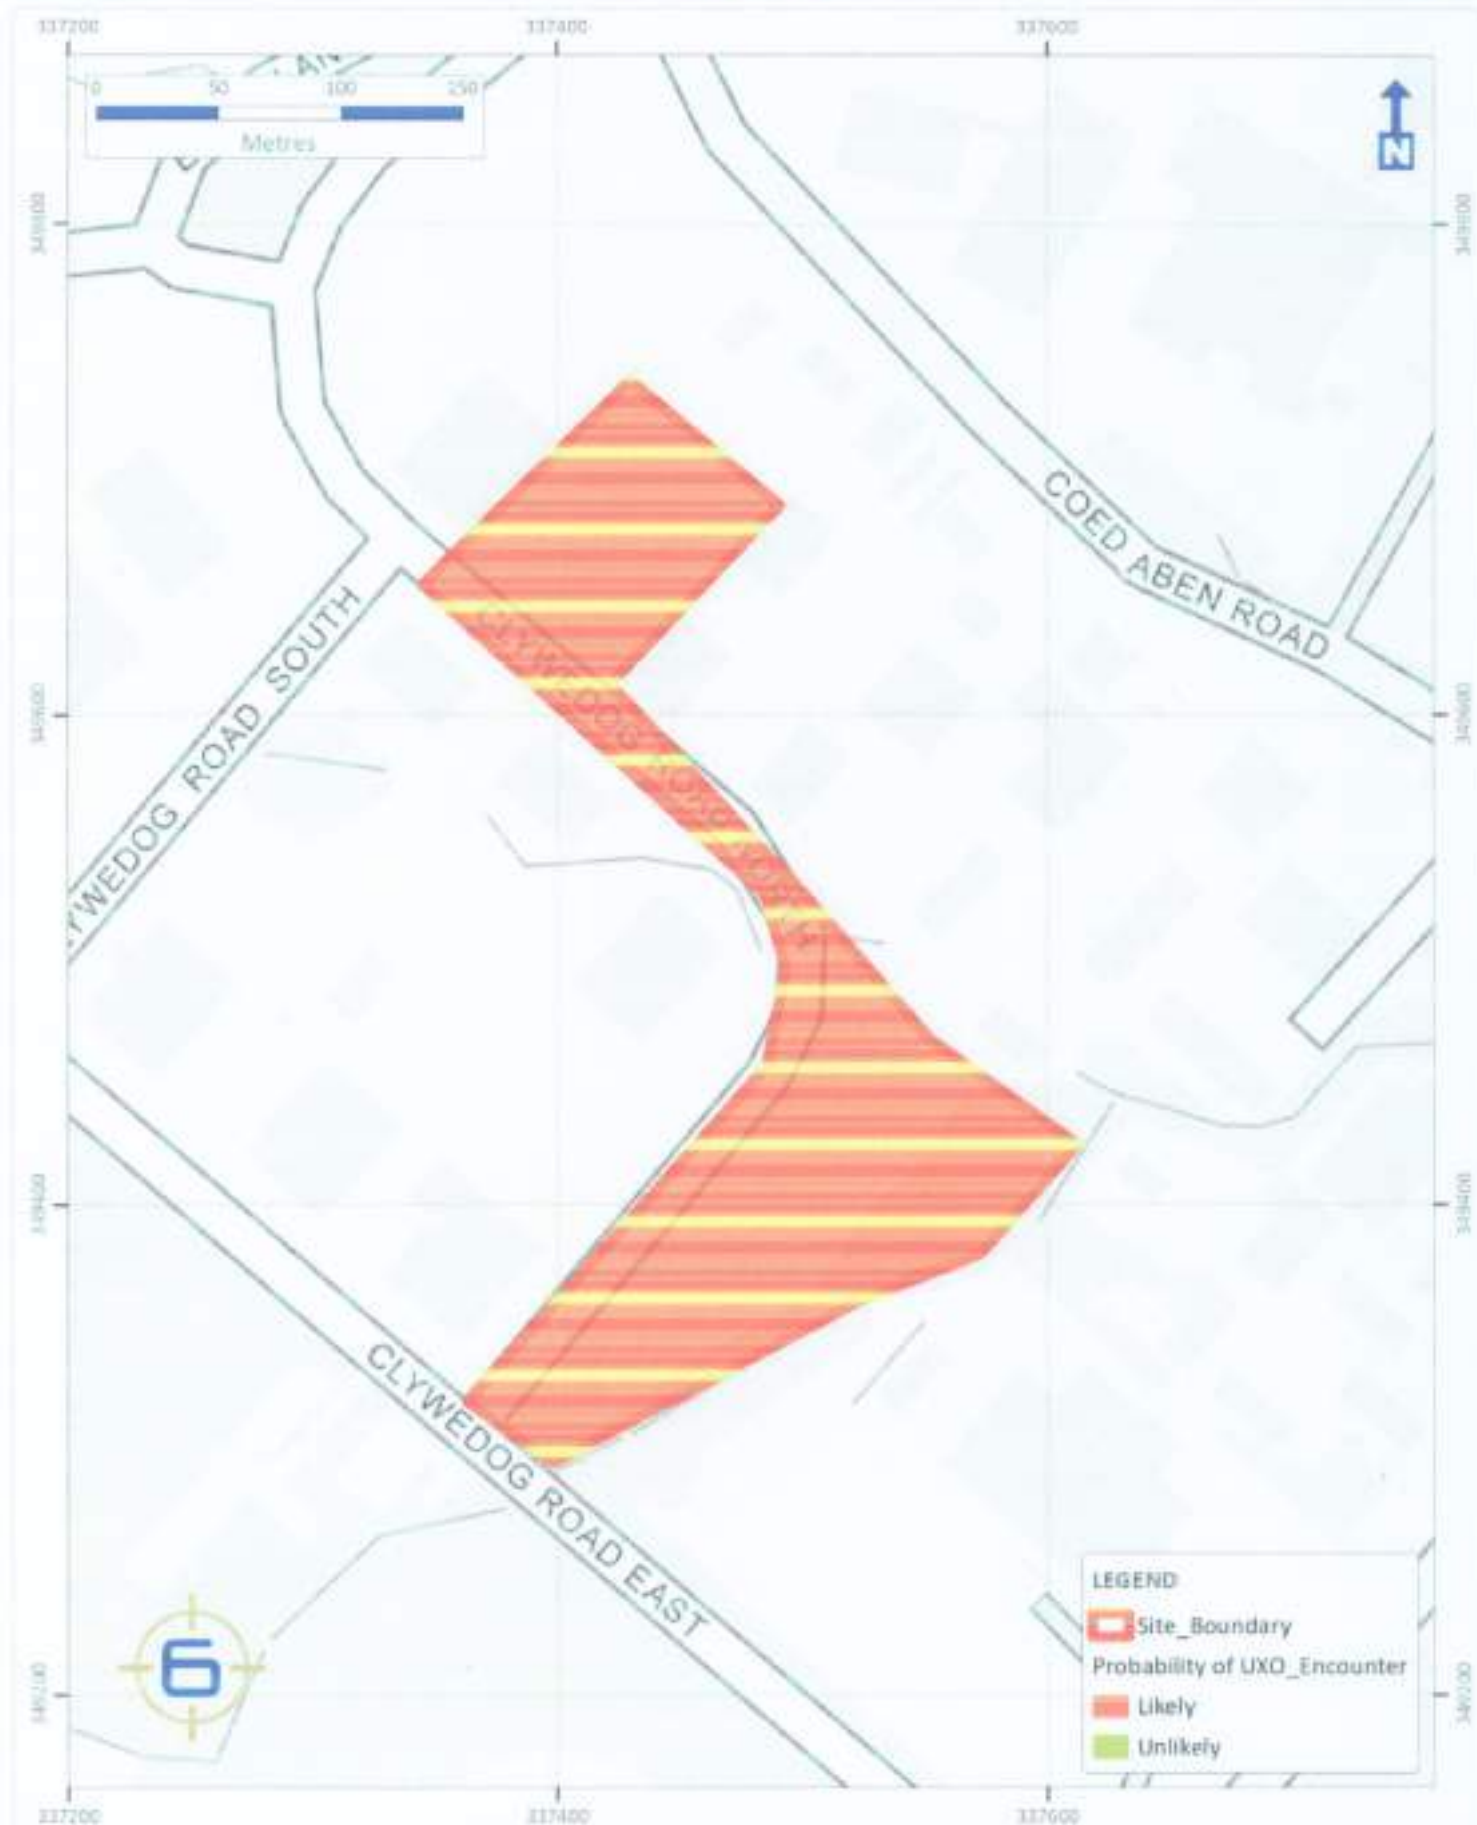
## Probability of UXO Encounter

The potential for UXO hazard to occur, and more specifically, the potential for unexploded WWI and WWII ordnance to exist at this site is assessed as being **LIKELY** (Figure 2).
