**TYDDYN DEDWYDD  
FRON-DEG, WREXHAM  
PROPOSED BARN CONVERSION**

BAT INSPECTION REPORT

**ETIVE ECOLOGY Ltd**

16 DECEMBER 2020

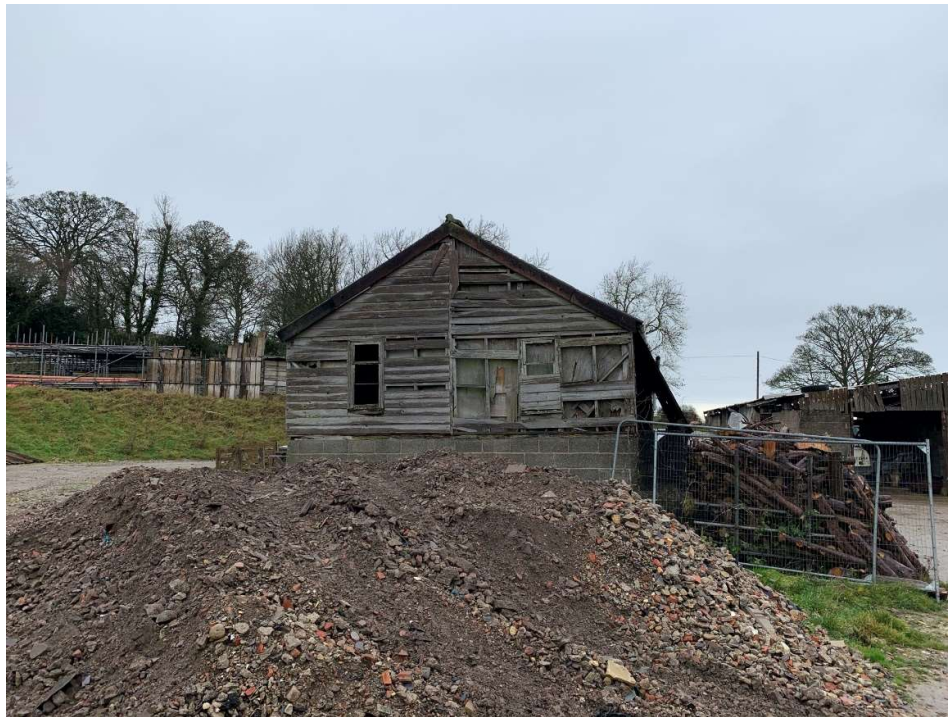
3.2.1 The barn at Tyddyn Dedwydd is an unused agricultural building, originally built in the 1970s as a chicken shed. However, for the last 20 years the barn has been used entirely for storage of agricultural materials, tools and supplies. The site is accessed off a narrow country lane off the B5426 and is a relatively isolated site, located at an altitude of ~250m. The barn is located on the western edge of a large residential and agricultural plot, with numerous residential buildings, agricultural barns and farmyard areas (Photograph 1).

Photograph 1; rear gable showing surrounding farmyard

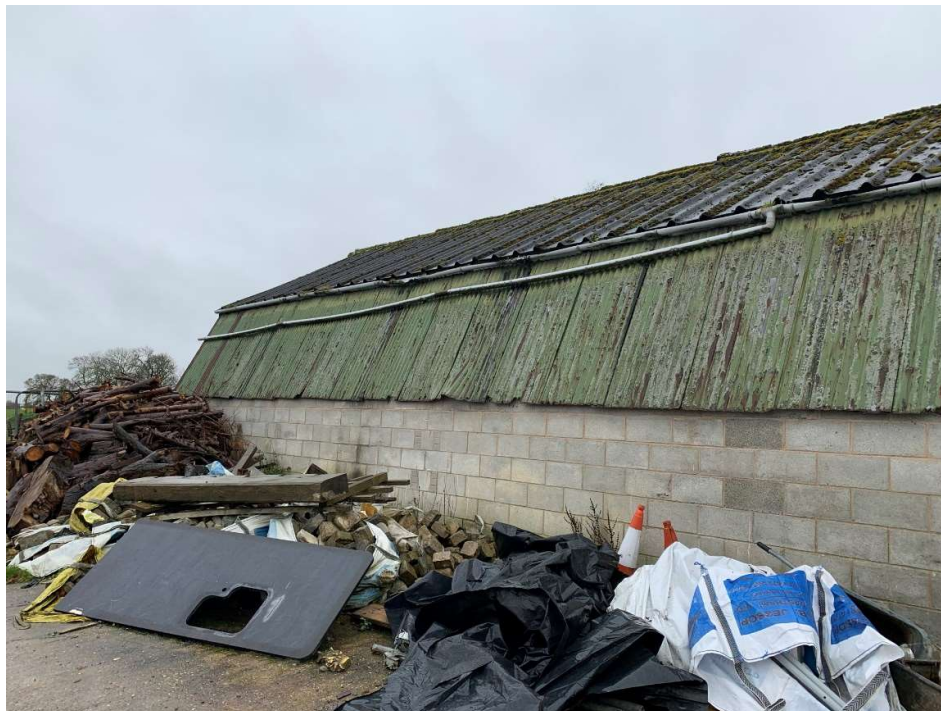
3.2.2 The barn covers a rectangular footprint approximately 5 x 15m and is comprised of blockwork elevations to a height of 1-1.5m on all four sides. Above the blockwork is a timber framed structure, with horizontal overlapping timber panels nailed to form the external skin of the building on the north, west and south elevations. There are numerous windows opening, all of which have either been boarded over or have had the glazed panels removed. The eastern elevation comprises corrugated metal panels bolted to the timber frame (Photograph 2).

Photograph 2; eastern elevation with corrugated metal panels

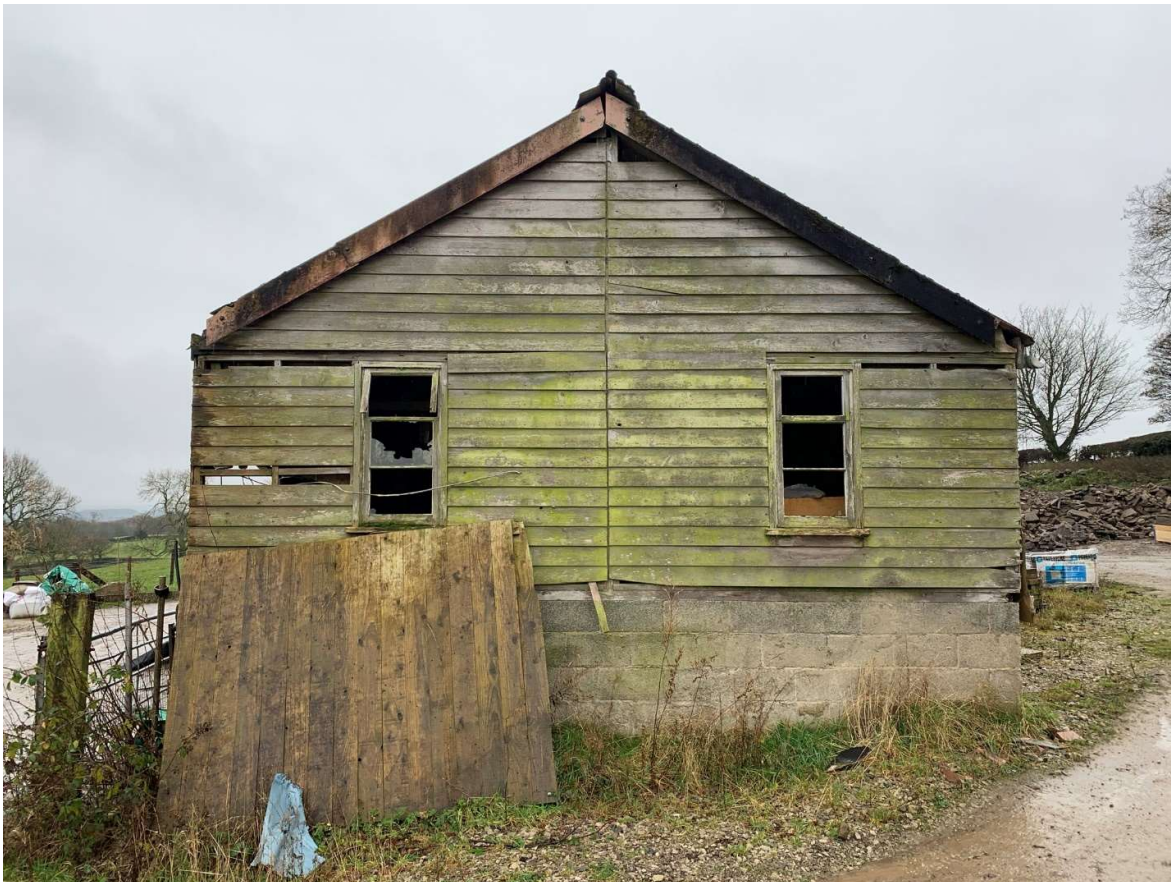
- 3.2.3 The roof of the barn is comprised of corrugated metal panels, bolted to the timber frame structure. There is also a metal roof ridge and at each gable end there are metal barge boards running from the apex to the eaves (Photograph 3). Guttering is in place but is in poor condition and there is most growth across parts of the roof.

Photograph 3; northern gable showing metal barge boards – heavily rusted

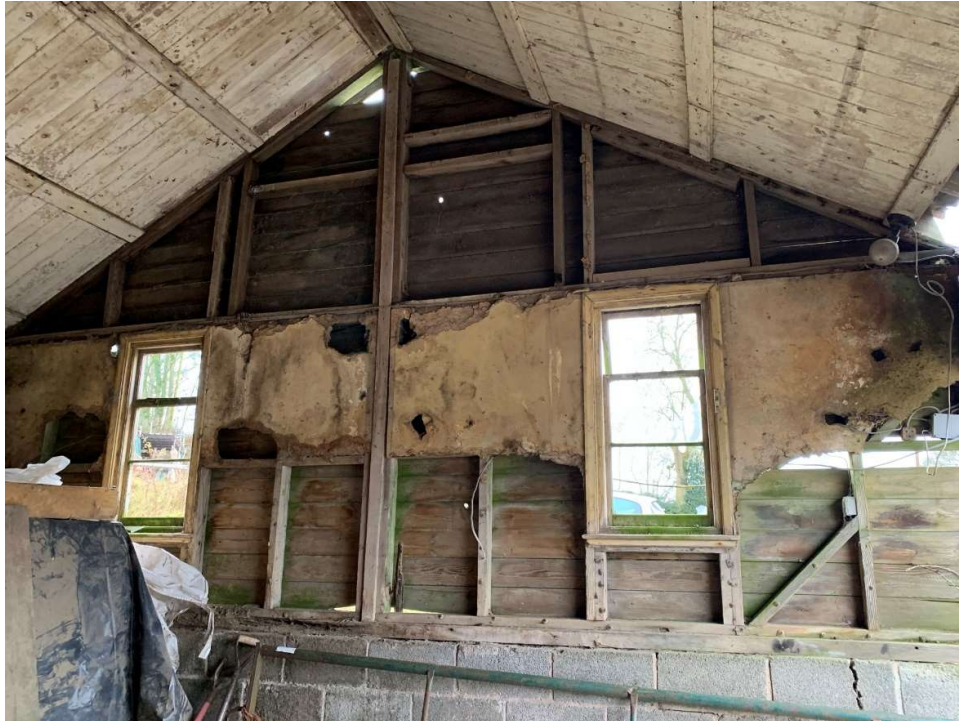
- 3.3.1 Internally, the barn was found to be in a relatively poor condition. The eastern elevation was unclad and comprised the metal panels as described previously, with no internal layer. The northern and southern gables were found to comprise timber stud walls, with the internal skin comprising patches of timber boards, most of which were damp and rotting (Photograph 4).

Photograph 4; patched and rotting boards on northern gable

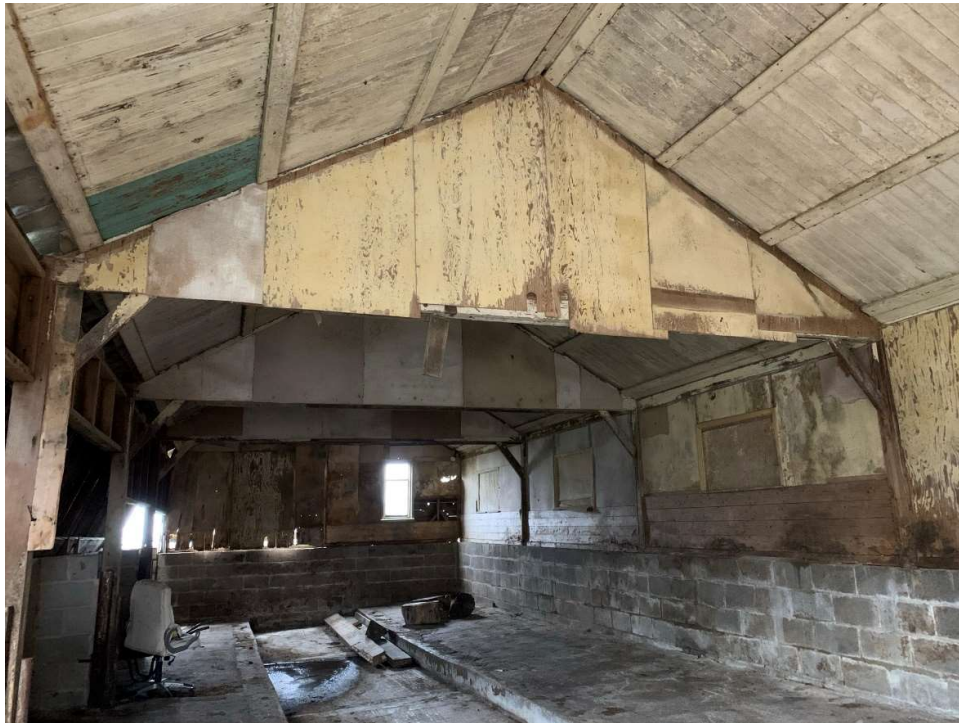
- 3.3.2 The western elevation comprised a patchwork of timber boards and panels, nailed to the inside of the timber structure of the building (Photograph 5). The timber work covered up former window openings and extended from the top of the blockwork walls to the timber sarking boards beneath the roof structure. A single layer of timber boards have also been nailed to each of the two bracing beams that run across the barn, attached from principal rafters to tie beams (Photograph 5).

Photograph 5; patchwork of timber boards on the western elevation

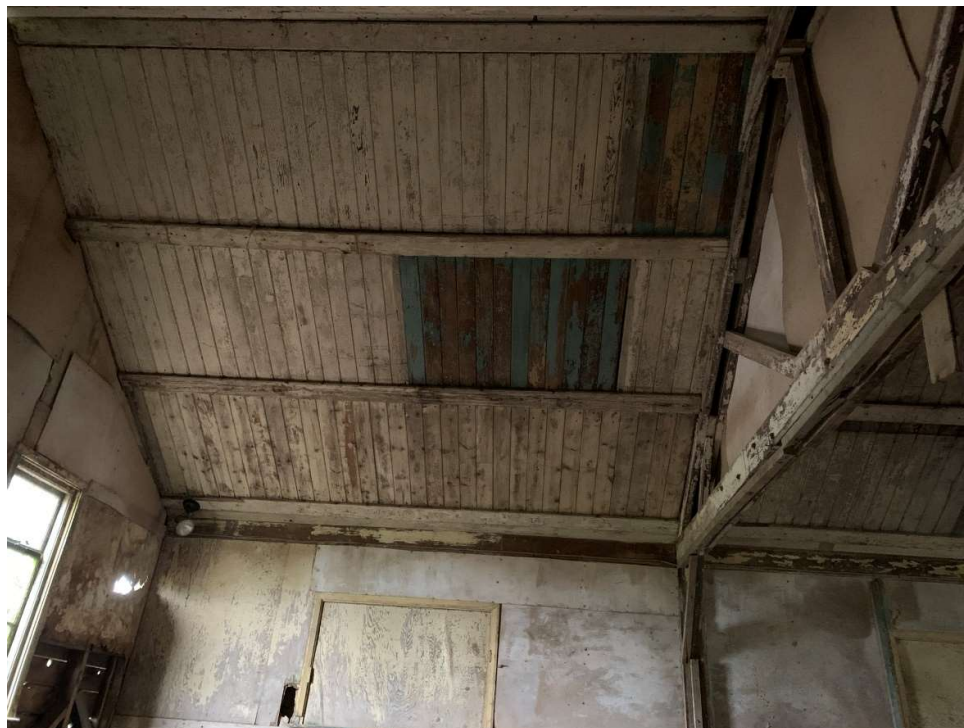
- 3.3.3 The roof is lined with timber sarking boards, which were found to be in surprisingly good condition (Photograph 6). The boards extended the length of the barn from gable to gable and appeared to be fixed securely to the timber frame of the building. The overall feel of the internal area was of a relatively well-lit space due to the numerous holes in the external walls, and a cool, damp and draughty environment.

Photograph 6; timber sarking boards in good condition
