**RE: Results of Soakaway Tests at Former Wrexham Police Station (LL12 7BW).**

Remada was appointed by Lidl Great Britain Ltd to undertake a day of soakaway tests at the former Wrexham Police Station, Bodhyfryd, LL12 7BW.

# FIGURE 1

| Soakaway Locations | | |

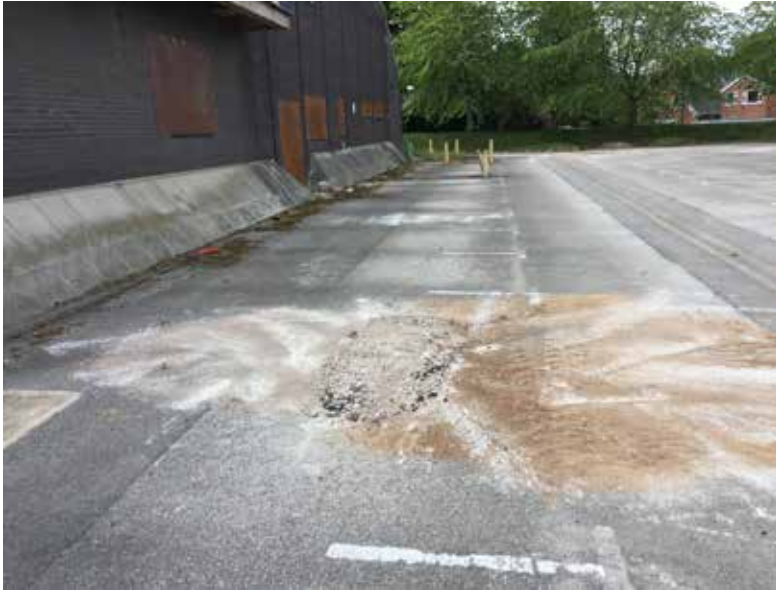
| Project<br>Former Wrexham Police Station, Bodhyfryd, LL12 7BW | | | | TRIAL PIT No<br><b>SA1</b> |

| Depth | No | DESCRIPTION | Depth | No | Remarks/Tests |
|---|---|---|---|---|---|
| 0.00-0.15 | | MADE GROUND: Asphalt. | | | |
| 0.15-0.45 | | MADE GROUND: Light brownish grey sandy angular to subangular fine to coarse gravel predominantly of limestone. | | | |
| 0.45-2.05 | | Brown slightly silty gravelly medium SAND with low cobble content. Gravel is subrounded to rounded fine to coarse of mixed lithologies including sandstone and quartzite. Cobbles are rounded. | | | |

Shoring/Support: No shoring required.  
Stability: Sides stable.

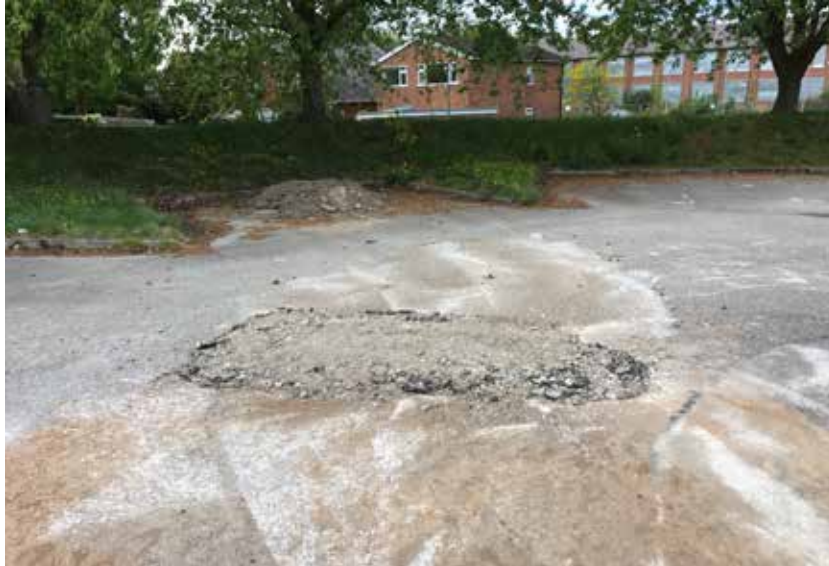
| Project<br>Former Wrexham Police Station, Bodhyfryd, LL12 7BW | | | | TRIAL PIT No<br><b>SA2</b> |

| STRATA | | | SAMPLES & TESTS | | |
|---|---|---|---|---|---|
| 0.00-0.10 | | MADE GROUND: Asphalt. | | | |
| 0.10-0.65 | | MADE GROUND: Grey sandy angular to subangular fine to coarse gravel with low cobble content. Gravel is predominantly of limestone, with rare brick and concrete fragments. Cobbles are angular of concrete. | | | |
| 0.65-1.10 | | MADE GROUND: Orangish brown gravelly fine to medium sand with low cobble content. Gravel is subrounded to rounded fine to coarse of mixed lithologies. Cobbles are angular to rounded of mixed lithogies including concrete. | | | |
| 1.10-1.70 | | Brown slightly silty gravelly medium SAND with low cobble content. Gravel is subrounded to rounded fine to coarse of mixed lithologies including sandstone and quartzite. Cobbles are rounded. | | | |

Shoring/Support: No shoring required.  
Stability: Sides stable.

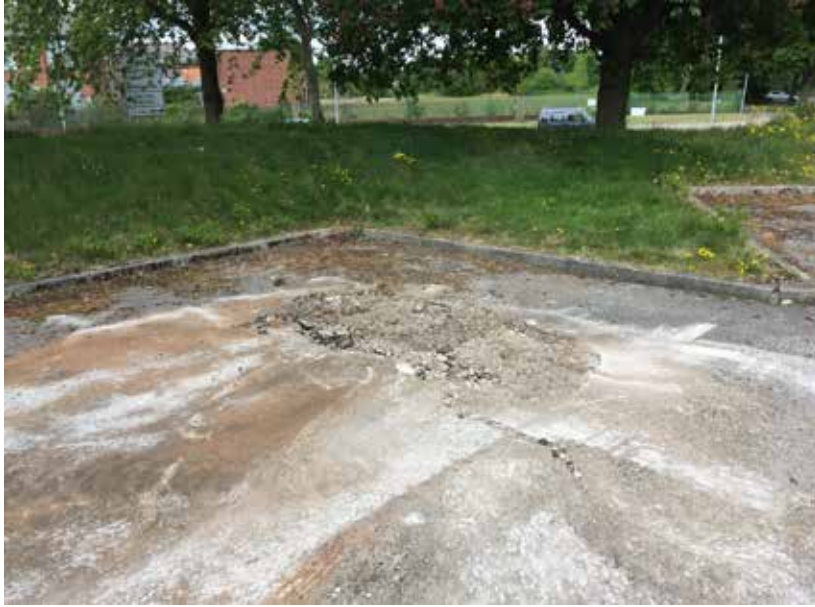
| Project<br>Former Wrexham Police Station, Bodhyfryd, LL12 7BW | | | | TRIAL PIT No<br><b>SA3</b> |

| Depth | No | DESCRIPTION | Depth | No | Remarks/Tests |
|---|---|---|---|---|---|
| 0.00-0.12 | | MADE GROUND: Asphalt. | | | |
| 0.12-0.50 | | MADE GROUND: Light brownish grey sandy angular to subangular fine to coarse gravel predominantly of limestone. | | | |
| 0.50-2.20 | | Brown slightly silty gravelly medium SAND with low cobble content. Gravel is subrounded to rounded fine to coarse of mixed lithologies including sandstone and quartzite. Cobbles are rounded. | | | |

Shoring/Support: No shoring required.  
Stability: Sides stable.

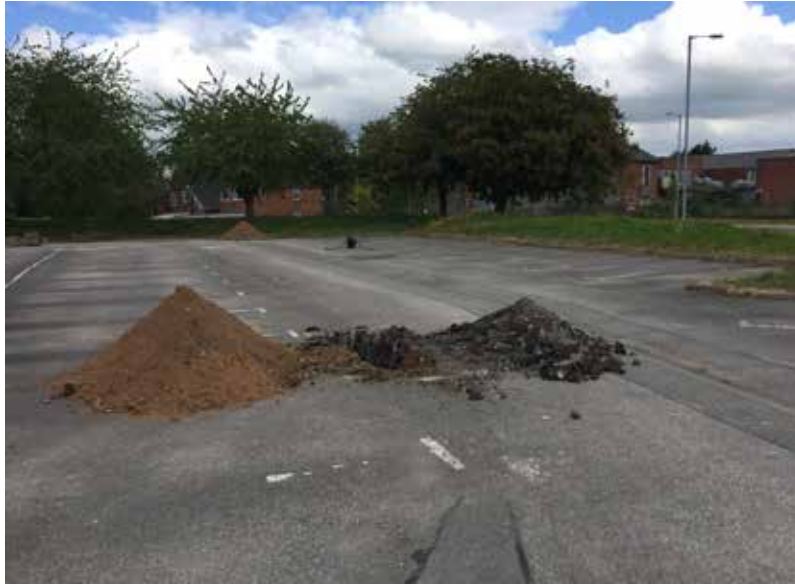
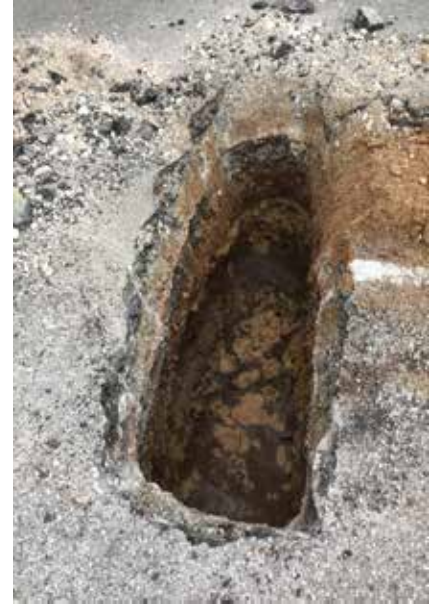
| Project<br>Former Wrexham Police Station, Bodhyfryd, LL12 7BW | | | | TRIAL PIT No<br><b>SA4</b> |

| STRATA | | | SAMPLES & TESTS | | |
|---|---|---|---|---|---|
| 0.00-0.12 | | MADE GROUND: Asphalt. | | | |
| 0.12-0.75 | | MADE GROUND: Light brownish grey sandy angular to subangular fine to coarse gravel predominantly of limestone. | | | |
| 0.75-1.40 | | Brown slightly silty gravelly medium SAND with low cobble content. Gravel is subrounded to rounded fine to coarse of mixed lithologies including sandstone and quartzite. Cobbles are rounded. | | | |
| 1.40-1.67 | | Brown slightly gravelly medium SAND. Gravel is subrounded to rounded fine to coarse of mixed lithologies including sandstone and quartzite. | | | |

Shoring/Support: No shoring required.  
Stability: Sides stable.

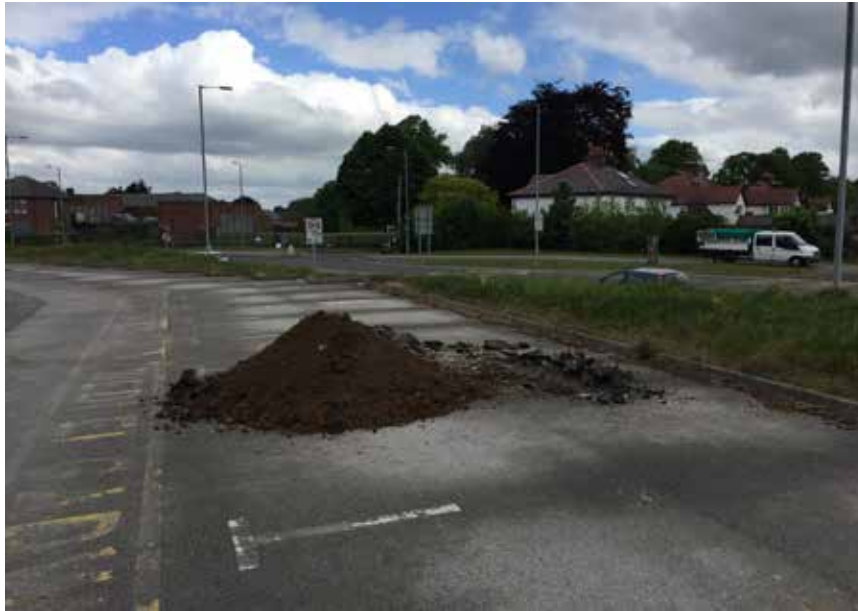
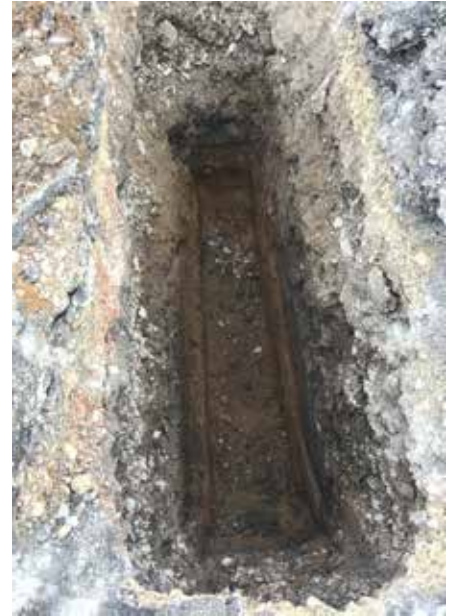
| Project<br>Former Wrexham Police Station, Bodhyfryd, LL12 7BW | | | | TRIAL PIT No<br><b>SA5</b> |

| Depth | No | DESCRIPTION | Depth | No | Remarks/Tests |
|---|---|---|---|---|---|
| 0.00-0.14 | | MADE GROUND: Asphalt. | | | |
| 0.14-0.75 | | MADE GROUND: Light brownish grey sandy angular to subangular fine to coarse gravel predominantly of limestone and rare brick fragments. | | | |
| 0.75-1.70 | | Brown slightly silty gravelly medium SAND with low cobble content. Gravel is subrounded to rounded fine to coarse of mixed lithologies including sandstone and quartzite. Cobbles are rounded. | | | |

Shoring/Support: No shoring required.  
Stability: Sides stable.

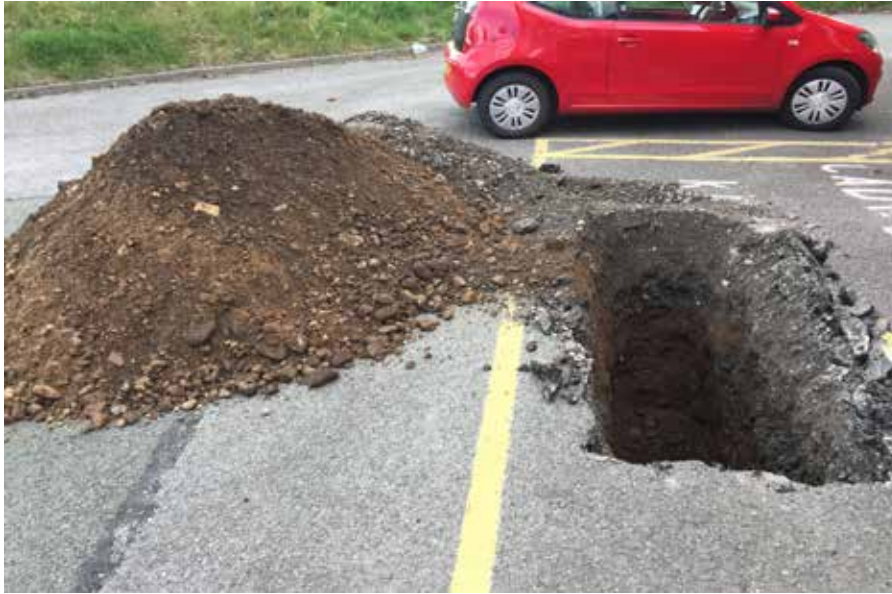
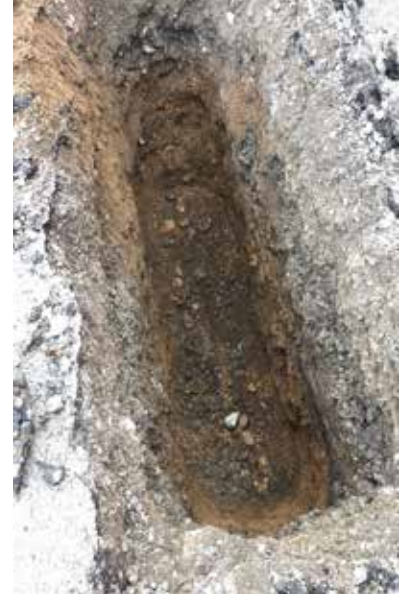
| Project<br>Former Wrexham Police Station, Bodhyfryd, LL12 7BW | | | | TRIAL PIT No<br><b>SA6</b> |

| STRATA | | | SAMPLES & TESTS | | |
|---|---|---|---|---|---|
| 0.00-0.08 | | MADE GROUND: Asphalt. | | | |
| 0.08-0.60 | | MADE GROUND: Light brownish grey sandy angular to subangular fine to coarse gravel predominantly of limestone. | | | |
| 0.60-0.85 | | MADE GROUND: Orangish brown mottled dark grey gravelly fine to medium sand. | | | |
| 0.85-1.60 | | Brown slightly silty gravelly medium SAND with low cobble content. Gravel is subrounded to rounded fine to coarse of mixed lithologies including sandstone and quartzite. Cobbles are rounded. | | | |

Shoring/Support: No shoring required.  
Stability: Sides stable.

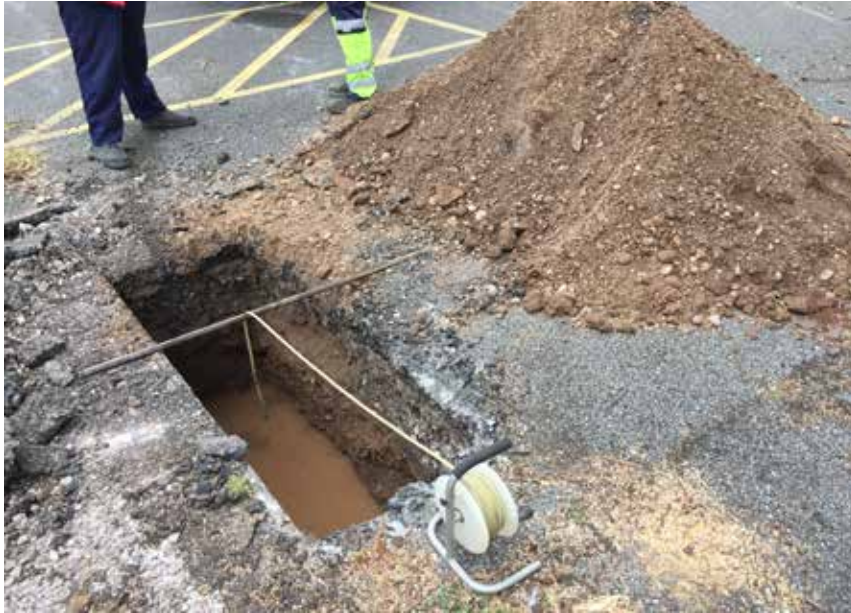
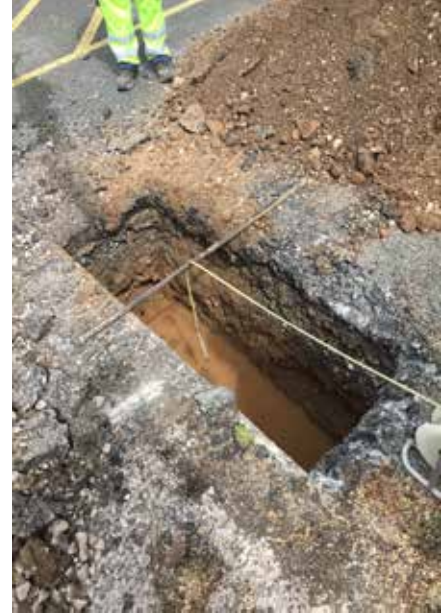
| Project<br>Former Wrexham Police Station, Bodhyfryd, LL12 7BW | | | | TRIAL PIT No<br><b>SA7</b> |

| Depth | No | DESCRIPTION | Depth | No | Remarks/Tests |
|---|---|---|---|---|---|
| 0.00-0.12 | | MADE GROUND: Asphalt. | | | |
| 0.12-0.50 | | MADE GROUND: Light brownish grey sandy angular to subangular fine to coarse gravel predominantly of limestone. | | | |
| 0.50-1.69 | | Brown slightly silty gravelly medium SAND with low cobble content. Gravel is subrounded to rounded fine to coarse of mixed lithologies including sandstone and quartzite. Cobbles are rounded. | | | |

Shoring/Support: No shoring required.  
Stability: Sides stable.

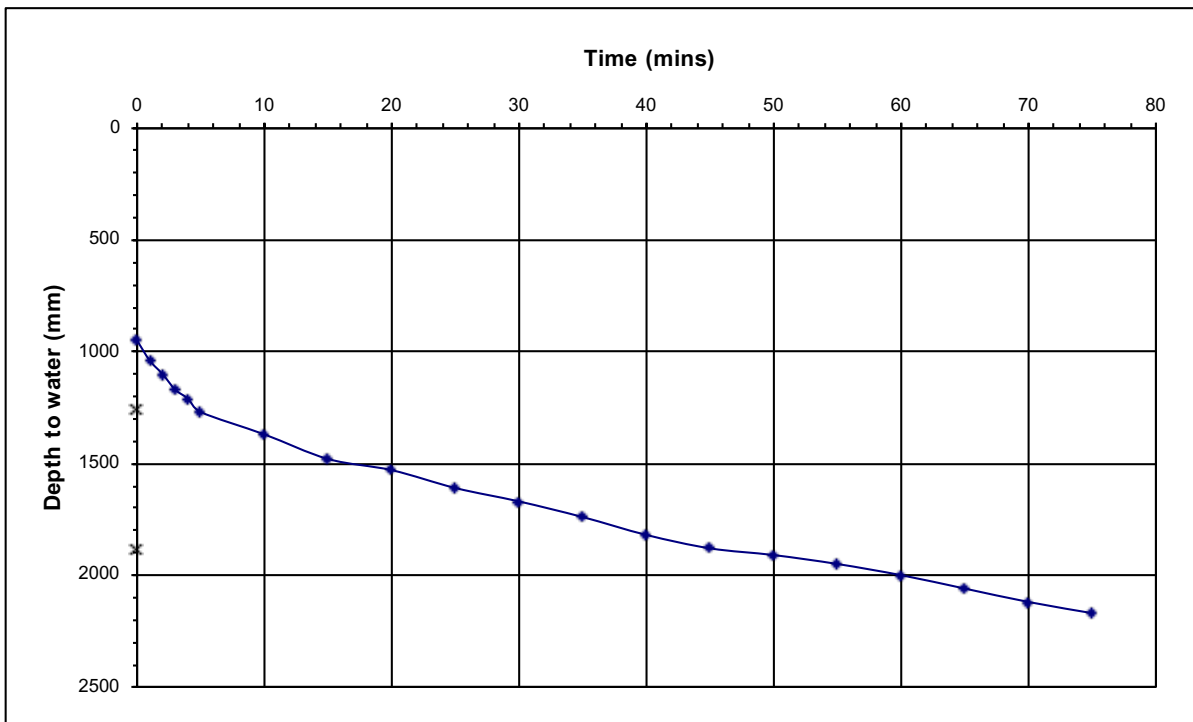
| Trial Pit No. | SA3 |

| $t_{p75}$ (min) = (Read from graph) | 5 |
| $t_{p25}$ (min) = (Read from graph) | 46 |
| $t_p$ values extrapolated from graph data = | 41 |

Soil infiltration rate,  $f$ , (m/s) = 7.30E-05 (normal test)  
Soil infiltration rate,  $f$ , (m/s) = (pit filled with stone)
