**Report Type:** Conservation Plan

**Site Address:** Knolton Farm  
Oswestry Road  
Overton  
Wrexham  
LL13 0LG

**Report Reference:** 20-08 234.CP

**Date of Issue:** 11<sup>th</sup> November 2020

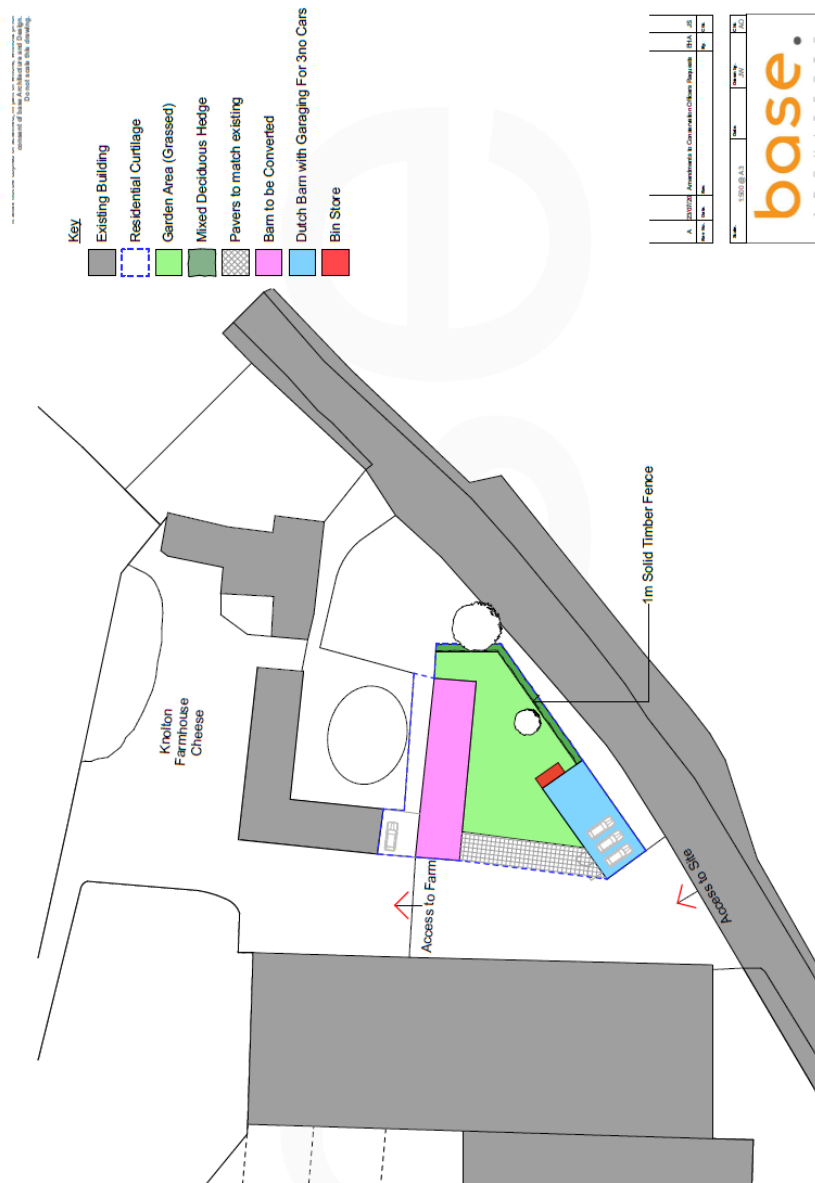
Figure 3.1. Excerpt of site plans

The proposal as agreed by the LPA is for the conversion of an agricultural building to a dwelling, and the change of use of a Dutch Barn to garaging.

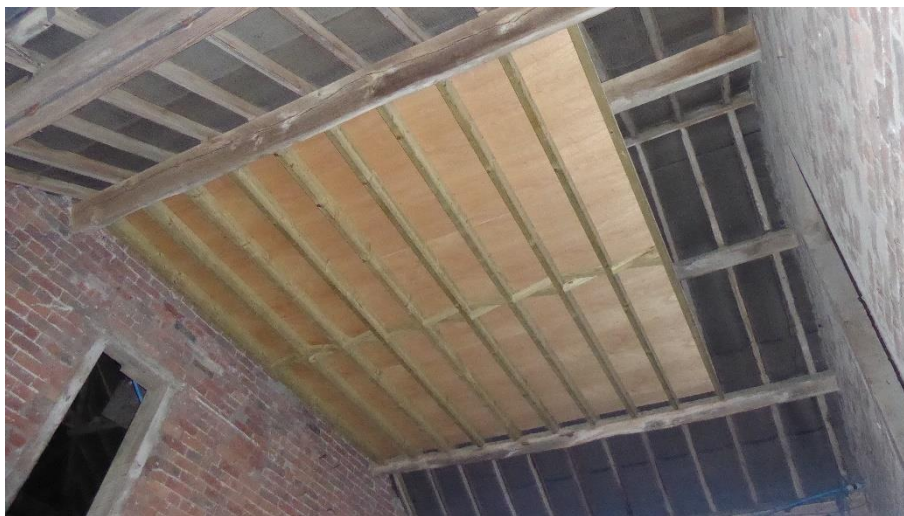
**Figure 5.1. The loft floor has already been installed**

Construction of the loft has commenced as it will not negatively impact on known bat roosts and does not need to be constructed under licence. The floor of the loft has already been installed and extends approximately 80% of the way across the gap, leaving access on the northern end. Within this loft space, a number of bat boxes will provide ongoing crevice opportunities for bats in perpetuity, as they will be sheltered from weather and damage. Another bat box will be erected on the exterior of the nearby buildings. Locations for the bat boxes can be seen in Figure 6.1.

The loft floor has already been installed (Figure 5.1).

The access into the loft as shown in Figure 5.1 will also provide sheltered space where swallows could make natural nests against the roof timbers. This is a typical behaviour of swallows, and the security provided by the loft floor may encourage the natural spread of nesting swallows into this area.

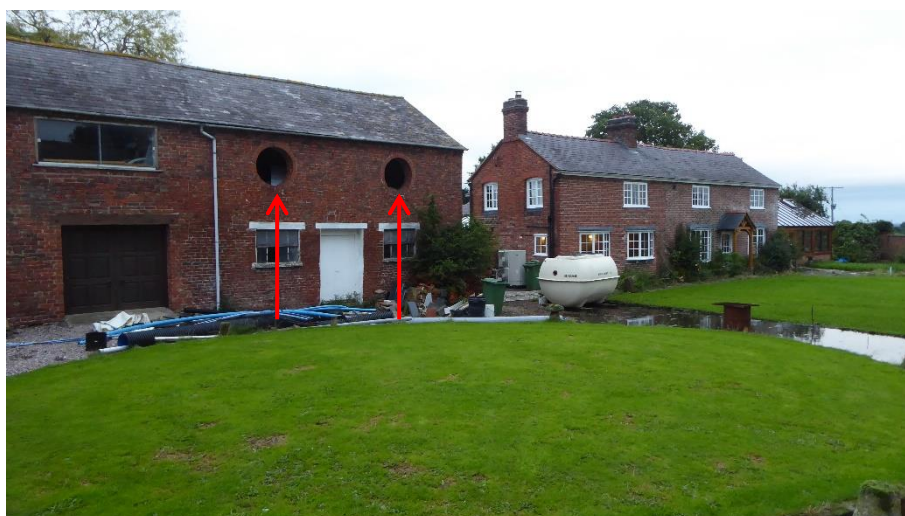
**Figure 5.5. Accesses into the loft which will be enhanced with swallow cups**

The redundant barn to the north has two porthole windows on the first floor which enter a disused loft space. The Clwydian report recommended that artificial swallow nest cups be installed within this loft, and these porthole windows are left open to ensure continued access to a sheltered nesting area.

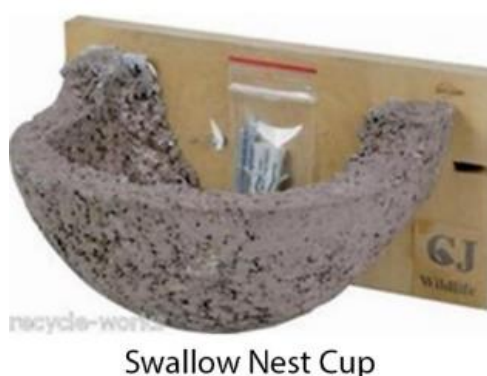
**Swallow Nest Cup**

**Figure 5.6. Example suitable artificial swallow habitat**
