# An historic buildings assessment of Wolvesacre Hall, Iscoyd, near Whitchurch

An historic buildings assessment of Wolvesacre Hall, Iscoyd, near Whitchurch.  
By Nigel Baker BA PhD FSA MCIfA  
June 2017 v.2

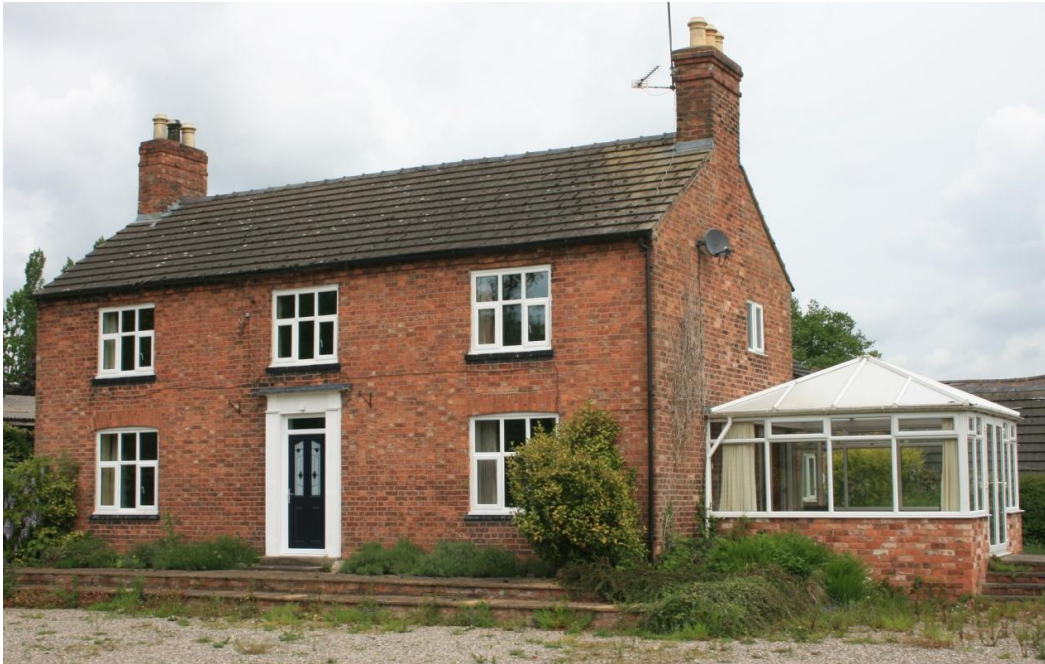
*The farmhouse from the front, looking north west. The change in level represented by the modern plinth/patio roughly reflects the edge of the medieval moat, infilled shortly before the house was built*

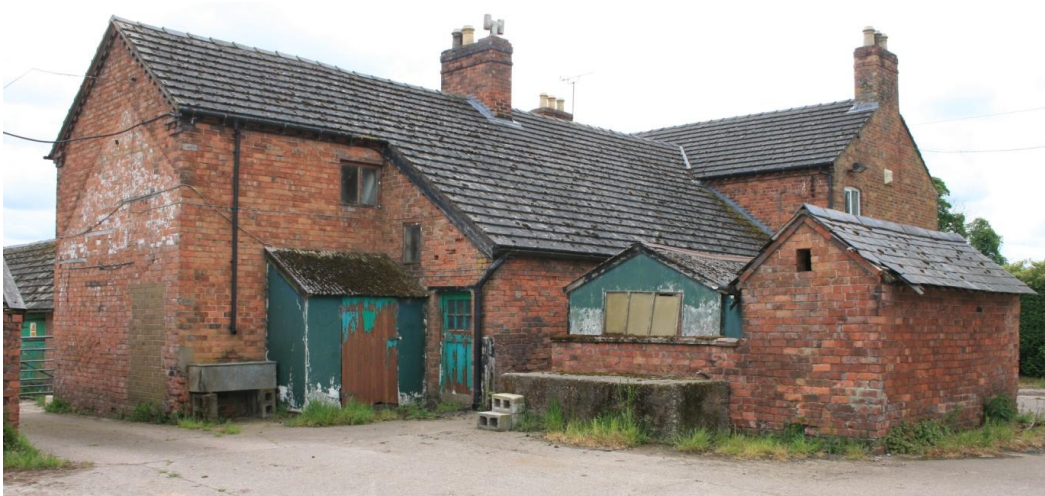
*The farmhouse from the rear, looking south east. The bay nearest the camera (left) is a later 19<sup>th</sup>-century extension to the original rear wing with its catslide-roofed section, of c.1850. The pigsty block (foreground) was convenient to receive waste from the kitchen and the dairy*

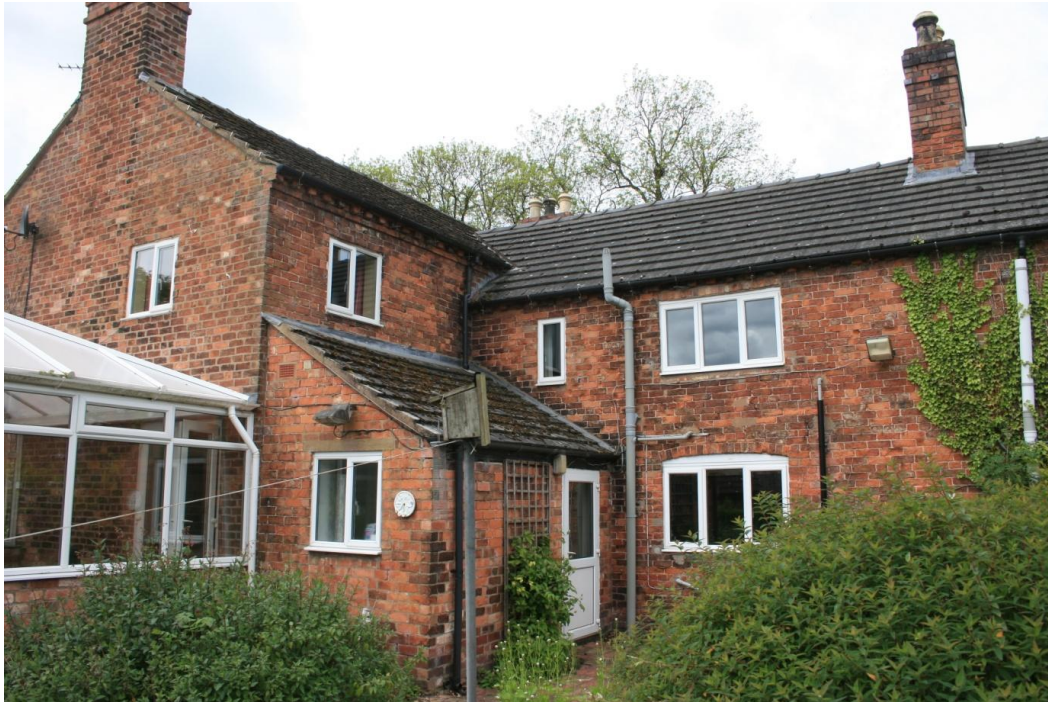
*The farmhouse, garden view, looking south west: the L-plan consisting of the 'polite' front wing (left) and the working rear wing (right)*

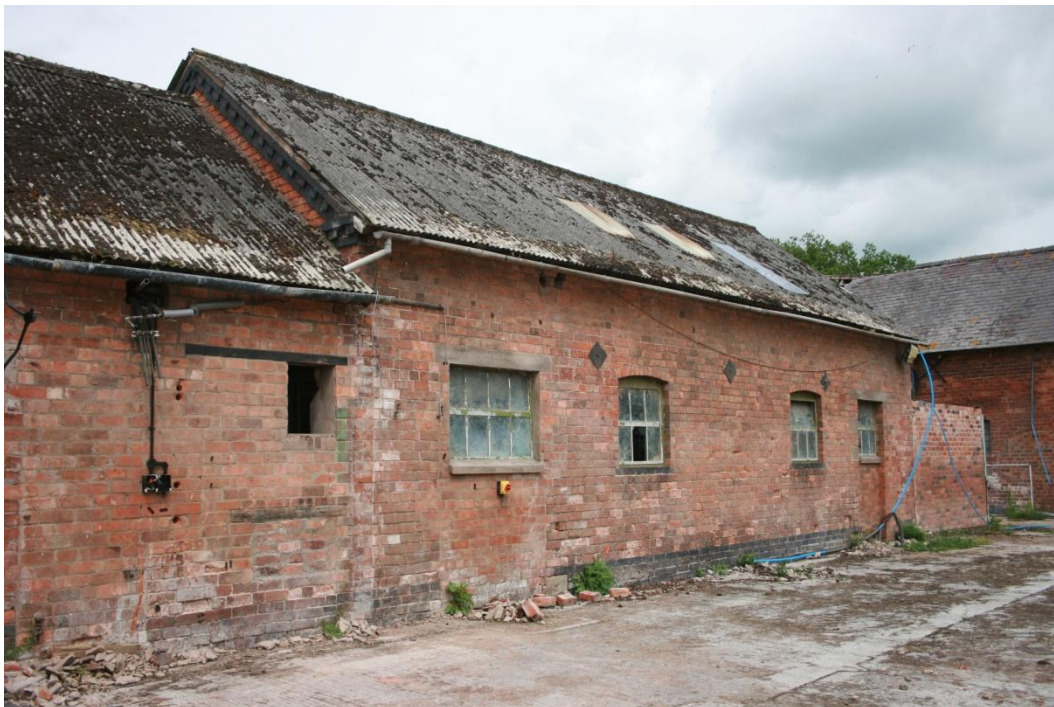
*Barn 'A' farmyard (east) elevation showing the main block with extensions added at both ends, that at the south end (nearest the camera) partly covering the engineering-brick gable pediment detail*

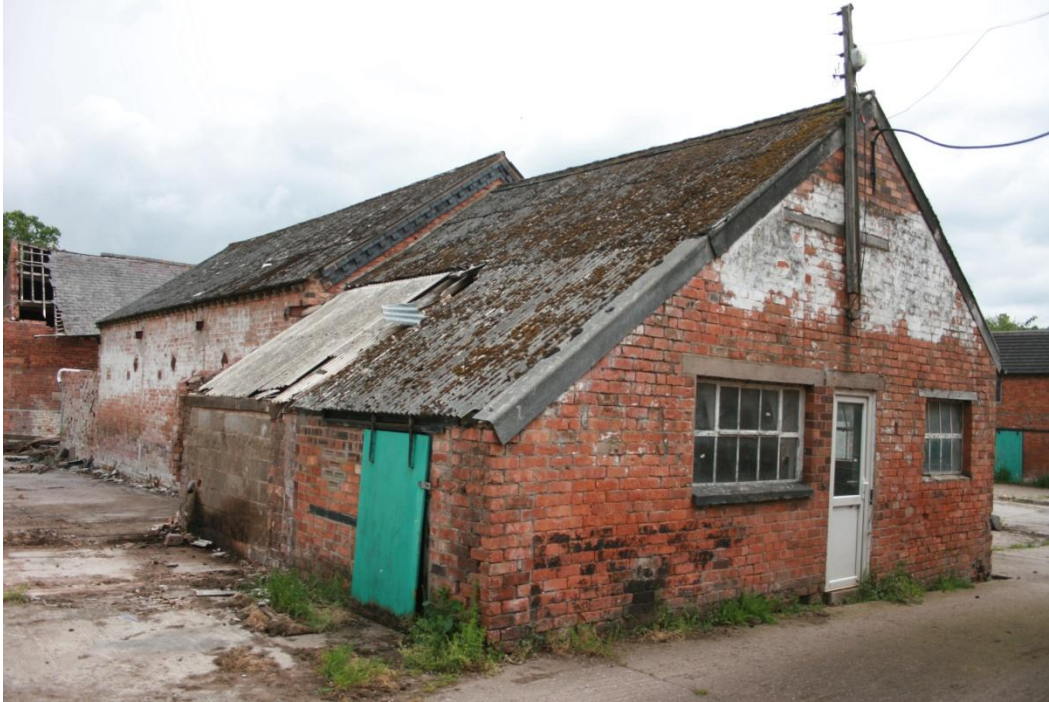
*'Barn A' view from south-west corner, dairy in foreground*

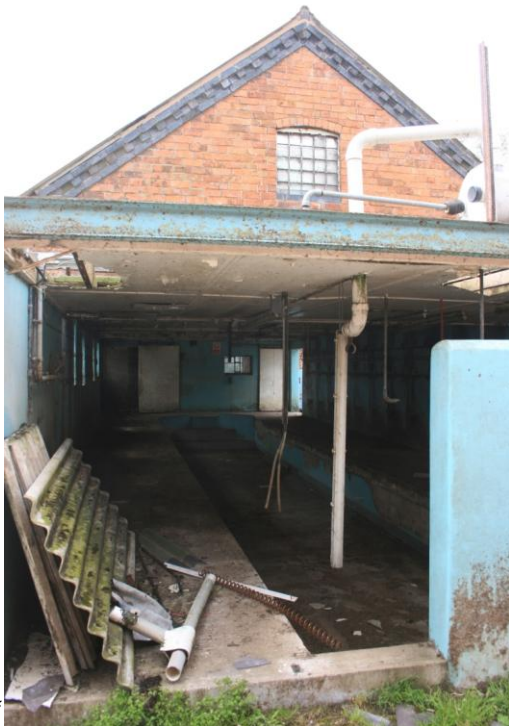
*'Barn A' flat-roofed N extension, including milking parlour, looking south*

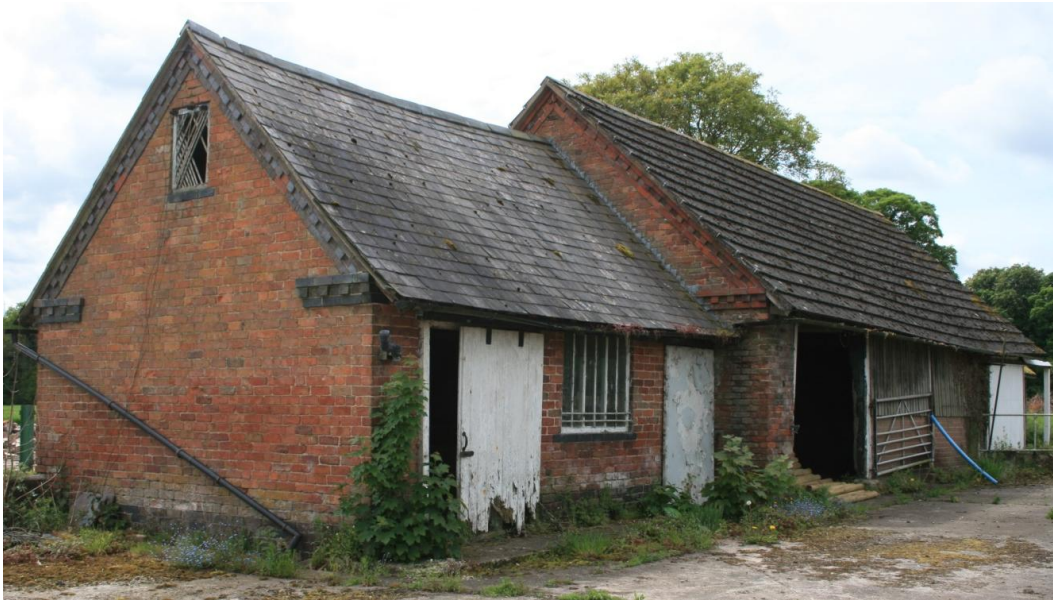
*Barn B from the north-west showing repetition of gable detail on the main block and on the extension*

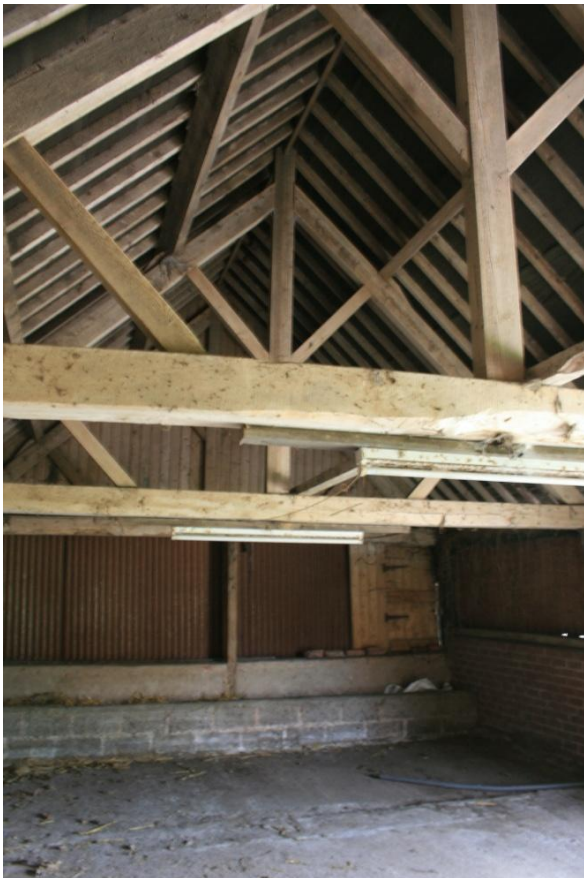
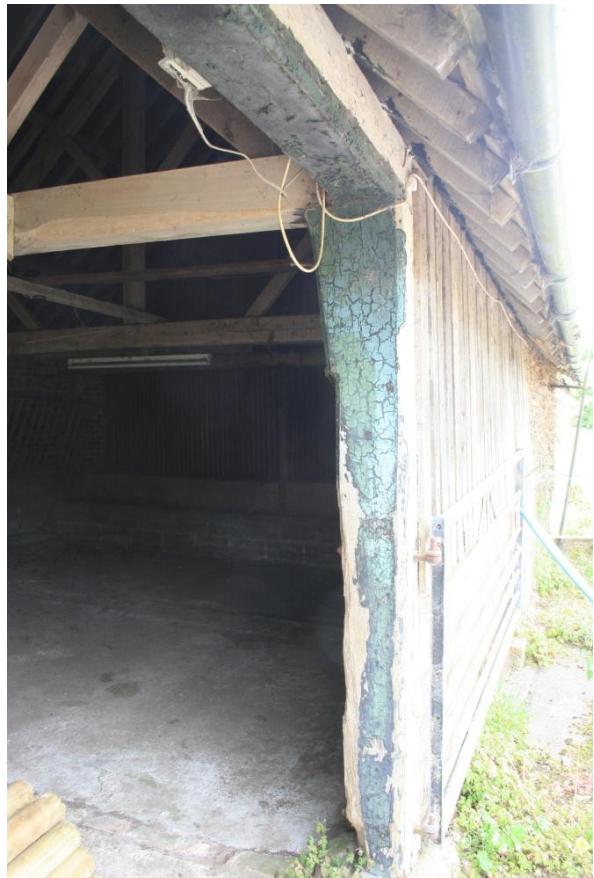
*Barn B: left: interior with modern roof, looking south; right: one of the jowled arcade posts*

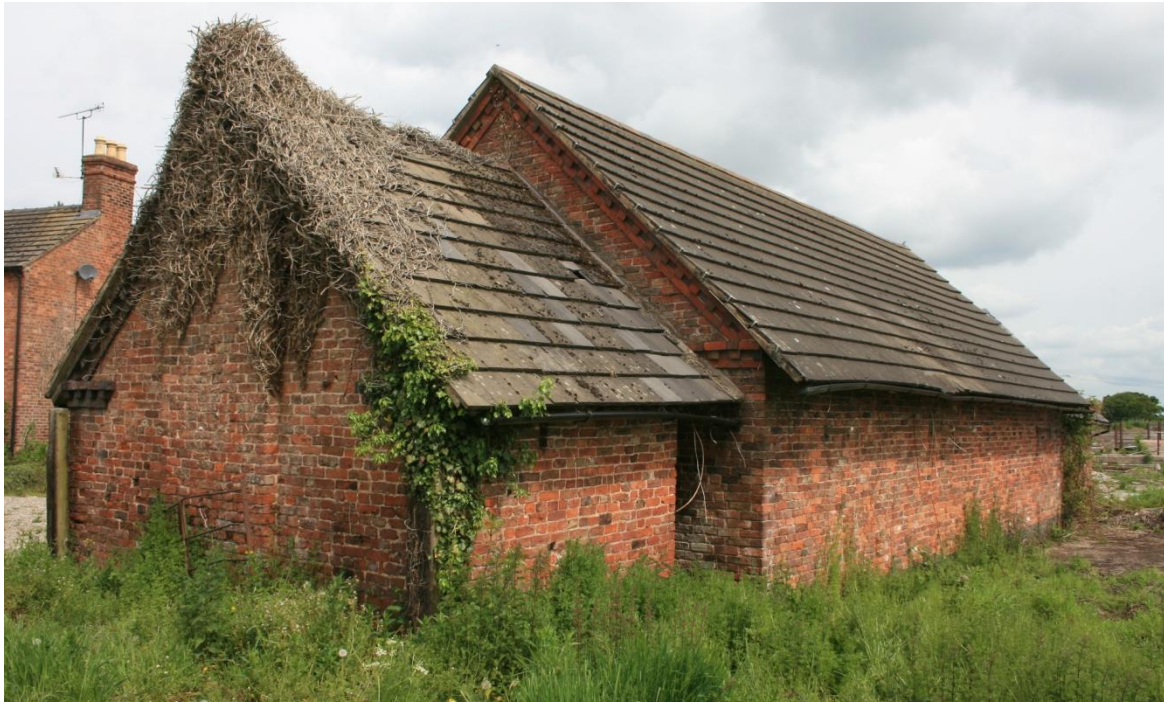
*Barn B, south-east corner, showing south extension and its privy entrance, and repetition of the gable detail*

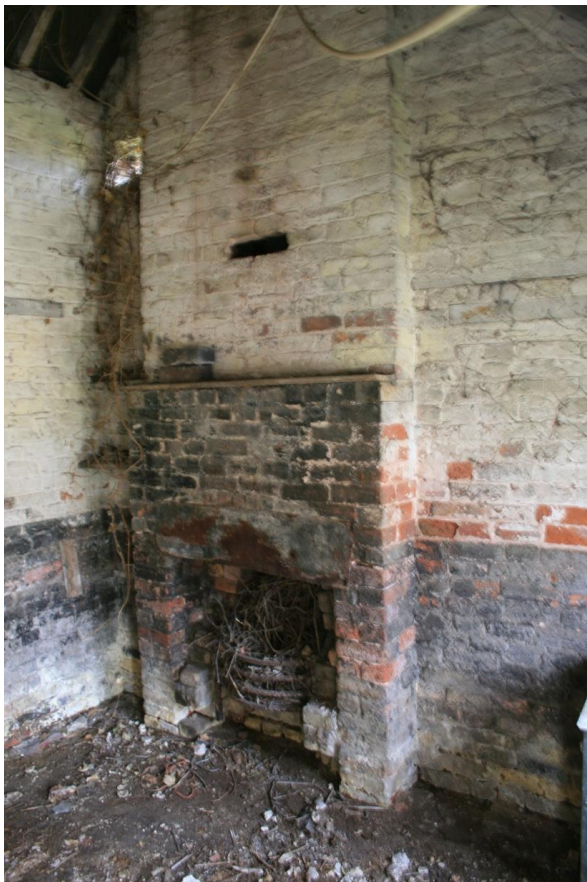
*Barn B, interior and fireplace of the heated and glazed room in the south extension*

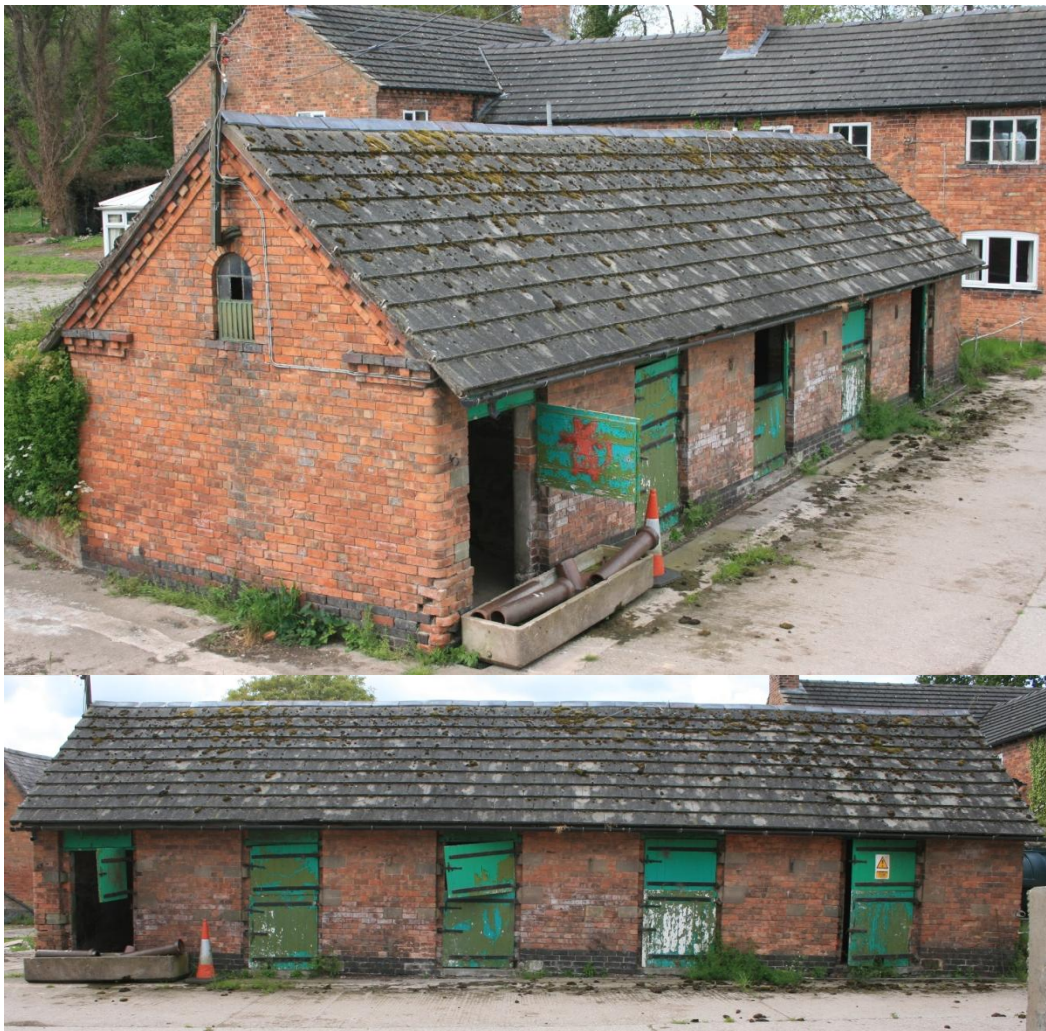
‘Barn C’, stable block. Top: general view from the east; bottom: the yard elevation

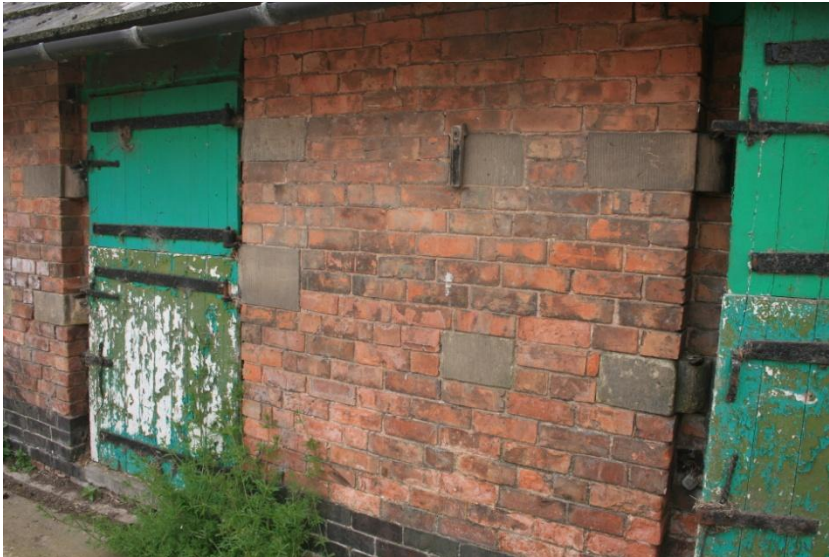
*'Barn C', stable block. Detail of yard elevation showing doors, their furniture and supporting masonry blocks*

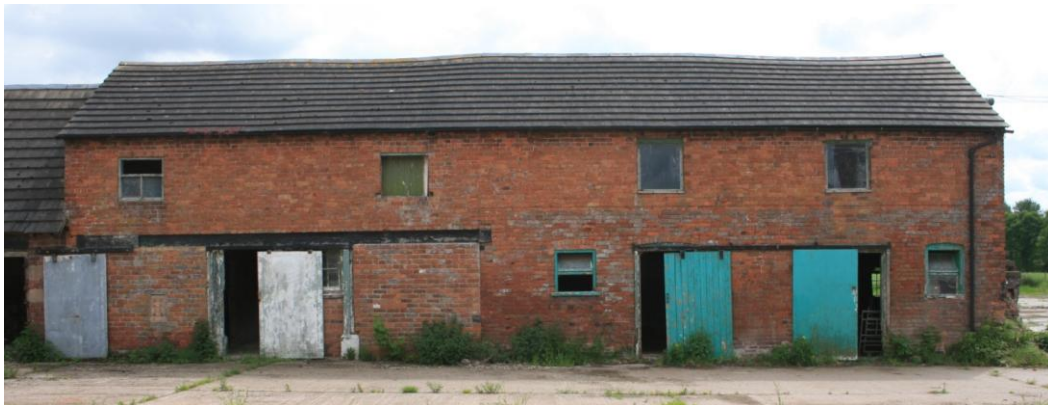
*The east range, farmyard (west) elevation. This is the earliest standing building on site. It consists of an open-arcade cart-shed (left) and loose-boxes (right) under rooms for grain or bedding storage*

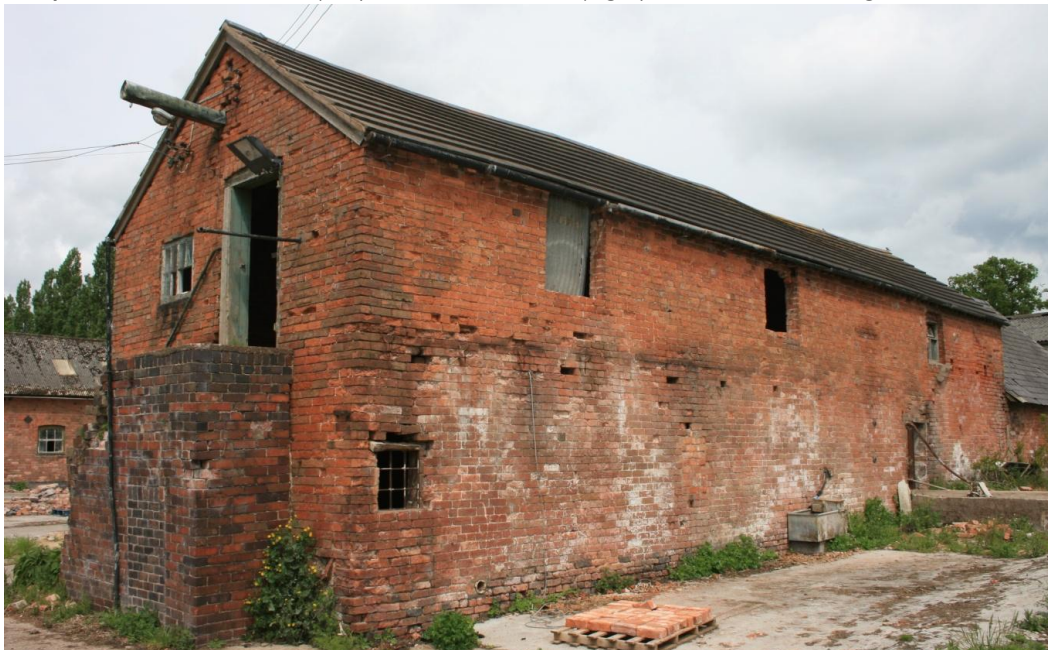
*The 'L-shaped barn' east range, rear/east elevation. Note the gable scar of a removed wing that projected from the far (north) end*

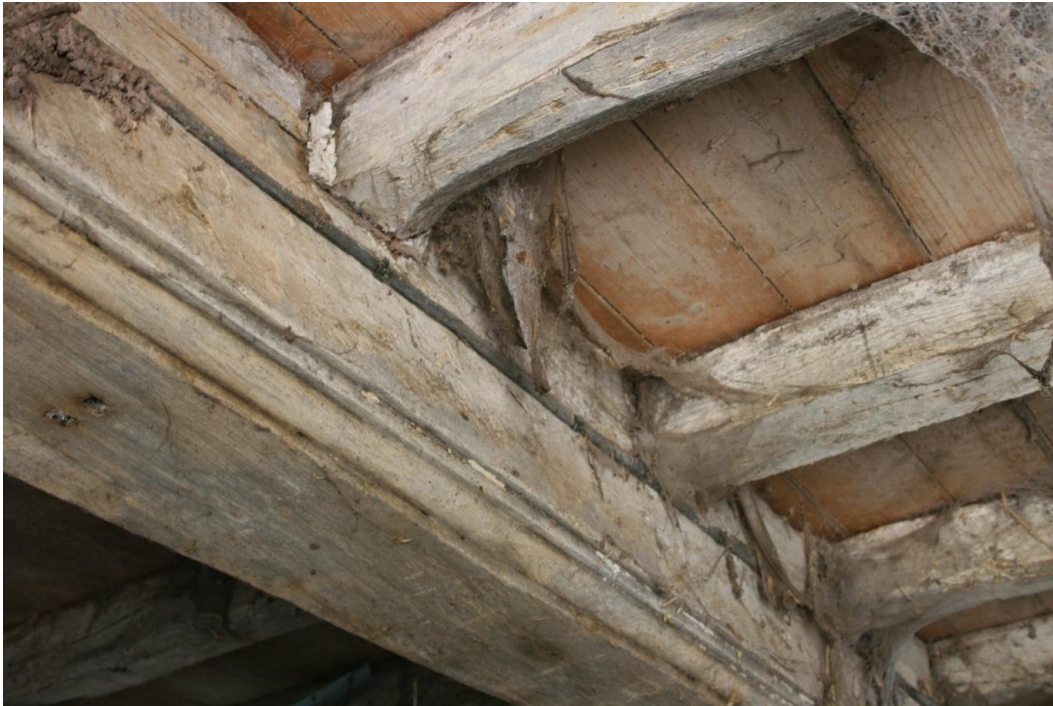
*'L-shaped barn', east range, loose-box ceiling showing one of the second-hand moulded cross-beams with the mortices for a previous set of (wider) joists infilled with plaster*

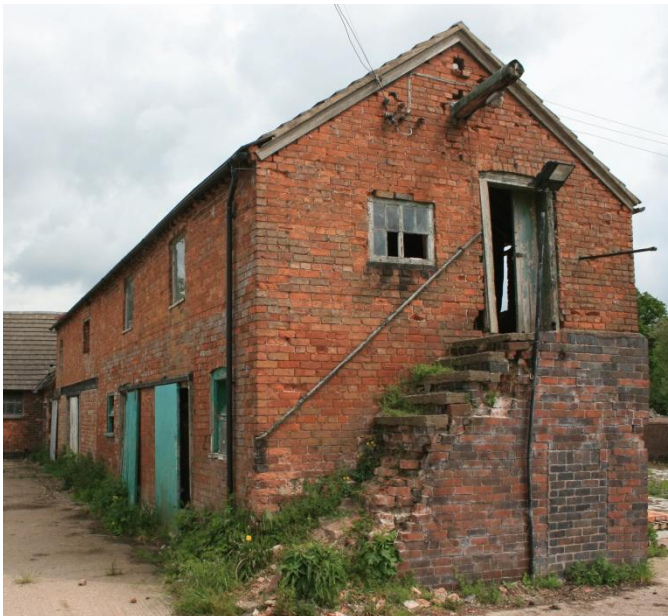
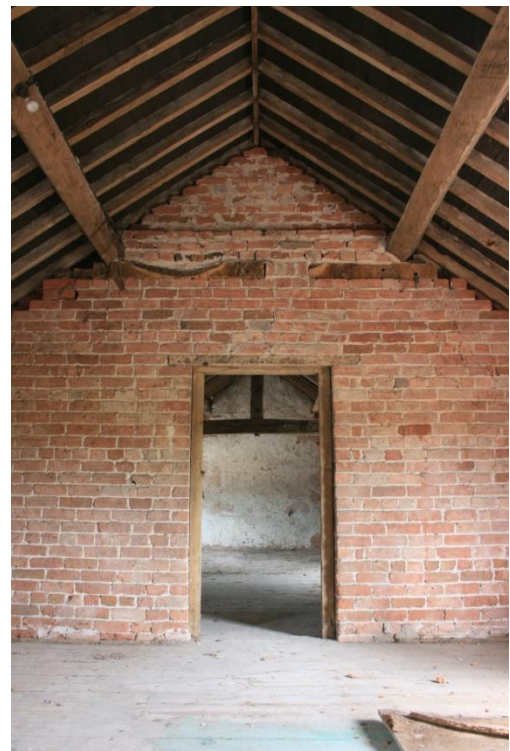
*'L-shaped Barn' east range. Left: south gable end with (later) external stair-block and hoist beam. Right: the rooms over the south end seen from 1<sup>st</sup>-floor doorway, looking north*

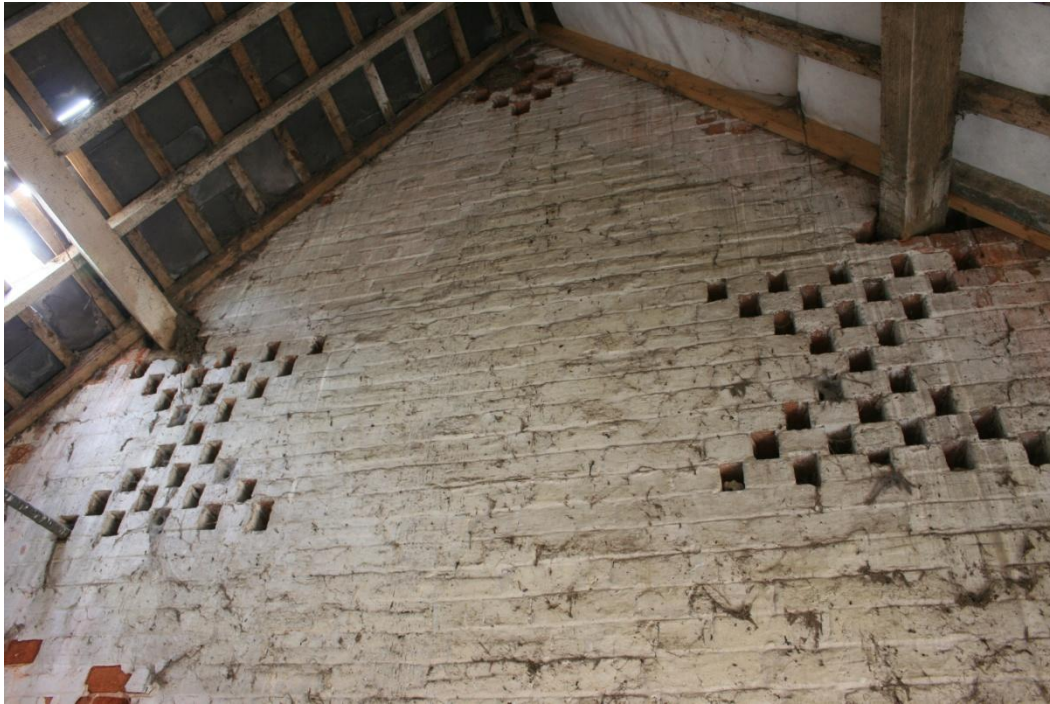
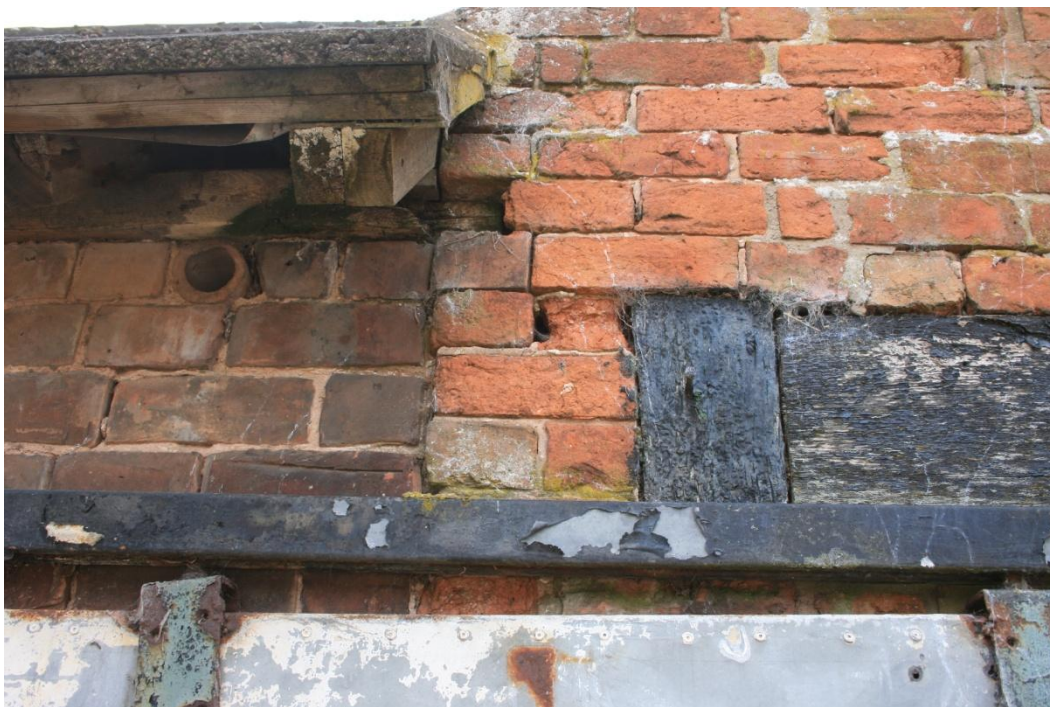
*'L-shaped barn', east range, the junction with the 1879 building. Above: the gable end of the east range with ventilator panels and crudely-inserted purlins. Below: vertical joint and contrasting brickwork and arcade lintel of the east range of c.1800 (right) with the 1879 building (left)*

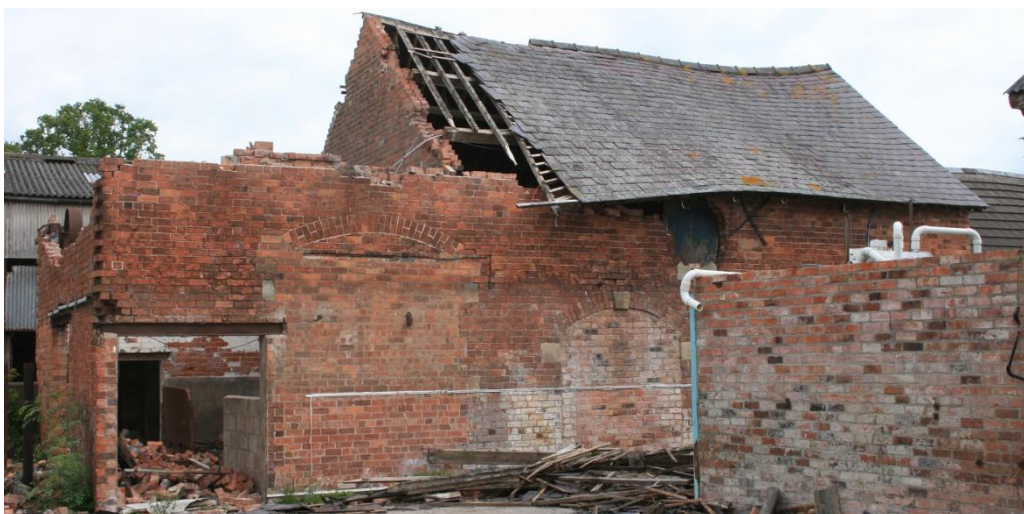
*The two-storey western end of the 1879 range: south (yard) elevation showing the extra high doorway for a portable steam engine, an inserted doorway to its left*

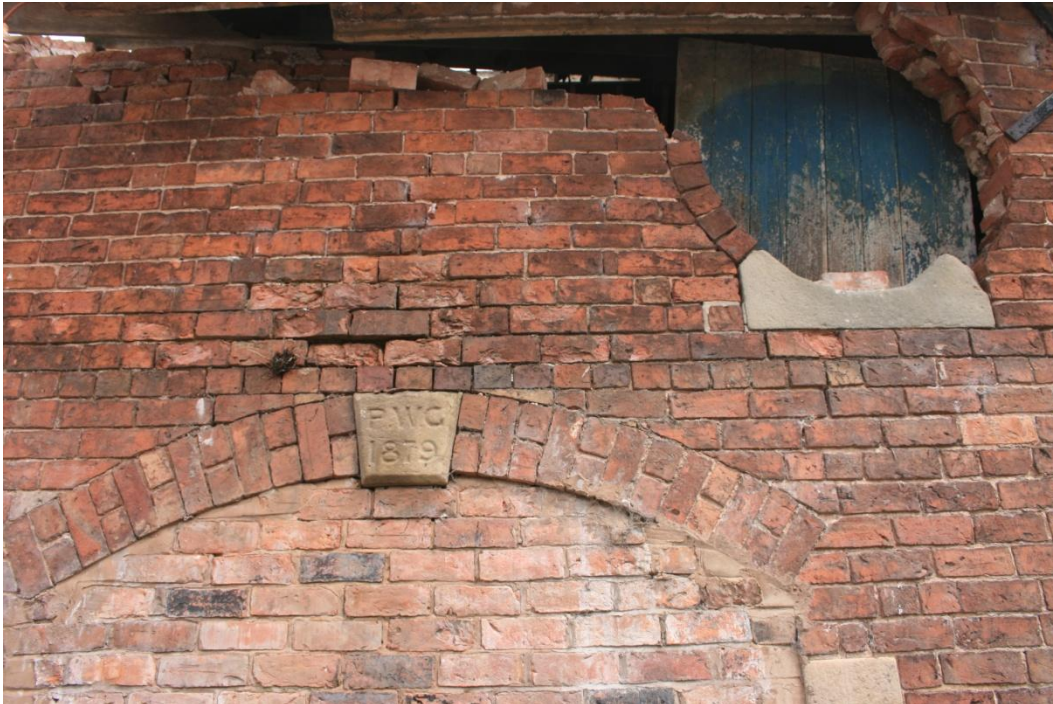
*The datestone and pitching eye to the feed loft of the two-storey section of the 'L-shaped barn'*

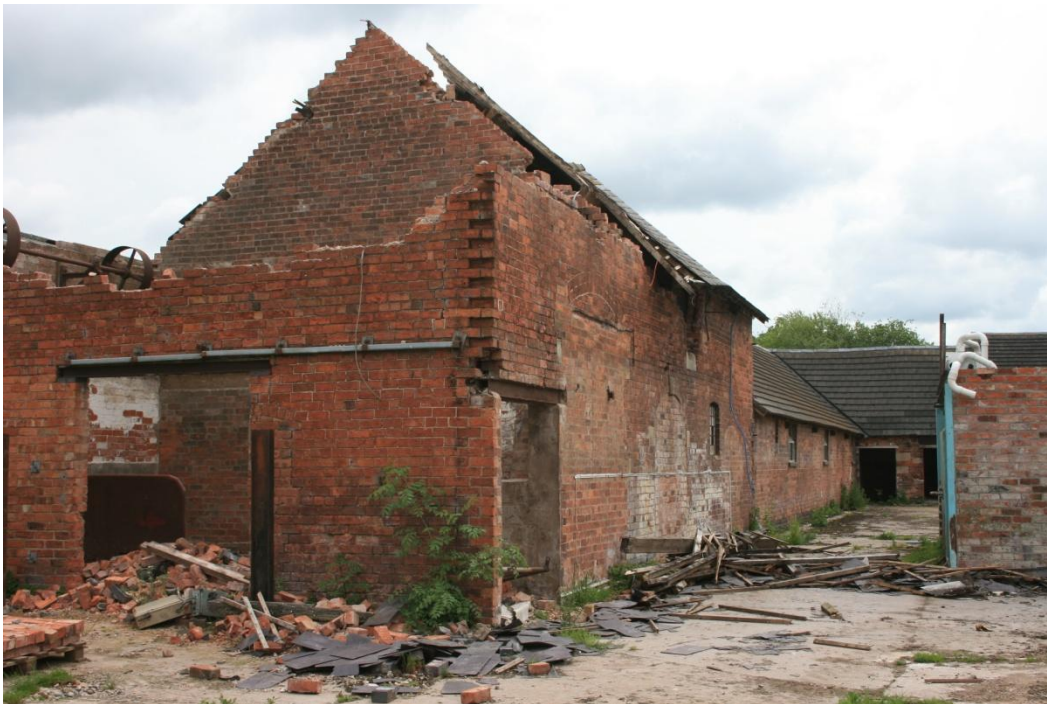
*The 'L-shaped barn' looking east. Before its collapse, the ruined gable had probably had the neoclassical detailing in engineering brick exhibited by all the 'estate phase' buildings*

The building, whose two-storey north-west end was recently ruined by winter gales, is, or rather was, a good if not uncommon example of a mechanised cowshed range of the Victorian 'high farming' period. The two-storey section has two halves. The (unroofed) western bay has an extra-high double-width doorway giving access to a space that was open to the roof internally. Its function is disclosed by the (primary) drive-shaft and belt wheels on the back wall. This was an engine bay, designed to accommodate a mobile power source – a steam engine – that would have been reversed in and linked by belt to the drive shaft to power machinery (feed mills, oil-seed crushers, chaff-cutters and so on) in the loft of the two bays to the east. Above the high doorway, inside, an iron plate with a large circular hole may represent the remains of a flue to exhaust the smoke from the engine. The adjoining east bays, now only partly floored, were accessible via the dated cart-width opening on the ground floor, a normal doorway further east and a round pitching eye (loading hatch) into the loft on the first floor. The range continues to the east as a single-storey cowshed with five blocked openings into the yard discernible, with some remains of the sandstone blocks of their door furniture. Two further doorways into the yard occupy the southern return of this range where it joins the earlier east range building. The north (external) elevation is plain, except for six windows spread between the two-storey and single-storey sections.

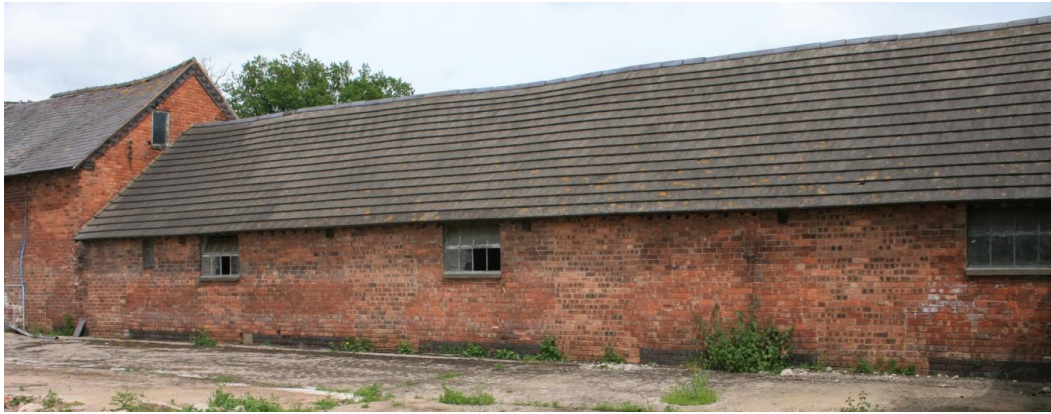
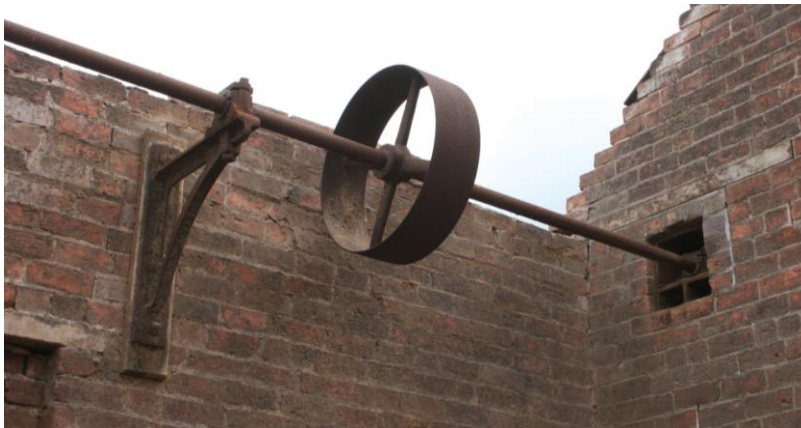
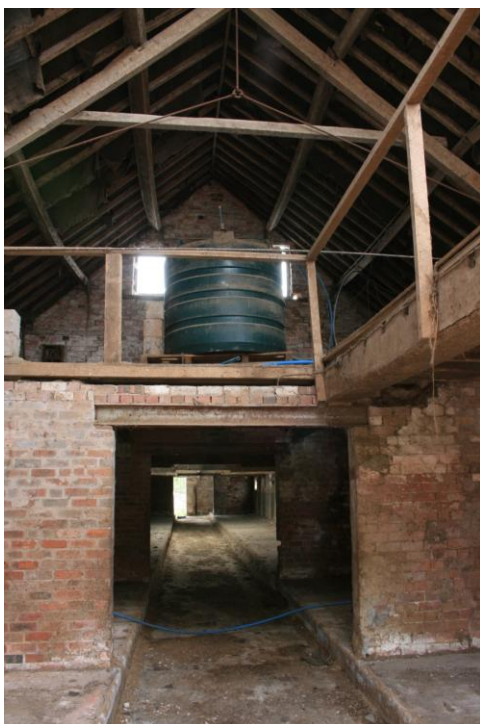
*The 'L-shaped barn' 1879 north range. Top: the yard elevation showing signs of five blocked doorways( note interruptions of the base courses); middle: the integral drive shaft in the engine bay passing through the wall into the feed loft; bottom: the partly-unfloored feed loft in the two-storey block, looking east into the cowhouse through an inserted or enlarged doorway*

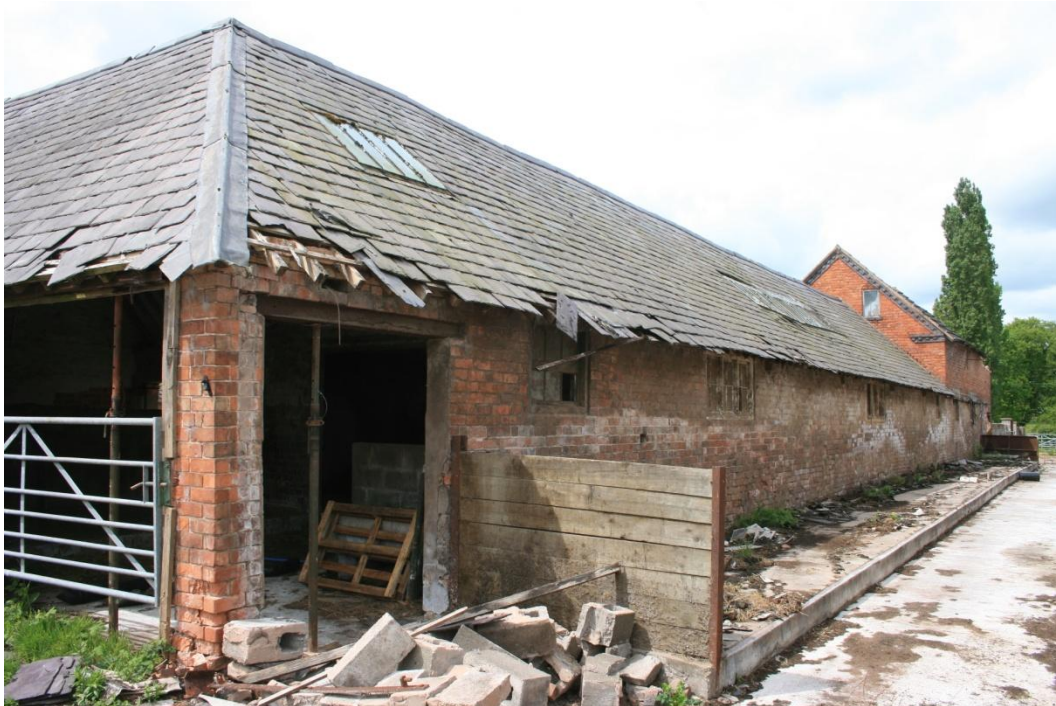
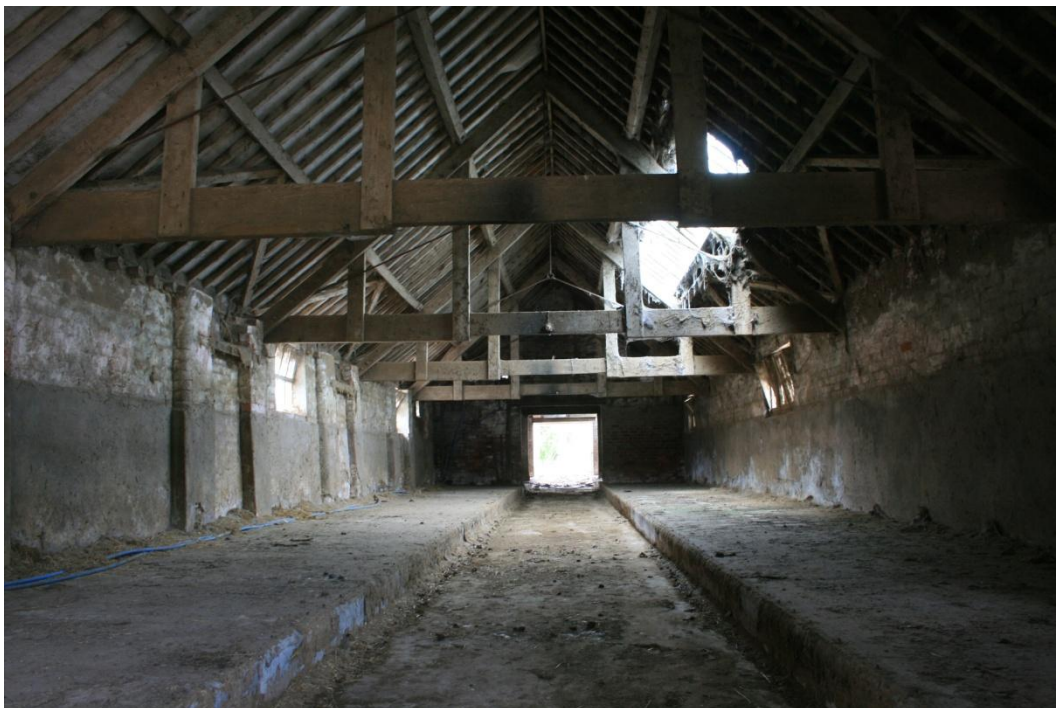
*The 'L-shaped barn' 1879 north range. Top: view looking west along the rear (north) wall; bottom: the cow house interior, looking west, some of the original door positions can be seen from their projecting reveals (left)*
