# TECHNICAL NOTE – Preliminary Ecological Appraisal

| <b>SUBJECT:</b> | Mold Road, Wrexham - Preliminary Ecological Appraisal | | |
| <b>PROJECT:</b> | 70075890 | <b>AUTHOR:</b> | Huw Bramhall |

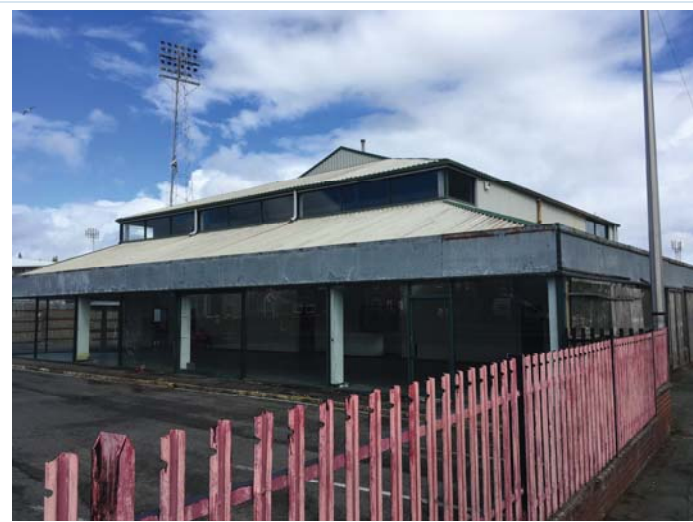
| Building Reference | Description | Suitable features and evidence of bats | Assessment |
|---|---|---|---|
| P1-B1 | <p>A large concrete block and glass walled building with a corrugated metal sheet roof and hipped ridges. Gaps through to the building's interior were noted where openings had been blocked up in the north-facing wall and over a rolling loading door in the west-facing elevation.</p> <p>Internally divided by blockwork and timber into multiple rooms over three floors. No roof void was present with internal spaces open to the metal beam roof structure and insulation panels fixed directly below the corrugated metal sheet roof (Appendix C, Photograph 5). Internal light levels varied as some windows were clear and others boarded.</p> <p>Building was located within an open urban setting with high levels of artificial lighting surrounding it and no direct connectivity with suitable bat foraging or commuting habitat.</p> | <p>Potential bat access points into the structure of the building.</p> <p>No suitable internal roosting features were noted. Although the roof structure was open, it was not considered suitable for bats to grip and roost on.</p> <p>No evidence of use by bats.</p> | Negligible |

| <p>Photograph 1 – Building P1-B1</p> | <p>Photograph 2 – Scattered scrub and colonising vegetation in Plot 1, section P1-B.</p> |

A pigeon nest was noted on the north west corner of building P1-B1 (P1-TN4) during the habitat survey. Pigeons can breed year-round. It is therefore recommended that the nest is checked by an appropriately experienced ecologist prior to works. If the nest is found to be active then a suitable buffer will be established and works affecting the nest or the buffer area will be postponed until the chicks fledge and the nest becomes disused. If the nest is found to be disused then works may proceed.

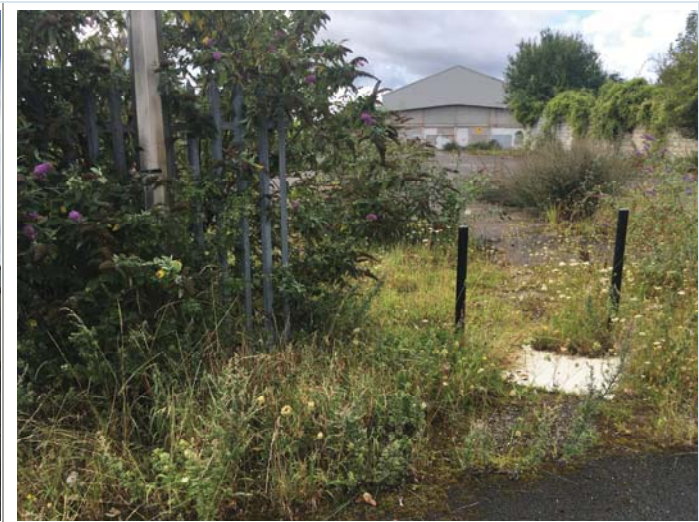
The gravelled areas and cracks in the concrete areas to the north of the building in Section P1-B supported colonising vegetation (P1-TN1, Appendix C – Photograph 2). A range of species typical of disturbed ground and regenerating brown-field sites were recorded but the coverage was predominantly buddleja, brambles *Rubus fruticosus agg.* and grasses, including false oat-grass *Arrhenatherum elatius*. An area of gravel in the west of the Plot had the greatest variety of plant species (P1-TN2). The larger stands of buddleia and areas of encroaching bramble and rose *Rosa canina agg.* were mapped as scattered scrub in Figure 2.

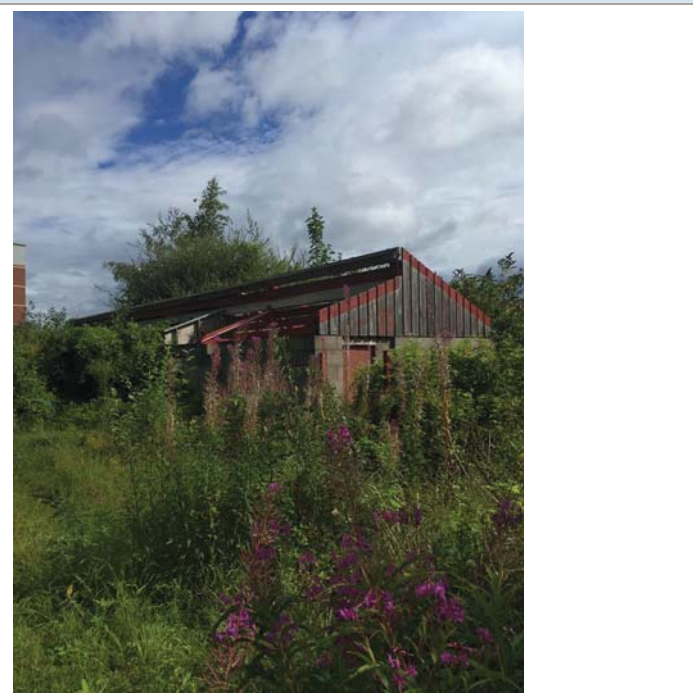
| <p>Photograph 3 - Building P1-B3 surrounded by dense scrub vegetation</p> | <p>Photograph 4 – Dumped material in Plot 1, section P1-C (P1-TN3)</p> |

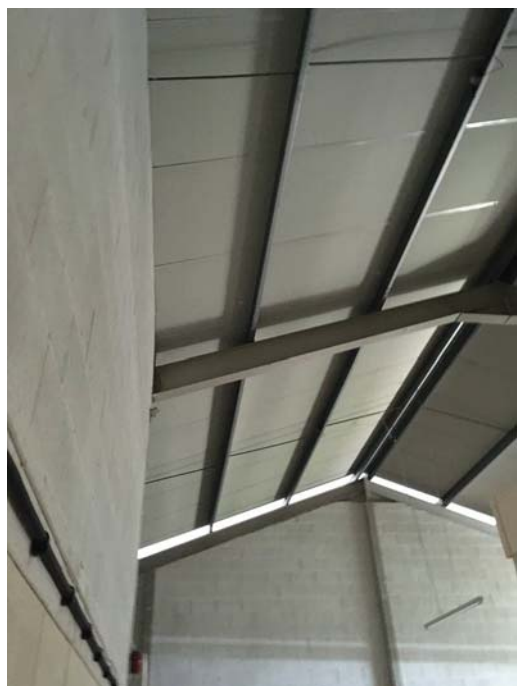
Photograph 5 – Interior of Building P1-B1 showing exposed roof structure

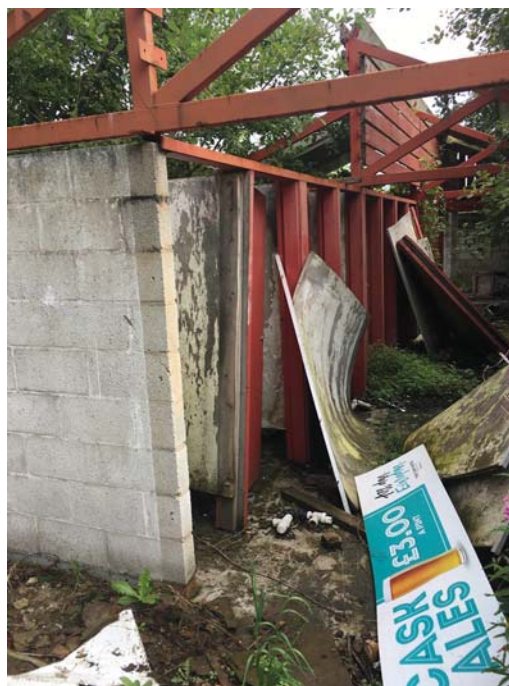
| Building Reference | Description | Suitable features and evidence of bats | Assessment |
|---|---|---|---|
| P1-B2 | <p>Two single-storey buildings with concrete block walls and pitched roofs (where present). Metal roof trusses largely intact, along with some timber weather boarding, however the corrugated metal sheet roof was missing over majority of both structures.</p> <p>Internally, the buildings were open to the elements and as a result were damp and dilapidated (Appendix C, Photograph 6).</p> <p>Buildings were surrounded and partially overgrown by scrub vegetation which continued into the surroundings to the north and west.</p> | <p>Buildings lacked suitable roosting features, due to the loss of much of the roof.</p> <p>No suitable roosting features noted.</p> <p>No evidence of use by bats.</p> | Negligible |

Photograph 6 – Interior of Building P1-B2 showing missing roof and dilapidated condition

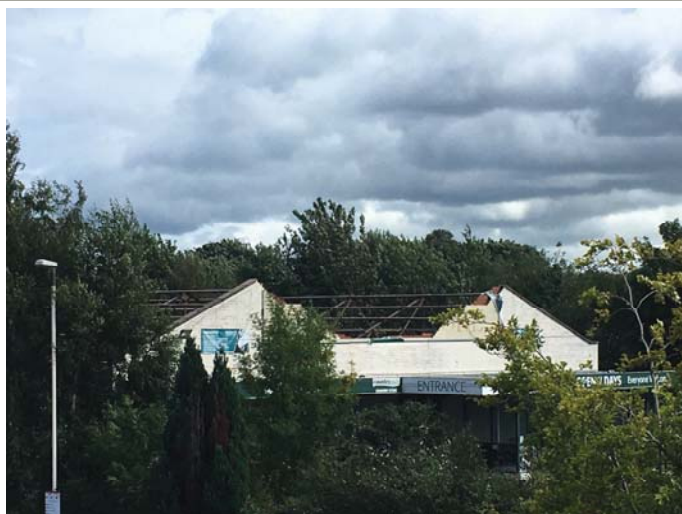
| Building Reference | Description | Suitable features and evidence of bats | Assessment |
|---|---|---|---|
| P2-B1 | <p>Large, single-storey, brick commercial unit, formerly with two pitched roof sections. Roof of main building had been removed prior to survey and the southern wall partially damaged/demolished. Brick cavity walls otherwise intact. Wall cavities were exposed from above.</p> <p>A flat-roofed extension to the western elevation was intact. This had a bitumen felt lining on the roof, and timber fascia boards tight to the brickwork.</p> <p>A flat-roofed extension on the southern elevation had glass walls and a corrugated metal sheet roof.</p> <p>Internally the main building had no ceiling and was open to the exposed, metal roof truss structure (Appendix C, Photograph 11). The flat-roofed section to the west contained a series of offices and storerooms, some of which had been partially dismantled to expose the wooden roof supports.</p> <p>The building was within an urban setting with artificial street lighting to the south but was adjacent to tree lines and semi-natural broadleaved woodland.</p> | <p>Bat access into the building possible through removed roof.</p> <p>Some suitable features between walls and roof timbers in the flat-roofed extension to the west created by recent demolition work. However, these features were inaccessible due to closed doorway between the open main building and the western extension.</p> <p>No evidence of use by bats.</p> | Negligible |

Photograph 7 – Building P2-B1 showing missing roof and broken wall

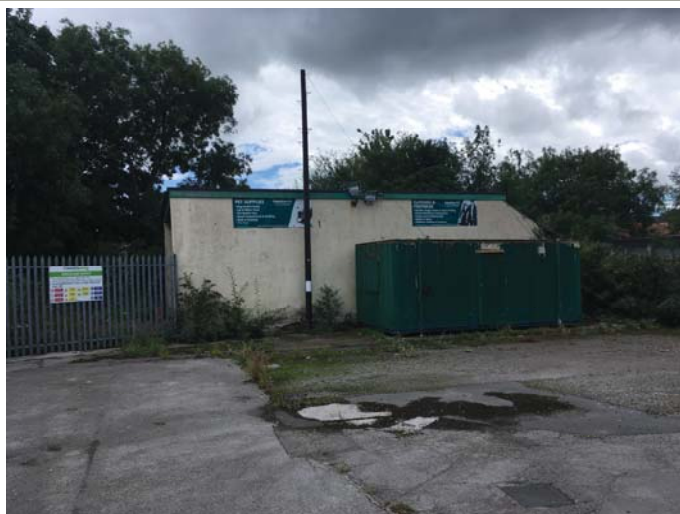
| Building Reference | Description | Suitable features and evidence of bats | Assessment |
|---|---|---|---|
| P2-B2 | <p>Single-storey brick building with a flat roof and lean-to section on the southern end. Flat roof was of chipboard, covered by a bitumen felt. Timber fascia board was tight against the brickwork. Brick cavity wall was rendered on the north, west and southern elevations. Metal concertina door was open at the time of survey.</p> | <p>Bat access into the building possible through the open doorway.</p> <p>No suitable roosting features recorded.</p> <p>No evidence of use by bats.</p> | Negligible |

Photograph 8 – Buildings P2-B2 and P2-B3

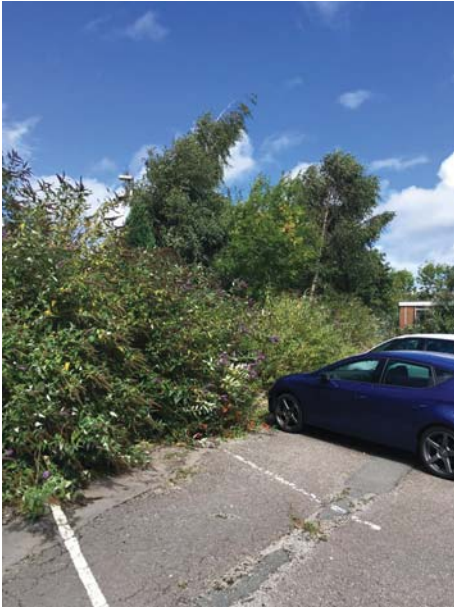
Photograph 9 – Area of introduce Shrub in south west corner of Plot 2.

One non-native invasive plant species was recorded during the habitats survey. Wall cotoneaster was recorded within the area of introduced shrub in the south west corner of Plot 2. This species is listed on Schedule 9 of the WCA and as such it is an offence to cause this species to grow in the wild. It is therefore recommended that the clearance and disposal of the wall cotoneaster is conducted under a precautionary method of works. The precautionary method of works should be produced in consultation with an appropriately experienced contractor.

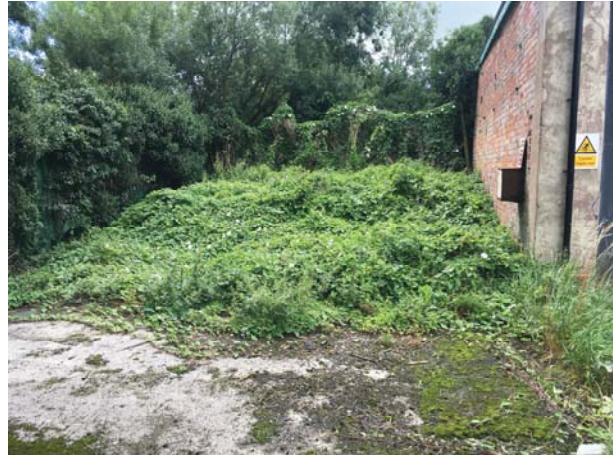
Colonising vegetation was noted round the edges of the hard standing, and in any cracks (P2-TN1). A range of species typical of disturbed ground and regenerating brown-field sites were recorded but the coverage was predominantly buddleja and herb species including herb-robert *Geranium robertianum*, nettles *Urtica dioica*, bindweed *Calystegia sepium*, dandelions *Taraxacum officinale* agg. and Canadian fleabane *Erigeron canadensis*. The greatest variety of species was noted along the eastern boundary of the Plot (P2-TN3). An area of dumped material in the south east corner of the Plot was completely obscured by nettles and bindweed (P2-TN2, Appendix C – Photograph 10).

Photograph 10 - Dumped material covered by nettles and bindweed – P2-TN2

- Phasing the development so that the buildings were demolished with the more sensitive areas, notably the pile of dumped material in the south east corner of Plot 2 (P2-TN2), being retained until the surveys of the pond can be completed.
- A precautionary approach to completing demolition works, including supervision of certain works by an Ecological Clerk of Works (ECoW) who holds a GCN survey licence from NRW;
- A clear statement that works will stop immediately if one or more GCN are found during works, and a derogation licence sought from NRW to permit works to proceed lawfully;
- A biosecurity risk assessment; and
- A clear ecological compliance audit system.

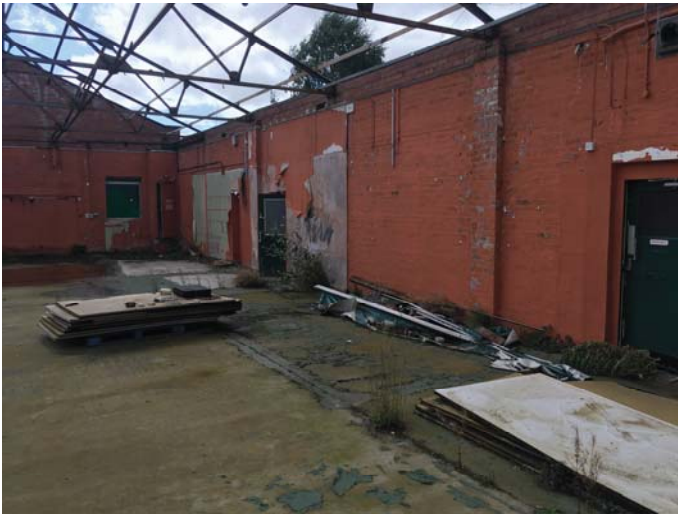
Photograph 11 – Interior of Building P2-B1 showing missing roof, exposed roof structure and doorways leading to flat-roofed section to the west.

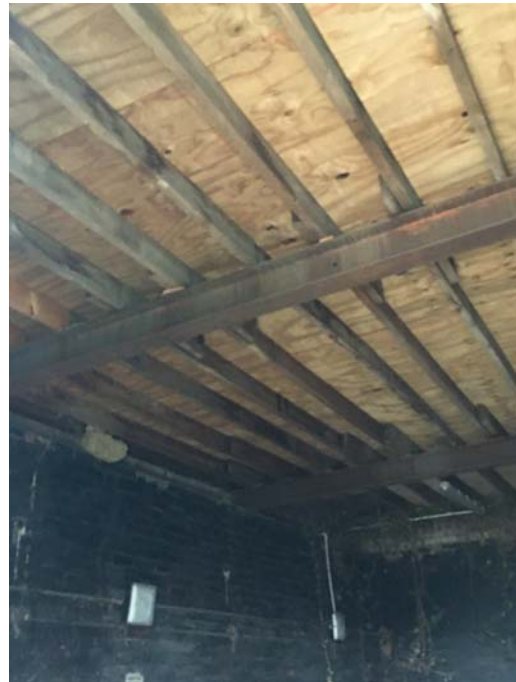
| Building Reference | Description | Suitable features and evidence of bats | Assessment |
|---|---|---|---|
| | <p>Lean-to section had a corrugated asbestos cement roof which was heavily overgrown with ivy.</p> <p>Internally the single open space had no roof void and the roof structure was exposed (Appendix C, Photograph 12). The remains of a large wasp's nest was noted. Unknown if wall cavity exposed from top. The lean-to section was viewed from the doorway but not accessed. Heavily cobwebbed and ivy growing under roof.</p> <p>The building was located adjacent to the semi-natural broadleaved woodland.</p> | | |

Photograph 12 – Interior of Building P2-B2 showing exposed roof structure.
