## BS5837 Tree Survey, Arboricultural Impact Assessment and Method Statement.

Chirk Land LL14 5AZ Proposed Coffee Shop & Car Park

11/02/21

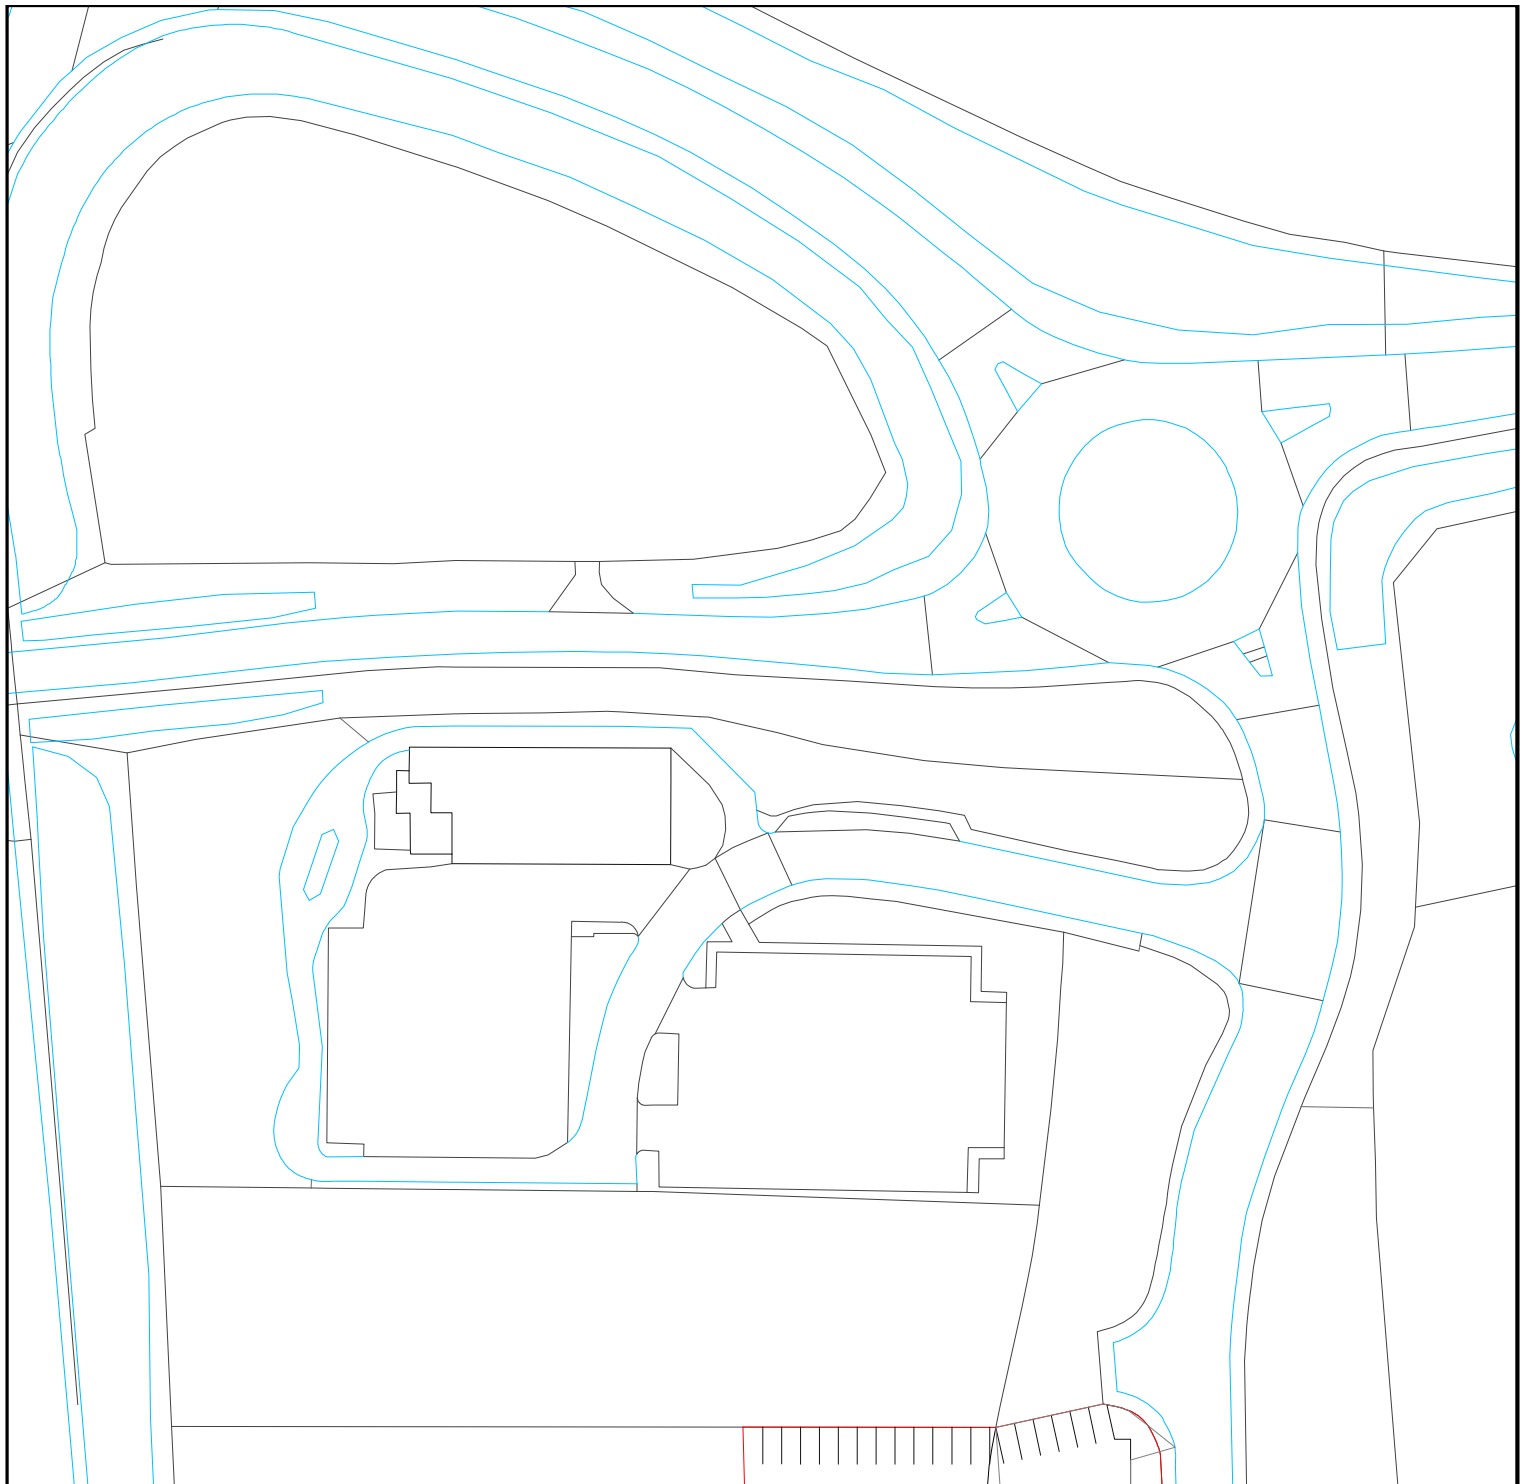
## Appendix 1 figure 1 Tree Location & Removal Plan

8.2 Group 1 and Group 2 category C young, planted tree groups offering low temporary/transient landscape benefits are proposed for removal. Low Arboricultural Impact compared with the volume of retained trees within a shelterbelt to the East.

9.2 Fell and remove Group 1, Group 2 and all scrub trees below 75mm diameter between groups to clear site. No other trees retained on site.

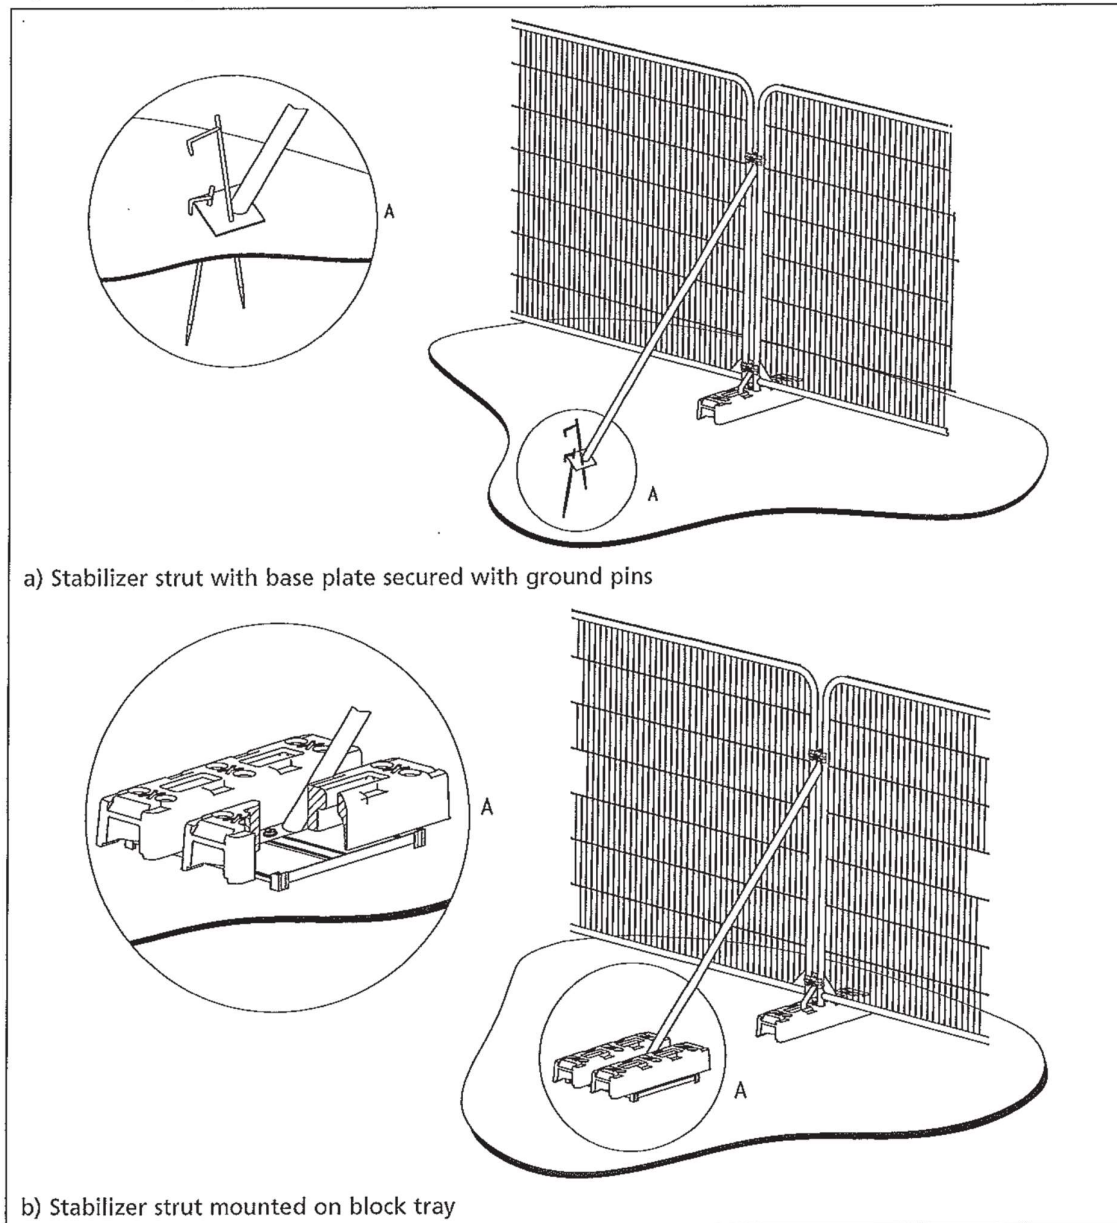
Figure 3 Examples of above-ground stabilizing systems

**6.2.2.3** Where the site circumstances and associated risk of damaging incursion into the RPA do not necessitate the default level of protection, an alternative specification should be prepared by the project arboriculturist and, where relevant, agreed with the local planning authority. For example, 2 m tall welded mesh panels on rubber or concrete feet might provide an adequate level of protection from cars, vans, pedestrians and manually operated plant. In such cases, the fence panels should be joined together using a minimum of two anti-tamper couplers, installed so that they can only be removed from inside the fence. The distance between the fence couplers should be at least 1 m and should be uniform throughout the fence. The panels should be supported on the inner side by stabilizer struts, which should normally be attached to a base plate secured with ground pins (Figure 3a). Where the fencing is to be erected

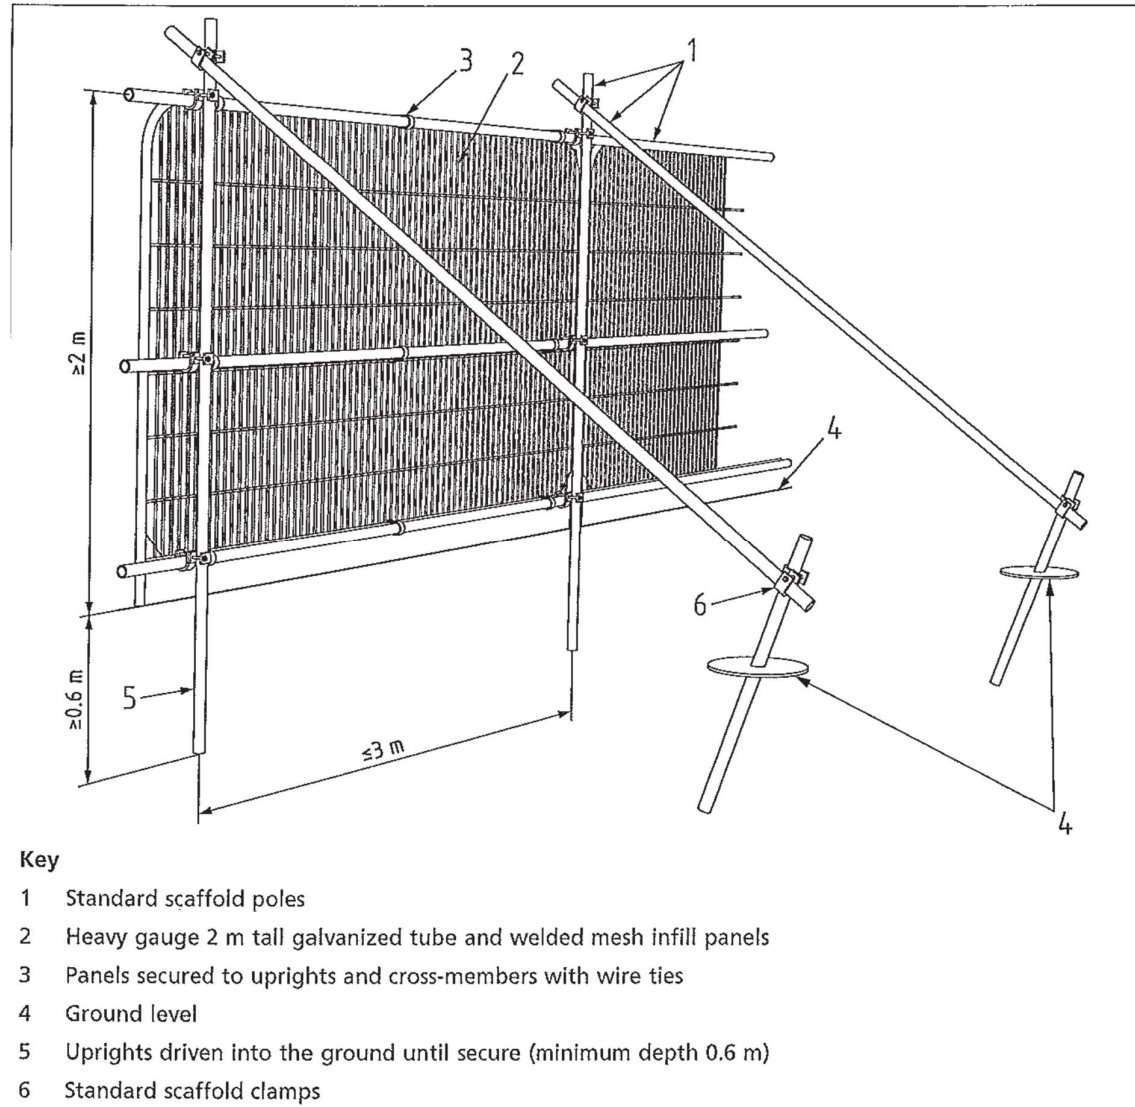
Figure 2 Default specification for protective barrier

**6.2.2.2** The default specification should consist of a vertical and horizontal scaffold framework, well braced to resist impacts, as illustrated in Figure 2. The vertical tubes should be spaced at a maximum interval of 3 m and driven securely into the ground. Onto this framework, welded mesh panels should be securely fixed. Care should be exercised when locating the vertical poles to avoid underground services and, in the case of the bracing poles, also to avoid contact with structural roots. If the presence of underground services precludes the use of driven poles, an alternative specification should be prepared in conjunction with the project arboriculturist that provides an equal level of protection. Such alternatives could include the attachment of the panels to a free-standing scaffold support framework.
