**Bronydd / Chwarel Wynne**

**Bat and Bird Survey Report**

**MR and Mrs Latham**

3133/11

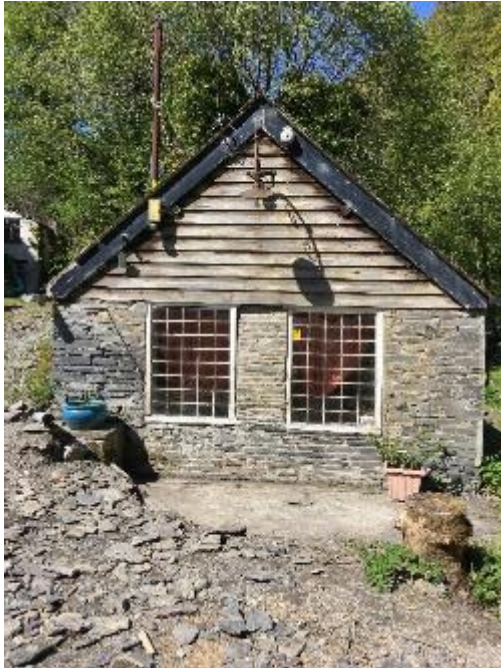
**PR1:** East gable showing weather boarding and fascia

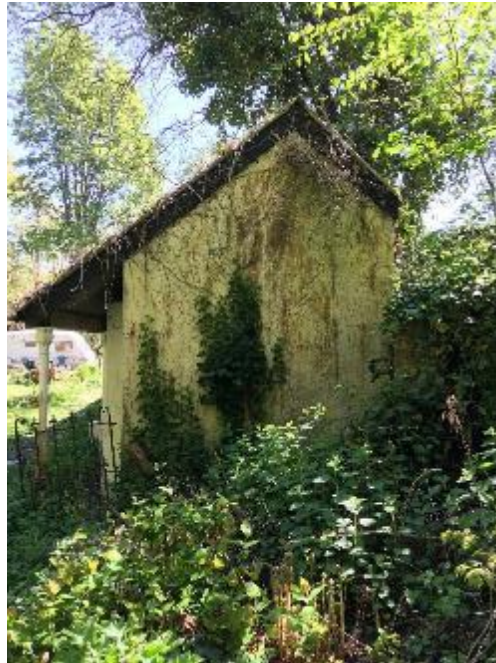
**PR2:** West gable end, no potential under fascia boarding here, damp and cool, fascia boarding close fitting.

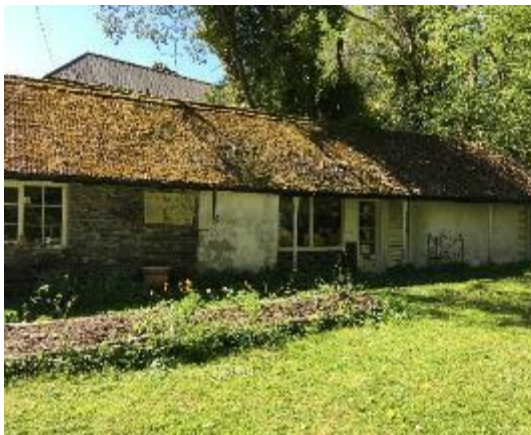
- 3.2.2 The north elevation consists of stonework which has been rendered to the western end. There are three windows, a set of double doors and two single doors, all of which are kept locked. To the western end of the building there is a small recess where part of the roof overhangs.

**PR3:** North elevation, recess to western end

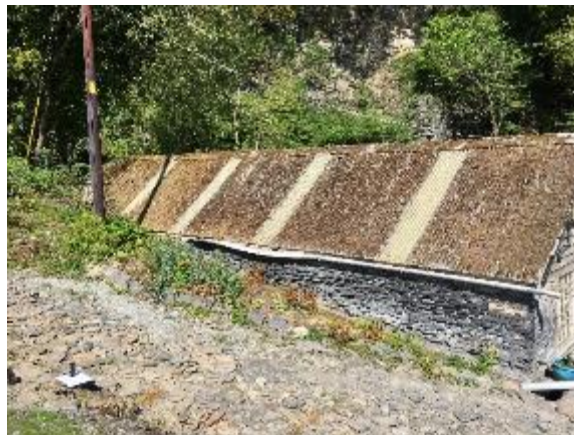
- 3.2.3 The west gable is rendered, with fascia boarding to the top and ivy covering (some of which has been removed).
- 3.2.4 The south elevation is set back within the adjacent track and only a small section of stonework is visible. Part of the wall is damaged.

- 3.2.5 The roof consists of an asbestos cement corrugated roof material.
- 3.2.6 In terms of potential roost features identified during the daylight inspection, these include gaps within the brickwork, gaps around the doors and window frames, under fascia boarding and weather boarding, small gap in the asbestos roofing and a missing windowpane. The gaps around the doors and windows, within the roof, under the fascia boarding and weather boarding all provide access to the internal areas of the building. All potential roost features were checked but no evidence of bats was found.

**PR4:** South elevation and asbestos roof

- 4.2.3 The roofing material will be lifted and carefully disposed of due to the presence of asbestos.
- 4.2.4 The facia and weather boarding should be removed by hand.

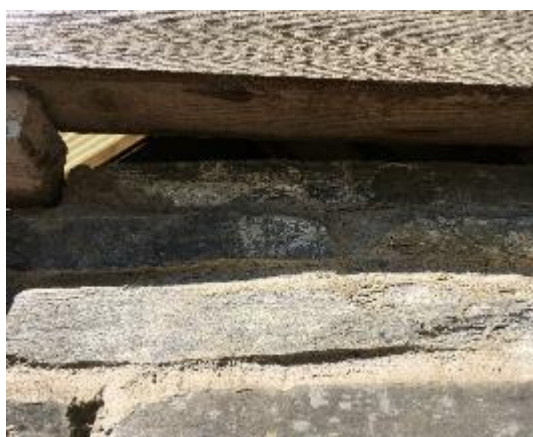
| Location | Potential roost features | Appendix B reference |
|---|---|---|
| Door frame and window frame | Gap behind door frame, checked no evidence found | PR5 |

**PR5:** Example of gaps under window and door frames providing internal access

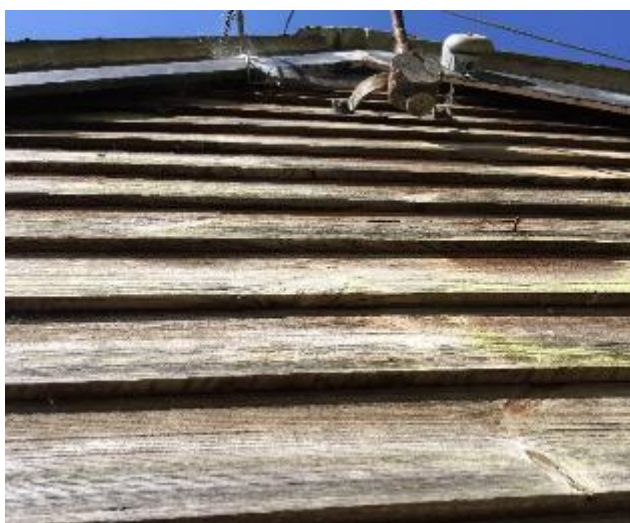
| Location | Potential roost features | Appendix B reference |
|---|---|---|
| Facia boarding east elevation | Gaps under fascia boarding, checked but no evidence found. | PR6 |

**PR6:** Gap under fascia boarding, the weather boarding has no backing, so no cavity

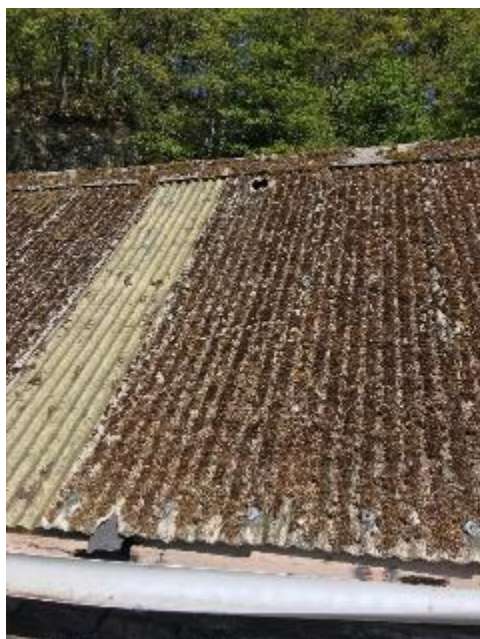
| Location | Potential roost features | Appendix B reference |
|---|---|---|
| Gap in asbestos roof | Provides access into internal areas | PR7 |

**PR7** Gap in asbestos roof – south elevation

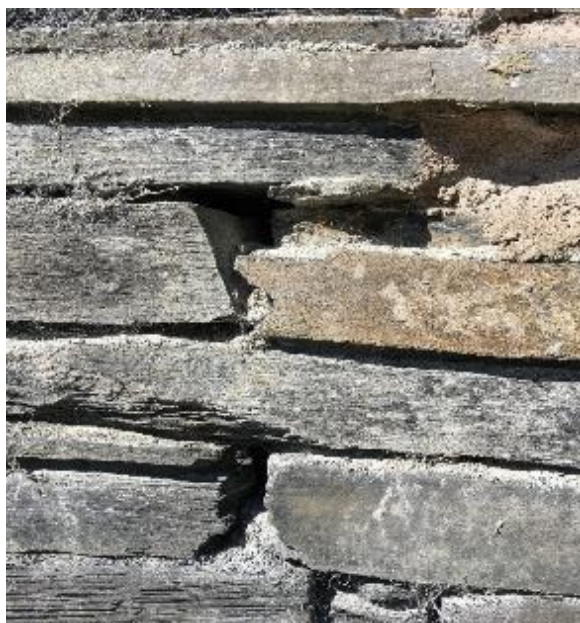
| Location | Potential roost features | Appendix B reference |
|---|---|---|
| Gaps in stonework | Some small crevices and gaps within stonework , checked no evidence noted. | PR8 |

**PR8** Gaps in stonework

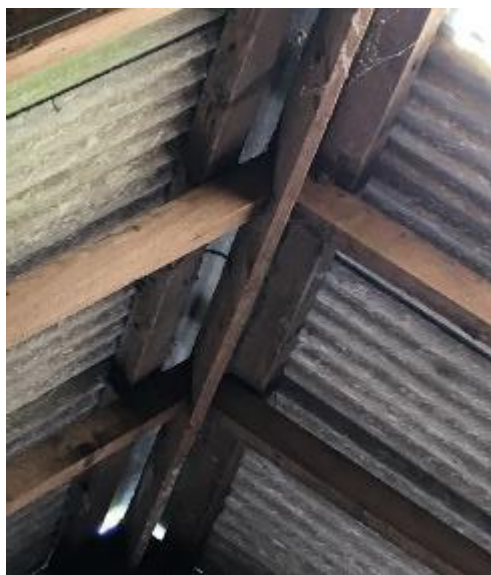
| Location | Potential roost features | Appendix B reference |
|---|---|---|
| Gaps under ridge tiles | Provides access into internal areas | PR9 |

3.2.8 There are no roof voids. The internal area consists of one room, with the exception of a separated toilet block located to the western end. The building is currently used for storage. The internal areas are light and 'airy'. The roof structure consists of a wooden king post construction. The internal walls are in a good condition with the exception of those which abut the track to the south elevation, which are damp and crumbling. The separated toilet block to the west is cool and damp. (Photos are provided in **Appendix B, PR9 and PR10**).

**PR9:** Internal roof structure, gaps under ridge into building

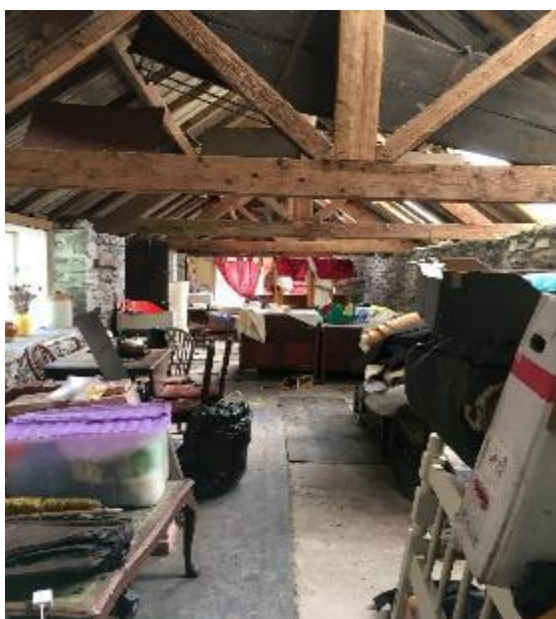
**PR10:** View of internal structure showing king post beams

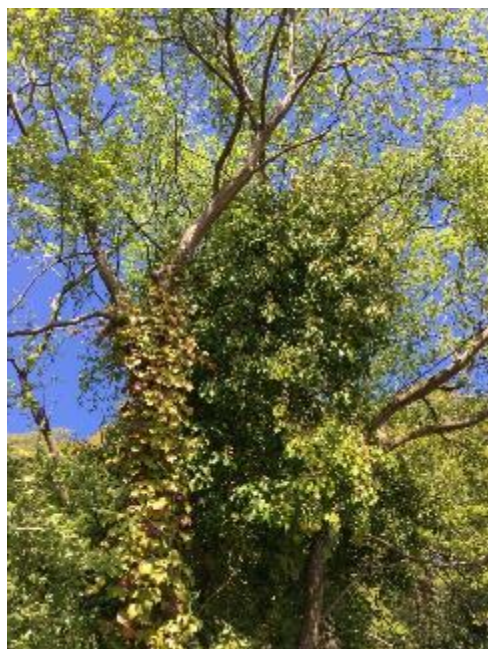
- 3.3.2 All habitat will be retained which the exception of a tree which is located in close proximity to the structure against the south elevation (refer to the photo in **Appendix B, PR11**). This was assessed as having negligible potential for bats, though it does provide suitable habitat for nesting birds.

**PR11** Tree which may need to be removed

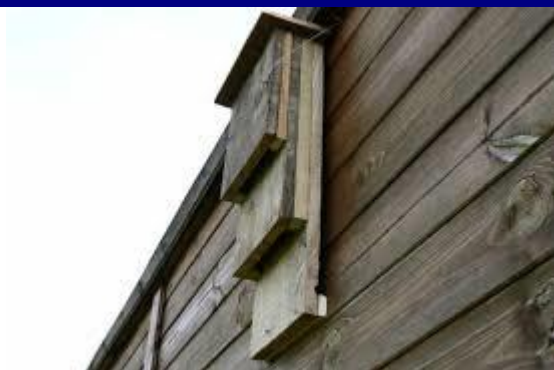
**PR13** Kent Bat Box

- 5.1.1 It is likely that the refurbished building would provide more roosting opportunities for bats due to the replacement roof with slate tiles. The majority of the roof space would remain open with no void. However, bats could still roost underneath ridge and roof tiles, the weather boarding and fascia boarding of the refurbished property. In addition, the client has been advised to install a bat box on the apex of the gable to the east elevation. This could be the Kent Bat Box (or similar) as shown in **Appendix B, PR13**.
