# **BORRAS PARK COMMUNITY**

## **PRIMARY SCHOOL:**

### **PRELIMINARY ECOLOGICAL APPRAISAL & PRELIMINARY ROOST ASSESSMENT**

Report Ref: EE.689.20.LB

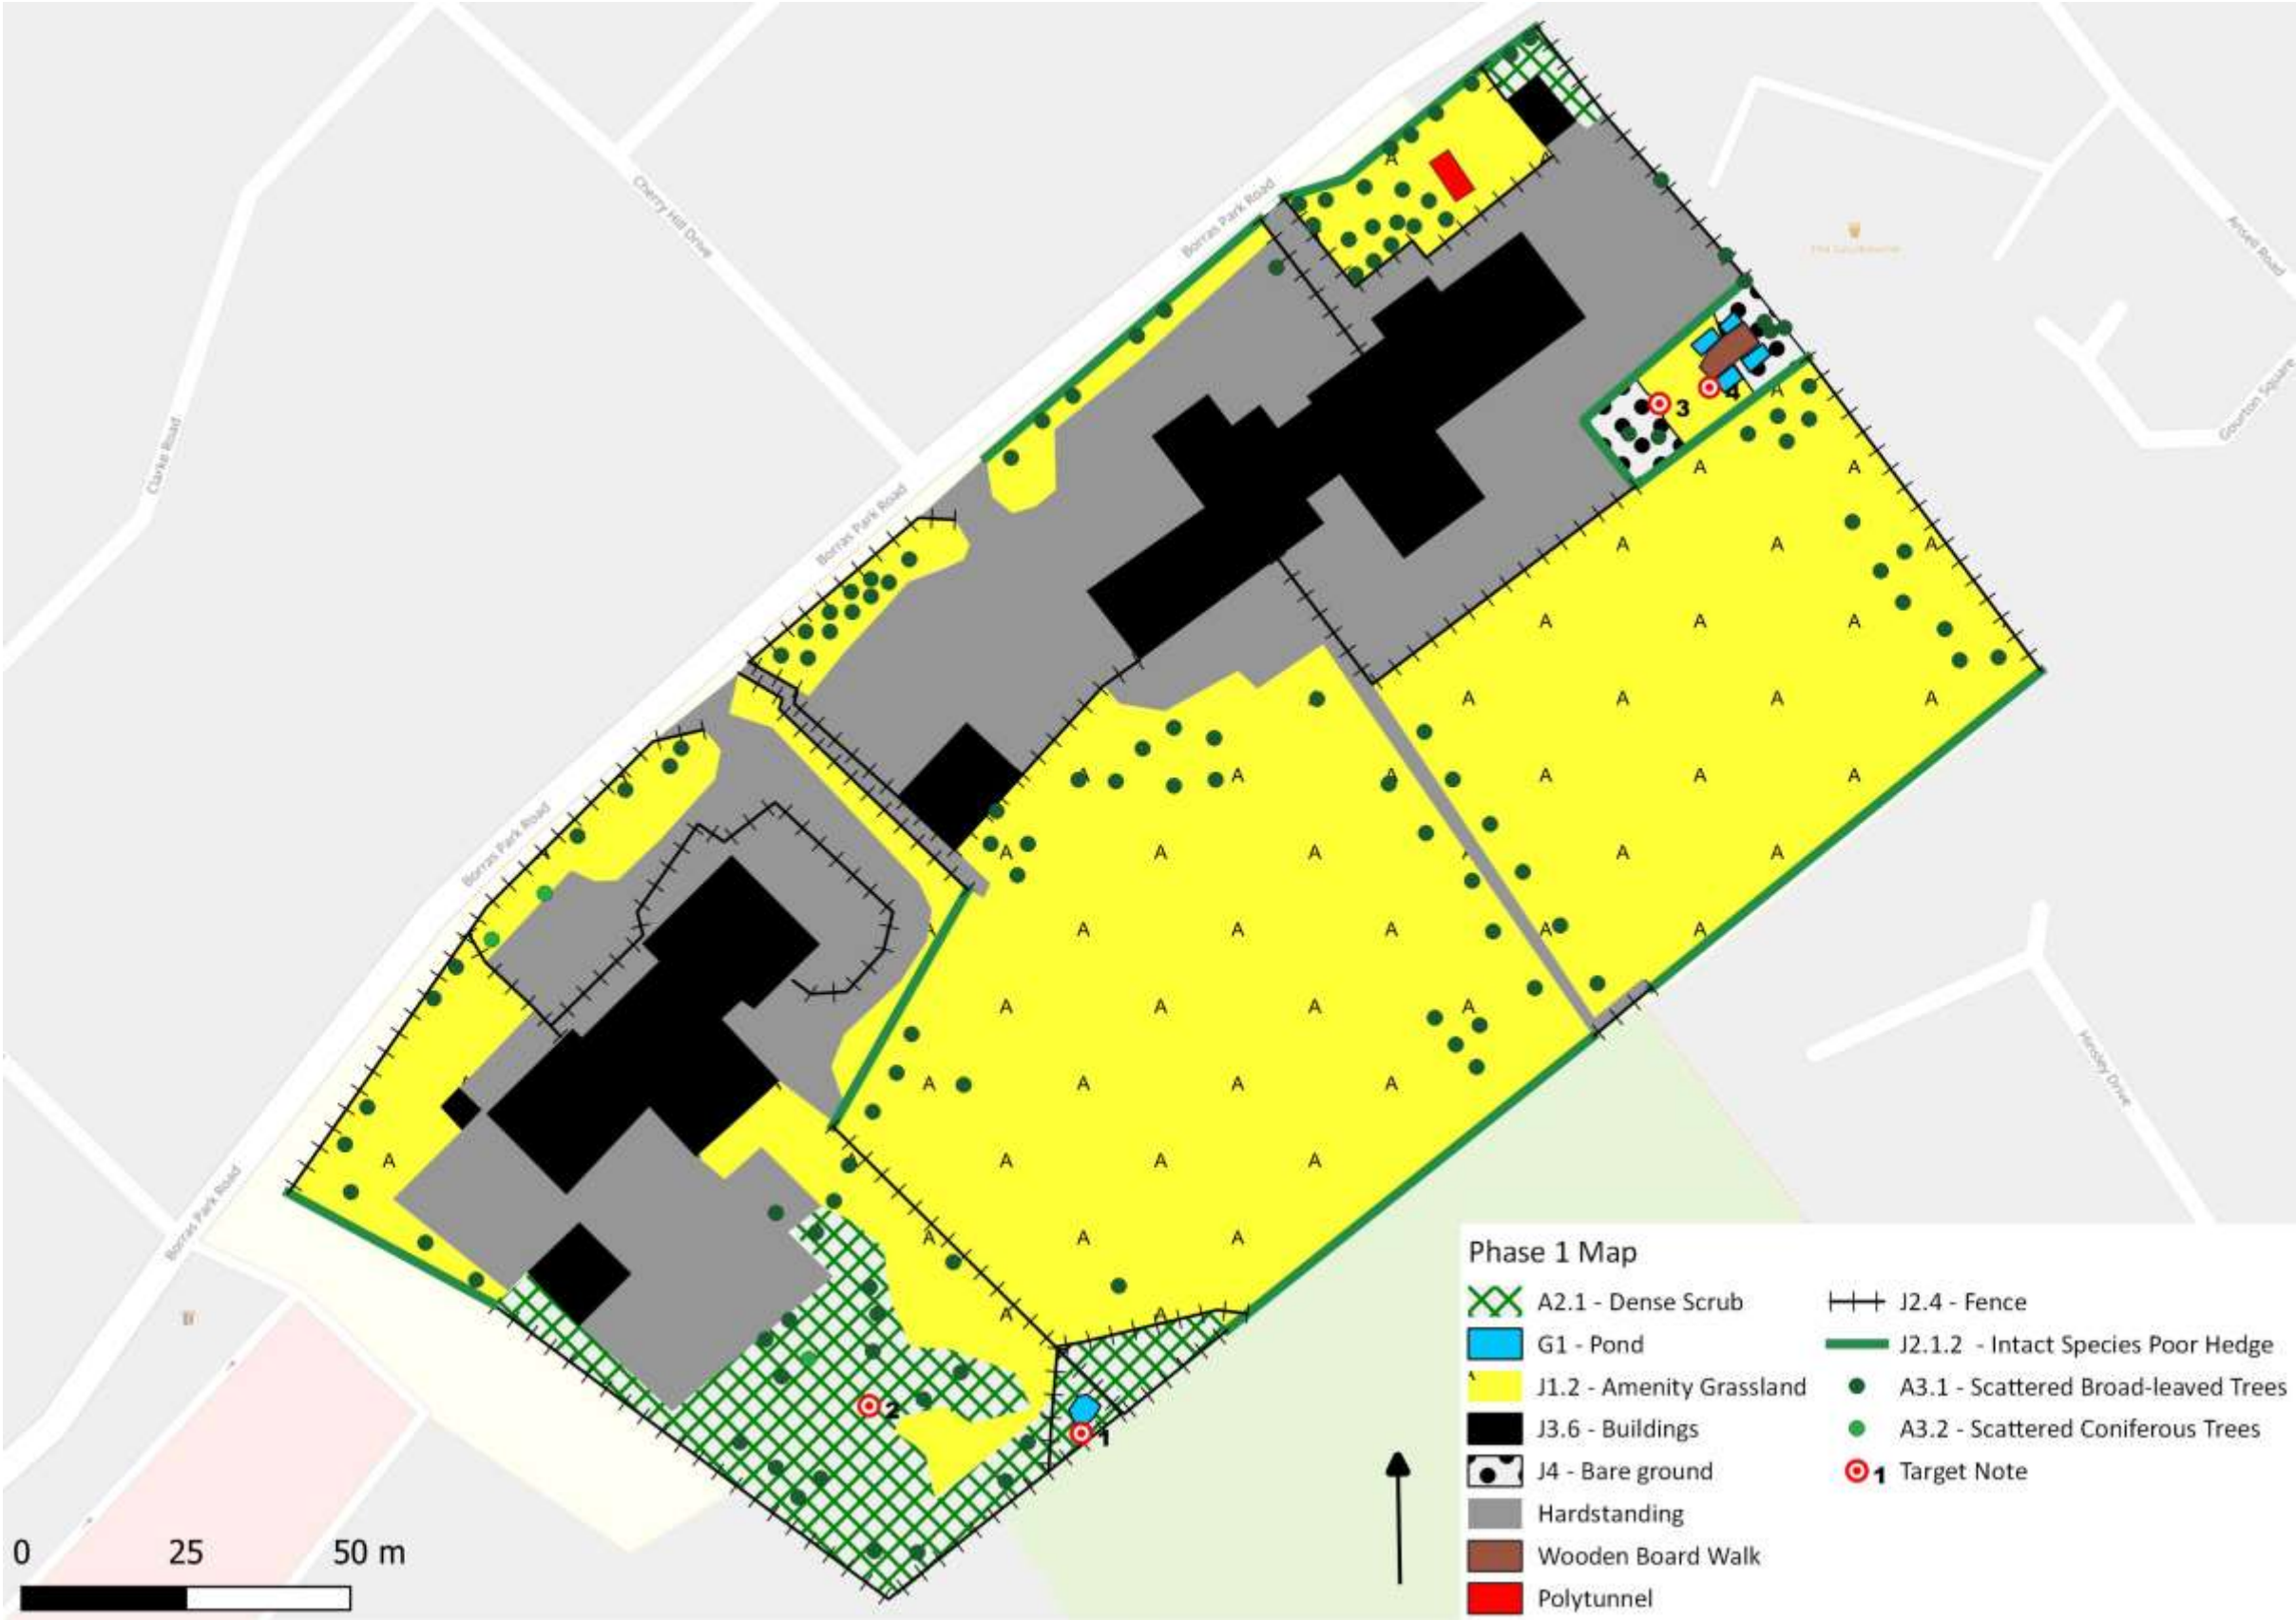
FIGURE 4.1 PHASE 1 HABITAT MAP OF SURVEY AREAS. TARGET NOTES AND DESCRIPTIONS OF THE HABITATS FOLLOW IN THE SUBSEQUENT SECTIONS.

4.2.2 A phase 1 habitat map of the site is provided in Figure 4.1. A description of the habitats including some species information and details of target notes from the map are provided below. Photographs of the site are included with the text.

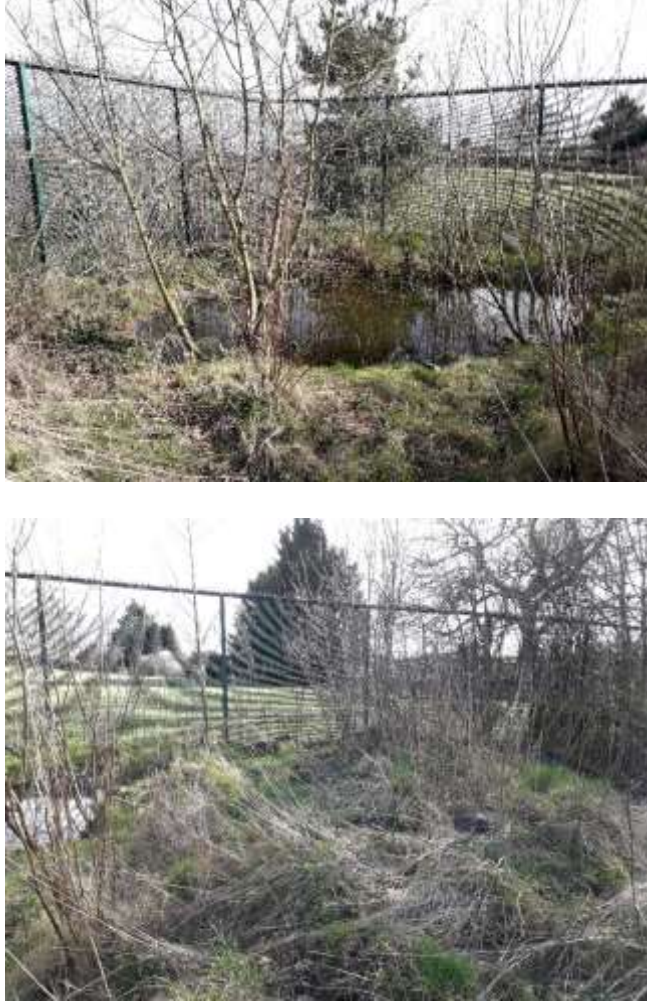
| Target note (TN) | Description | Photo |
|---|---|---|
| 1 | Pond within the infant site conservation area (description within Table 4.3) | |

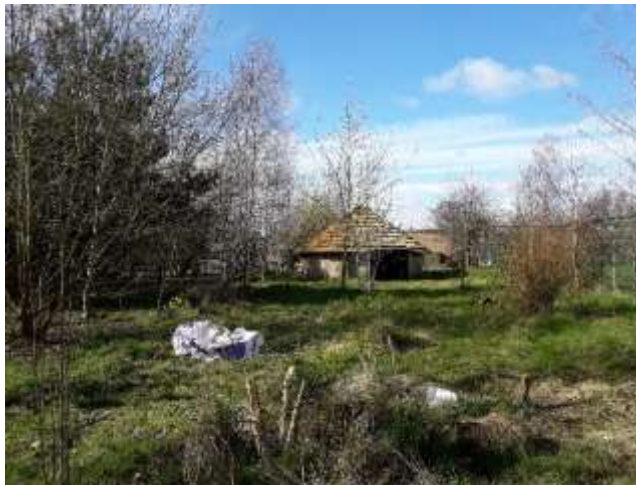
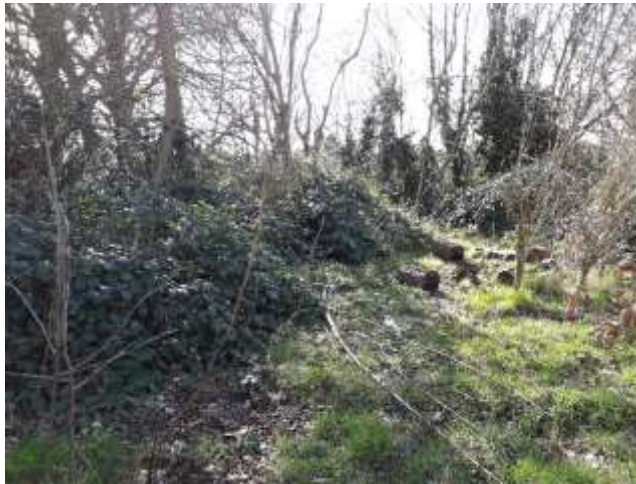
| Target note (TN) | Description | Photo |
|---|---|---|
| 2 | <p>Infant Site Conservation Area</p> <p>This area was the result of a number of conservation projects and currently serves as an outdoor classroom and educational resource.</p> <p>The area comprised amenity grassland, scrub and scattered trees including bramble (<i>Rubus fruticosus</i>), holly (<i>Ilex aquifolium</i>), hazel (<i>Corylus avellane</i>), birch (<i>Betula</i> sp.), cherry (<i>Prunus</i> sp.), willow (<i>Salix</i> sp.), ash (<i>Fraxinus excelsior</i>), rowan (<i>Sorbus aucuparia</i>), field maple (<i>Acer campestre</i>), scots pine (<i>Pinus sylvestris</i>) and larch (<i>Larix</i> sp.).</p> <p>There was a pond in the north eastern corner (Target Note 1) which is described in Table 4.3).</p> <p>A historic, single badger sett entrance, which was filled in, was located towards the centre of the conservation area. At the time of the survey, a member of staff said that it had not been used for a number of years.</p> | |

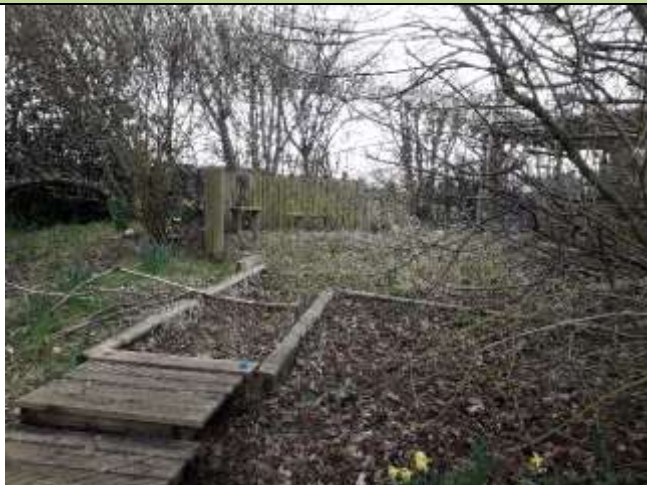
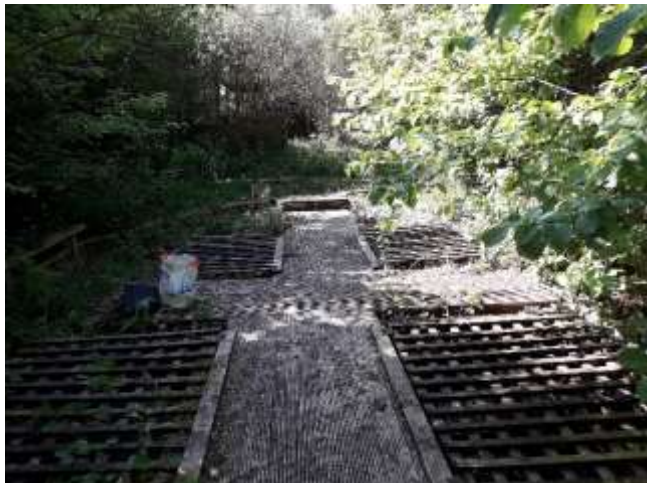
| Target note (TN) | Description | Photo |
|---|---|---|
| 3 | <p>Junior Site Conservation Area</p> <p>This area comprised areas of amenity grassland, bare ground, scrub and a series of wooden steps, board walks and benches. It was surrounded by a tall, mature, species poor hedgerow comprising field maple and holly, which shaded much of the area.</p> <p>To the centre of the area was a board walk with four small preformed ponds (two on each side), which were partially sunk into the ground and were covered by large pieces of trellis for safety purposes. Further description of the ponds is given in Table 4.3.</p> | |

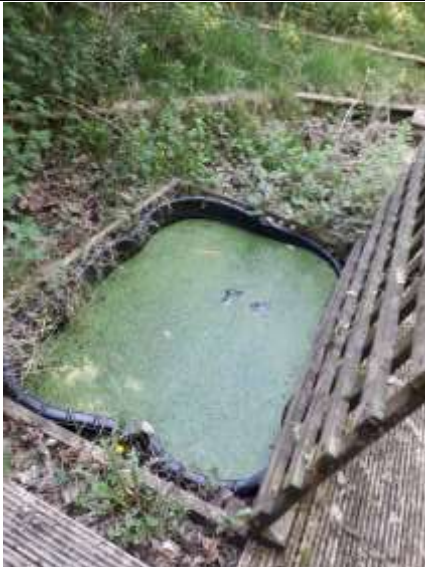
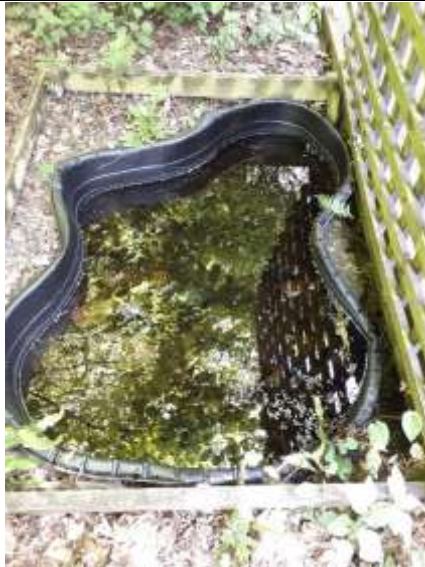
| Target note (TN) | Description | Photo | |
|---|---|---|---|
| 4 | Four Ponds within Junior Site Conservation Area (Description within Table 4.3) | | |

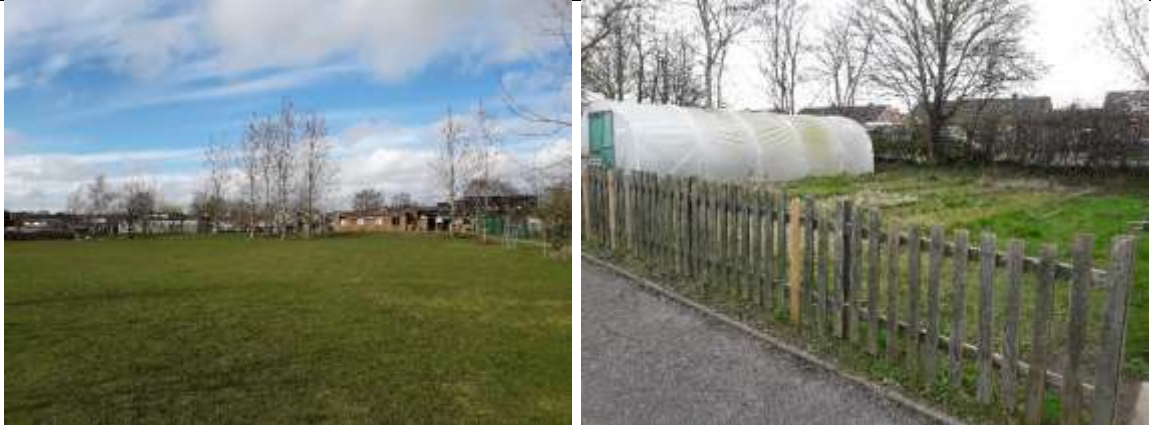
| Description | Photo |
|---|---|
| <p>The southern half of the site was predominantly a large area of amenity grassland playing fields, which were well maintained and regularly mown (Photos 4.1).</p> <p>A small horticulture area in the northern corner of the site, comprised an area of amenity grassland with scattered broad-leaved trees, empty wooden planters and a poly tunnel (Photo 4.2).</p> <p>There were small strips of amenity grassland between the car park areas and the main road, along the northern boundary of the site.</p> | <p><b>PHOTO 4.1 &amp; 4.2</b></p> |

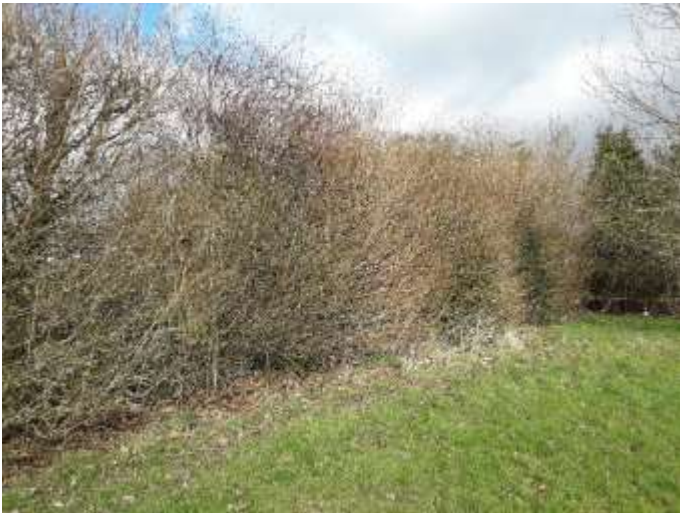
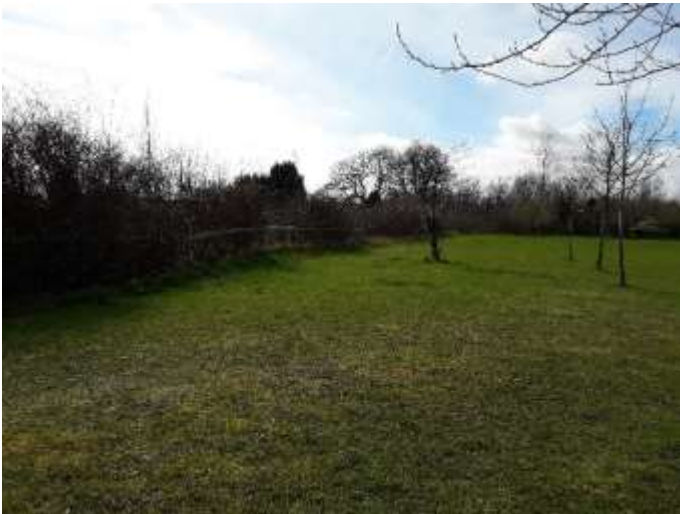
| Description | Photo |
|---|---|
| <p>The mature hedgerow surrounding the junior site conservation area was approx. 4m in height and comprised predominantly field maple and holly (Photo 4.3) There were two small gaps for pedestrian gateways but it was otherwise intact.</p> <p>There was a species poor hedgerow along the southern boundary of the site, comprising predominantly hawthorn (Photo 4.4). It was approx. 1.5m in height and had many gaps along its length.</p> <p>There was a hawthorn hedge, which ran about halfway along the northern boundary between the school and the main road.</p> | <p><i>PHOTO 4.3</i></p> <p><i>PHOTO 4.4</i></p> |

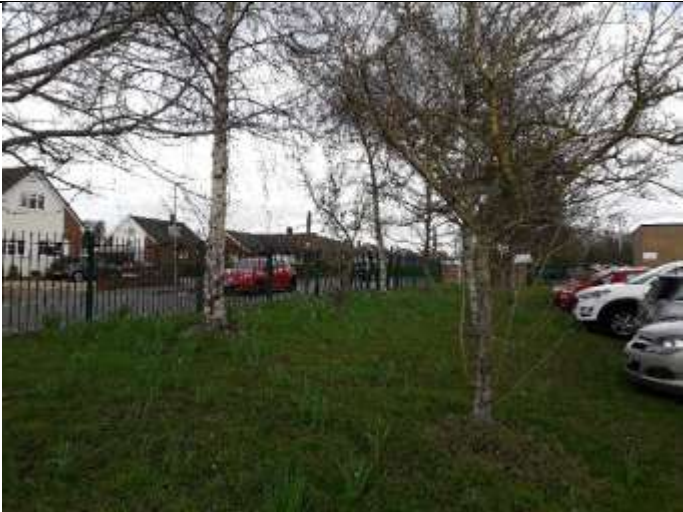
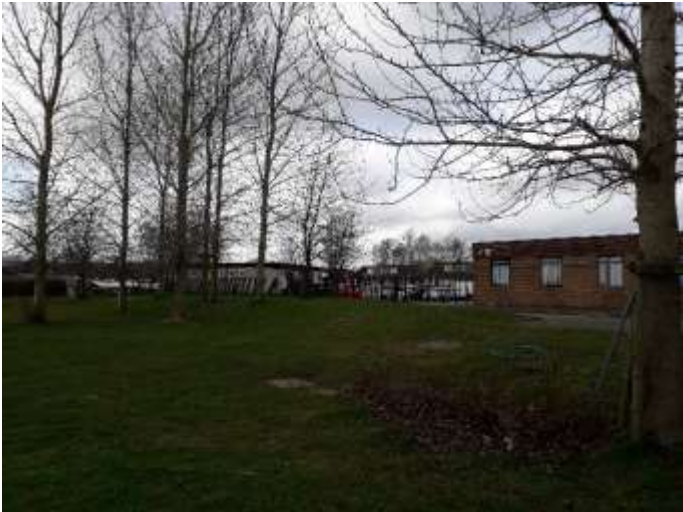
| Description | Photo |
|---|---|
| <p style="text-align: center;"><b>Scattered Trees</b></p> <p>There were scattered broad-leaved trees along the northern boundary of the site, within the small areas of amenity grassland. Species included rowan, cherry, field maple, cypress (<i>Cupressus</i> sp.), birch and hawthorn (Photo 4.5).</p> <p>A cluster of broad-leaved trees in the northern corner of the site included poplars (<i>Populus</i> sp.), rowan, field maple, birch and willow.</p> <p>There was a cluster of hybrid poplars towards the centre of the site and along a pedestrian walkway through the playing fields (Photo 4.6).</p> <p>Scattered trees on the outer edges of the playing field included <i>Sorbus</i> sp., cherry, <i>Malus</i> sp., birch, ash, maple (<i>Acer</i> sp.) and willow.</p> | |

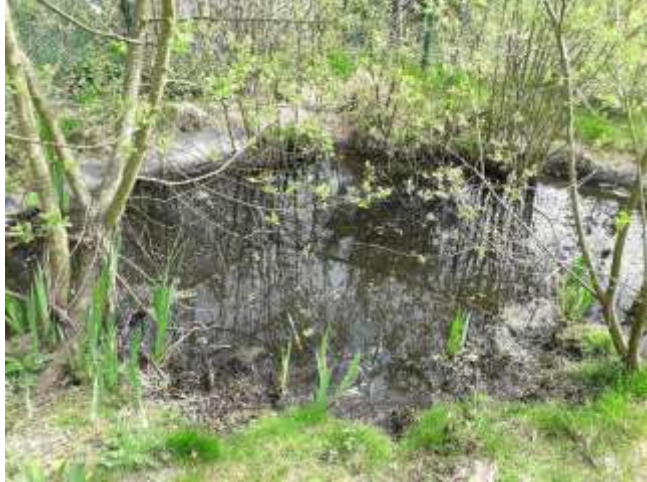
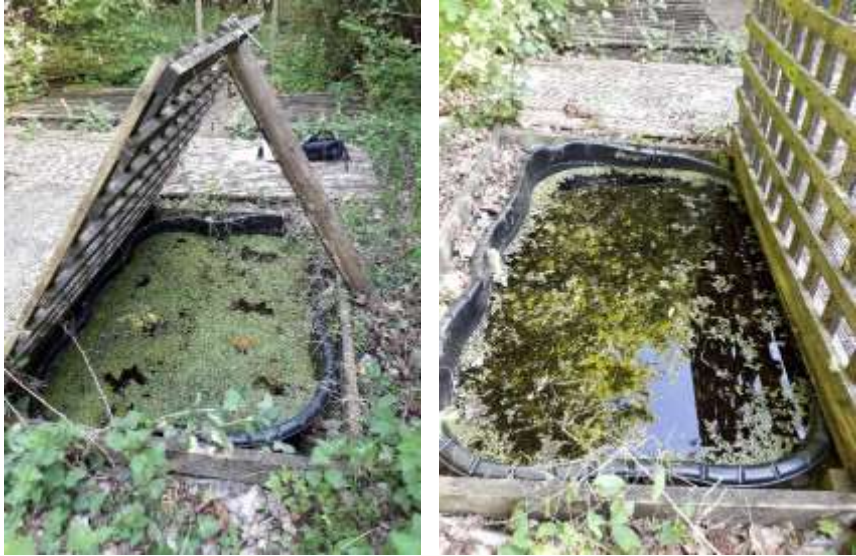
| Description | Photo |
|---|---|
| <p style="text-align: center;"><i><b>Ponds</b></i></p> <p>A small, lined pond was located within a fenced area in the north eastern corner of the Infants site conservation area. There were willow saplings around the pond edge and limited vegetation within the pond itself. Many tadpoles were seen during a visit in April 2020.</p> <p>There were four small, preformed ponds within the junior site conservation area. These measured approx. 1.5m x 1m and were partially sunk into the ground, within a wooden frame. Each pond was covered by a large removable piece of wooden trellis for safety purposes. The ponds were approx. 60cm deep but were at least half full with leaf litter. Duckweed was present but there were no other aquatic plants and a small number of tadpoles were seen during a visit in April 2020.</p> | |

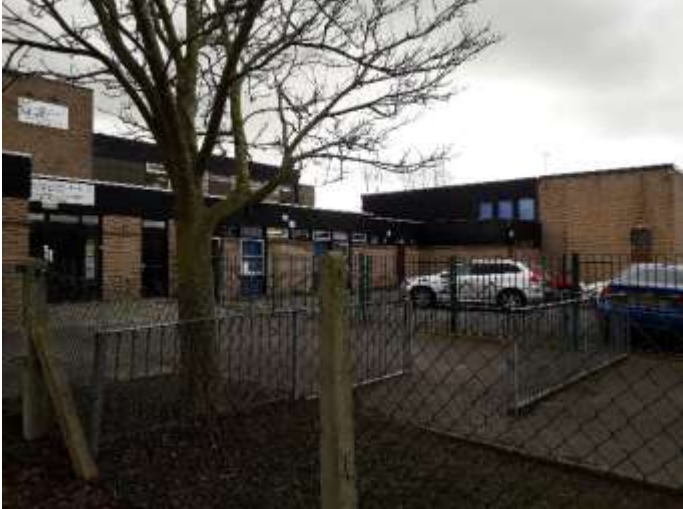
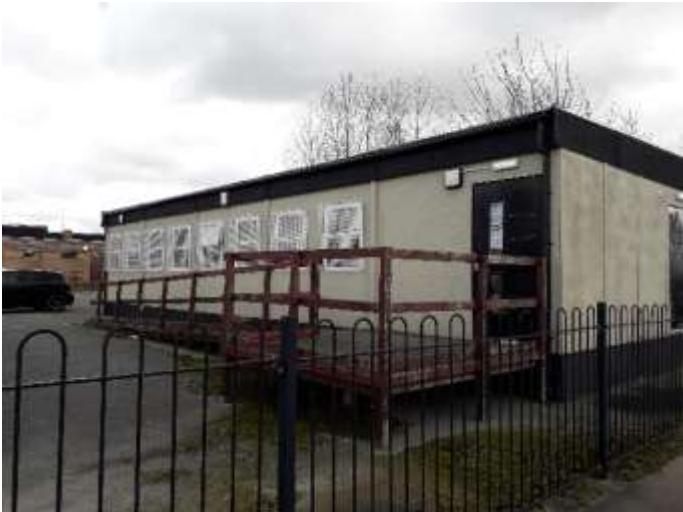
| Description | Photo |
|---|---|
| <p style="text-align: center;"><i>Buildings</i></p> <p>There were two main school buildings, one of which was single story (infant site) and the other was mostly single storey but with some two-story sections (junior site) (Photo 4.10). These were both constructed of brick and were flat roofed. There were also two portable classrooms, one within the centre of the site (Photo 4.11) and the other within the northern corner.</p> | |

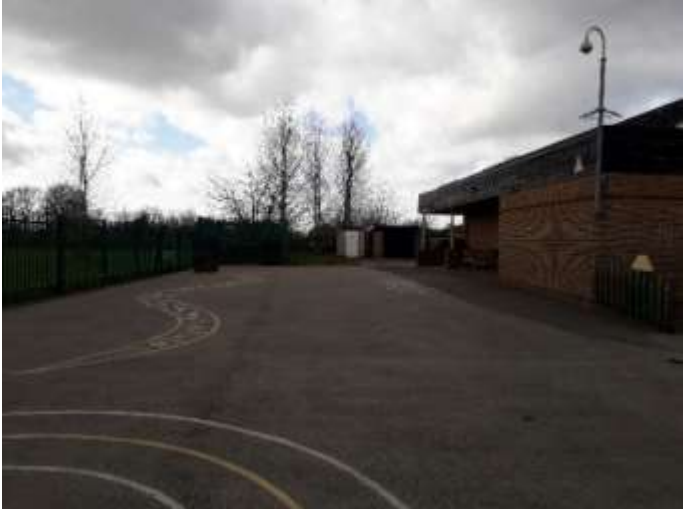
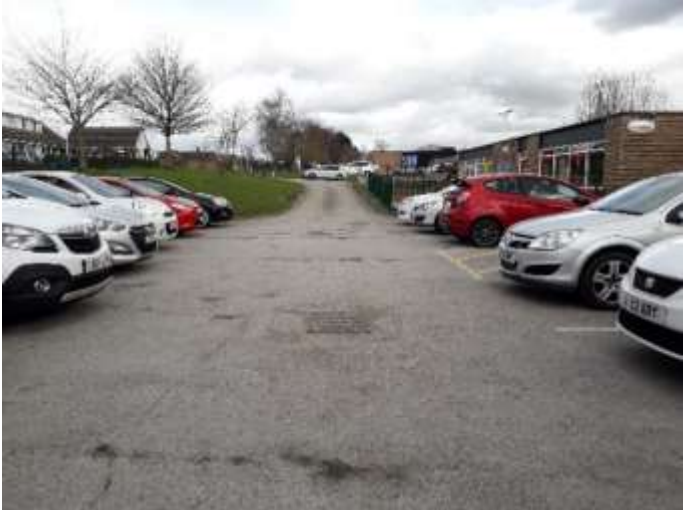
| Description | Photo |
|---|---|
| The majority of the site comprised hardstanding; playgrounds (Photo 4.12) and car parking areas for both infant (Photo 4.13) and junior sites. | <div><p><b>PHOTO 4.12</b></p></div> <div><p><b>PHOTO 4.13</b></p></div> |

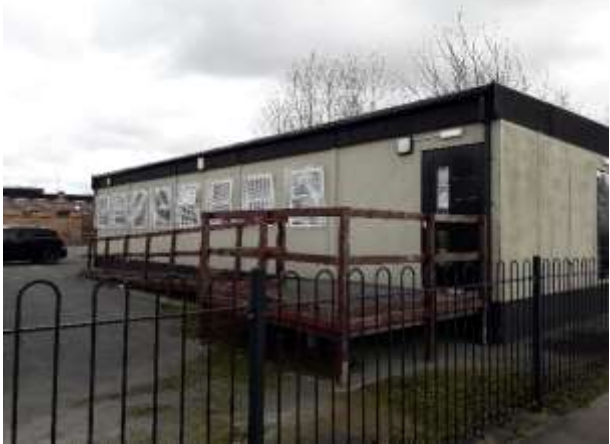
| Building No.<br>(Figure 5.1) | Building Description and potential roosting features | Photo |
|---|---|---|
| 1 | <p>This building, towards the centre of the site, was a standard prefabricated portable classroom, stood on hardstanding. It was in good condition and the fascia boards were intact with no gaps behind.</p> <p>No potential roosting features were identified.</p> | |

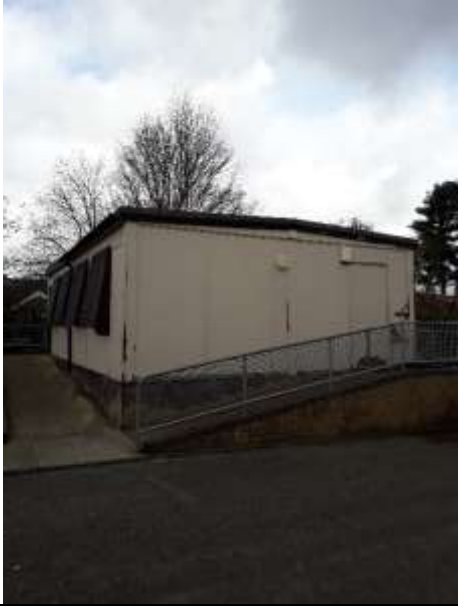
| Building No.<br>(Figure 5.1) | Building Description and potential roosting features | Photo |
|---|---|---|
| 2 | <p>This building in the northern corner of the site, was a standard prefabricated portable classroom, stood on hardstanding. The building was in good condition and the fascia boards were intact with no gaps behind.</p> <p>No potential roosting features were identified.</p> | |

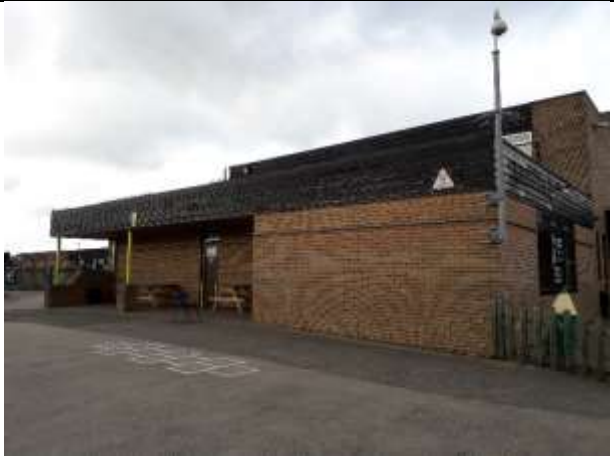
| 3 | <p>This section of the main junior school building was brick built, flat roofed with wooden cladding along the top of the walls. The brick work and wooden cladding were in good condition with no gaps or crevices identified.</p> <p>No potential roosting features were identified.</p> | |

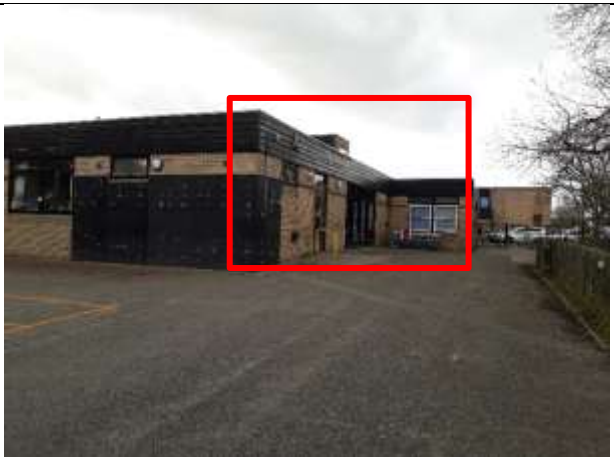
| 4 | <p>This section was brick built, flat roofed with wooden cladding along the top of the walls. The brick work and wooden cladding were in good condition with no gaps or crevices identified.</p> <p>No potential roosting features were identified.</p> | |
