**FIRST CHOICE HOUSING ASSOCIATION**

**NR 2 NANT LAIS, MINERA, WREXHAM, LL11 3YY**

**STAGE 1 - PHASE 2 – GROUND CONTAMINATION INVESTIGATION REPORT**

**REPORT No. E1330.S1.P2.GCI.R1**

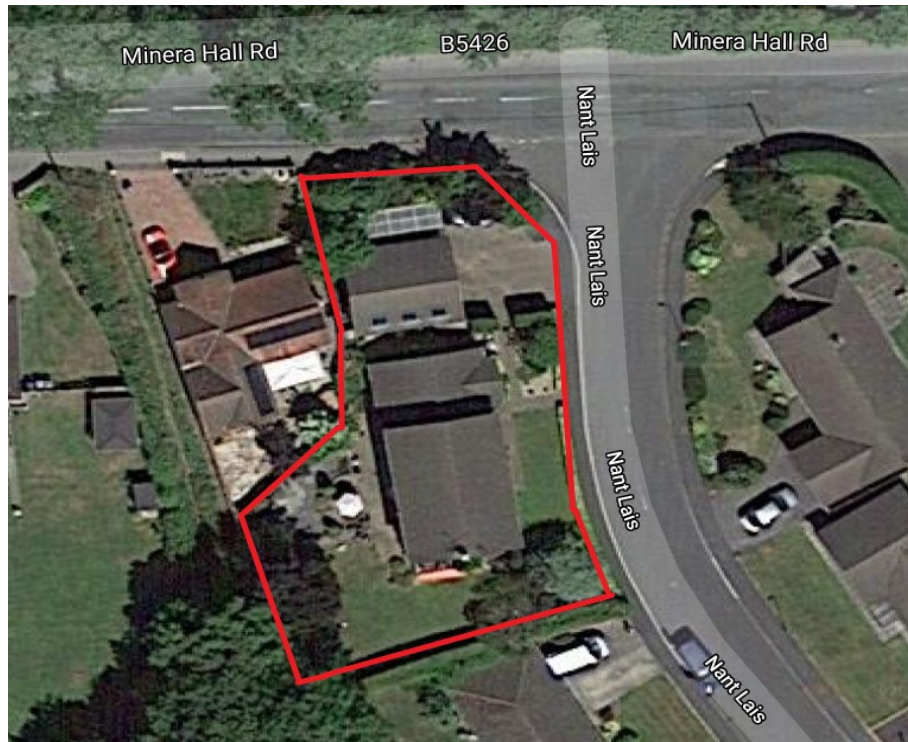
Figure 2 -Aerial Photograph

- 2.2.1 The site area is at the junction of the Nant Lais housing estate road and the B5426. The site comprises a relatively new two storey brick built residential property with adjacent double garage surrounded by small grassed lawns and paved patio and parking areas. The site is flat and level and at a similar elevation as the surrounding land. An aerial photograph of the site showing the site boundaries and surrounding land use is presented as Figure 2.

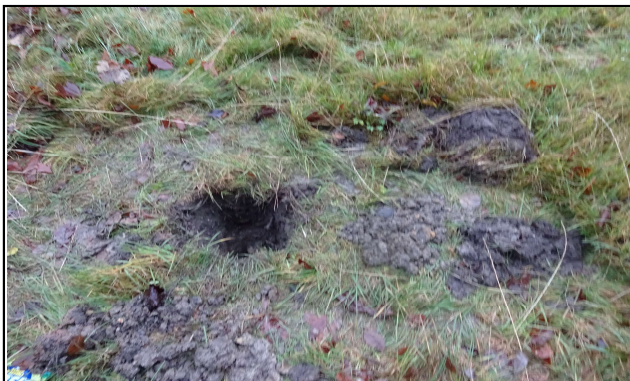
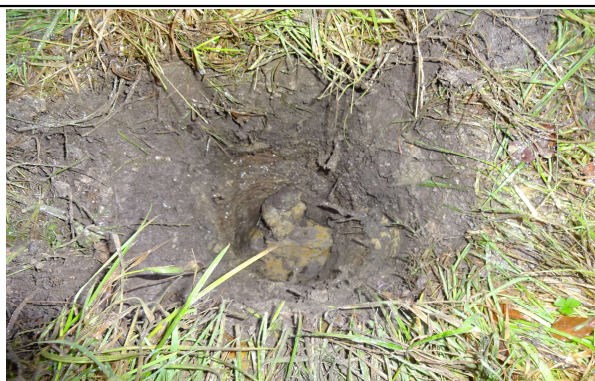
| | | | | | | Trial Pit No: <b>TP1</b> | | | |
|---|---|---|---|---|---|---|---|---|--|
| <b>Remarks</b><br><div> <div>Sidewalls :</div> <div>Groundwater :</div> <div>In-situ testing :</div> <div>Contaminants :</div> <div>Services :</div> </div> <div> <div>Pit sides stable</div> <div>None</div> <div>None</div> <div>None observed</div> <div>None</div> </div> | | | | | | | | | |
