## Wrexham Sheltered Housing – Llys y Mynydd, Rhosllanerchrugog

### Coal Mining Risk Assessment

**Document Reference:** 4315-CAU-XX-XX-RP-O-0300.S3.P1

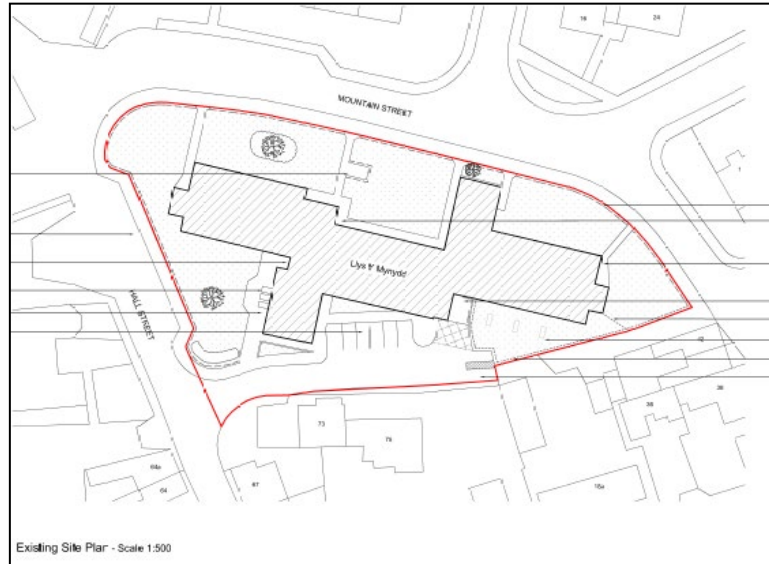
**Figure 1: Extract of the existing site plan**

- 1.3.3 The existing site plan is shown in more detail on Michael Dyson Associates Ltd drawing No. 001-(LLYS Y MYNYDD)-7990 and presented in Appendix 1, an extract is provided below.

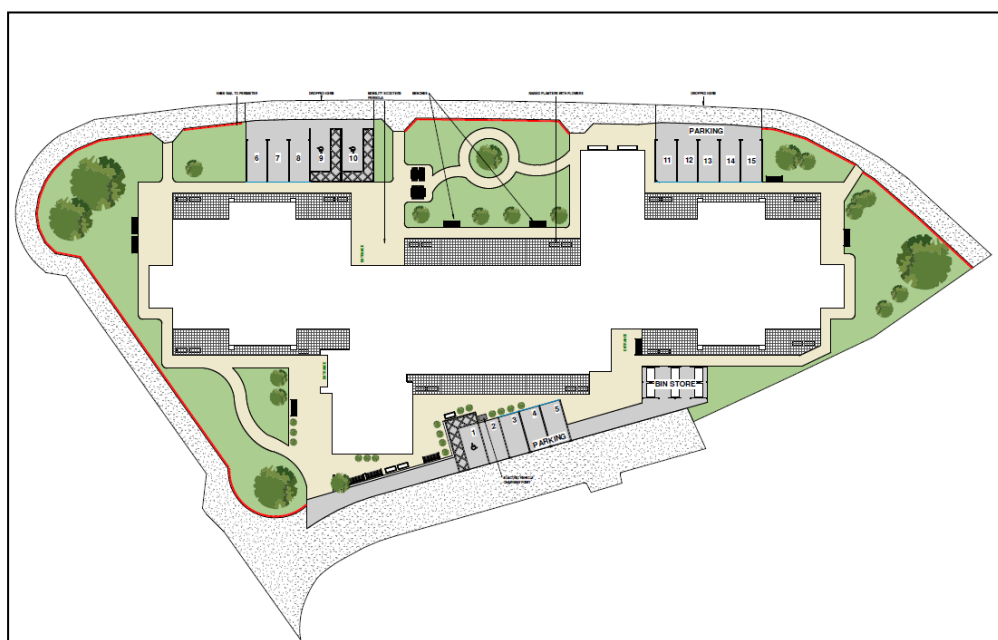
**Figure 2: Extract of the proposed site plan**

- 1.4.1 The proposed development will comprise the re-modelling and refurbishment of existing building layout, provision of additional car parking spaces and re-development of external areas.
- 1.4.2 The proposed development is shown in more detail on Michael Dyson Associates Ltd drawing No. 051-(LLYS Y MYNYDD)-7990 and presented in Appendix 1, an extract is provided below.

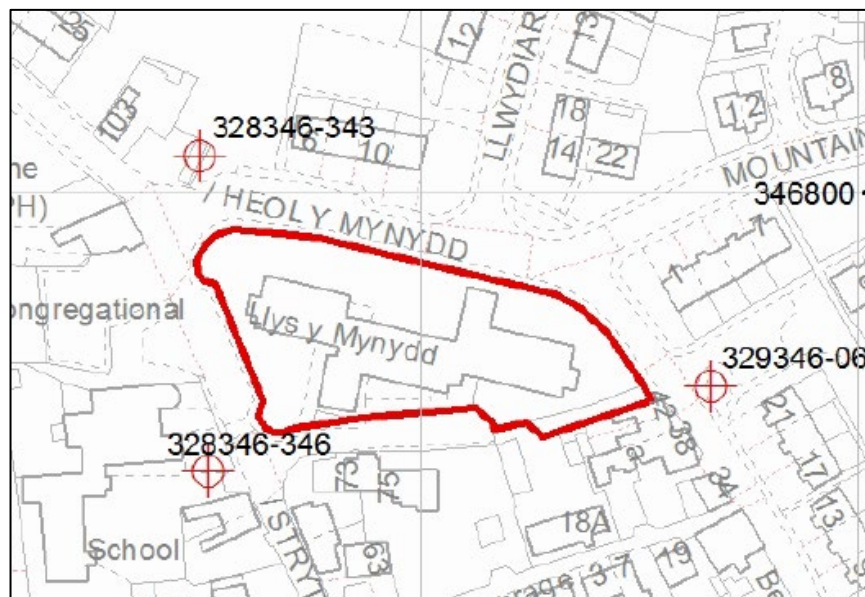
**Figure 4: Extract from the CON29M report indicating location of mine entries**

- Mine entry 328346-346 (south west of the site) – No treatment details

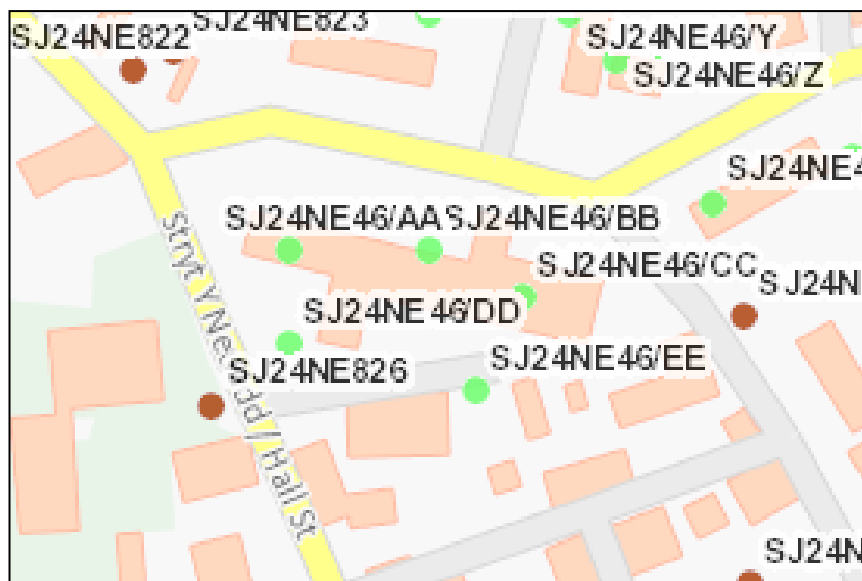
Figure 5: Extract from the BGS online viewer showing positions of historical boreholes

2.5.1 Four historical borehole records held by BGS have been reviewed as part of this study, the boreholes were positioned on the site, and although it cannot be confirmed, it is extremely likely that they were carried out to facilitate the design of the current building. The records are presented in Appendix 4 and summarised below.

- 2.5.2 **SJ24NE46/AA** (North western area of the site) – The borehole encountered 0.9m of topsoil overlying boulder clay to 23.5m below ground level. This was underlain by siltstone bedrock to a maximum recorded depth of 27m.
- 2.5.3 **SJ24NE46/BB** (Northern area of the site) – The borehole recorded 1.1m of topsoil, overlying boulder clay to 5.9m depth, this was then underlain by a sequence of interbedded mudstone, shale, fireclay, siltstone and coal to a depth of 27.0m

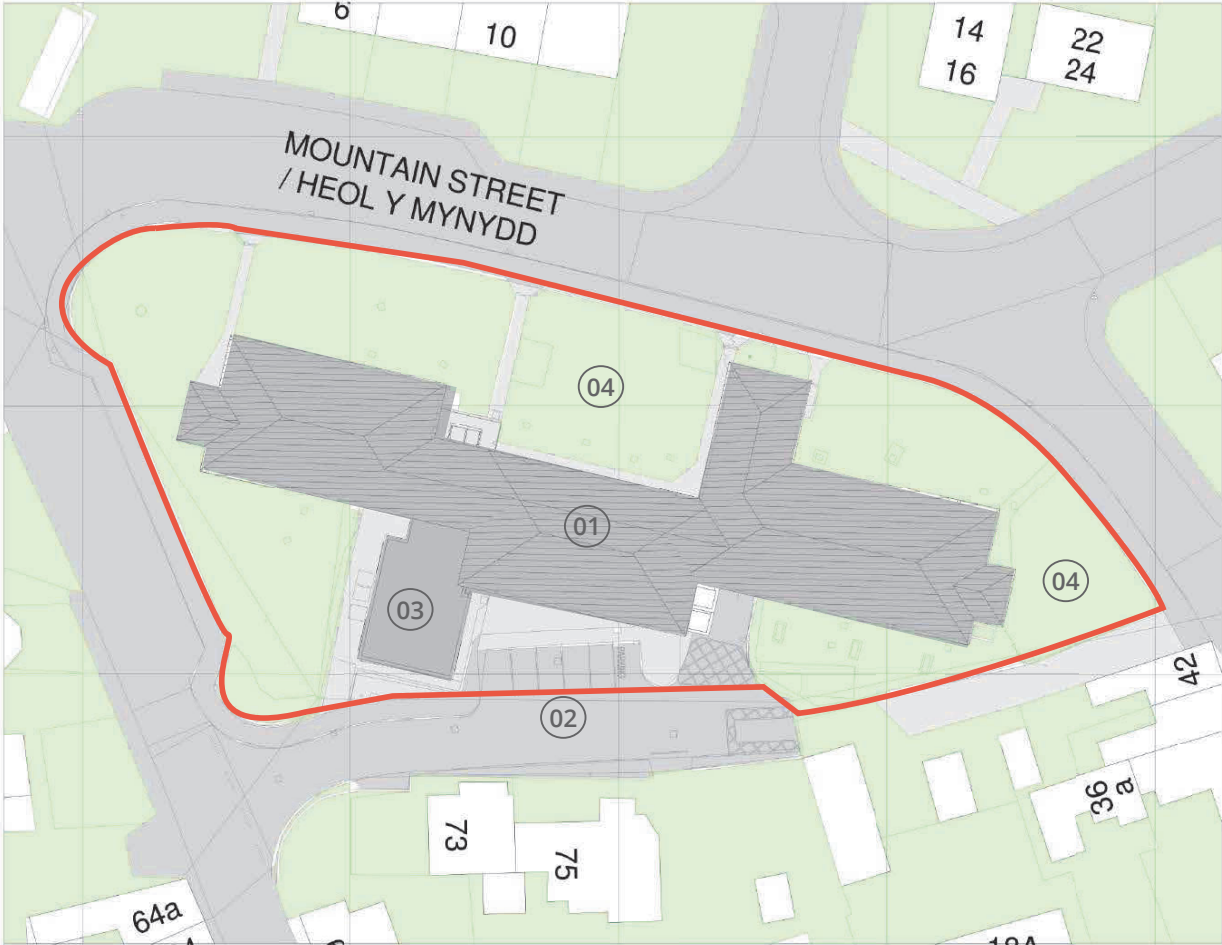
Llys y Mynydd  
Existing Site Plan

- Key**
- 01 - Main Building
  - 02 - Deliveries and Drop off
  - 03 - Communal Space
  - 04 - Gardens
