| <b>Report Title</b> | <b>Proposed Demolition of Redwither Business Centre, Abbey Road, Wrexham Industrial Estate, Wrexham – Preliminary Roost Assessment</b> |
| <b>Report Version</b> | <b>C432/ PRA/ 1.0</b> |
| <b>Client</b> | <b>Wrexham County Borough Council</b> |

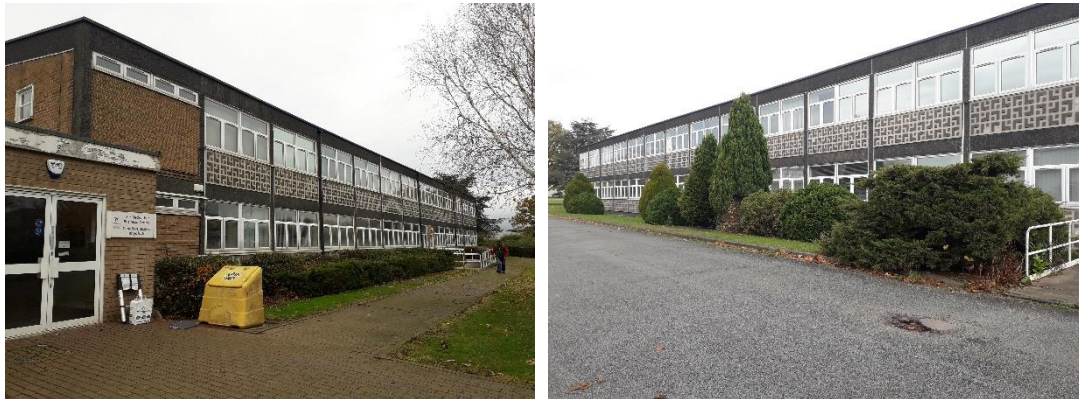
- 4.1.1 The building comprises two main sections, a two-storey section and a single-storey section.
- 4.1.2 The western and eastern elevations of the two-storey section, are both faced with prefabricated concrete panels and have two rows of windows (*Photos 4.1 & 4.2*). The southern and northern elevations are of brick, with three small windows on the southern side and two fire escape doors and external metal stairs on the northern side. The roof is covered by roofing felt and is split level, with the western half having less of a slope and almost flat.

**Photos 4.1 & 4.2: The eastern and western elevations of the two-storey section**  
(*Target Note 14 in Marches Ecology, 2020*)

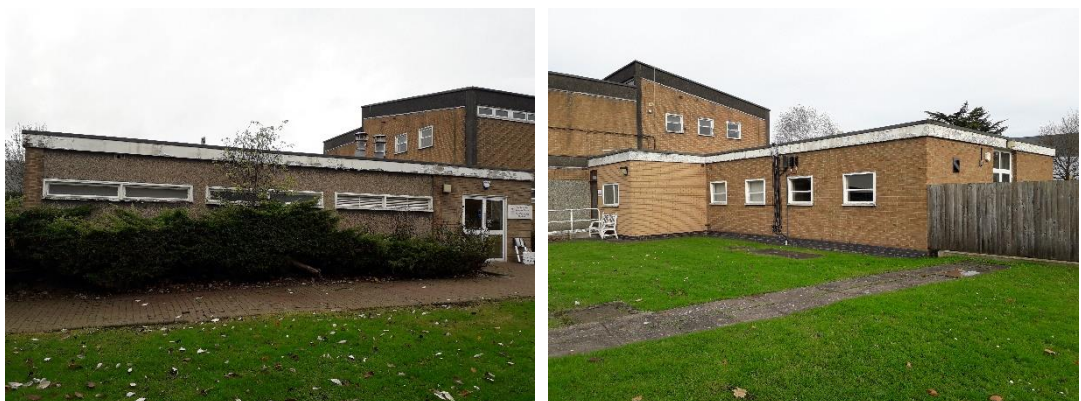
- 4.1.4 A single-storey, brick-built section, adjoins the two-storey section on its southern gable end (*Photos 4.3 & 4.4*). It has a flat roof, covered with roofing felt and has large timber fascias.

**Photos 4.3 & 4.4: The eastern and western elevations of the single storey section**  
(*Target Note 14a in Marches Ecology, 2020*)

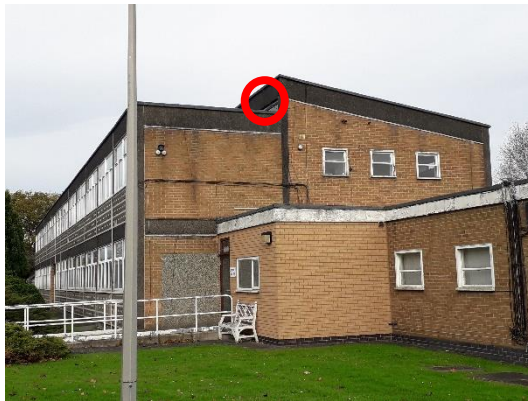
- 4.2.1 Both sections of the building are in good condition with very few potential roosting features present.
- 4.2.2 Within the small roof void, the window on the western elevation has a circular hole of approximately 10 cm diameter in it, providing potential access into the space (*Photo 4.5*). There are a number of deep gaps between the blocks forming the roof, where corners had chipped off (*Photo 4.6*). No bats or signs of bats were seen within this space and there is moderate airflow and the light levels are high.

**Photo 4.5: Location of small roof void**

- 6.1.1 To determine if a roost is present within the building, at least one emergence survey must be carried out during May to August (inclusive), prior to any works to the building. If bats are found to be roosting within the building, a licence from NRW must be obtained before any works can begin.

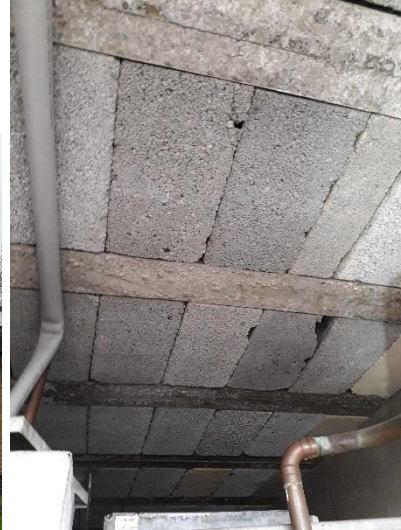
- 4.1.3 There is a small roof void over the first floor WC and kitchen, within the two-storey section, which measures approximately 2.5 m x 5 m x 1 m in height. The roof comprises a concrete beam and block construction, which is sloped. There is a window approximately 50 cm in height, on the western elevation, which spanned the width of the void. The void houses a number of water tanks and pipework.

**Photo 4.6: Concrete beam and block roof structure with gaps between the blocks**

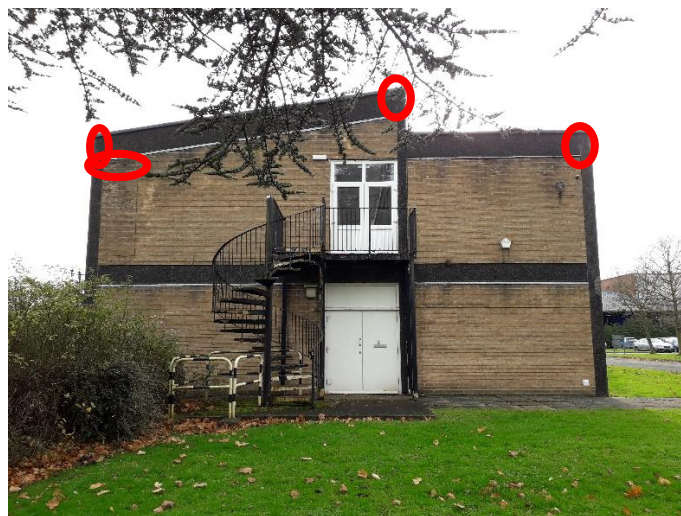
- 4.2.3 On the northern elevation of the building, there are two old drill or pipe holes approximately 0.5 m down from the roof line at the eastern edge (*Photo 4.7*). At least one of these holes is big enough to be a potential roosting feature. There are also three small gaps between concrete panels near the roof level where the sealant has come apart.

**Photo 4.7: Location of potential roosting features on the northern elevation of the building**

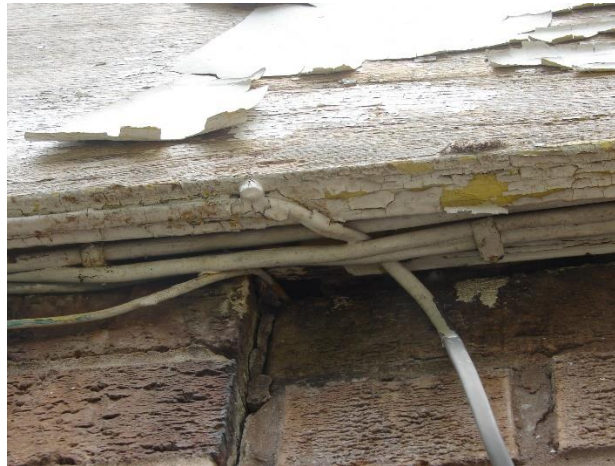
- 4.2.4 There are small gaps under lead flashing on the southern elevation, however the gaps are unlikely to be big enough to be a potential roosting feature.
- 4.2.5 The western and eastern elevations are well sealed with no visible potential roosting features.
- 4.2.6 The single-storey section is generally well sealed though there are a few small gaps beneath the timber fascias.

**Photo 4.8: Small gap beneath fascia on single-storey section**

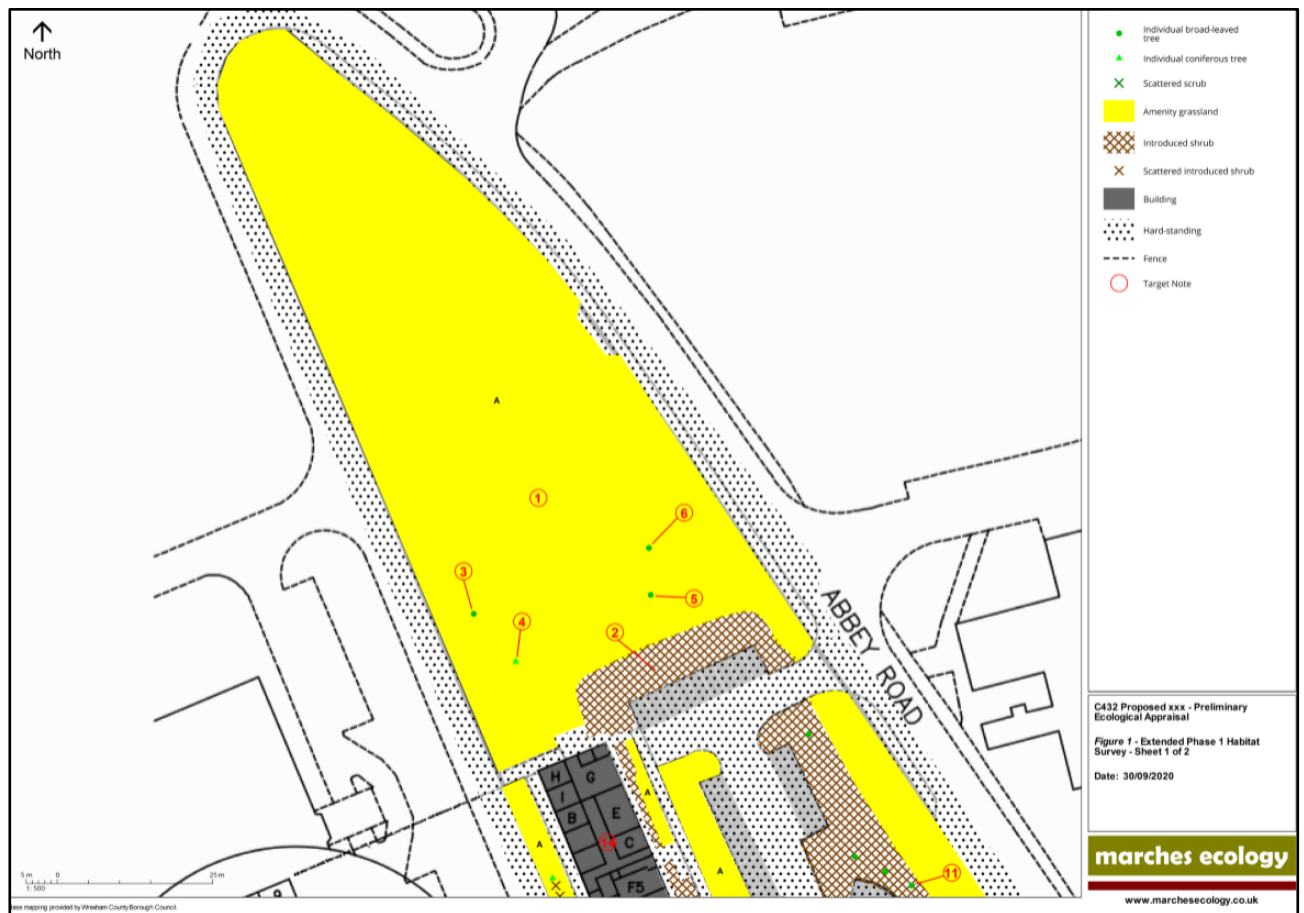
**Figure 4.1a: Locations and numbers of trees identified as requiring a Potential Roost Feature Assessment – TN3, TN4, TN5 & TN6 (Marches Ecology, 2020)**

- 4.3.1 A number of trees were identified as requiring a Potential Roost Feature (PRF) assessment, due to their proximity to the building and the potential for indirect disturbance during demolition. These trees were assessed from the ground. A location plan of the trees is provided as *Figure 4.1* below (Reproduced from Marches Ecology, 2020) and a summary description is provided in *Table 4.1* below. The target note numbers in *Table 4.1* are taken from Marches Ecology (2020) and shown on *Figure 4.1*.

- 5.1.4 The three mature Pedunculate Oaks, approximately 20 m to the north of the building, and the Norway Maple, approximately 35 m to the east, were found to have potential roosting features and are of low and moderate suitability for bats. As the works are not due to directly affect the trees no further surveys are recommended. If works to these trees are required in the future, further surveys will be required, to include a climbed PRF inspection, followed by at least one emergence or re-entry survey if the features are found to be suitable or signs of bats are found. Although the trees are not due to be affected by the proposed works, Reasonable Avoidance Measures (RAMs) must be implemented during the works to reduce the risk of disturbance to bats (see *Section 6*).

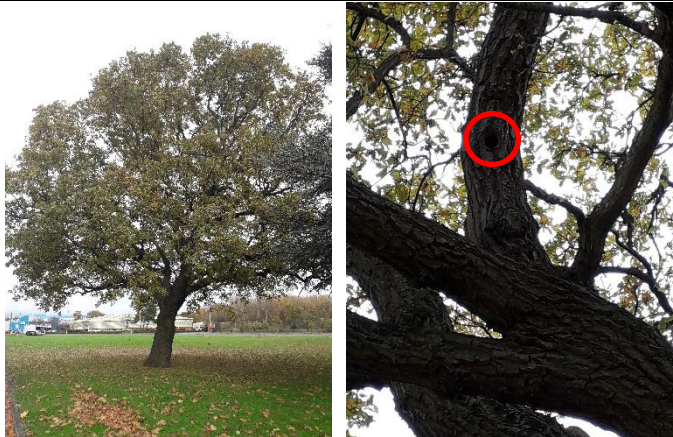
| Tree number | Species | Preliminary Roost Feature Description | Photos (where relevant) | Suitability |
|---|---|---|---|---|
| TN3 | <i>Quercus robur</i><br>(Pedunculate Oak) | <ul style="list-style-type: none"> <li>Semi-mature, with an approximate diameter at breast height (dbh) of 0.7 m.</li> <li>Woodpecker hole in a small limb at approximately 3.5 m on the west side (as shown by red circle in photo).</li> <li>A large limb has internal rot and is split at approximately 2.5 m on the east side.</li> <li>There is a bark split/ rot-hole at approximately 6 m in a limb on the southwest side.</li> </ul> | | Moderate |

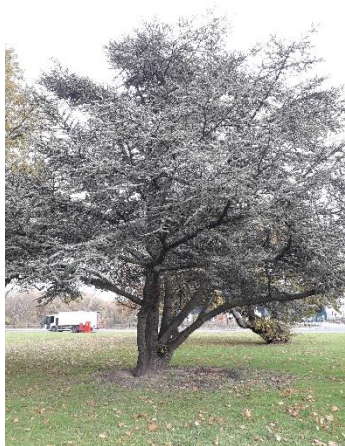
| Tree number | Species | Preliminary Roost Feature Description | Photos (where relevant) | Suitability |
|---|---|---|---|---|
| TN4 | <i>Cedrus atlantica</i><br>f. <i>glauca</i> (Blue Atlas Cedar) | <ul style="list-style-type: none"> <li>Semi-mature, largest stem has an approximate dbh of 0.45 m.</li> <li>No features of potential value for roosting bats were visible.</li> </ul> | | Negligible |

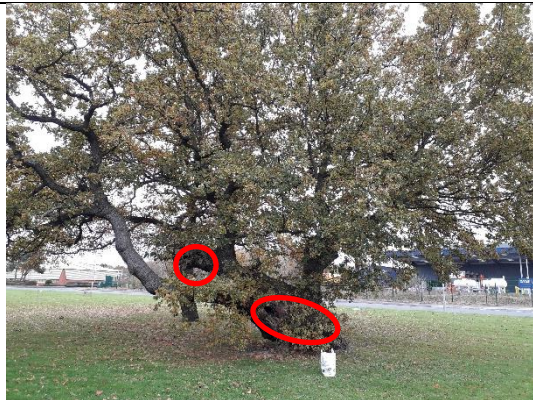
| TN5 | <i>Quercus robur</i><br>(Pedunculate Oak) | <ul style="list-style-type: none"> <li>Over-mature tree, with an approximate dbh of 1.2 m.</li> <li>The main trunk is partly filled with concrete and bricks (approximately 1 m from the ground), though some of it had fallen out on the southern side. This left a large cavity in the main trunk with access holes from the southern elevation and top of the trunk.</li> <li>A large limb has been removed on the west side at approximately 2 m. This may contain a cavity.</li> </ul> | | Low |

- 6.2.1 Marches Ecology (2020) recommends the installation of temporary protective fencing around the trees at *Target Notes 4* and *5* prior to, and during, the demolition. This fencing does not need to encircle the trees – it should be located to the south of them and be aligned approximately east-west across the entire site. The fence should be installed at least 10 m from the trees so that should any bats be using them their flight-lines would not be obstructed. All site personnel should be made aware of the importance of not entering the area to the north of this fence.

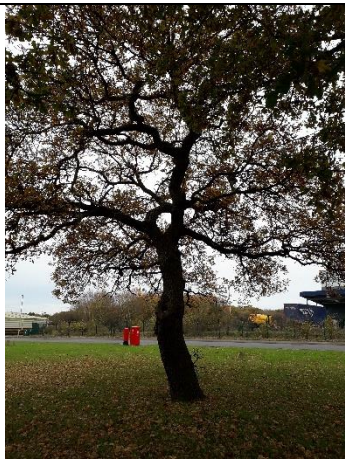
| TN6 | <i>Quercus robur</i><br>(Pedunculate Oak) | <ul style="list-style-type: none"> <li>Semi-mature tree, with an approximate dbh of 0.5 m.</li> <li>A large limb has been removed at approximately 2 m on the southwest side. This feature may contain a small cavity.</li> <li>Split/ rot-hole at approximately 4.5 m on the northwest side.</li> <li>Small rot-hole at approximately 4.5 m in the southern limb.</li> <li>Several further small pruning wounds.</li> </ul> | | Low |

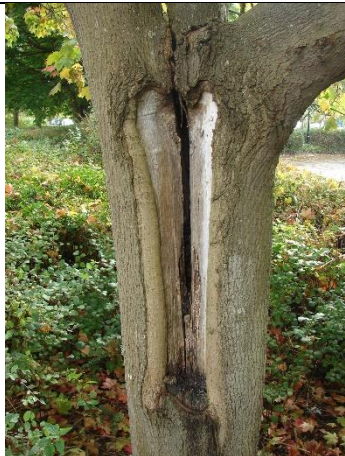
| TN11 | <i>Acer platanoides</i><br>(Norway Maple) | <ul style="list-style-type: none"><li>• Semi-mature tree, with an approximate dbh of 0.3 m.</li><li>• Large split down the centre of the trunk to approximately 1.3 m long. The split is up to 2.5 cm wide and may be too open/exposed to be of value for roosting bats.</li></ul> | | Low |

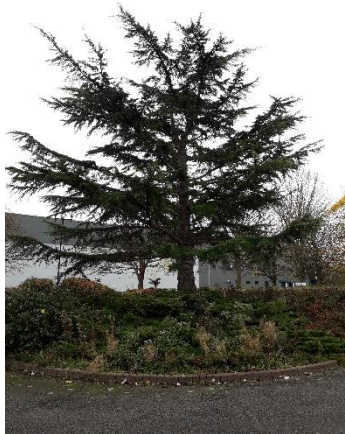
| TN14 | <i>Cedrus deodara</i><br>(Deodar) | <ul style="list-style-type: none"><li>• Semi-mature tree, with an approximate dbh of 0.4 m.</li><li>• No features of potential value for roosting bats were visible.</li></ul> | | Negligible |
