PLAS GRONO FARM, ERDDIG

PRELIMINARY BAT ROOST ASSESSMENT, BAT EMERGENCE SURVEY, AND NESTING BIRD SURVEY

Report Ref EE.756.JK.20

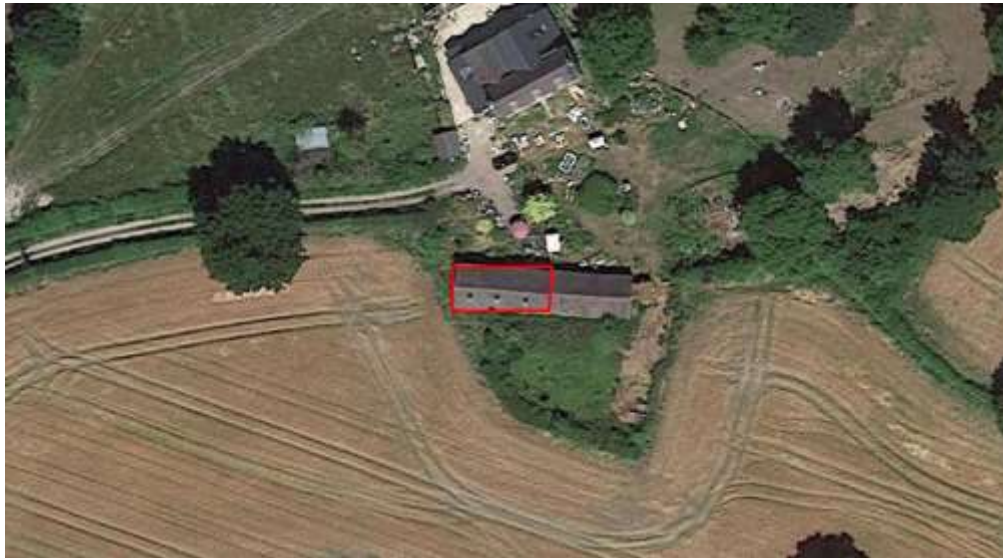
- 2.1 The surveyed building, was a barn located at Plas Grono Farm, Erddig. It sits at the southern edge of the farm, with agricultural land with crops on three sides and the farmhouse approx. 20m to the north. The barn adjoins a single storey building (not surveyed) currently used as stables. To the immediate north is a small area of semi-improved grassland and a pond. The approximate grid reference of the site is SJ 31541 48048 (Figures 2.1 and 2.2).

FIGURE 2.1 AERIAL VIEW OF THE SITE AND SURROUNDINGS. THE SURVEYED BUILDING IS SHOWN IN RED. BASE MAP © GOOGLE 2020

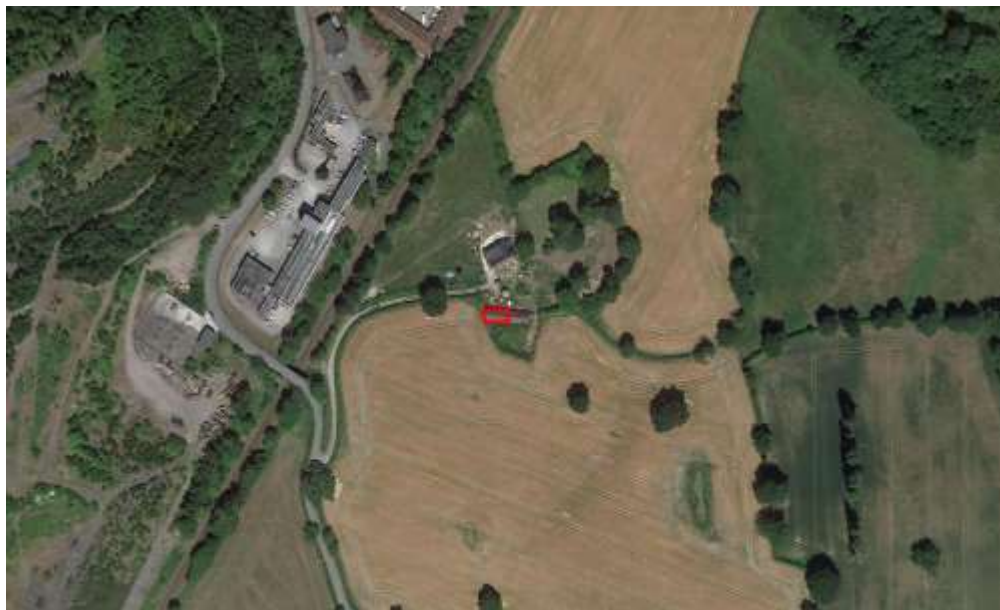
- 2.2 The wider surroundings are predominantly agricultural pasture with the village of Rhostyllen approx. 0.4km to the north and the town of Wrexham approx. 2km to the north-east. There is a railway line 80m to the north-west, lined with trees and scrub, providing connectivity to the wider area. There are also several blocks of broadleaved woodland nearby, including 160m to the north-west and 200m to the north-east. These woodlands are well connected to a much wider network of woodlands to the east, including Erddig Park.

FIGURE 2.2 WIDER LANDSCAPE, THE SURVEYED BUILDING IS SHOWN IN RED. BASE MAP © GOOGLE 2020

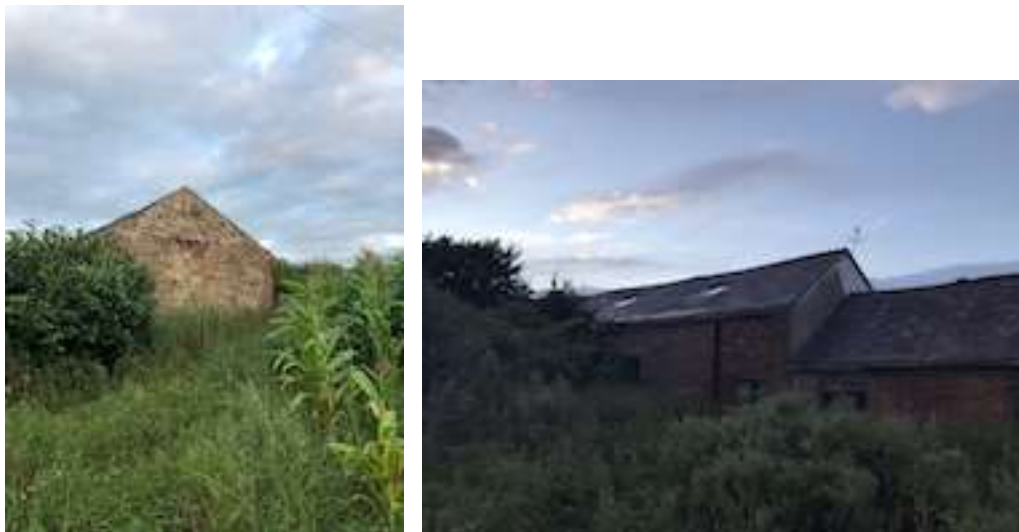
PHOTOS 2.1 AND 2.2. SURROUNDING HABITAT, WESTERN GABLE AND SOUTHERN SIDE OF THE BARN RESPECTIVELY

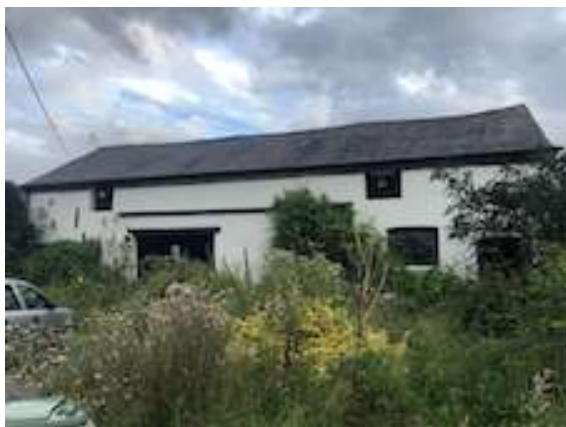
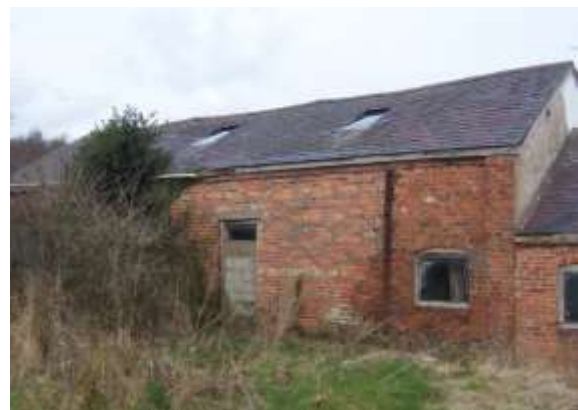
4.1.1 The building comprised a two-storey, semi-detached barn, with stone and brick walls and a pitched roof with natural slate (Photos 4.1 & 4.2). The barn was rectangular in footprint, with a large opening on the northern side, along with two further doorways (one obscured by vegetation). There were several windows on the ground floor, along with a boarded door on the southern side. There were also two boarded windows on the 2nd floor, on the northern side.

PHOTOS 4.1 & 4.2. NORTHERN AND SOUTHERN ASPECTS OF THE BARN

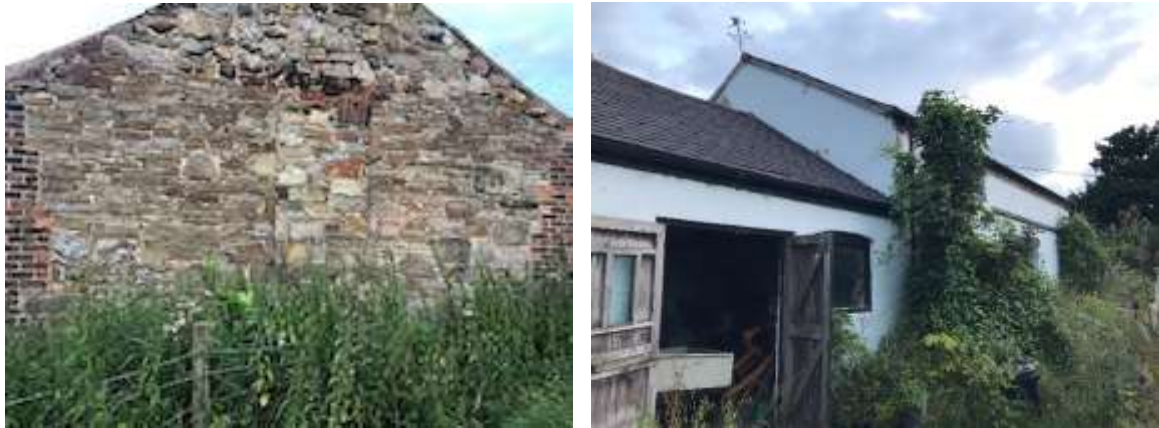
- 4.1.2 The western gable wall comprised un-rendered stonework (Photo 4.3) and the eastern gable wall adjoined a single-storey stable (Photo 4.4).

PHOTO 4.3 & 4.4 WESTERN AND EASTERN GABLE ENDS

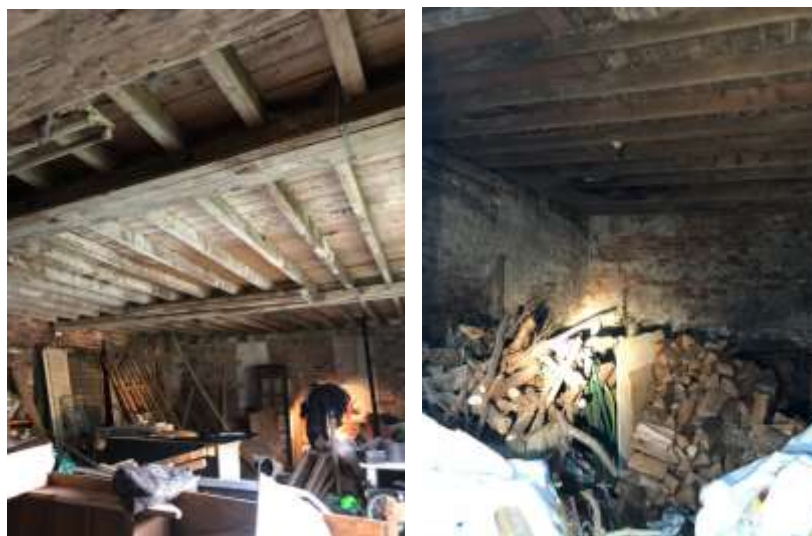
- 4.2.1 On the ground floor, there was a dividing wall, which created a large main barn section and a smaller room on the western side of the building (Photo 4.5 & 4.6).
- 4.2.2 There were two floors within both sections of the barn, with one area full height to the roof, within the main barn section. This allowed open access from outside to all areas of the main barn section.
- 4.2.3 The roof was timber framed and lined with bitumen felt, which was in good condition throughout (Photo 4.7). The first floor was open to the roof with skylights on the southern side.

PHOTO 4.5 & 4.6 MAIN BARN SECTION AND SMALLER ROOM ON THE WESTERN SIDE OF THE BUILDING

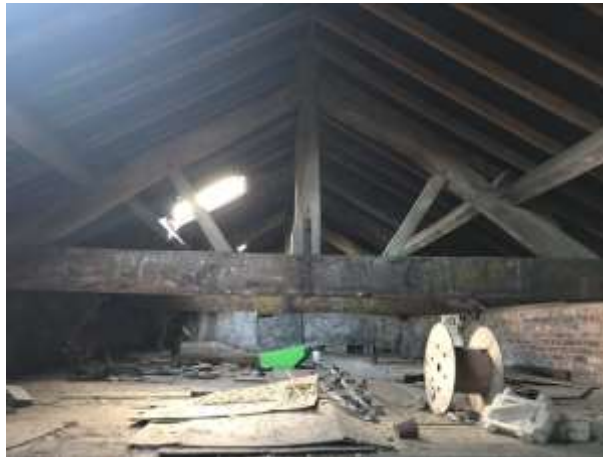
PHOTO 4.7. 2ND FLOOR

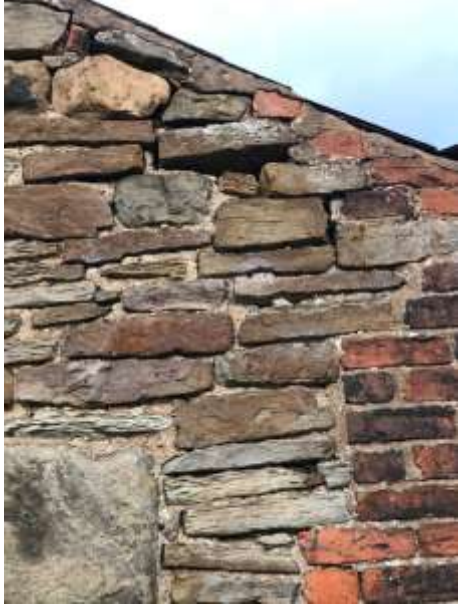
- 5.1.2 There were numerous crevices in the stone and brickwork, where mortar was missing, some of which may provide access into the barn. The roof was in need of repair, although the bitumen felt largely intact there were a number of slipped and missing slates and raised ridge tiles. There were some gaps underneath barge boards.

Description of Potential Roosting Features	Photo
Gaps in stonework

- Prior to the start of works, a toolbox talk will be given to everyone involved in the project and a log of this will be kept.
- Any works to the roof including the removal of slates, fascia's and soffits or repointing of the stone or brick walls will be supervised by a suitably qualified ecologist. At this time, a bat box will be available and if a bat is found during works, the box will be erected for the bat to be placed in. If carried out over winter and a hibernating bat is found, work must stop until the bats have dispersed naturally if possible. If this is not possible then the bat must be placed in a box suitable for hibernation erected on the property.

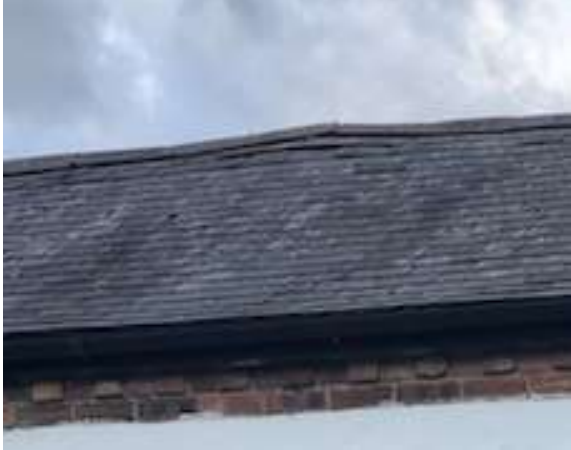
Raised ridge tiles

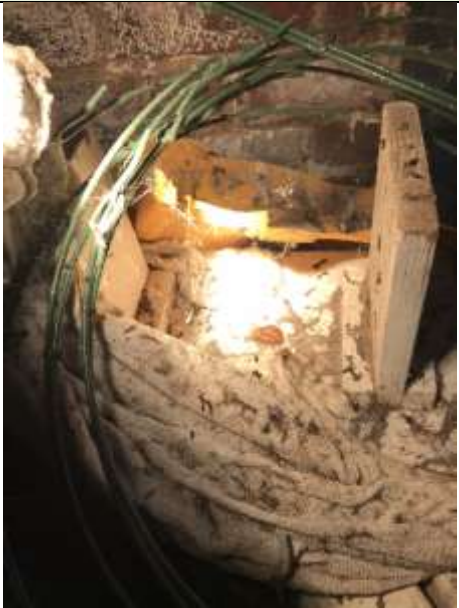
Evidence	Location	Photograph
Bat droppings, consistent with BLE	<ul style="list-style-type: none"> • Small number scattered on items on the ground floor. • A collection below the ridge board, at the eastern gable end. • Scattered droppings on first floor, concentrated underneath ridge board.

- 8.4.1 Droppings from BLE were found, predominately under the ridge board at the eastern gable end and on the first floor. Feeding remains, which are commonly associated with BLE, were seen throughout the building but again were mostly concentrated at the eastern gable end and on the first floor.

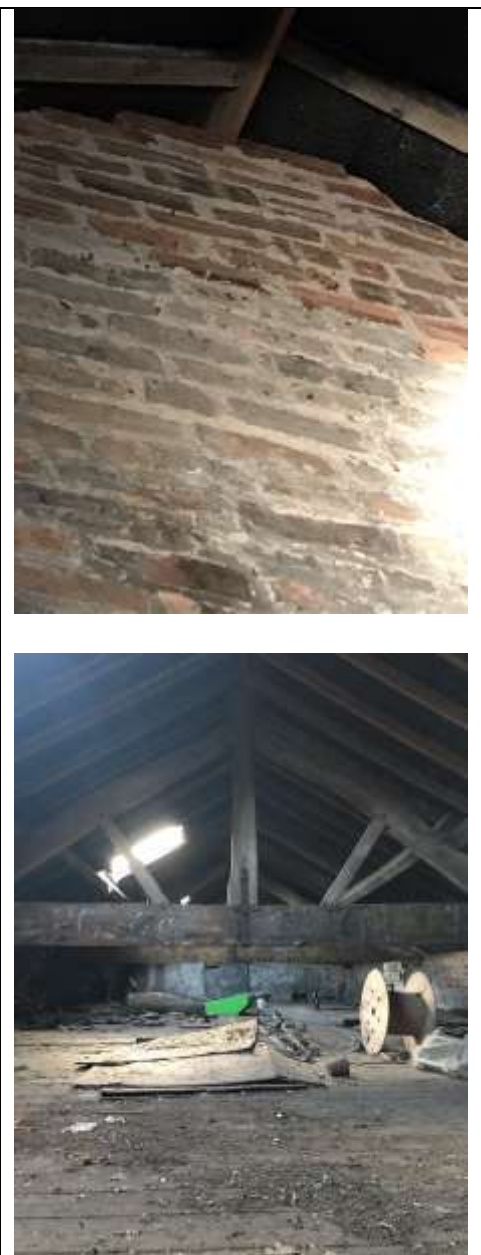
- 5.1.3 No bats were seen during the PRA, however evidence of bats was present. There were a large number of moth and butterfly wings stuck on the internal eastern gable wall and on a ledge underneath the apex, half way up this same wall. There were also further wings on the first floor. A small number of droppings, consistent with brown long-eared bats, were found scattered on the ground floor, underneath the apex at the eastern end and also on the first floor.

<p>Moth and butterfly wings (feeding remains)</p>	<ul style="list-style-type: none">• Many wings in cobwebs on eastern gable wall and on ledge underneath ridge board.• Wings on floor, underneath ridge board on first floor.

The table contains two photographs. The top photograph shows a close-up of a brick wall in a barn, with cobwebs and wings visible. The bottom photograph shows the interior of a barn, with a wooden spool and wings on the floor.
---	---	--

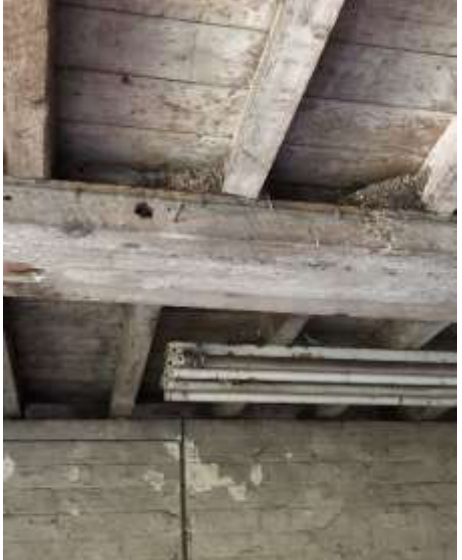
- 5.1.4 Table 5.1 below, provides examples of potential roosting features present and Table 5.2 shows the evidence of bats and birds found.
- 5.1.5 A number swallow nests were seen inside the building, above both the ground floor and first floor beams.

Ground and first floor	Small number of swallow nests

9.7.1 Evidence was found that birds nest within the building, specifically swallows. Where possible, work to these areas within the building should be avoided during the bird nesting season (April to September inclusive). If this is not possible, a bird nest check needs to be carried out by a qualified ecologist no less than 48 hours before works commence. If birds

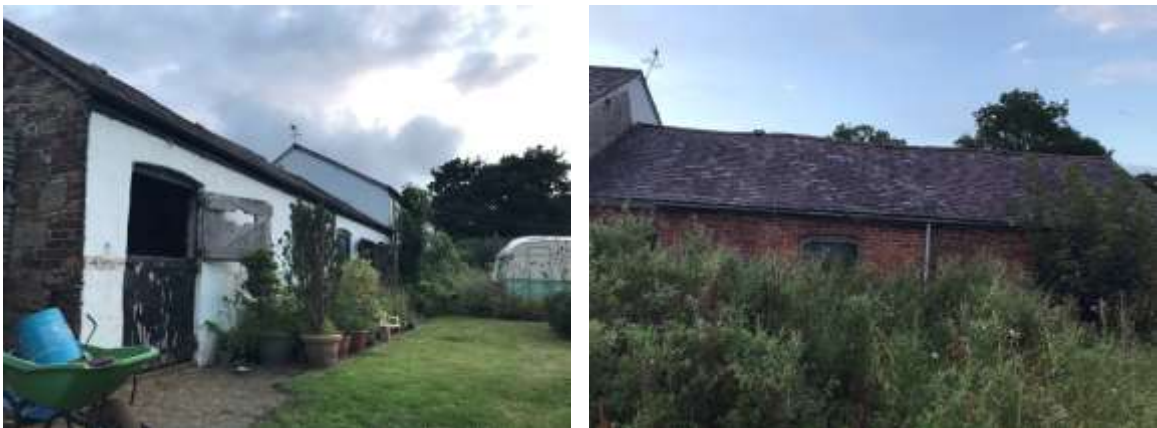
PHOTOS 9.1 & 9.2 ADJOINING STABLE FOR NEW ROOST CREATION

- 9.4.4 The specifications of the new roost within the adjoining stable are detailed below:
- The new roost will comprise a boarded area within the roof space, measuring at least 3m x 3m, with a floor to roof apex height of 2.8m (1.8m minimum, as not a maternity roost).
 - The roof will be of appropriate design to provide an as open and unimpeded loft void space as possible, to allow free movement and flight by bats inside the space.
 - Only timber treatments listed on Natural England Technical Information Note TIN092 will be used on the timbers.
 - The roof within the bat roost will be underlined with F1 bitumasticfelt only (no breathable membrane can be used).

- Two bat access points will be created, at the eaves, provided by 100mm x 20mm slots cut through the eaves boards. Alternative methods of creating these access points at the eaves are shown in Appendix A. Internally, baffles will be created to prevent light and draughts into the main roosting area.

- Further access points will be provided by two bat vent/access slates.
- The roost will include two Kent style wooden bat ladders, to be situated on the ridge beam/purlins/rafters.

- A double ridge board will be created, both consisting of rough-sawn and untreated timber, set 20mm, which will offer bats enhanced roosting opportunities.

- Two panel boxes will be created and mounted on two sides of the roost, providing additional roosting space. These will comprise a piece of plywood board fitted to 1 inch x 1 inch timbers with a gap on the underside only so bats can access the space from underneath.
