**FIRST CHOICE HOUSING ASSOCIATION**

**NR 2 NANT LAIS, MINERA, WREXHAM, LL11 3YY**

**STAGE 1 - PHASE 1 – DESK STUDY AND PRELIMINARY GROUND  
CONTAMINATION RISK ASSESSMENT**

**REPORT No. E1330.S1.P1.R1**

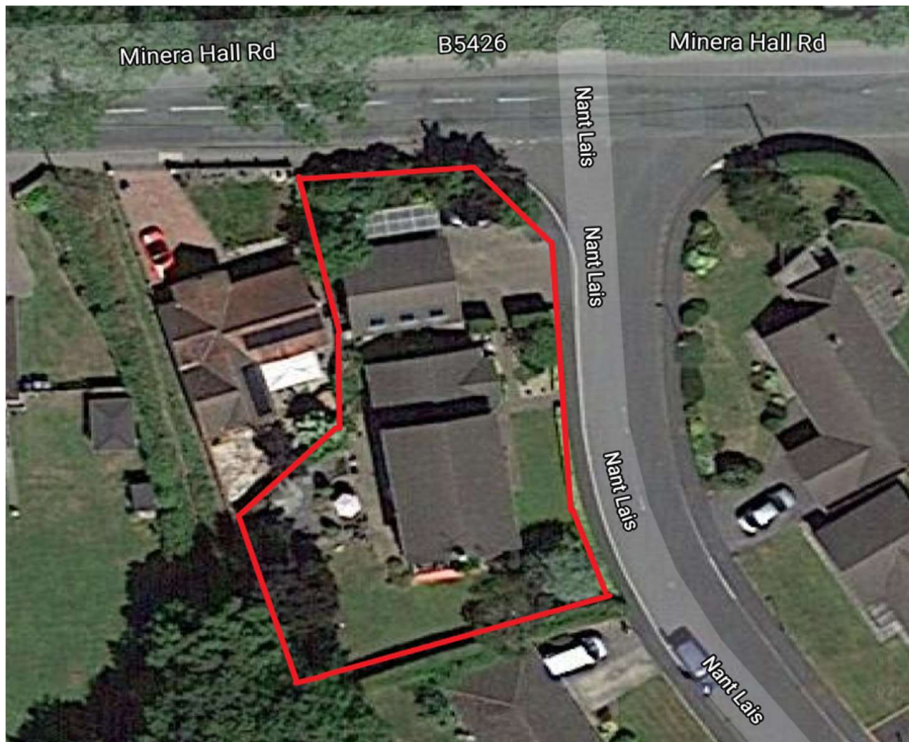
Figure 2 – Aerial Photograph and Site Context

- 2.2.1 The site area is at the junction of the Nant Lais housing estate road and the B5426. The site comprises a relatively new two storey brick built residential property with adjacent double garage surrounded by small grassed lawns and paved patio and parking areas. An aerial photograph of the site is presented as Figure 2.
- 2.2.1 The site is flat and level and at a similar elevation as the surrounding land.

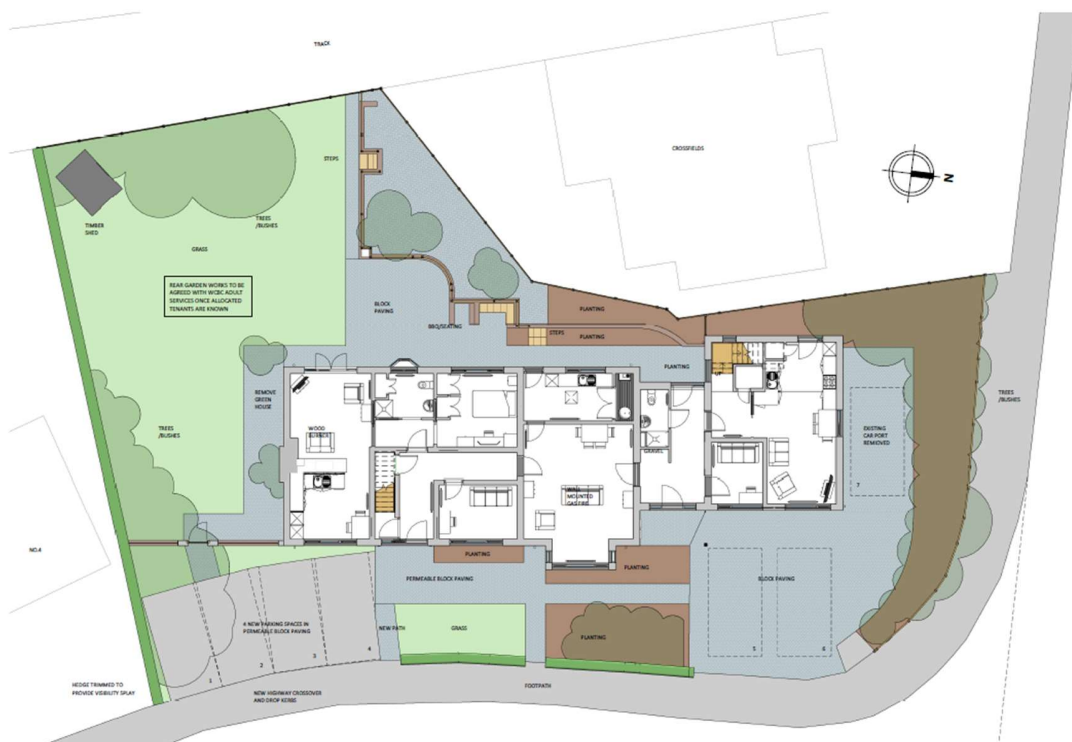
Figure 3 – Proposed Layout

- 5.1.2 The proposed site development involves the conversion of the existing dwelling and double garage into one and two person flats. The existing structures will remain in their present form and the only addition will be a constructed link between the garage and existing dwelling containing a bathroom. There are no changes to the external areas other than provision of additional parking areas to the front of the property. A proposed site payout is shown as Figure 3.
