## Preliminary Bat Roost Assessment (PRA) Report

**Project:** Bowling Bank Farm, Worthenbury, LL13 0AW

**Date:** June 2018

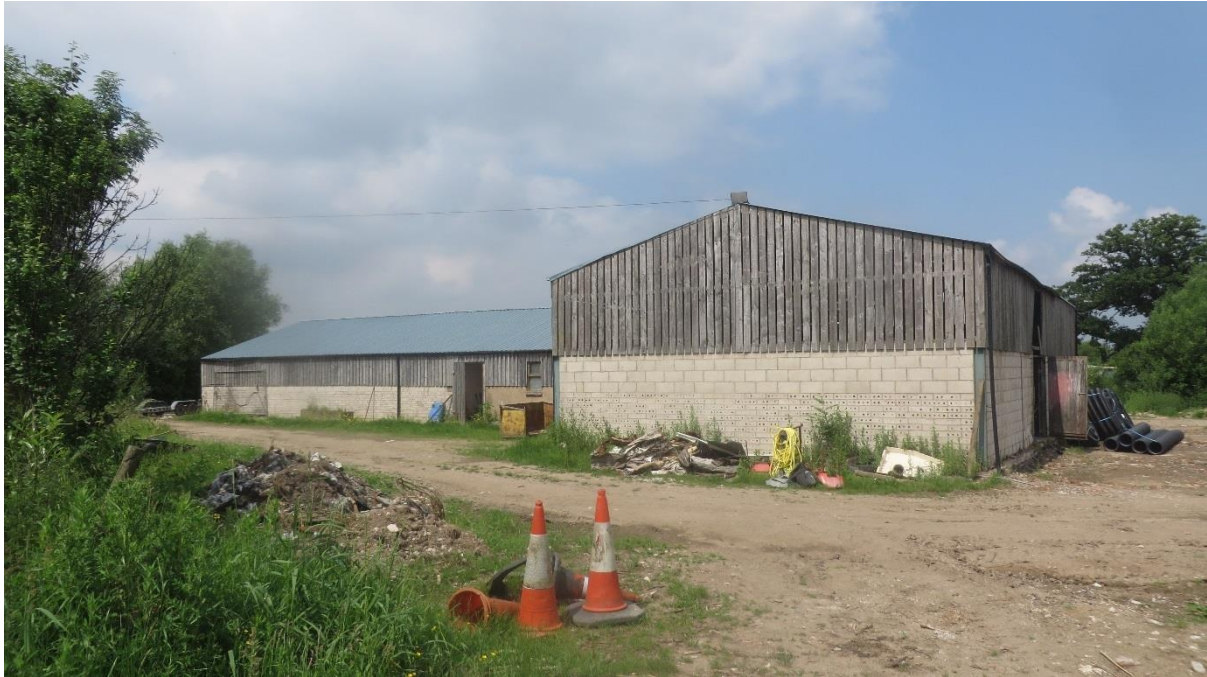
- The site consists of one (1) built structure, summarised below (**Figure 3.2**):
  - **B1** – adjoining barn and stables (**Image 3.3**).

**Image 3.3** South-eastern aspect of **B1**

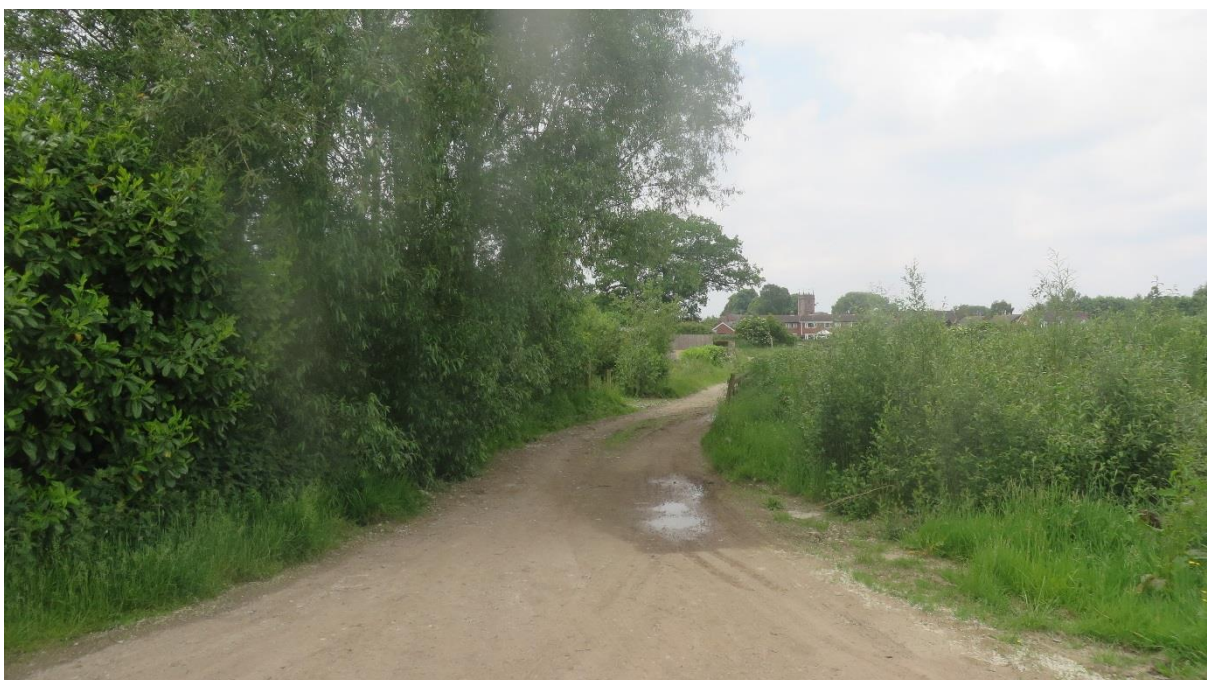
- **B1** is set upon concrete hardstanding, with a compacted earth track surrounding the building (**Image 3.4**).

**Image 3.4** Hard earth track leading on site and surrounding **B1**

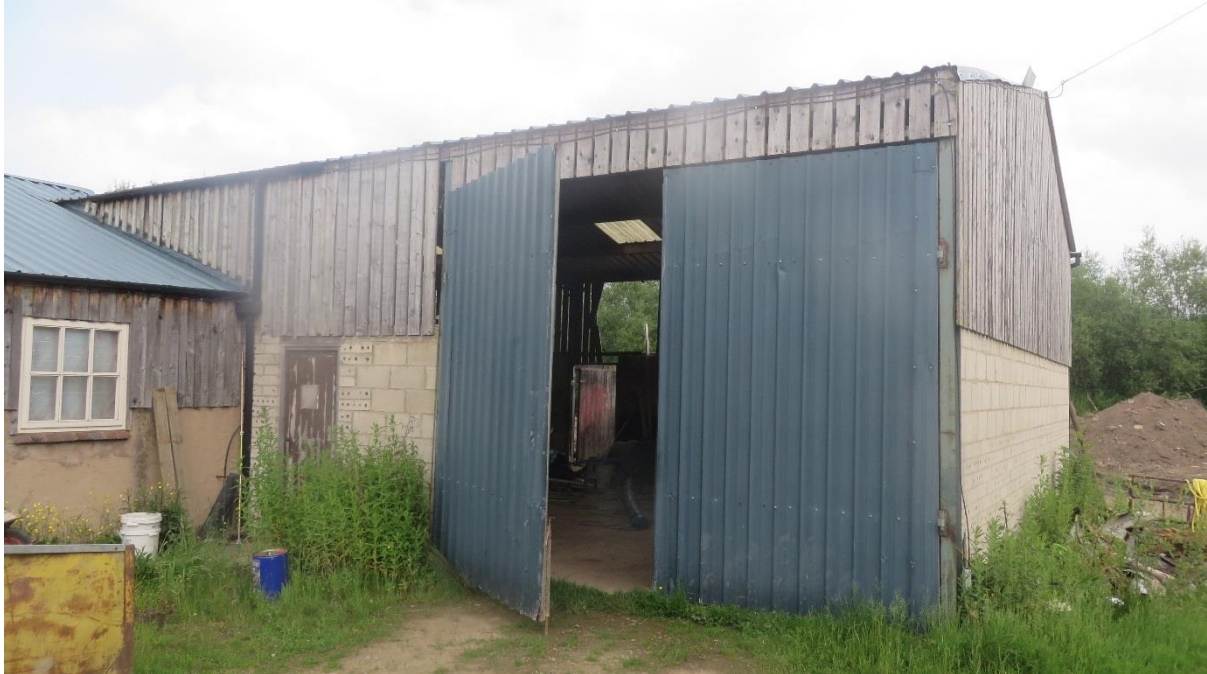
- **B1** (SJ 42289 46033; **Image 3.3**) is a single-storey L-shaped barn constructed with a breezeblock base, timber cladding and corrugated metal roofing (**Image 3.5**). The western portion of **B1** constitutes stables (**Image 3.6**), the central and eastern portions consist of storage.
- Externally and internally, **B1** is in good condition. Potential bat ingress/ egress opportunity is present around the entirety of the building between the timber cladding (**Image 3.7**).
- The stables contain little light infiltration and the roof contains a single skin of corrugated metal (**Image 3.8**).
- The adjoining storage barn towards the central and eastern portions of the building contain a single-skin roof of corrugated metal with steel roof supports (**Image 3.9**). Much light infiltration was noted in the eastern portion of the building, deeming it unsuitable for roosting bats.

**Image 3.5** The eastern portion of **B1** with timber cladding, corrugated metal roof and breezeblock base

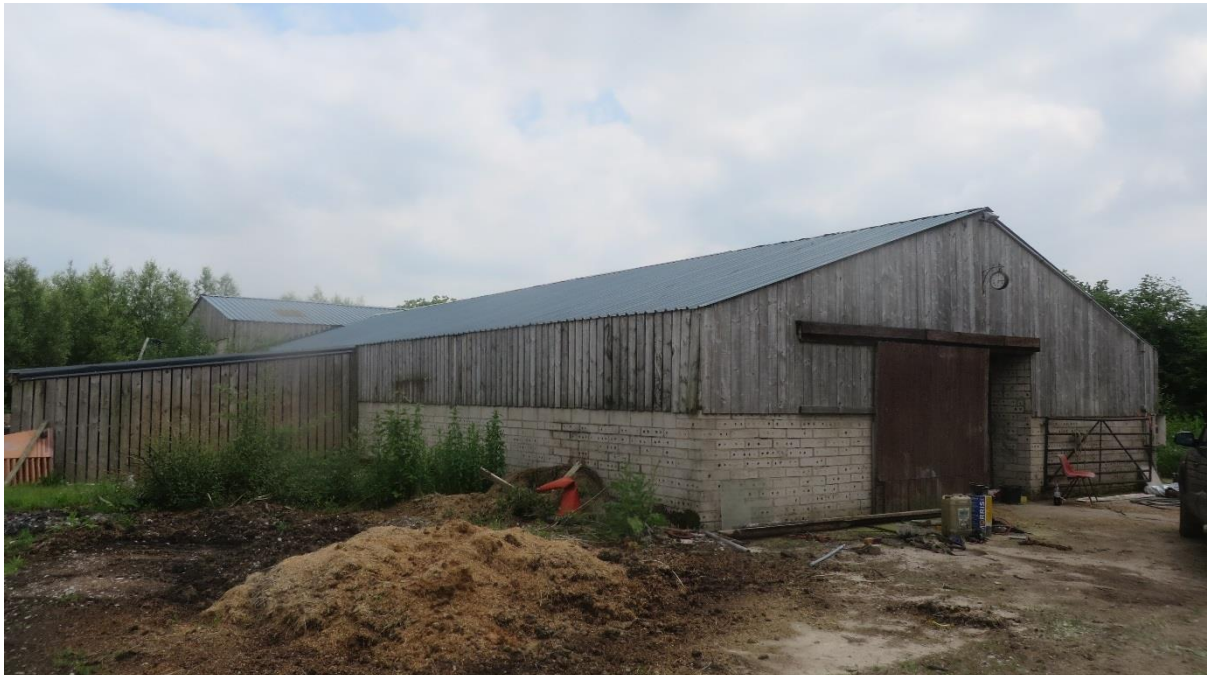
**Image 3.6** The western portion of **B1** constituting as stables

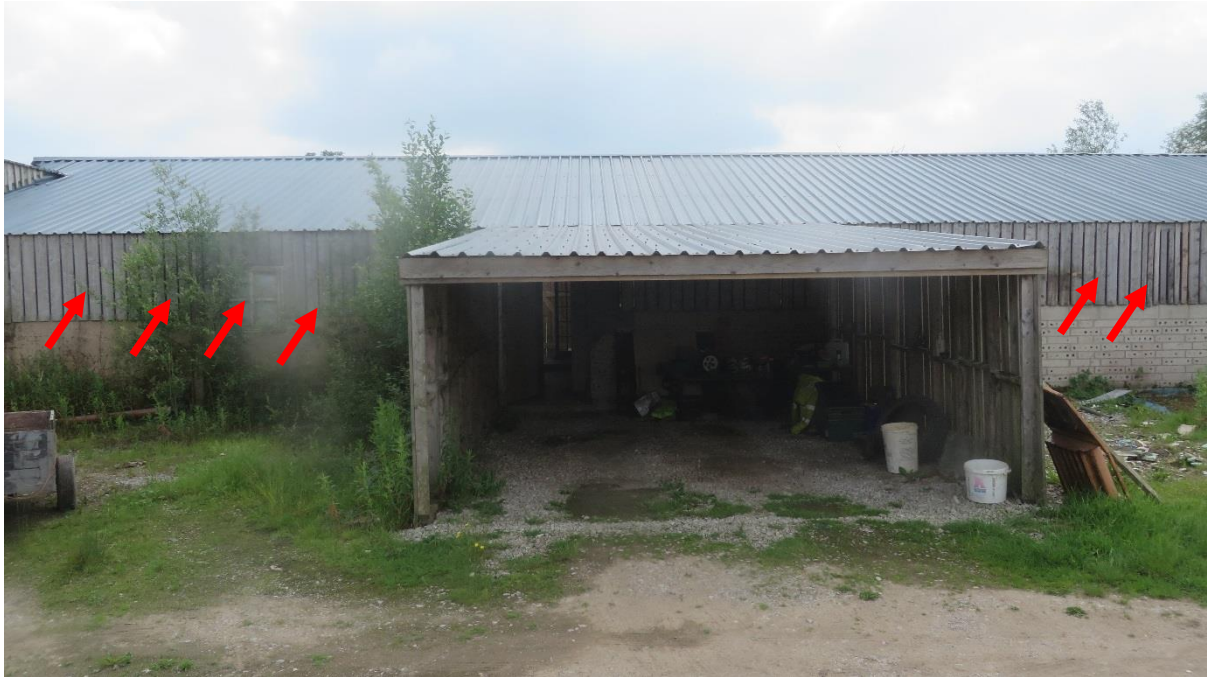
- Owing to the absence of evidence indicative of the use of **B1** by bats, and given the absence of several potential roosting features, this building is considered to offer 'negligible' bat roosting potential.

**Image 3.7** Potential bat ingress/ egress opportunity between cladding around building

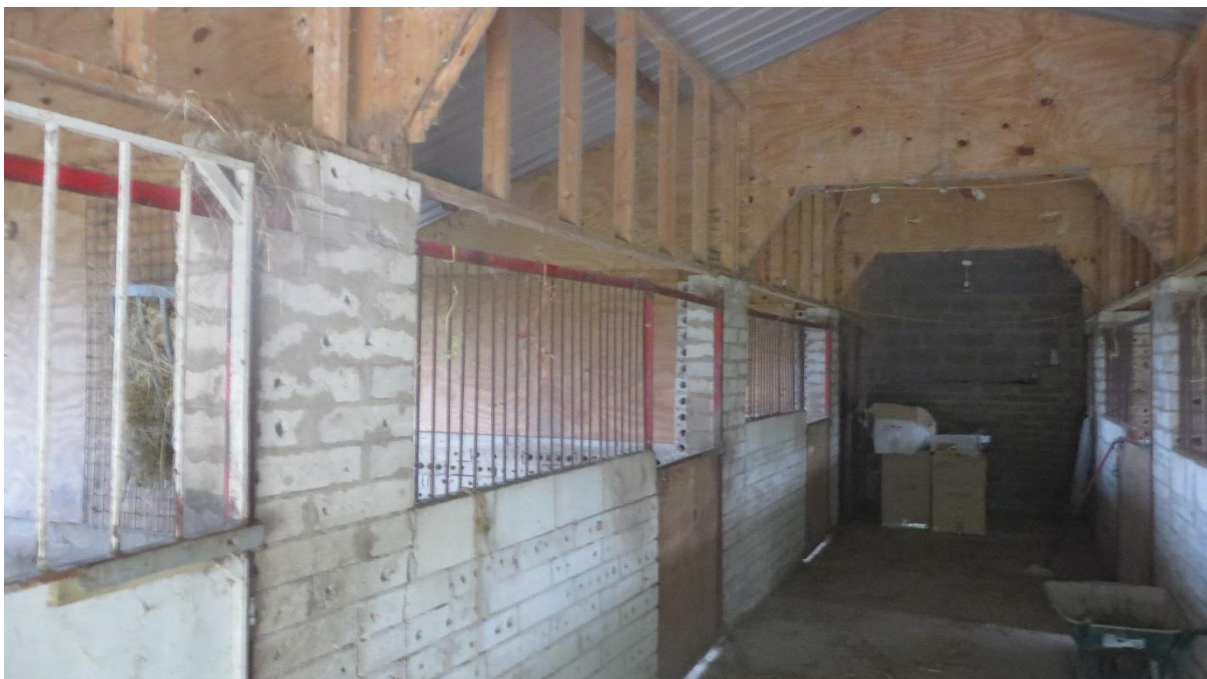
**Image 3.8** The stables containing little light infiltration

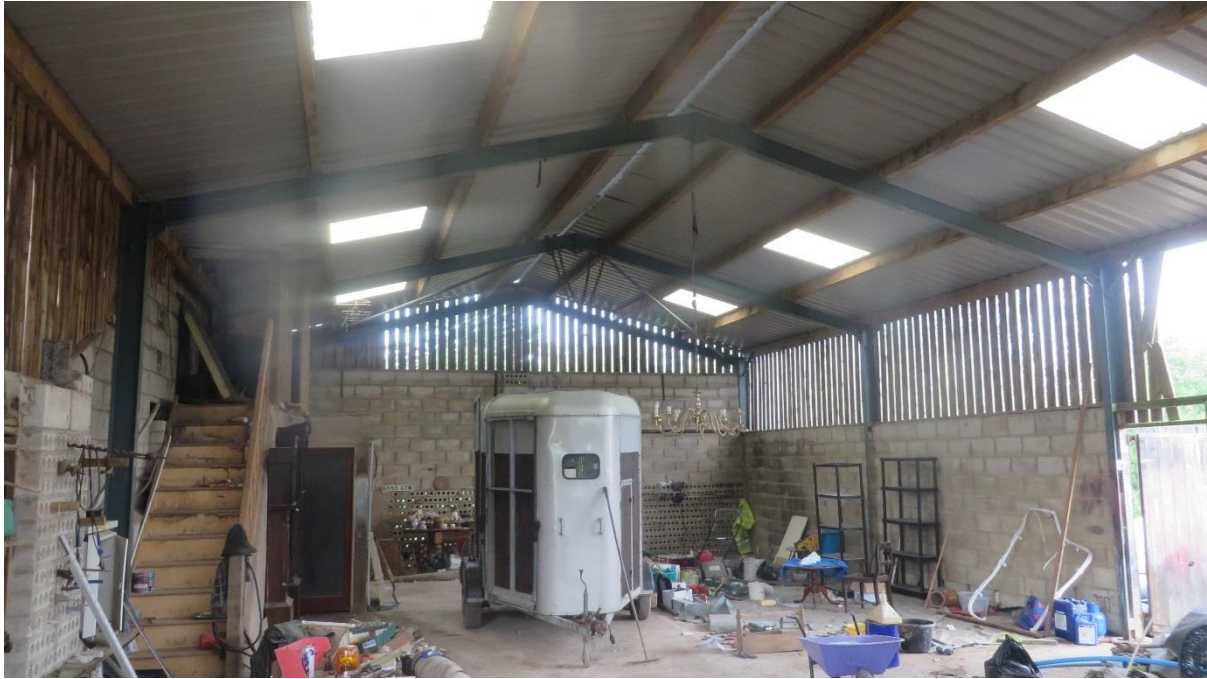
**Image 3.9** Eastern portion of **B1** with steel roof supports and light infiltration, unsuitable for bats

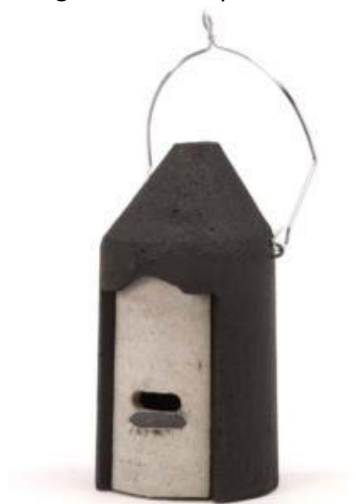
**Image 3.10** Example of Schwegler 2F bat box

- No further survey with regards to **B1** is considered necessary.
- To enhance the ecological value of the site it is recommended that a minimum of one (1) Schwegler 2F bat box (**Image 3.10**) is incorporated on site.
- Bat boxes should be installed onto an existing building or mature tree at a height no less than 4m and preferably orientated in a south or southwestern aspect.

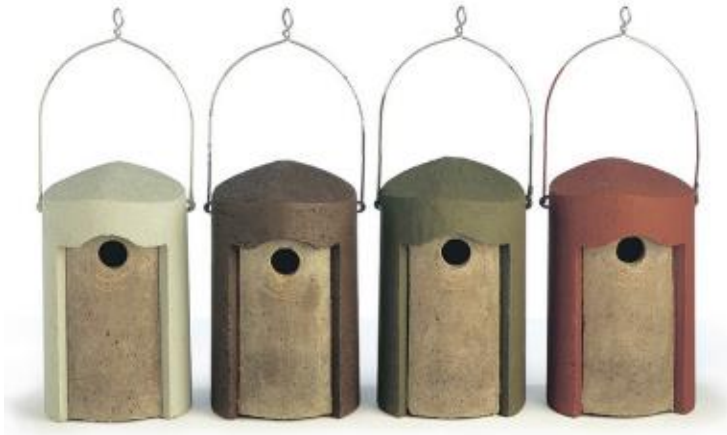
**Image 3.11** An example of Schwegler 1B Woodcrete boxes

- A minimum of one (1) Schwegler Woodcrete (1B) box, or equivalent, is recommended as an enhancement for common passerine bird species on the site (**Image 3.11**). This is to be installed onto any suitably mature tree or fencing on or near to the application site, at a height of no less than 2m and orientated in a southerly or westerly direction. Nest boxes are to be maintained for the lifetime of the development.
