## Archaeological Watching Brief

Groundworks being undertaken at 'Holt Hill', Green Street, Holt, Wrexham. LL13 9JF

| Site Code | HH20 |

## Application No: P/2020/0065

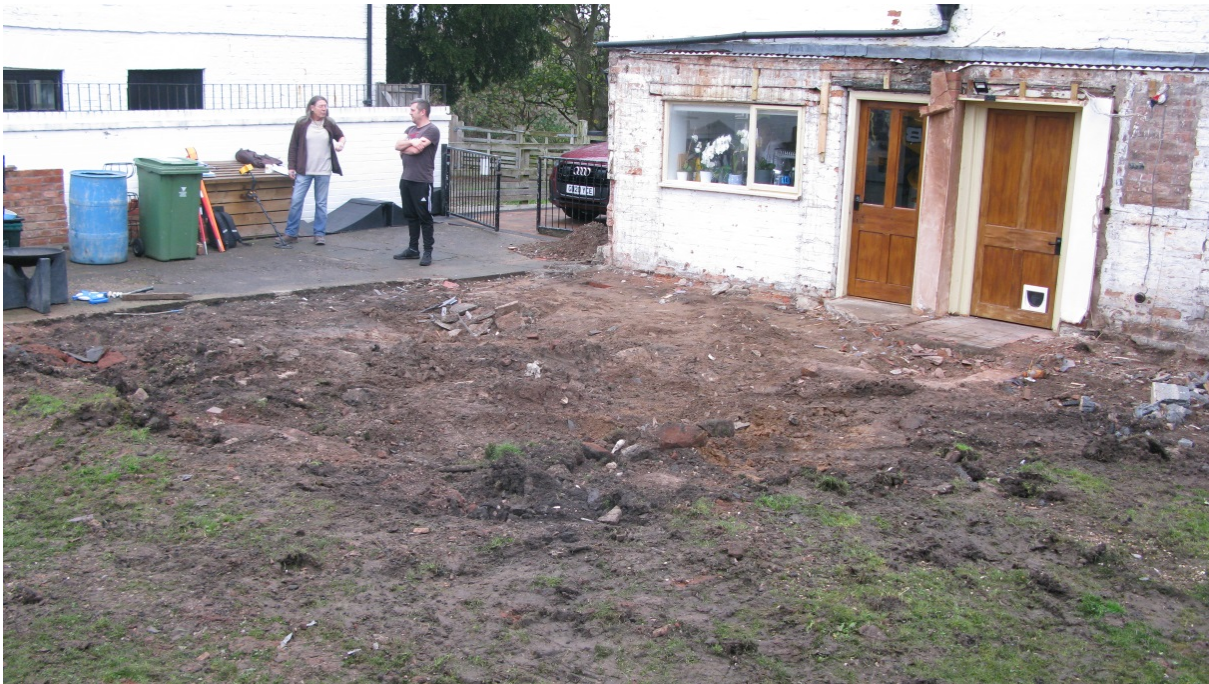
The site prior to excavation from the south-west. *Alan Wilmshurst*

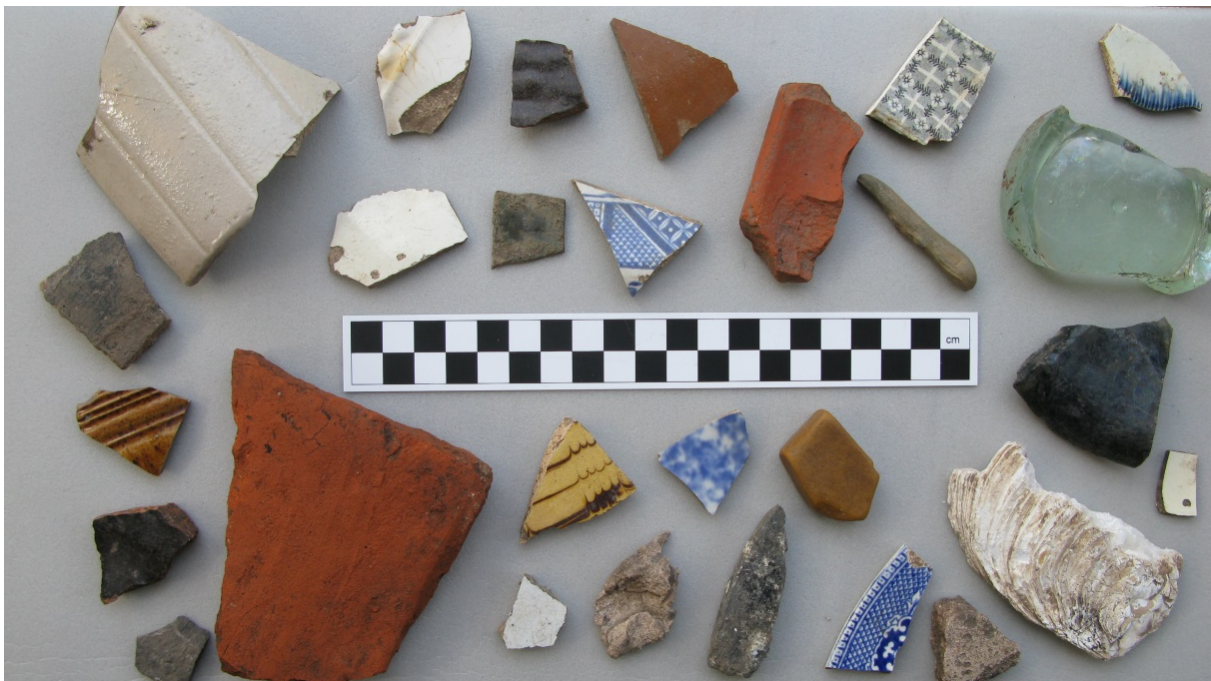
A selection of the finds. *Alan Wilmshurst*

Finds present were primarily of brick/tile fragments.

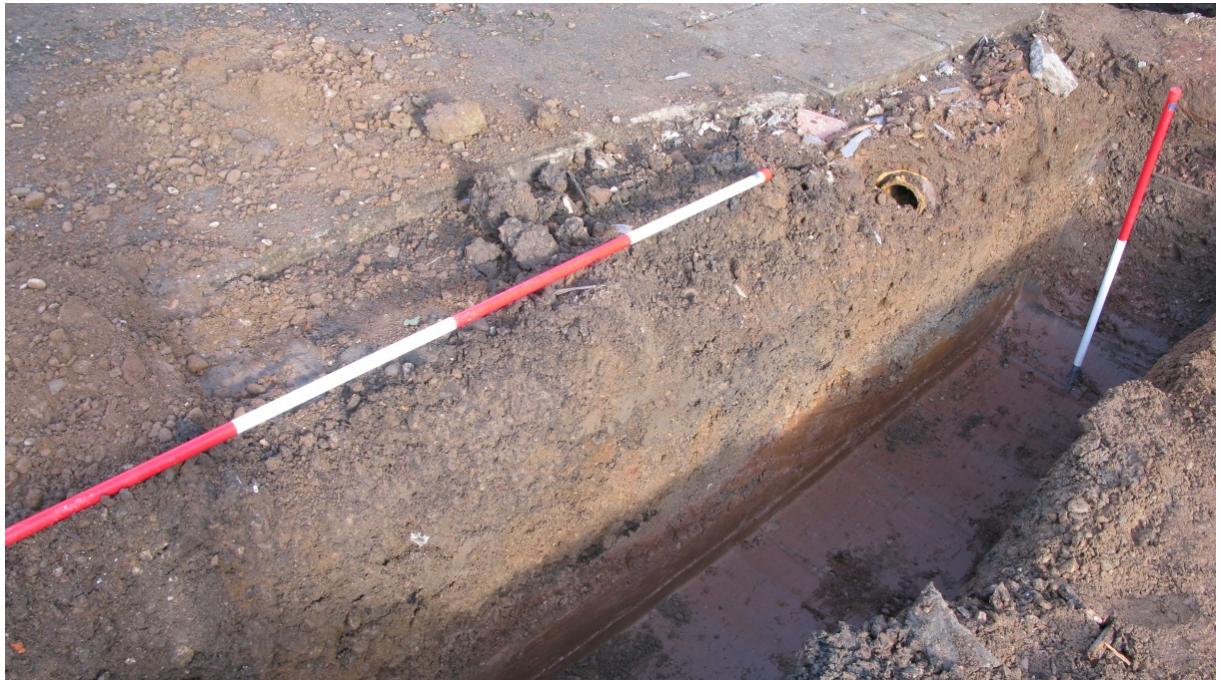
Below this was a sand and fine pebble layer that measured 0.17m in depth. This would appear to relate to the early 18<sup>th</sup> century redevelopment of the house.

The 'natural' dense boulder-clay (OD 15.70m) underlay the above, at which point the agreed foundation level was attained, 0.20m into the clay. The maximum depth of all trenches did not exceed the OD 15.50 level.

Trench 1 from the south-west. Alan Wilmshurst

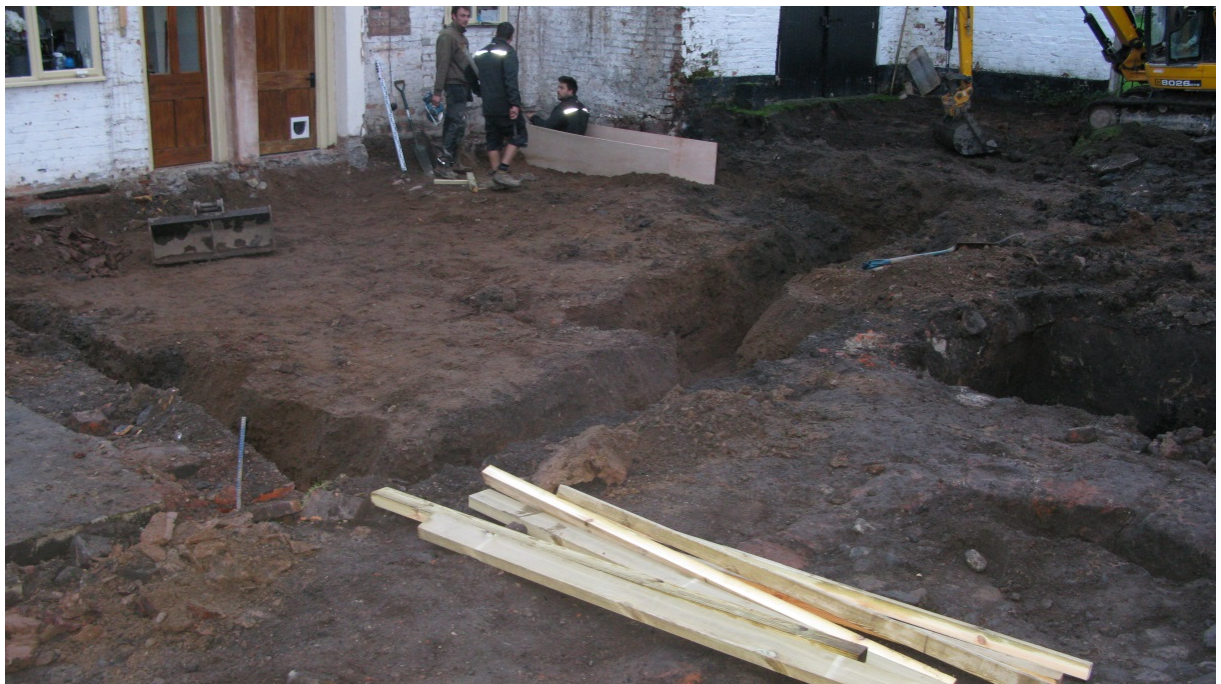
No archaeological features were present in Trenches 1–5, nor any finds recorded, apart from those dating to the 18<sup>th</sup>–20<sup>th</sup> century. These were all recovered from ‘made-up ground’ that reached an average depth of 0.63m from the present day ground level (OD 16.5m).

Trenches 1–5 from the north-west. Alan Wilmshurst

Each trench was badly disturbed by late 19<sup>th</sup>/20<sup>th</sup> century activity to an average depth of 0.60-65m. These disturbances overlay a fine layer of sand/gravel, which in turn overlay the natural boulder clay. No finds were recorded.

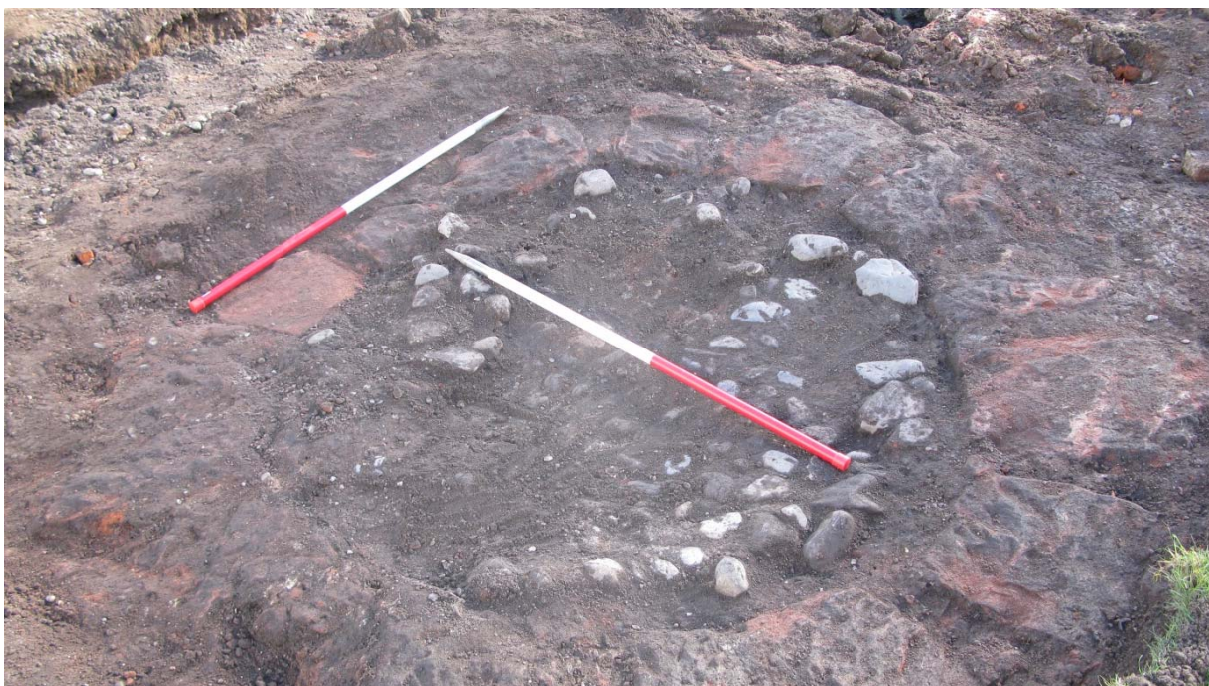
## Well Feature

The well feature. Alan Wilmshurst

Immediately to the west of trenches 1–5 an area was cleared to a depth of 0.60m, at which point a circular/oval well was revealed (OD 15.90m), consisting of fine-hewn sandstone blocks; this would have originally stood proud of the existing ground-surface. At the behest of the client, the well has been retained, and no further excavation was undertaken.

The extant, surviving, sandstone block course-structure was circular to oval in form. On its N-S axis it measured 2.70m (outer edge); its E-W alignment registered 2.20m. The visible top course bore traces of white/grey mortar. Its inner 'diameter/oval' measured 1.50m x 1.60.

The major sandstone block components measured 0.62m x 0.40 x 0.20. The smaller blocks averaged 0.42m x 0.30 x 0.20.

It is probable that this feature relates to one of the earliest phases of the 17<sup>th</sup>/18<sup>th</sup> century structure, though no artefacts were present, at this level, to positively identify its date of origin.

This feature was located 8.62m west of Holt Hill.

The only features present were a finely preserved well (which is to be retained in its entirety) and a 20<sup>th</sup> century septic/slurry tank.

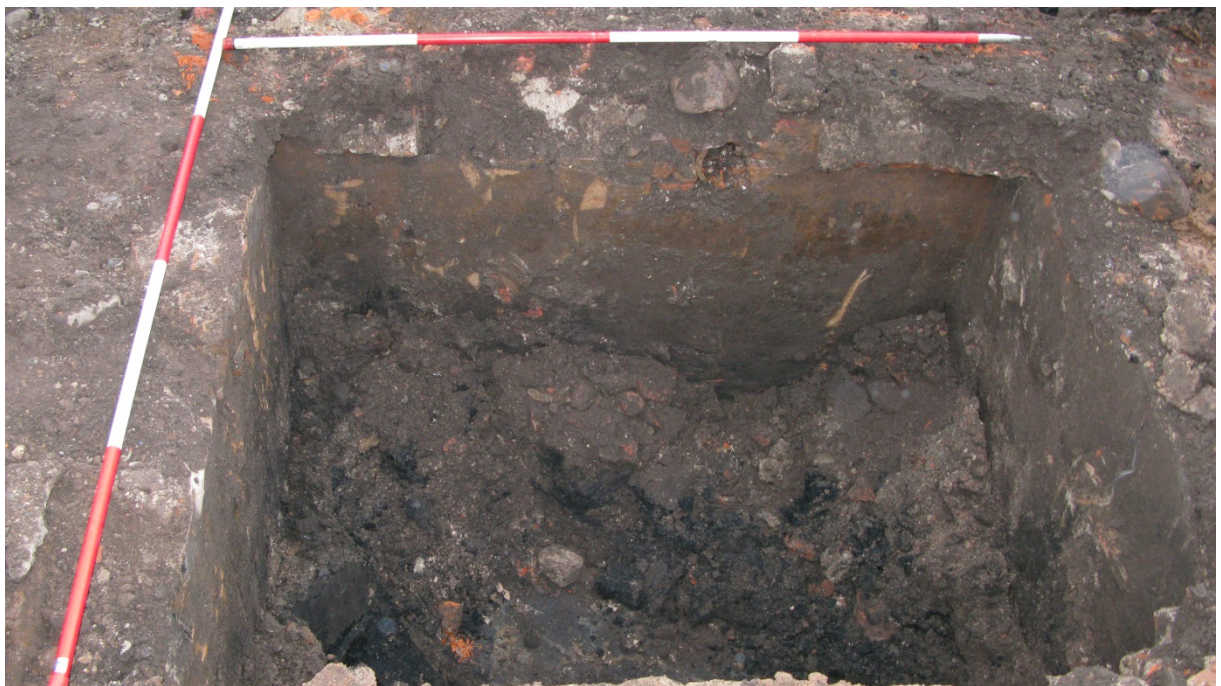
### **Septic Tank/Slurry-Pit**

Septic-tank/slurry-pit. Alan Wilmshurst

A large rectangular feature was located 8.48m west of the house, and 1.30m to the south of the well, 0.60m below ground level. Its dimensions measured 2m x 1.80 x 1.50. Its concrete structure was pierced on its northern side by a ceramic drain. The whole structure was covered by a concrete plinth.

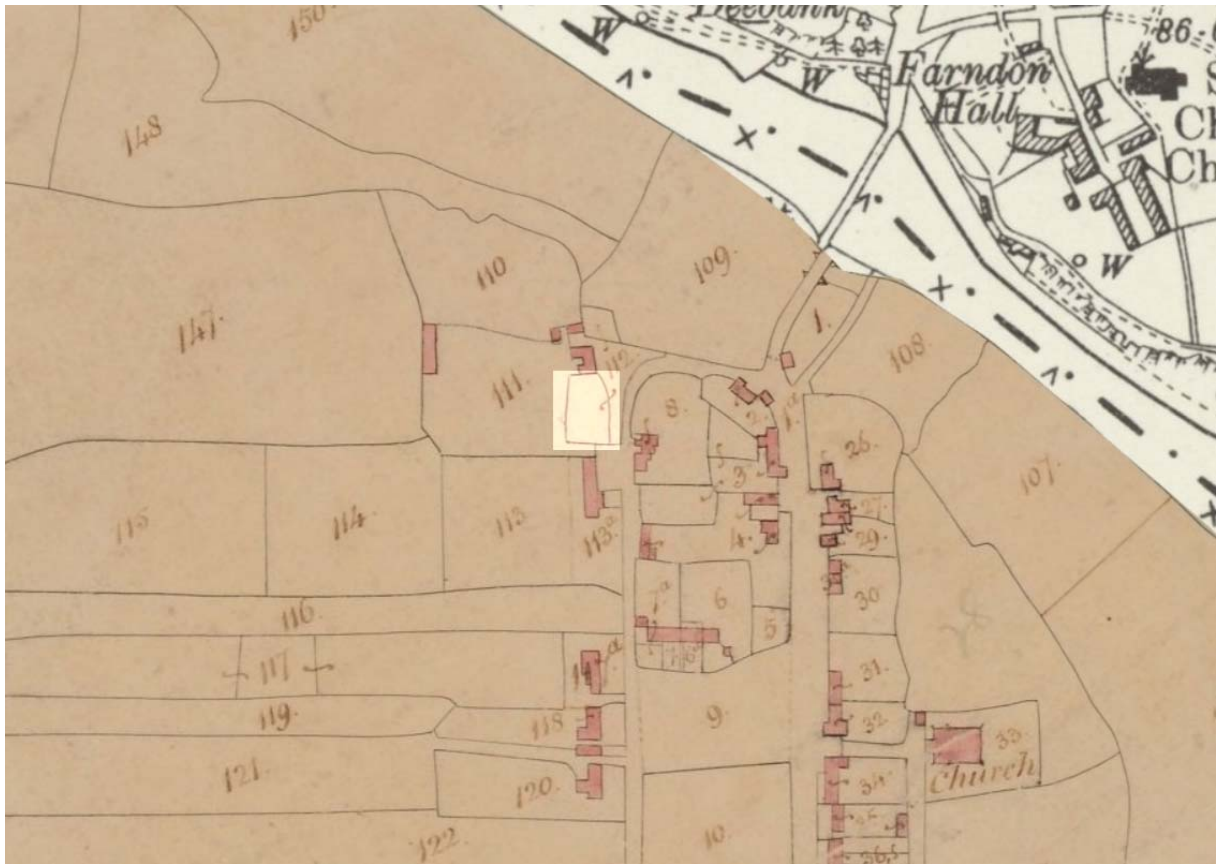
Section from the 1843 Tithe Map with the survey area highlighted. The National Library of Wales

The client is extremely keen for a resistivity survey of the rectangular field adjoining the main house, immediately to the south (appears on Tithe-Map of 1843), which has retained its configuration to the present day. The rectangular field warrants further investigation not only because it might shed further light on the history of the Holt Hill property itself, but also due to its close proximity to a known Roman tile works and a Roman road. Holt Hill was for many years owned by the Crew(e) family, wealthy landowners and members of the gentry, before passing on to the Jones family of Pentref in the 1740s. The property was also connected with the prominent aristocratic Leche family via the 1789 marriage of John Leche of Stratton Esq. and Margaret Jones. The Leche family were Lords of the Manor of Nether Carden from the early fifteenth century to the early twentieth century. The census returns for 1871 until 1901 record the Beard family farming at Holt Hill. Shortly afterwards, the Thomas family of Holt became the owners of Holt Hill. Chapel Archaeology has agreed to undertake the non-invasive survey, at no cost and purely for research purposes. If there are no objections to this proposal the survey will be undertaken in the near future. The results of the survey will be forwarded to the client, LPA and other relevant bodies.
