**PHASE 2 BAT ACTIVITY SURVEY**

**PIGEON HOUSE, PIGEON LANE**

**Project name:** Pigeon House, Pigeon Lane, Hanmer, Whitchurch, SY13 3DS

**Date:** 28/10/2020

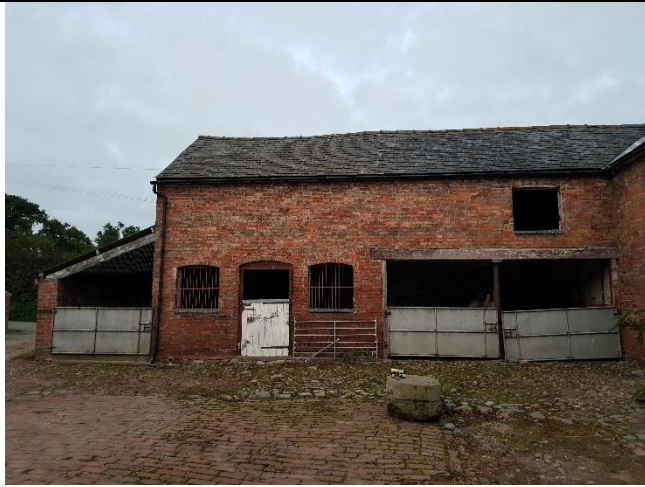
West wing of the barn to be converted

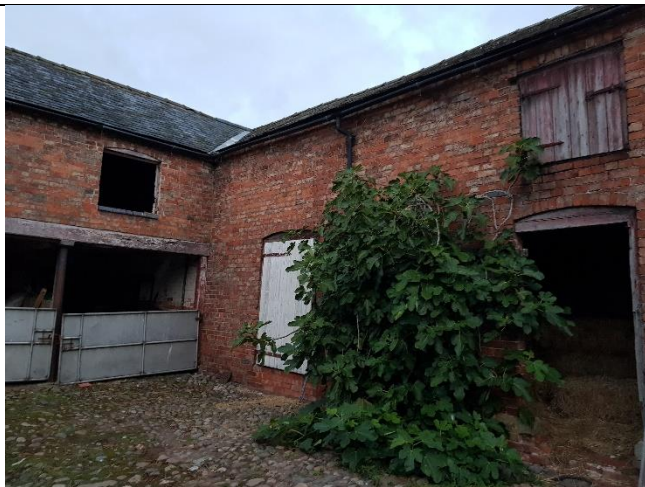
Part of the hay loft at the west end of the north wing of the barn will be included within the conversion

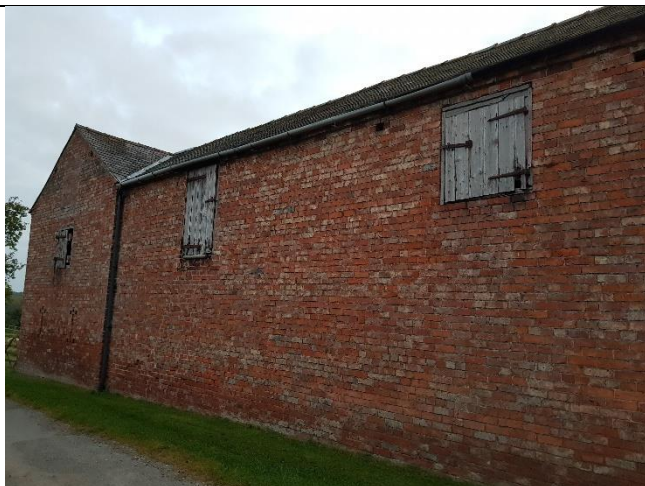
North facing elevation of the barn

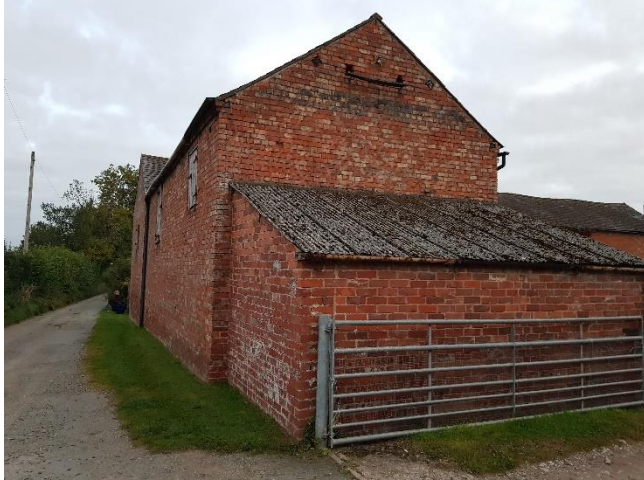
South facing gable of west wing

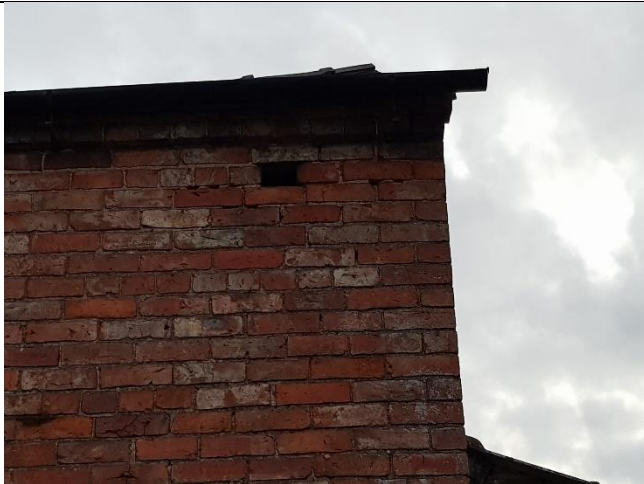
Other internal roosting features exist such as gaps between the lintels and the brickwork above, joins between large roof timbers and gaps between brickwork where mortar has crumbled away. There are also aeration gaps in the brickwork which could be used as entrance points into the building and a gap between the top of the wall plate and the roof structure also provides ample access opportunities.

Aeration brick in use as an entry point into the loft

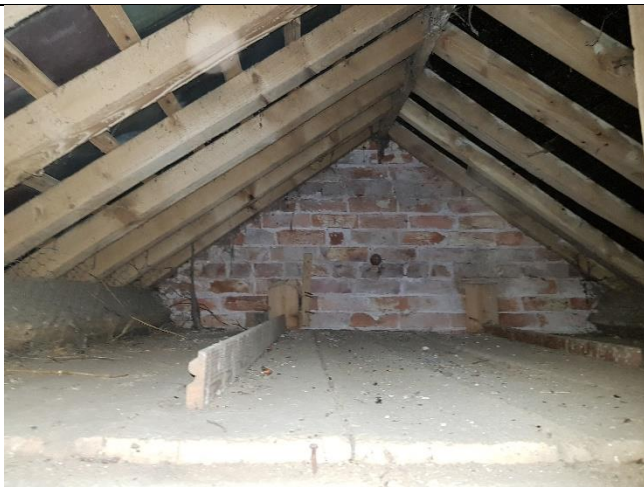
Feeding signs and bat droppings were found within the loft above the west wing of the barn along with a large number of potential roosting features. The section of barn to be converted has 'high' potential as a bat roost and therefore three bat activity surveys were carried out.

Internal loft space above west wing

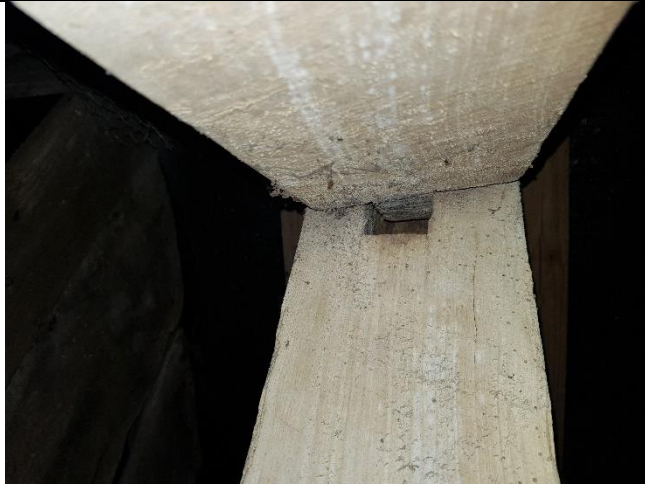
The DNA analysis of droppings from within the west wing loft space confirmed that *Myotis brandtii* were roosting within a small hole in the timber structure of the roof. Other dropping samples were not sent for analysis as the echolocation analysis could be used to determine the species emerging from the buildings reasonably confidently.

Potential roost site in timber joint with droppings beneath. Brandt's bat confirmed roosting within.

- A purpose built bat loft will be constructed within the north wing of the barn in order to provide roosting features being lost by the conversion. The bat loft will contain several features to make it suitable for use by a range of bat species, specifically those found within the barn. This will include: an enclosed loft space with a minimum height of 2.5m, crevice roosting features either internally or externally e.g. beneath ridge tiles and suitable access points into the bat loft. The final design of the bat loft will be agreed with Natural Resources Wales.

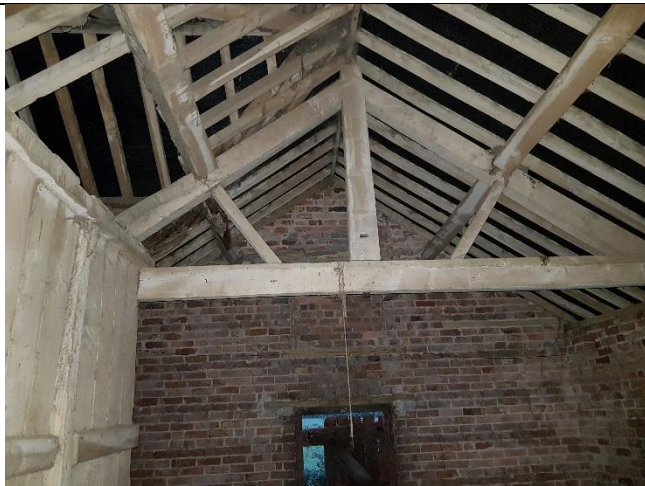
A maximum of two Brandt's bats are using the hay loft of the north wing as a day and night time roost.

Hay loft at the west end of the north wing
