# Phase 2 land quality assessment: Adwy Grange, Tanllan Lane, Coedpoeth, Wrexham

**Report reference:** 4127R1

**Date of reporting:** 08 January 2020

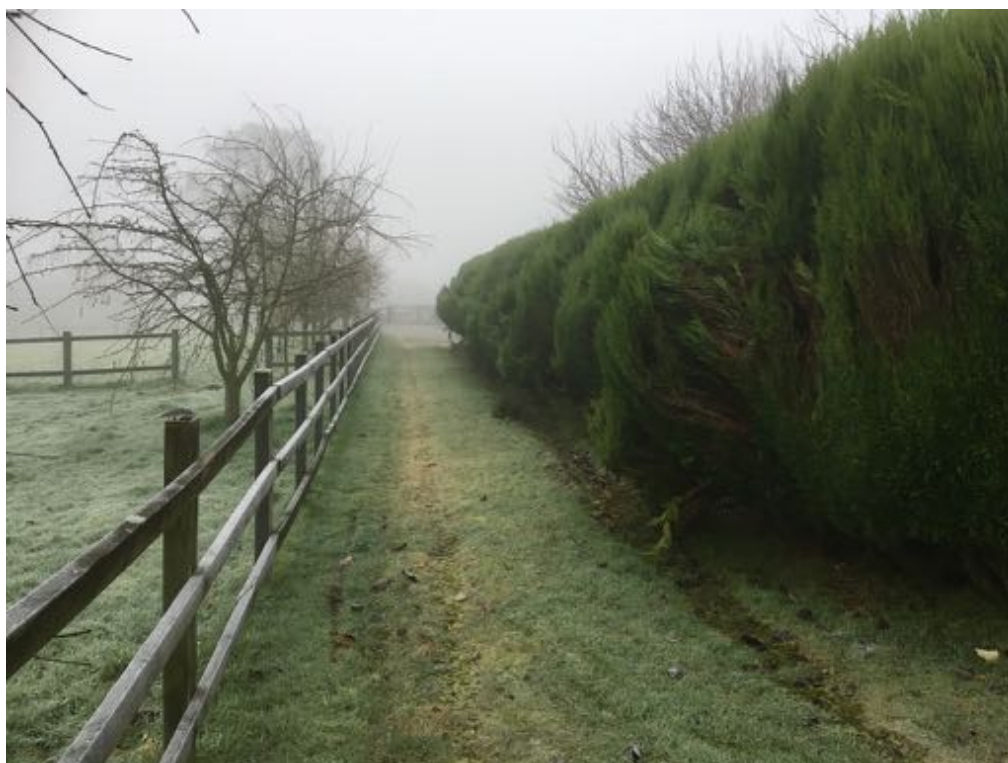
**Photograph 2**

- The Site was well maintained and orderly.
- The ground surface across the orchard area was relatively flat and level; no signs of differential settlement were observed.
- The Site driveway was observed to comprise compacted gravel with a grass covering (see Photograph 2 in Appendix C).
- No signs of any vegetation stress were observed (although given the timing of the Site investigation any such signs are unlikely to have been readily detected).
- There was no evidence of any past or present bulk fuel or chemical storage at the Site.

**Description:** Site driveway

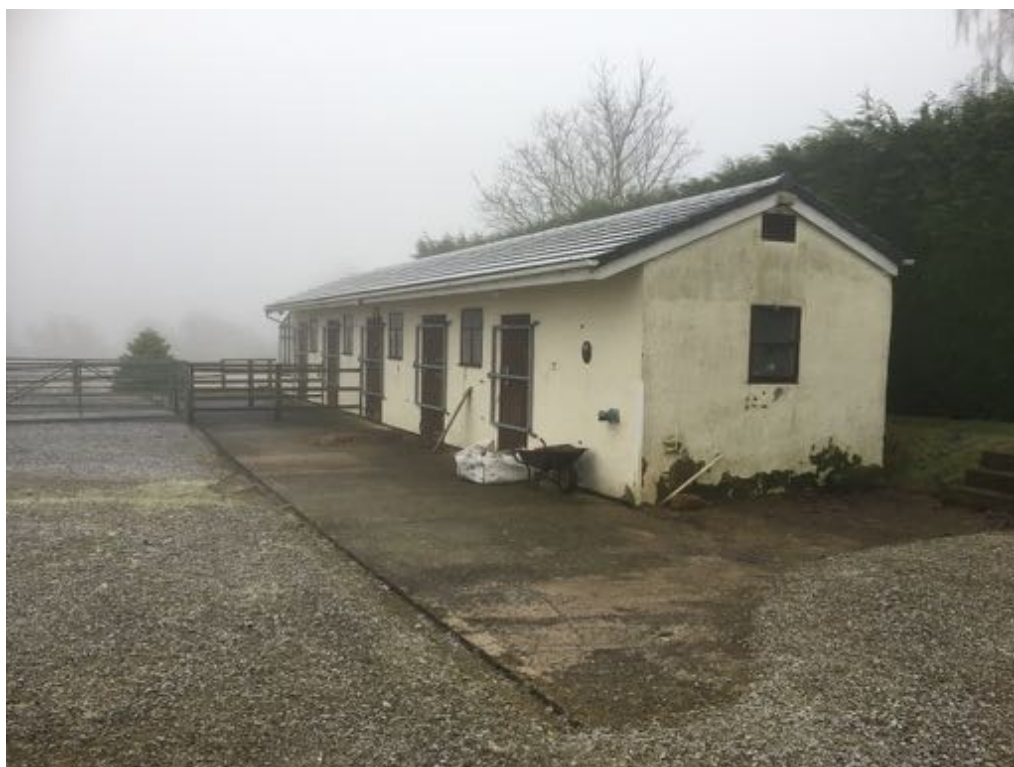
**Photograph 3**

**Description:** Former stable block and associated hard standing

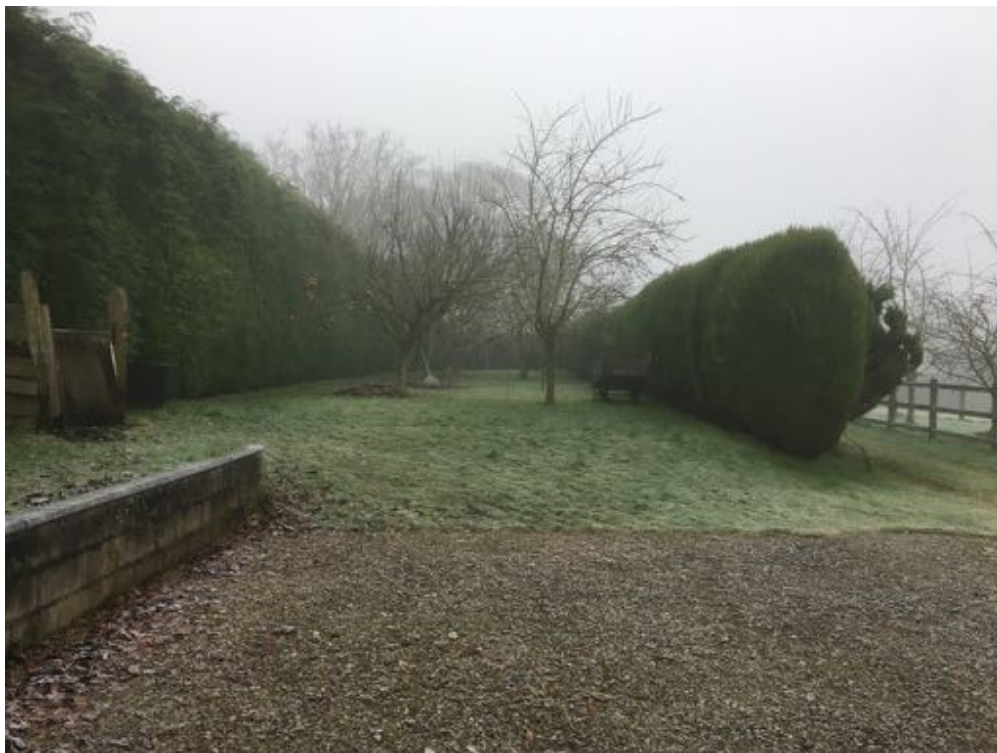
**Photograph 6**

**Description:** Orchard area

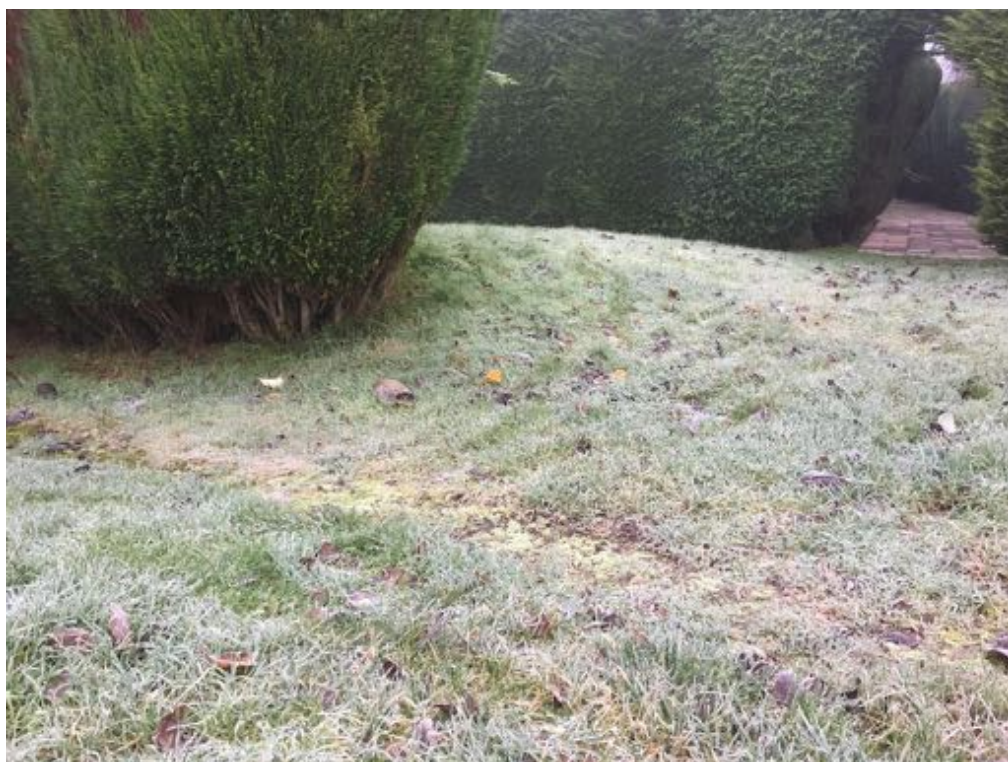
**Photograph 10**

**Description:** Topographic change between driveway and orchard area

**Location:** Northern part of the Site – looking to the west

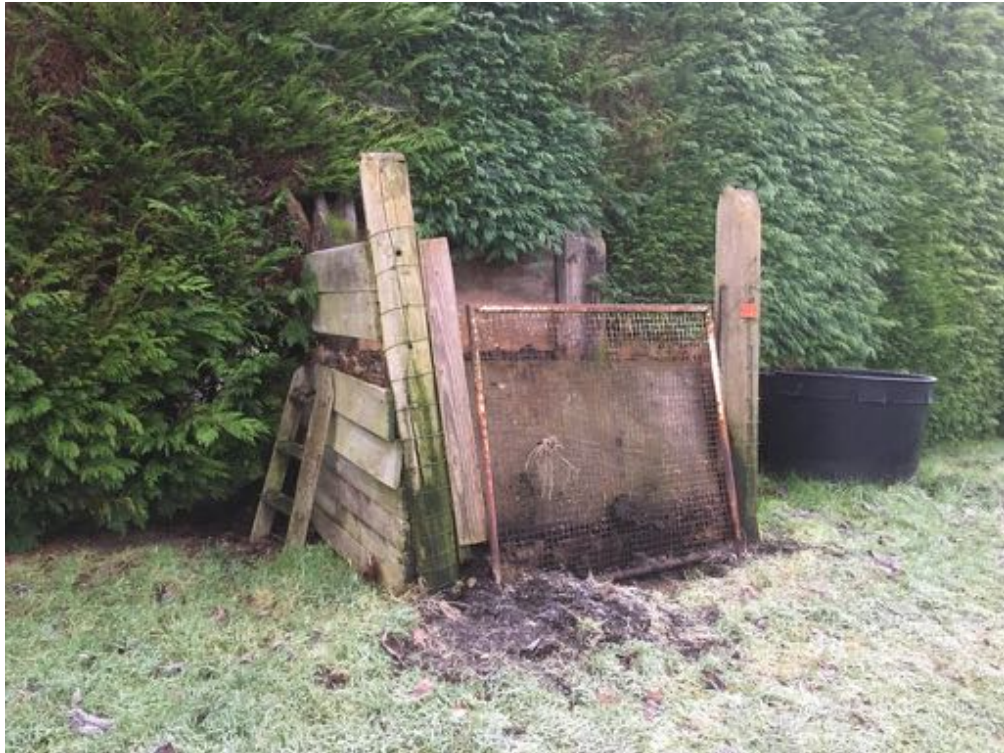
**Photograph 11**

**Description:** Compost heap

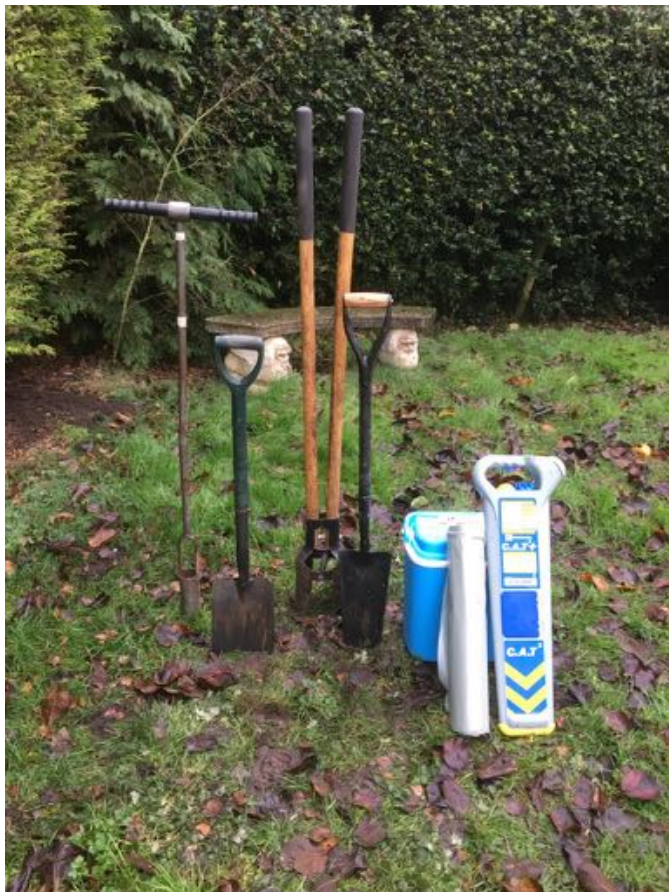
**Photograph 12**

**Description:** Field equipment used during site investigation works

| Element of investigation | Details | Rationale |
|---|---|---|
| Hand pitting | <p>10 hand pit locations (HP01 to HP10) were excavated at the study Site by hand (using a spade, pincer shovel and hand auger – see Photograph 12 in Appendix C).</p> <p>The pits were distributed across the orchard/garden area in the north-west of the Site.</p> <p>The hand pit locations are shown on Figure 3.1.</p> <p>The pits were excavated to depths of between 0.35 m and 0.75 m bgl.</p> <p>All pits were backfilled on completion. The excavated spoil was replaced in broadly the same order as it was excavated.</p> <p>All excavated materials were logged by an experienced site supervisor.</p> | <p>To characterise existing ground conditions across the main area of soft standing to be retained as part of the Site redevelopment.</p> <p>To assess the extent, thickness and composition of any Made Ground, including the presence of any possible mining spoil.</p> <p>To assess the composition of the natural superficial geology.</p> <p>To make a visual assessment of any ground contamination.</p> <p>To facilitate environmental soil sampling of the near surface soils.</p> |

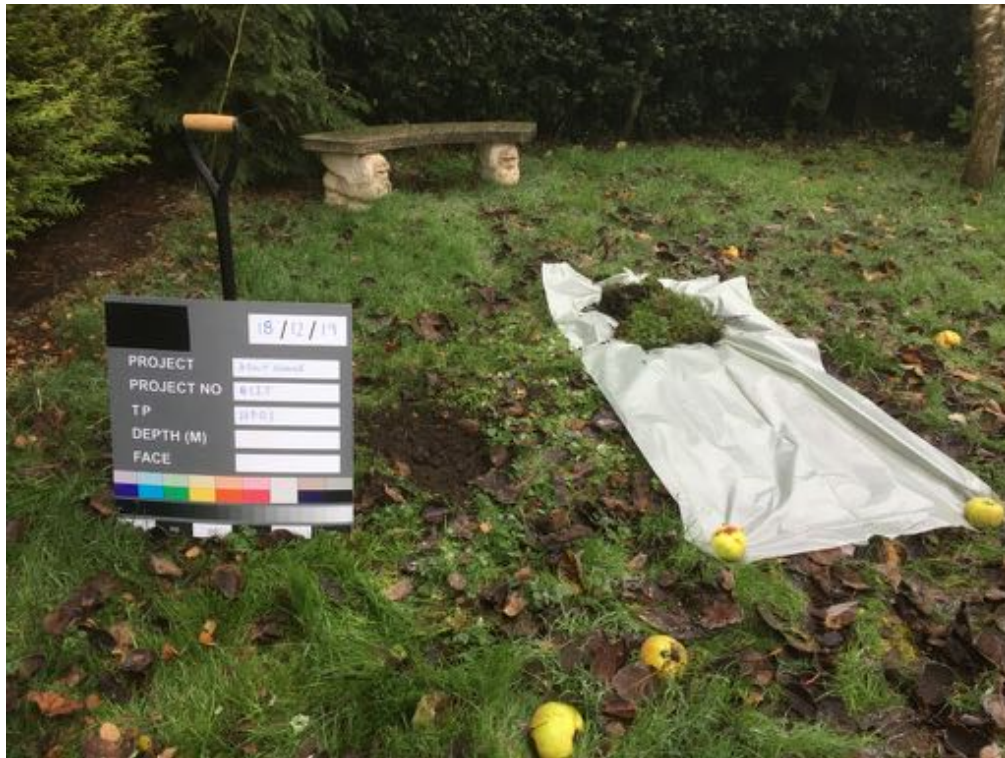
**Photograph 13**      **Description:** Hand pit HP01  
                                  **Date:** 18/12/2019  
                                  **Location:** North-western corner of the Site

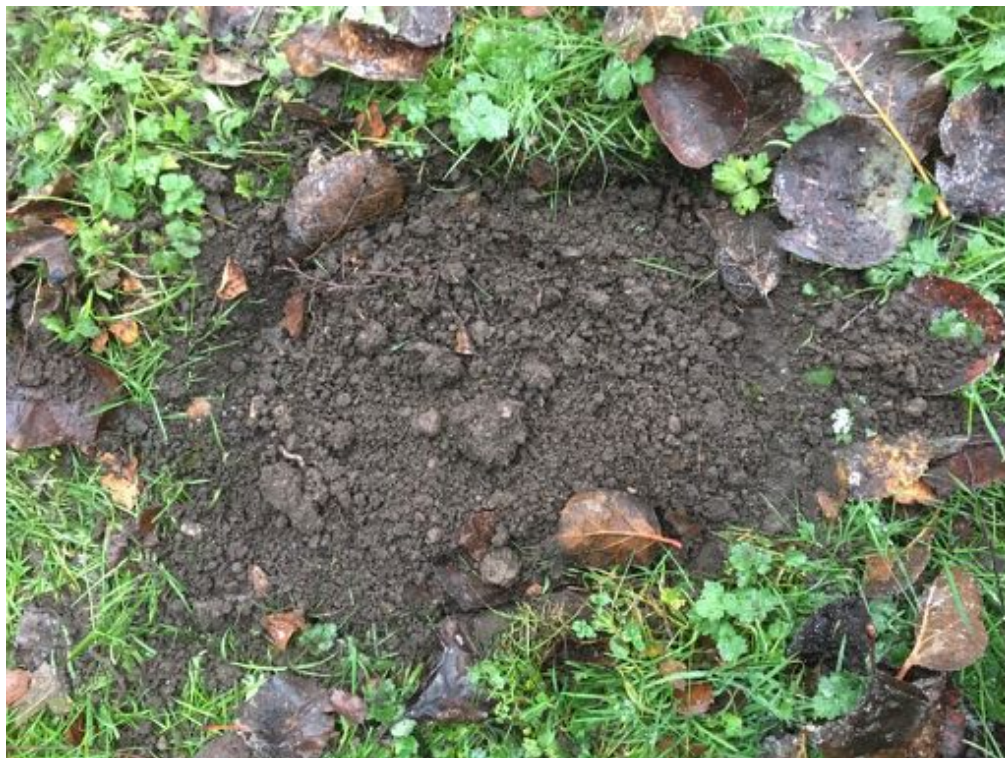
**Photograph 14**      **Description:** Topsoil observed at hand pit HP01  
                                  **Date:** 18/12/2019  
                                  **Location:** North-western corner of the Site

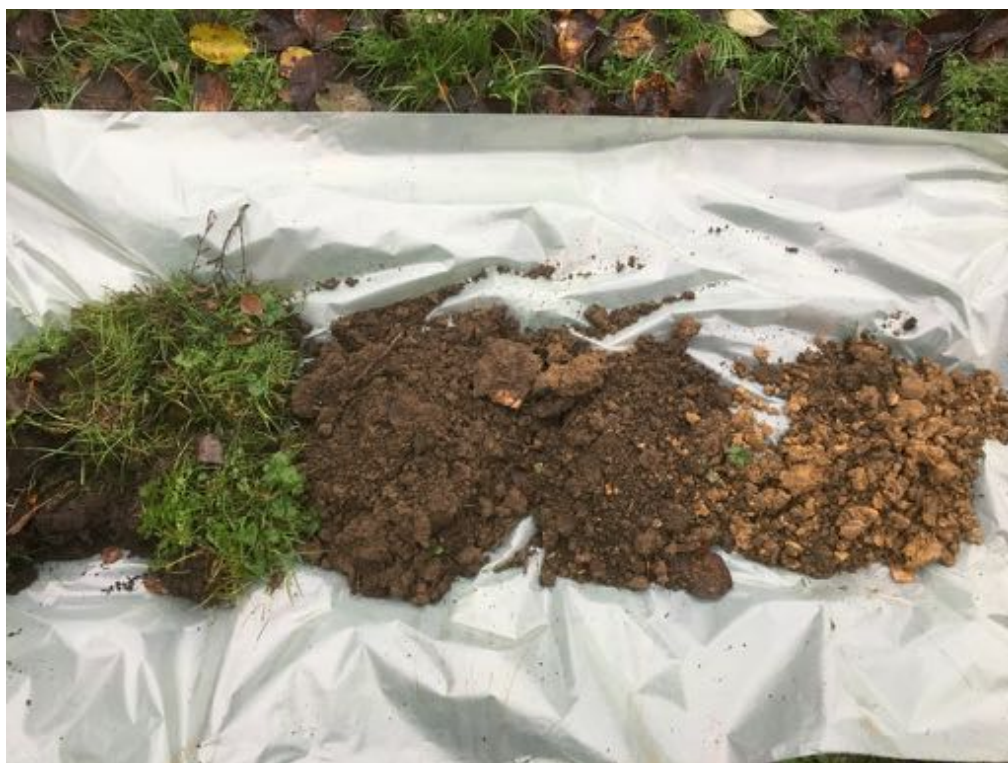
**Photograph 15**

**Description:** Soil sequence encountered at HP01

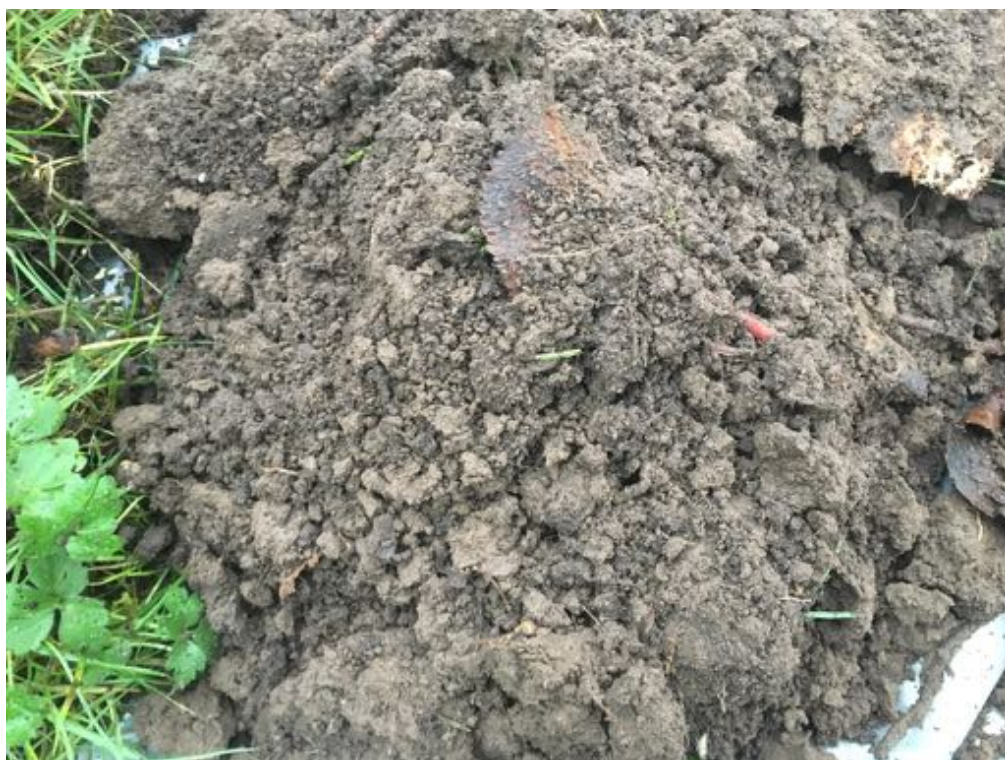
**Photograph 16**

**Description:** Soil layer encountered at HP01

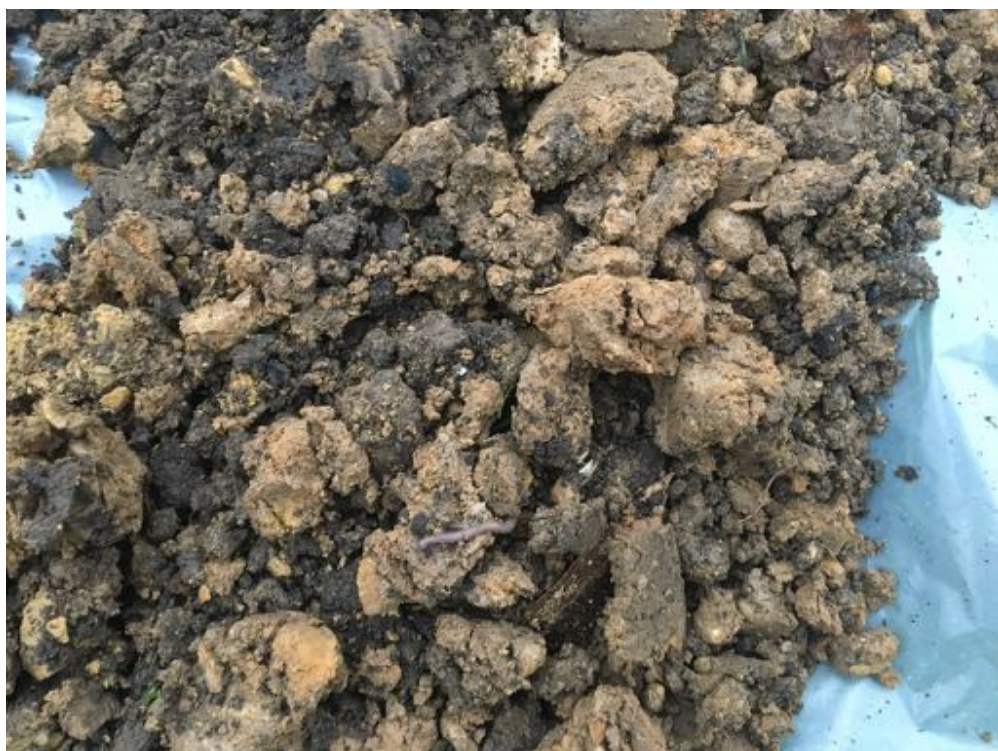
**Photograph 17**      **Description:** Reworked Till encountered at HP01  
                             **Date:** 18/12/2019  
                             **Location:** North-western corner of the Site

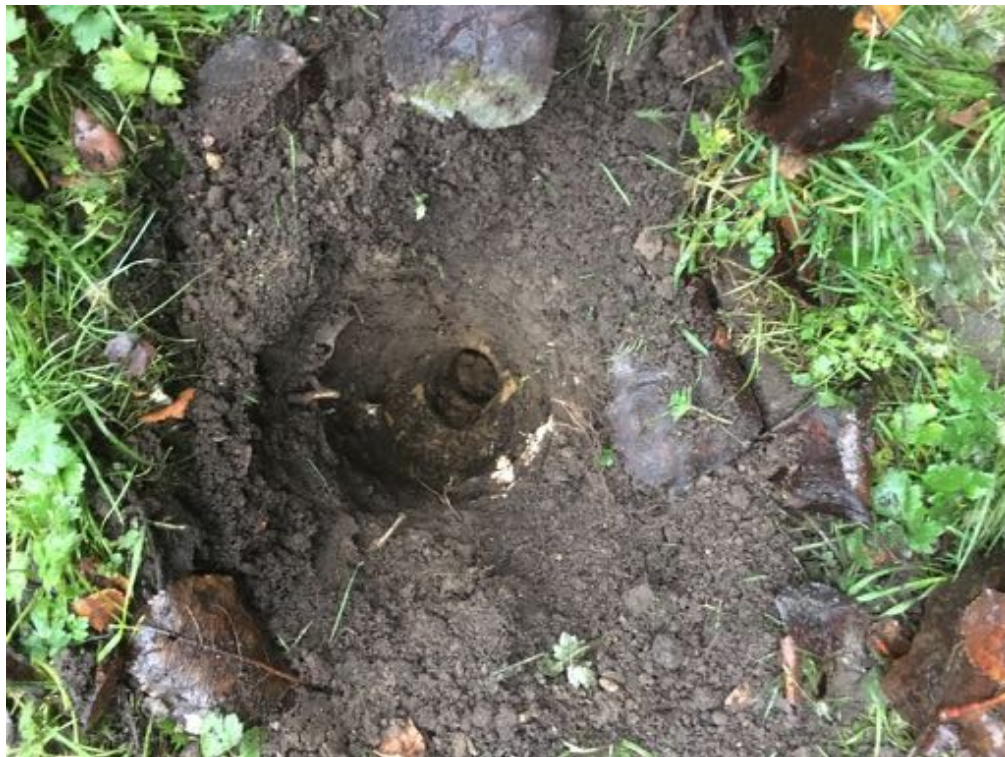
**Photograph 18**      **Description:** Hand pit HP01  
                             **Date:** 18/12/2019  
                             **Location:** North-western corner of the Site

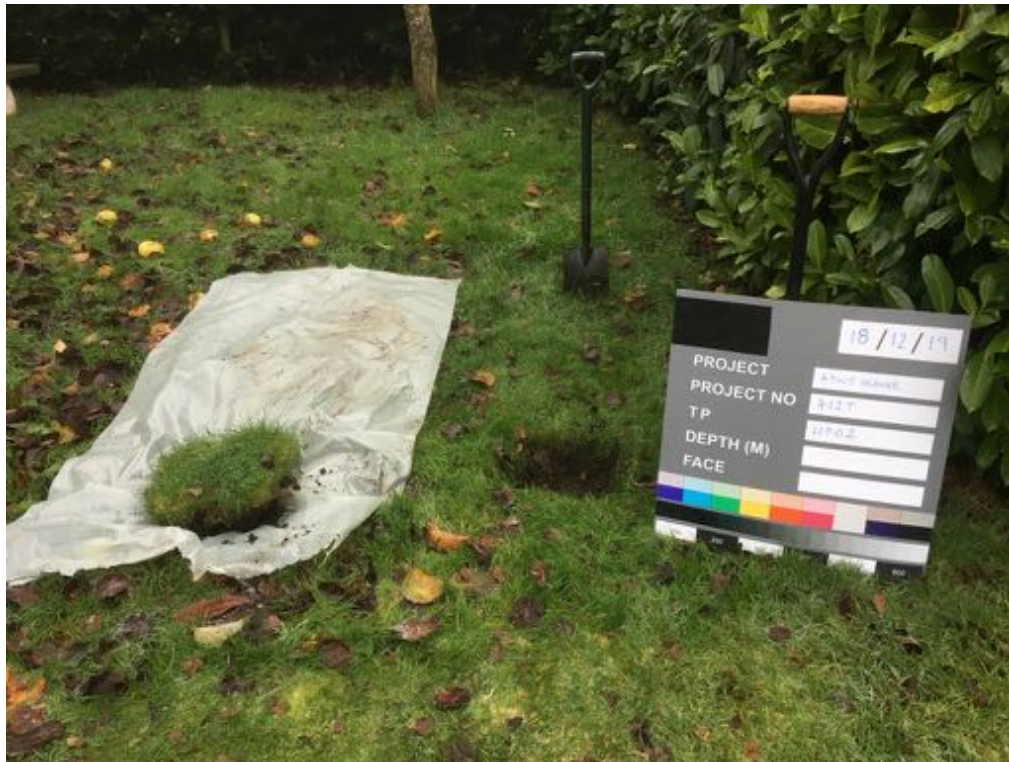
**Photograph 19**      **Description:** Hand pit HP02  
                                  **Date:** 18/12/2019  
                                  **Location:** Northern part of the Site

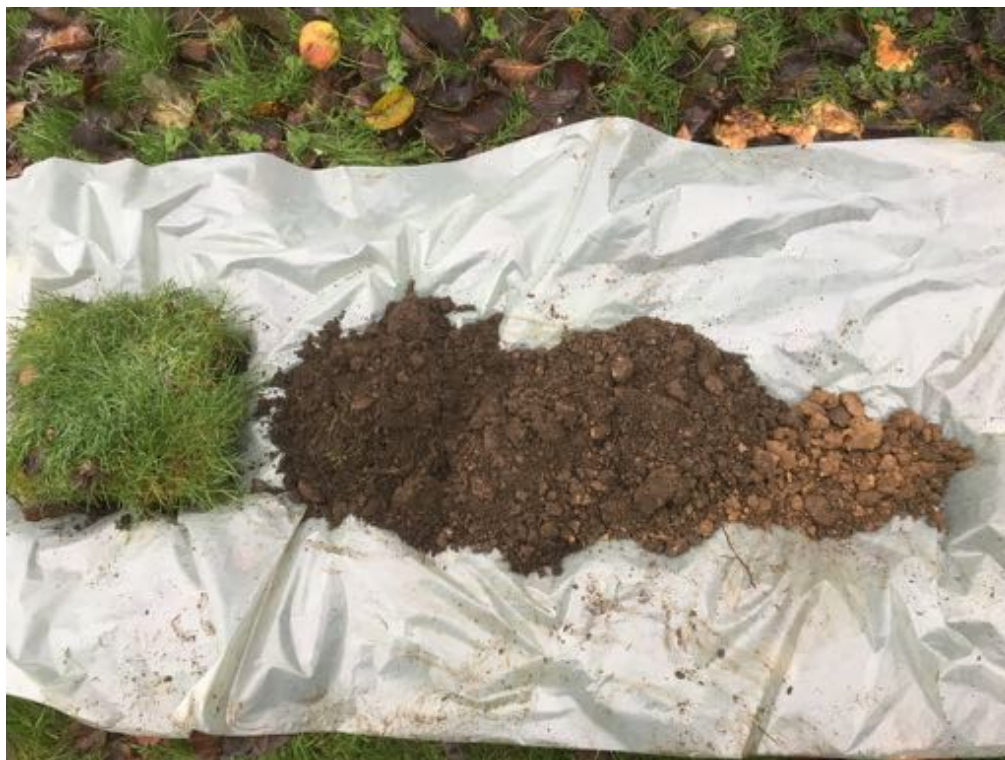
**Photograph 20**      **Description:** Soil sequence encountered at HP02  
                                  **Date:** 18/12/2019  
                                  **Location:** Northern part of the Site

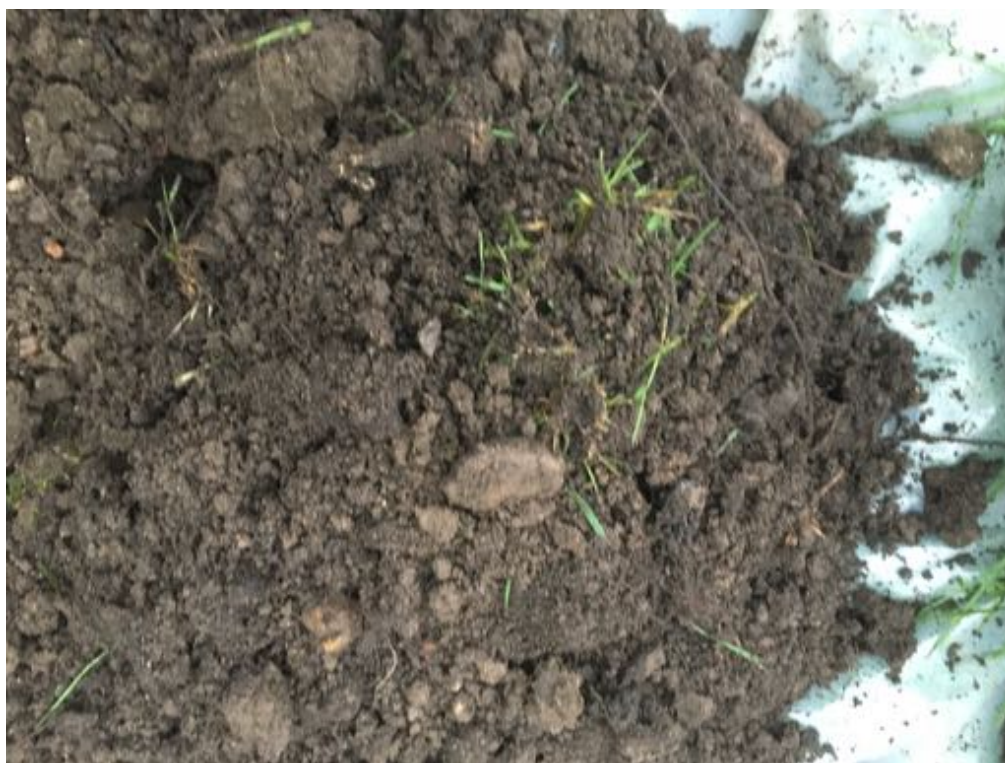
**Photograph 21**

**Description:** Upper soil layer encountered at HP02

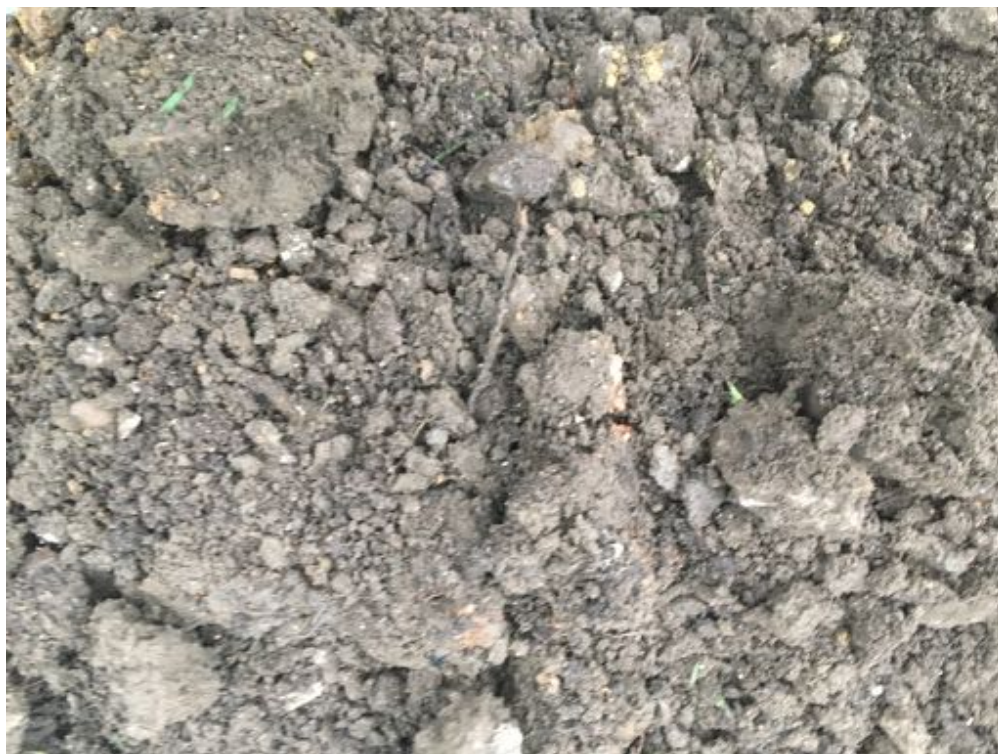
**Photograph 22**

**Description:** Lower soil layer encountered at HP02

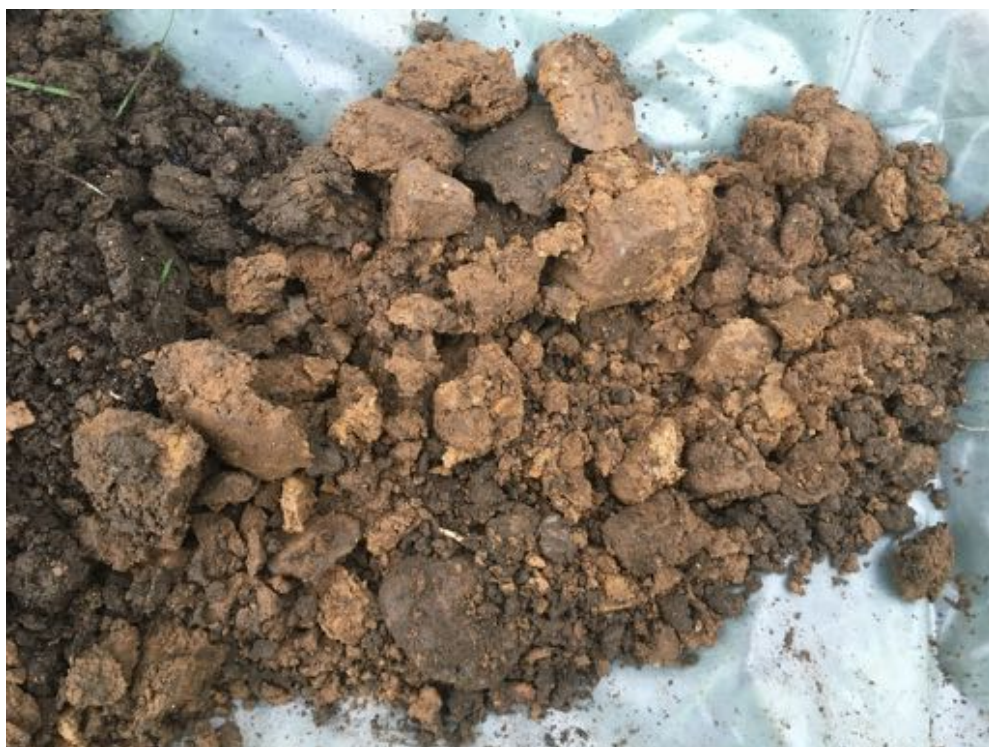
**Photograph 23**

**Description:** Reworked Till encountered at HP02

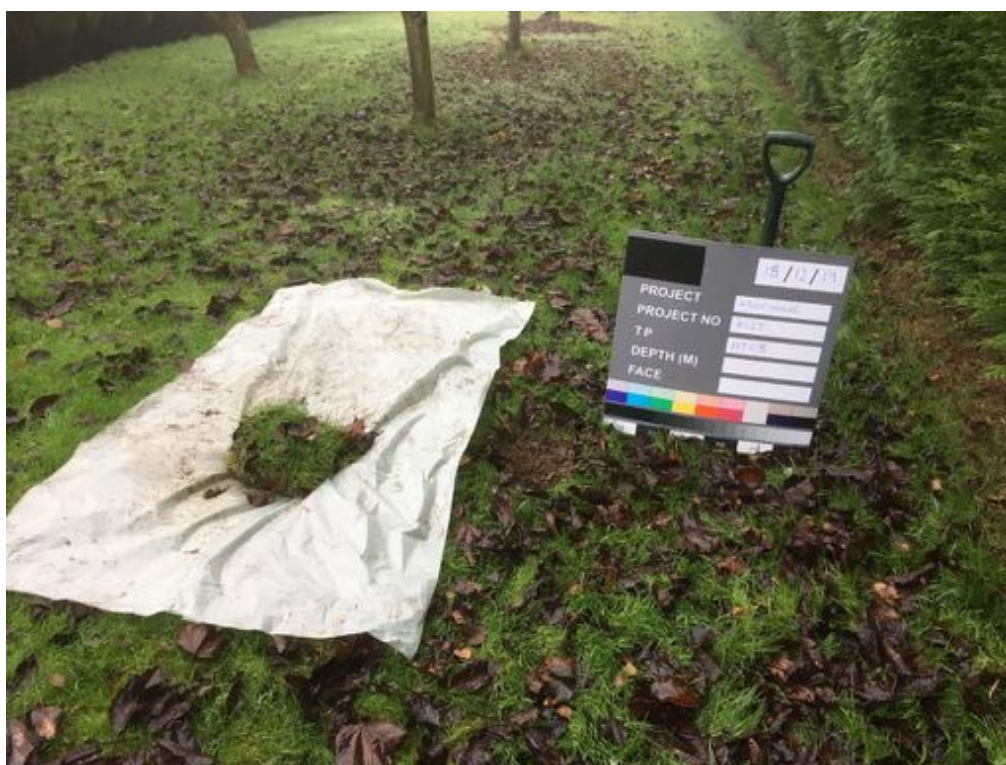
**Description:** Hand pit HP03  
**Date:** 18/12/2019  
**Location:** Northern half of the orchard area

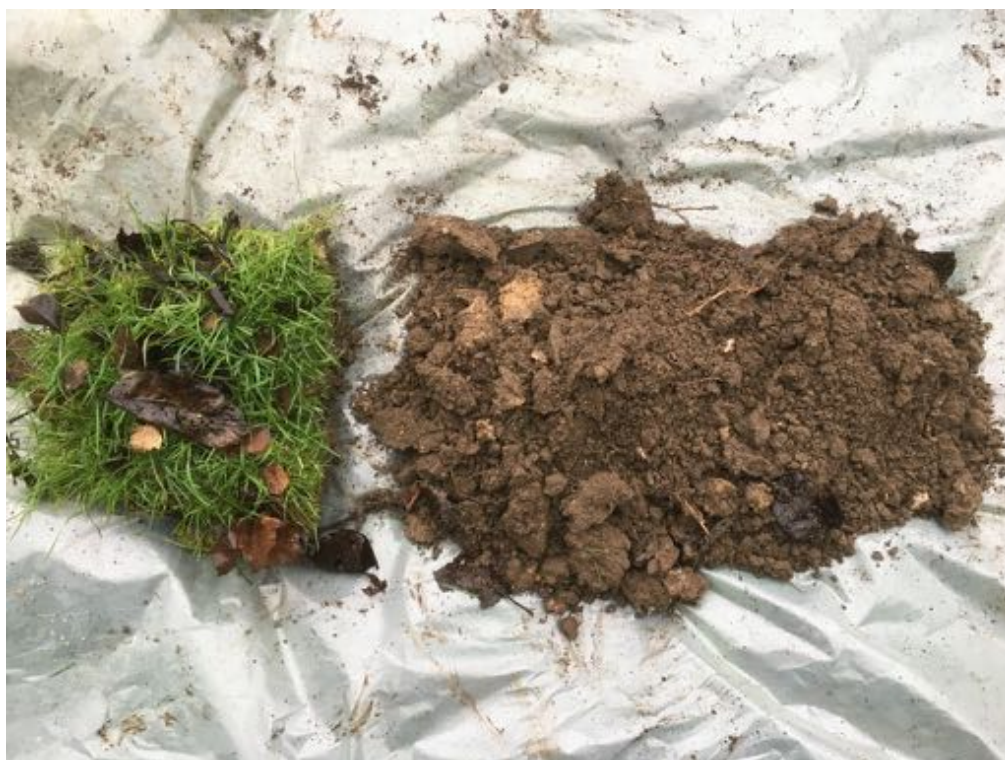
**Photograph 27**

**Description:** Soil sequence encountered at HP03

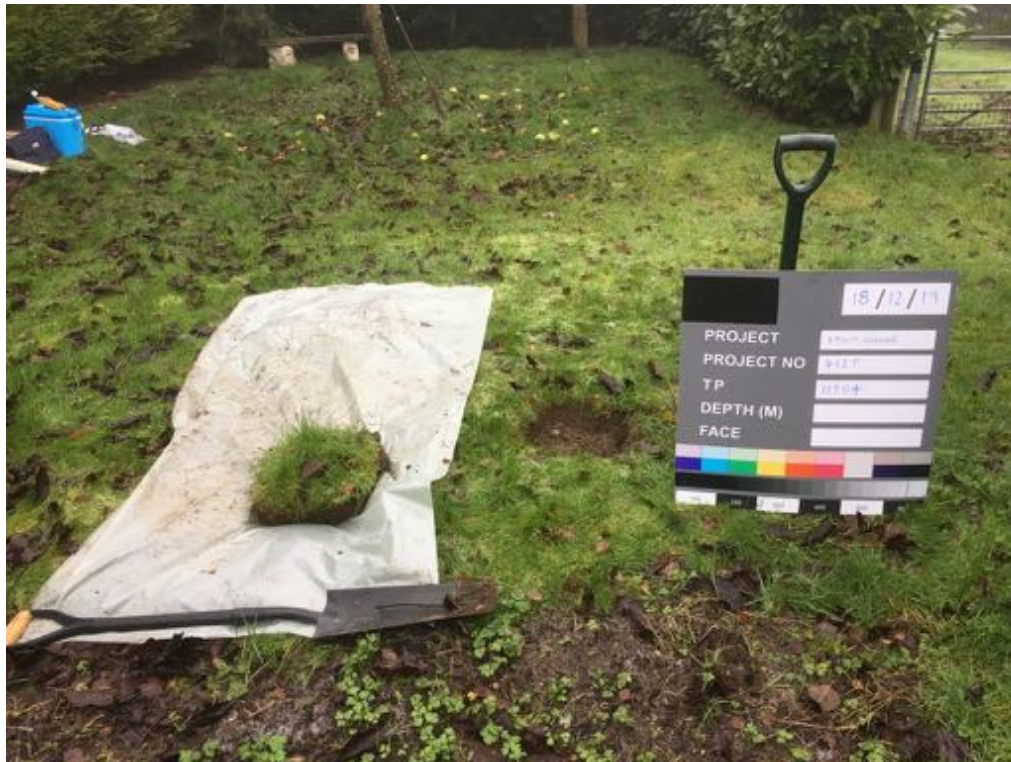
**Photograph 29**      **Description:** Hand pit HP04  
                                  **Date:** 18/12/2019  
                                  **Location:** Northern half of the orchard area

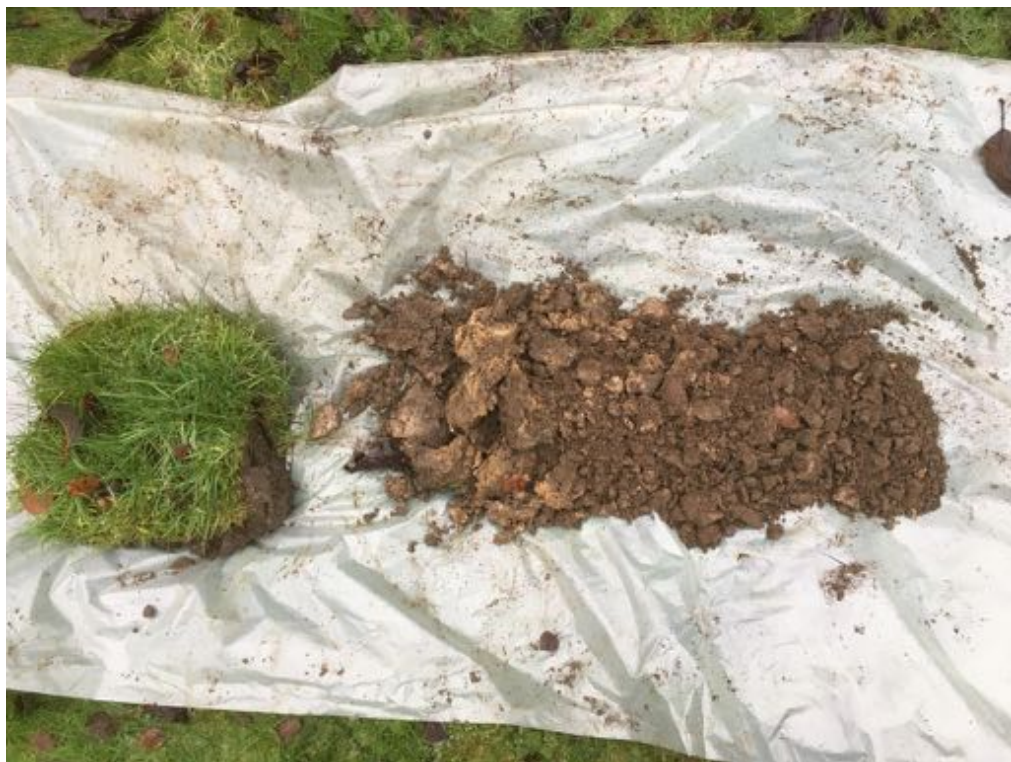
**Photograph 30**      **Description:** Soil sequence encountered at HP04  
                                  **Date:** 18/12/2019  
                                  **Location:** Northern half of the orchard area

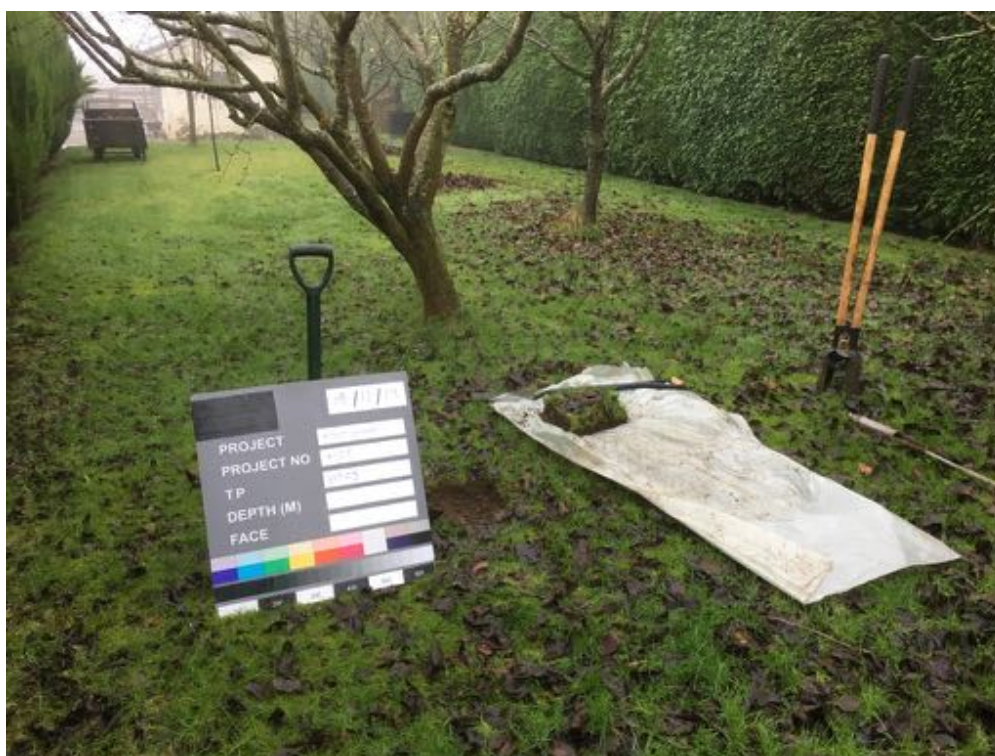
**Photograph 32**      **Description:** Hand pit HP05  
                                  **Date:** 18/12/2019  
                                  **Location:** Central part of the orchard area

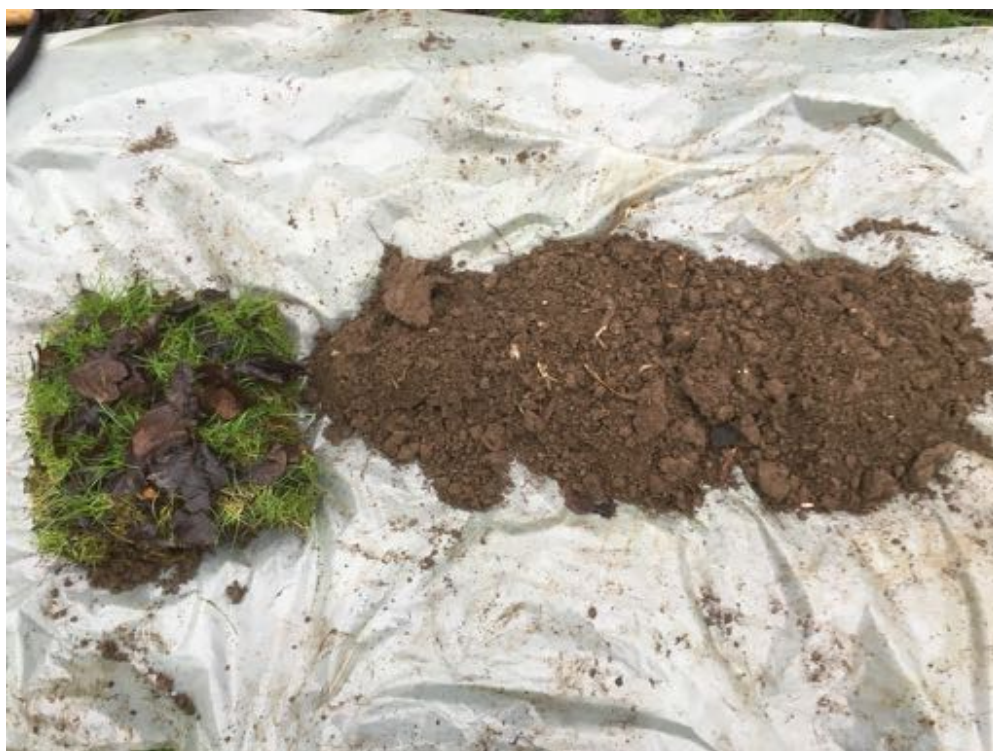
**Photograph 33**

**Description:** Soil sequence encountered at HP05

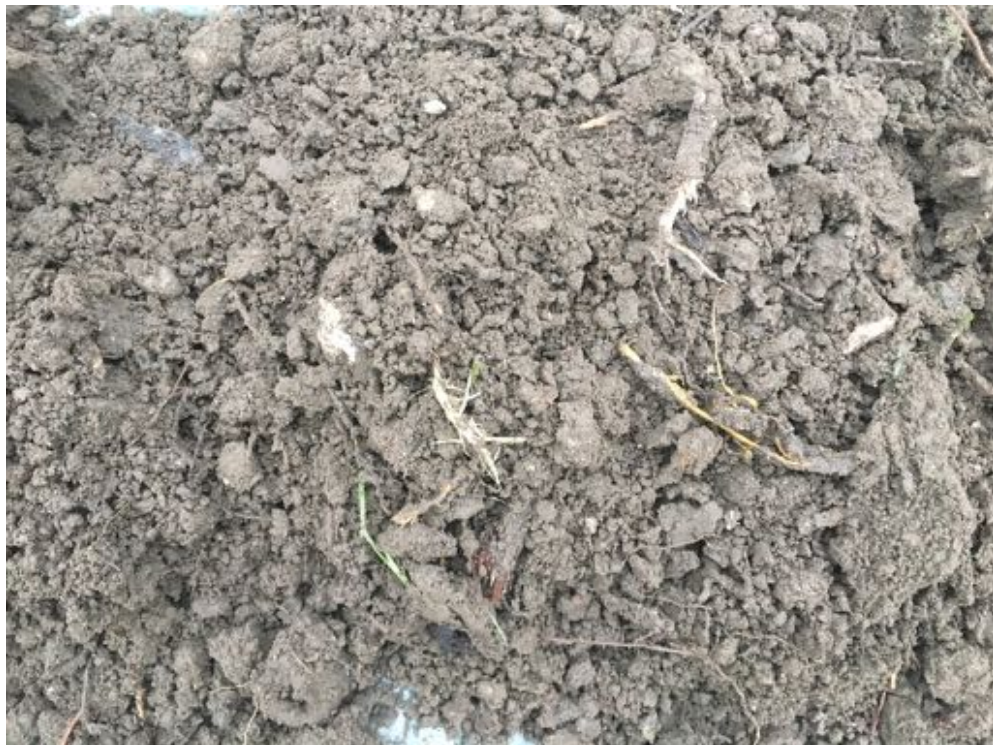
**Photograph 34**

**Description:** Soil layer encountered at HP05

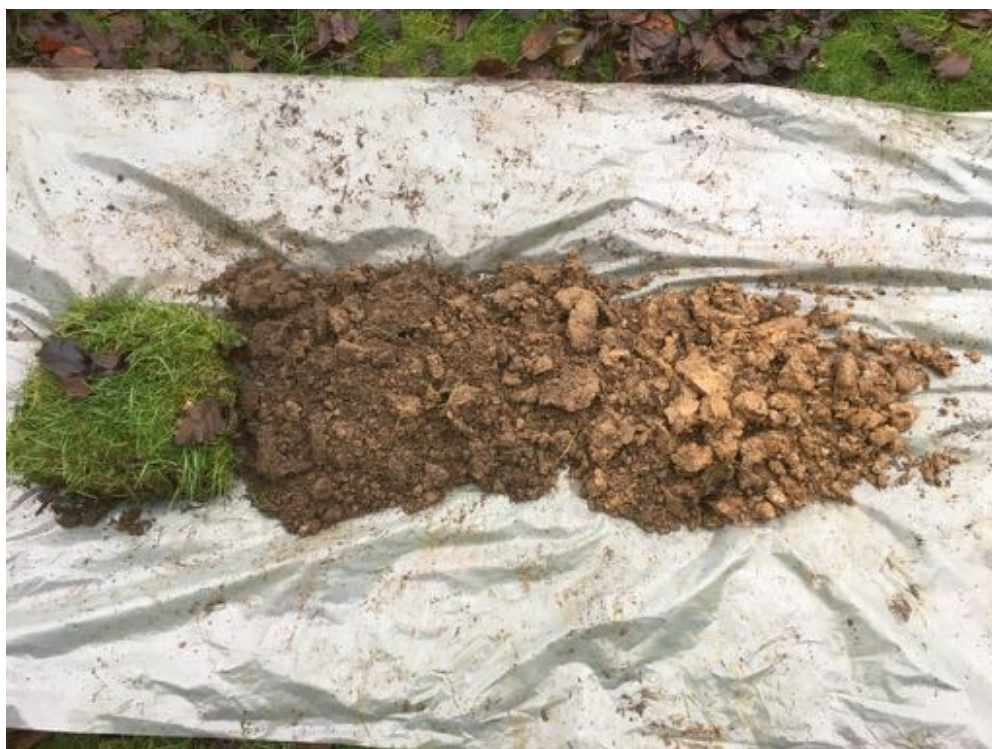
**Photograph 37**      **Description:** Soil sequence encountered at HP06  
                         **Date:** 18/12/2019  
                         **Location:** Central part of the orchard area

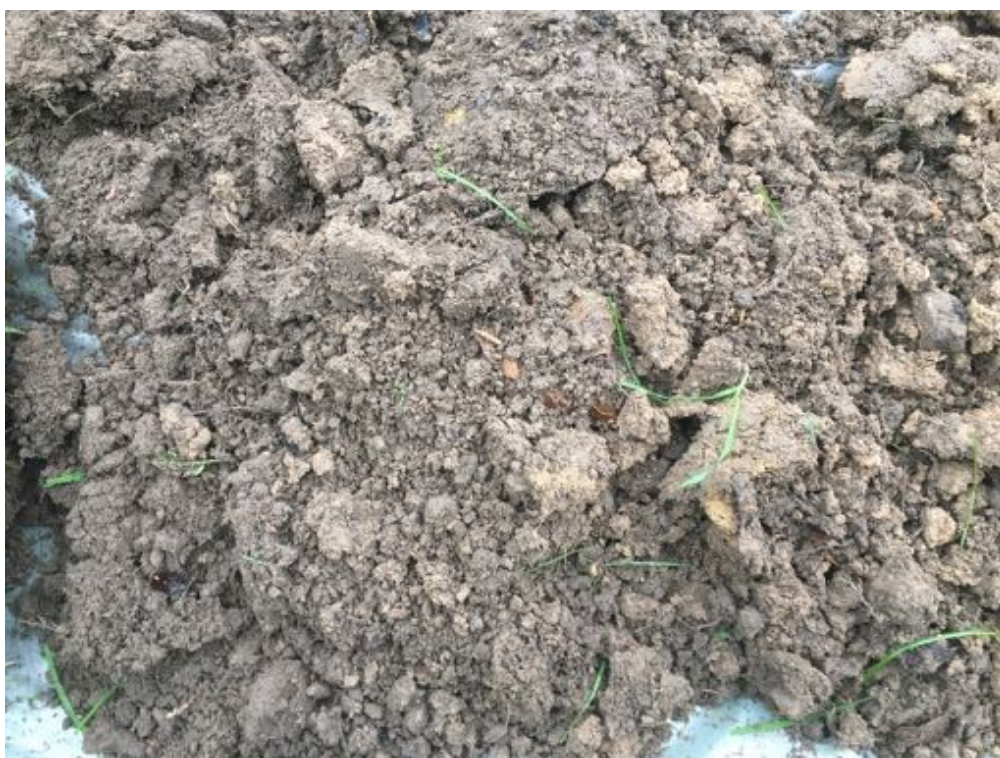
**Photograph 38**      **Description:** Soil layer encountered at HP06  
                         **Date:** 18/12/2019  
                         **Location:** Central part of the orchard area

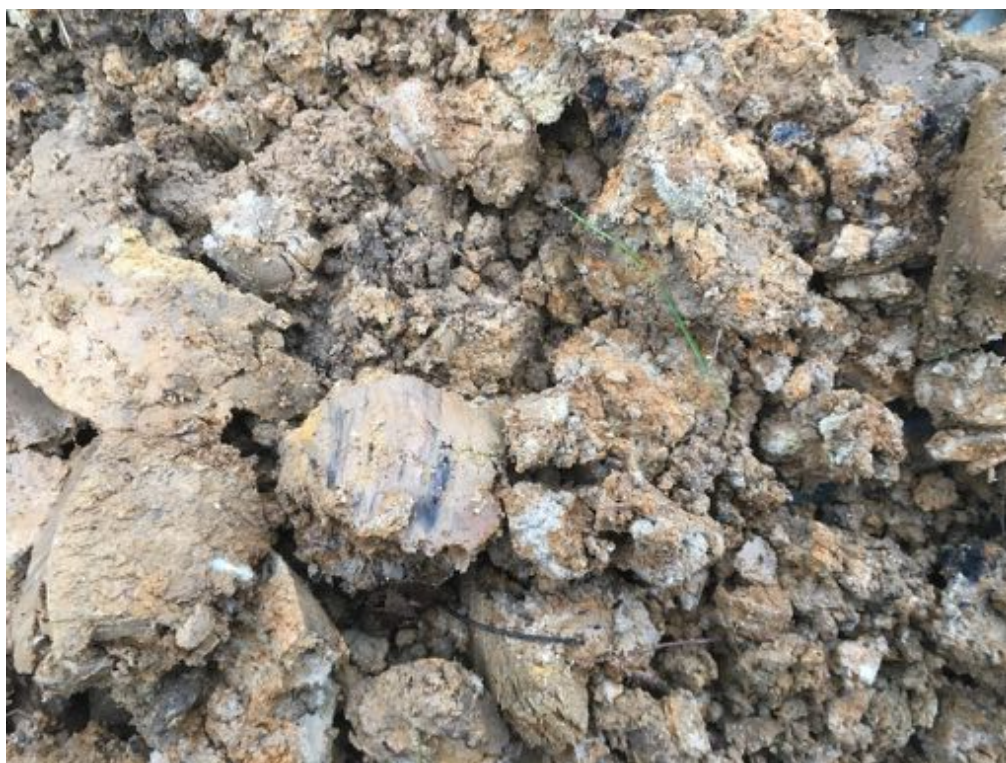
**Photograph 39**

**Description:** Reworked Till encountered at HP06

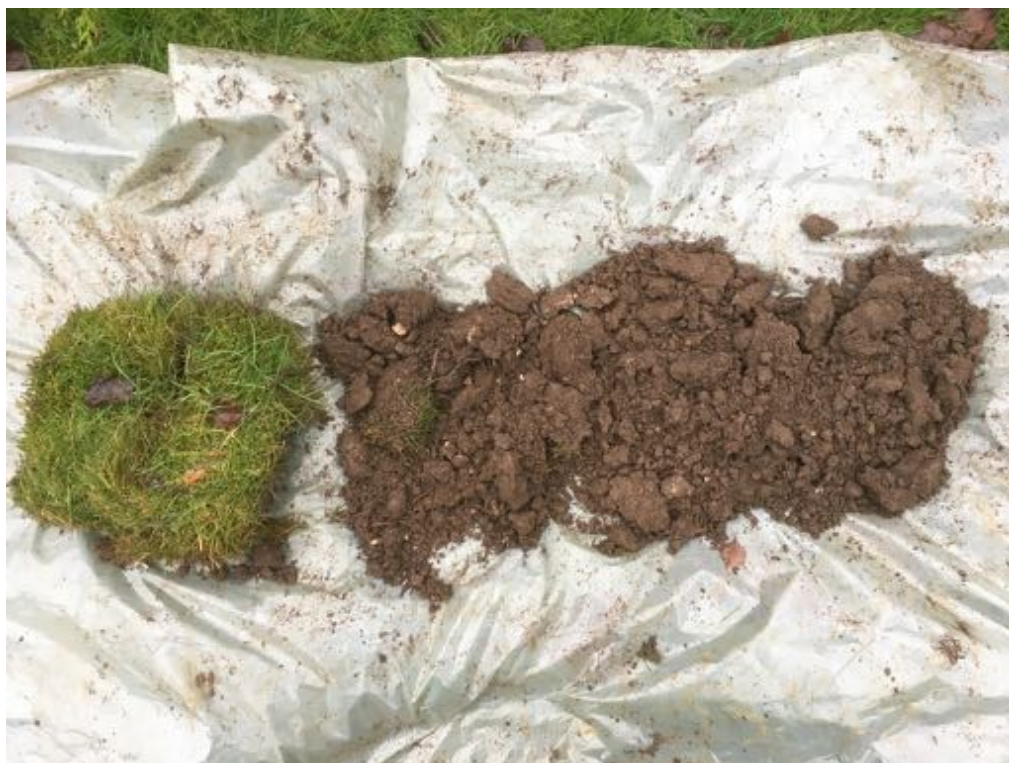
**Photograph 41**      **Description:** Soil sequence encountered at HP07  
                                  **Date:** 18/12/2019  
                                  **Location:** Central part of the orchard area
