# Phase 2 land quality assessment: Adwy Grange, Tanllan Lane, Coedpoeth, Wrexham

**Report reference:** 4127R1

**Date of reporting:** 08 January 2020

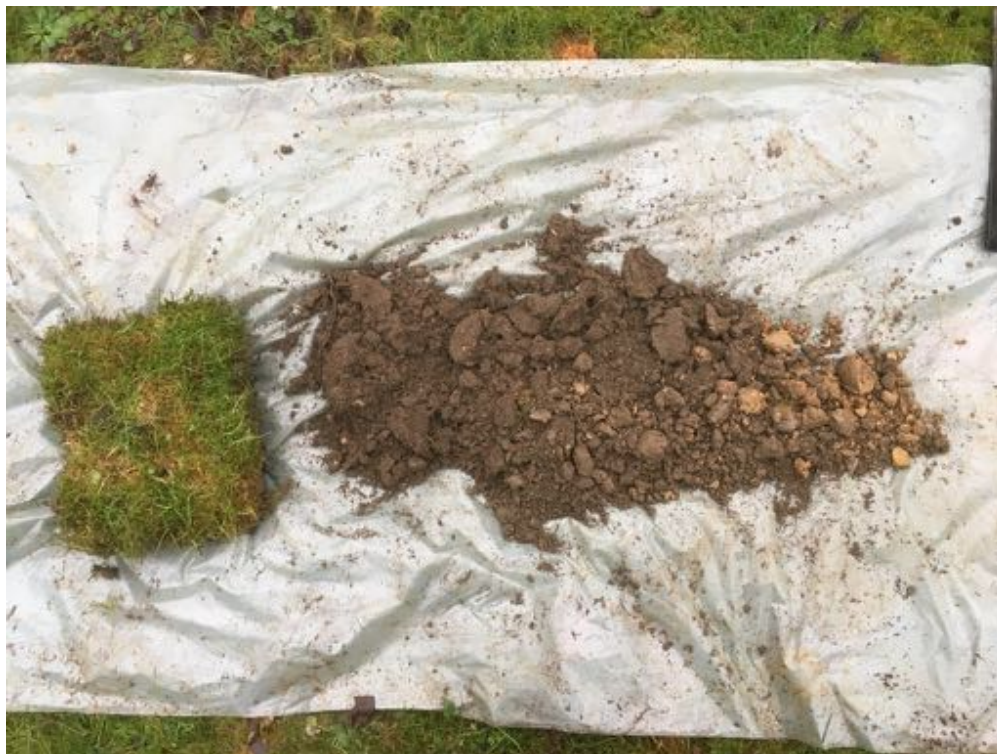
**Photograph 44**

**Description:** Soil sequence encountered at HP08  
**Date:** 18/12/2019  
**Location:** Southern half of the orchard area

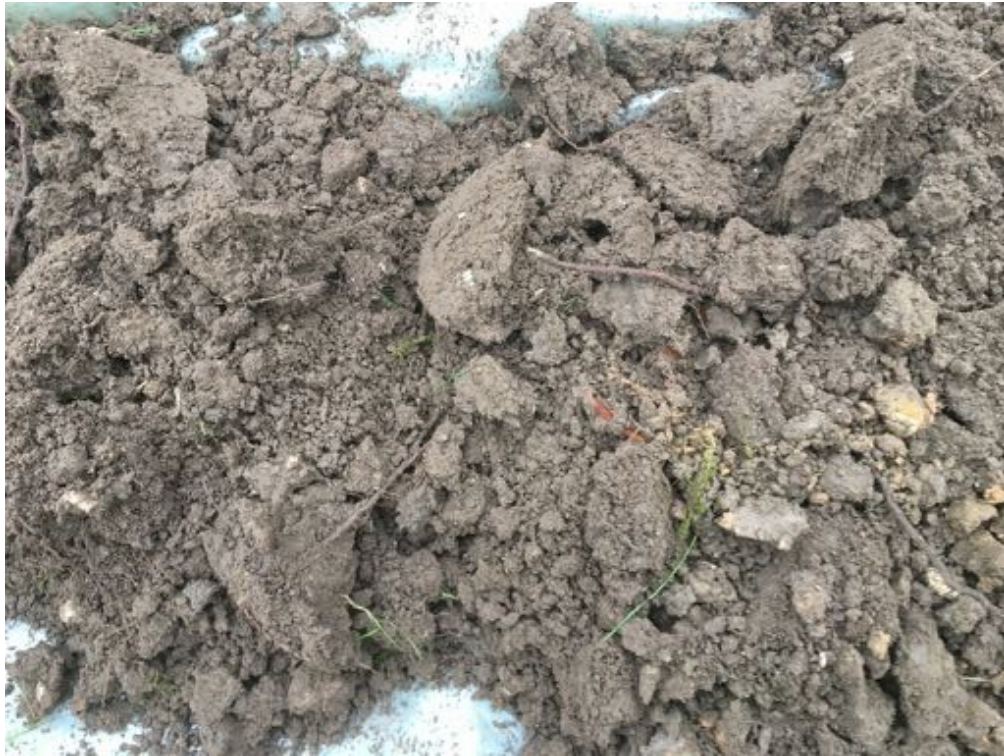
**Photograph 45**

**Description:** Soil layer encountered at HP08

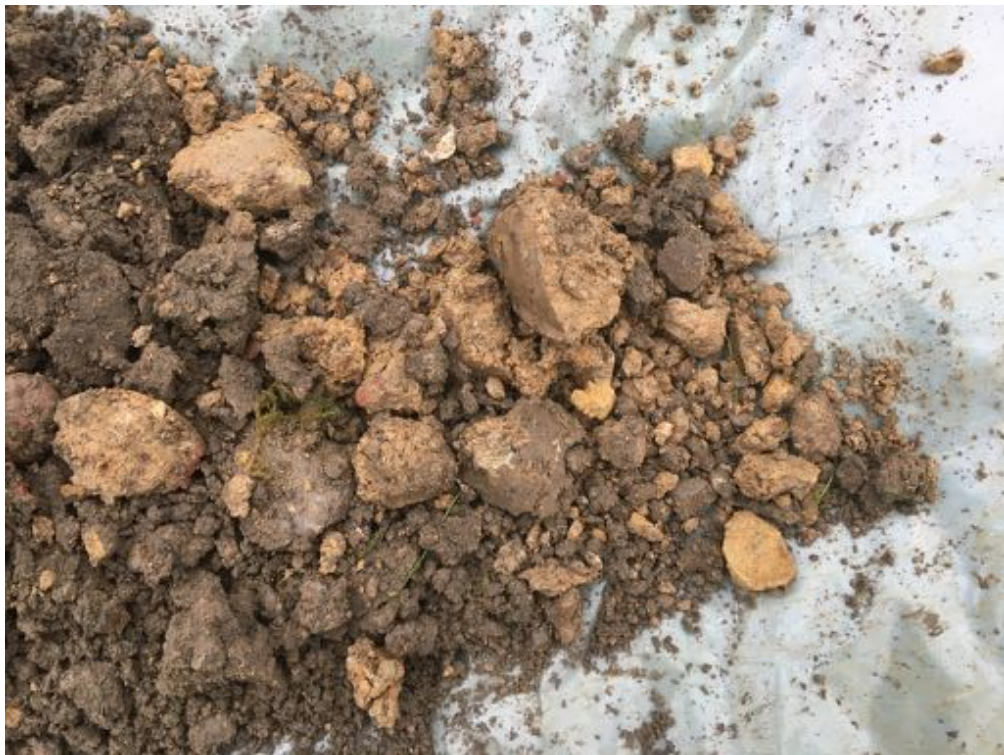
**Photograph 46**

**Description:** Reworked Till encountered at HP08

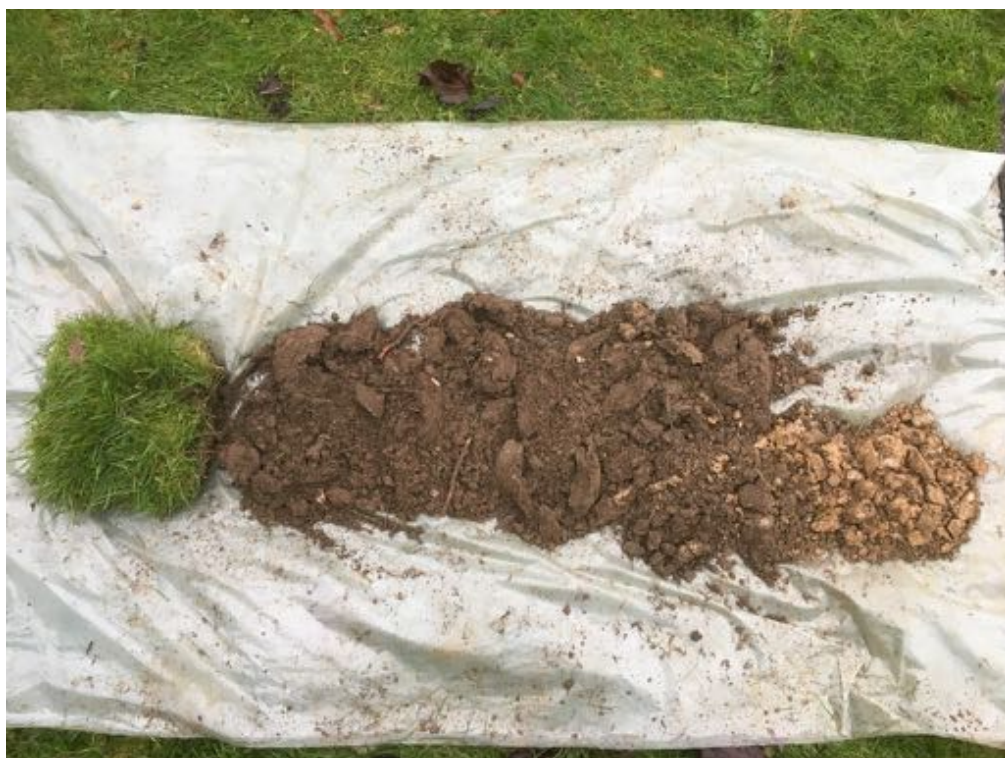
**Photograph 49**

**Description:** Soil sequence encountered at HP09

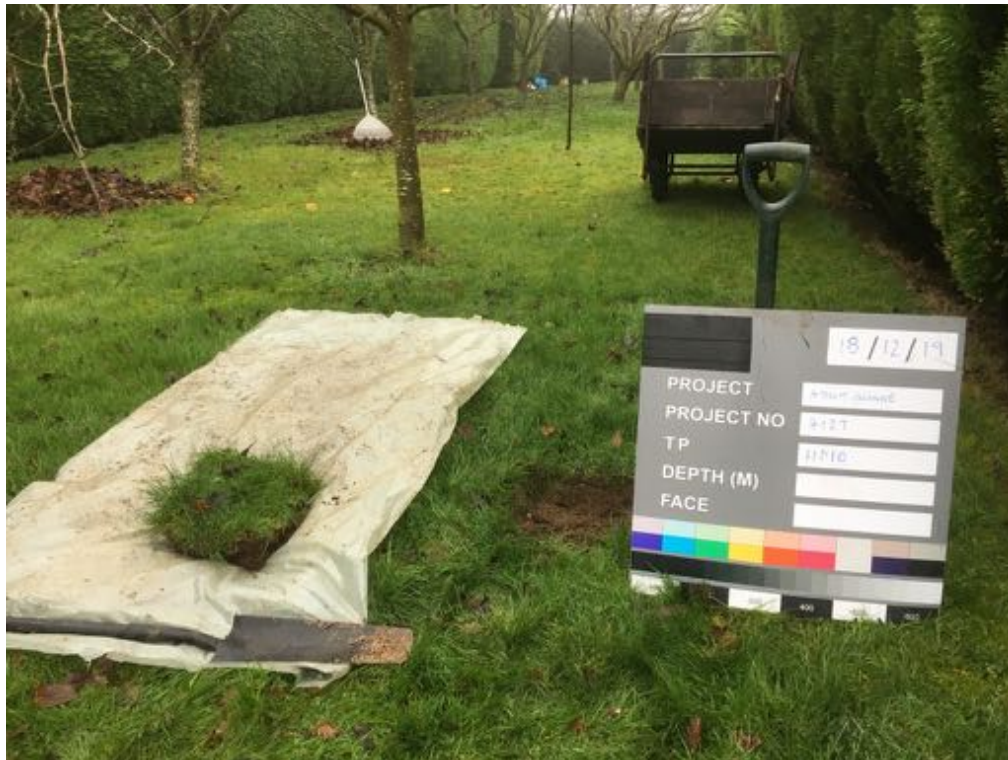
**Photograph 51**      **Description:** Hand pit HP10  
                                  **Date:** 18/12/2019  
                                  **Location:** Southern edge of the orchard area

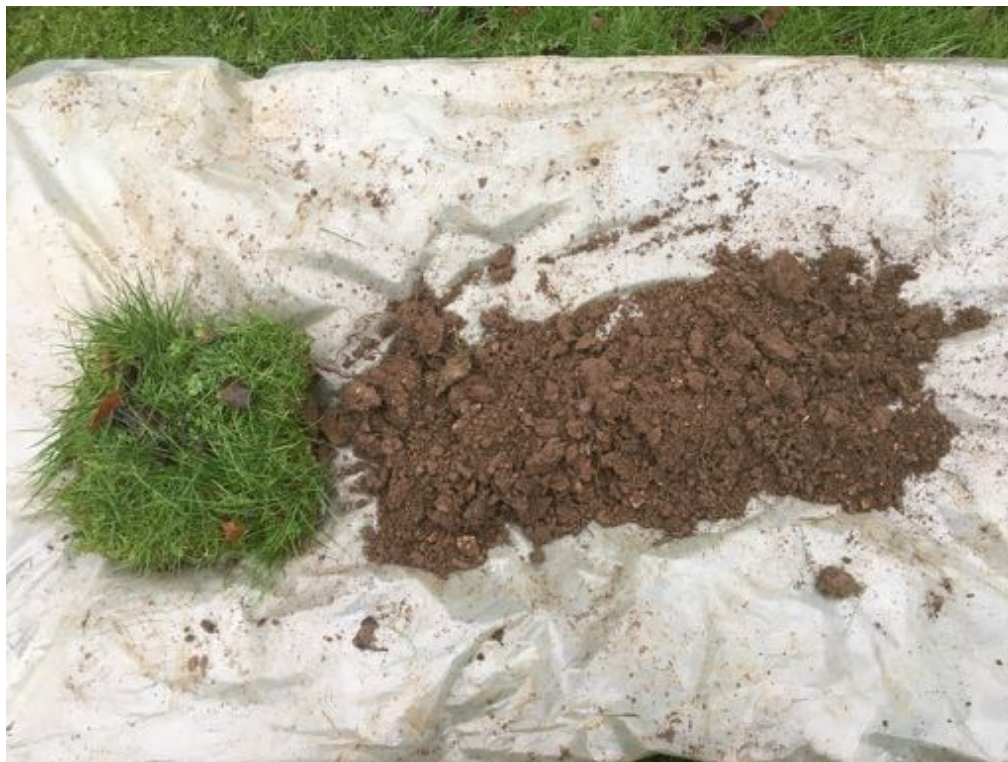
**Photograph 52**      **Description:** Soil sequence encountered at HP10  
                                  **Date:** 18/12/2019  
                                  **Location:** Southern edge of the orchard area

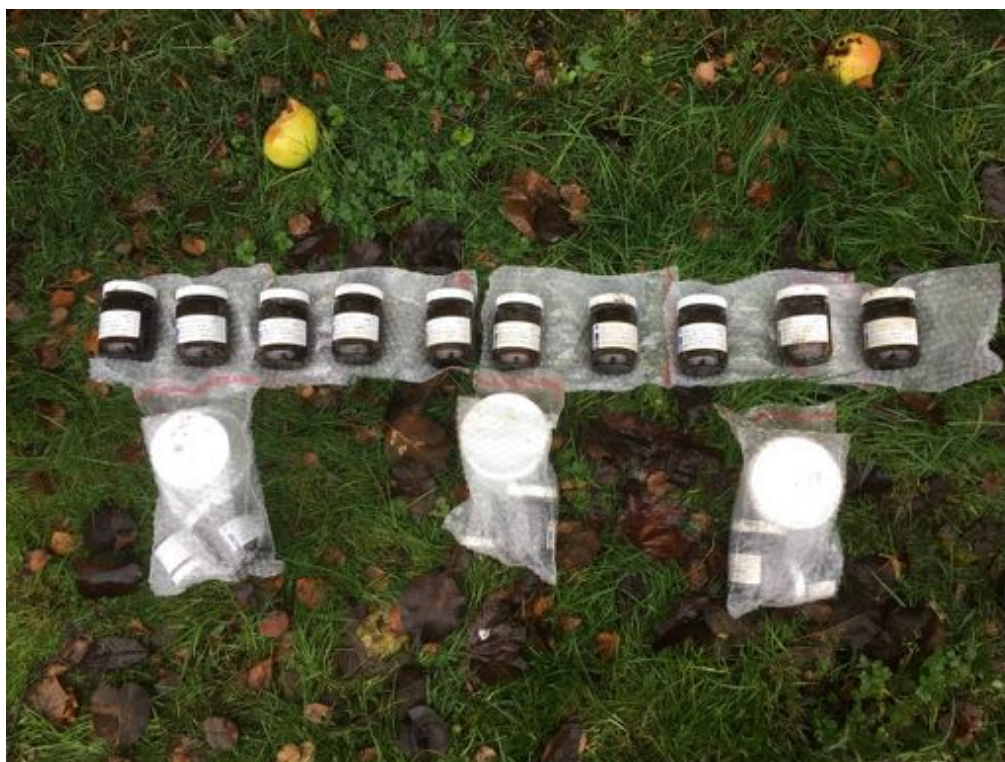
**Photograph 54**

| Element of investigation | Details | Rationale |
|---|---|---|
| Soil sampling | <p>12 soil samples were taken from the trial pits at depths of between 0.1 m bgl and 0.6 m bgl (see Photograph 54 in Appendix C).</p> <p>Soil samples were typically taken from the upper 0.4 m in order to adequately characterise the chemical composition of those soils most accessible to human receptors.</p> | <p>To provide appropriate samples for chemical laboratory analysis (analytical suite described below) in order to inform the subsequent environmental risk assessment.</p> |

**Description:** Sample containers

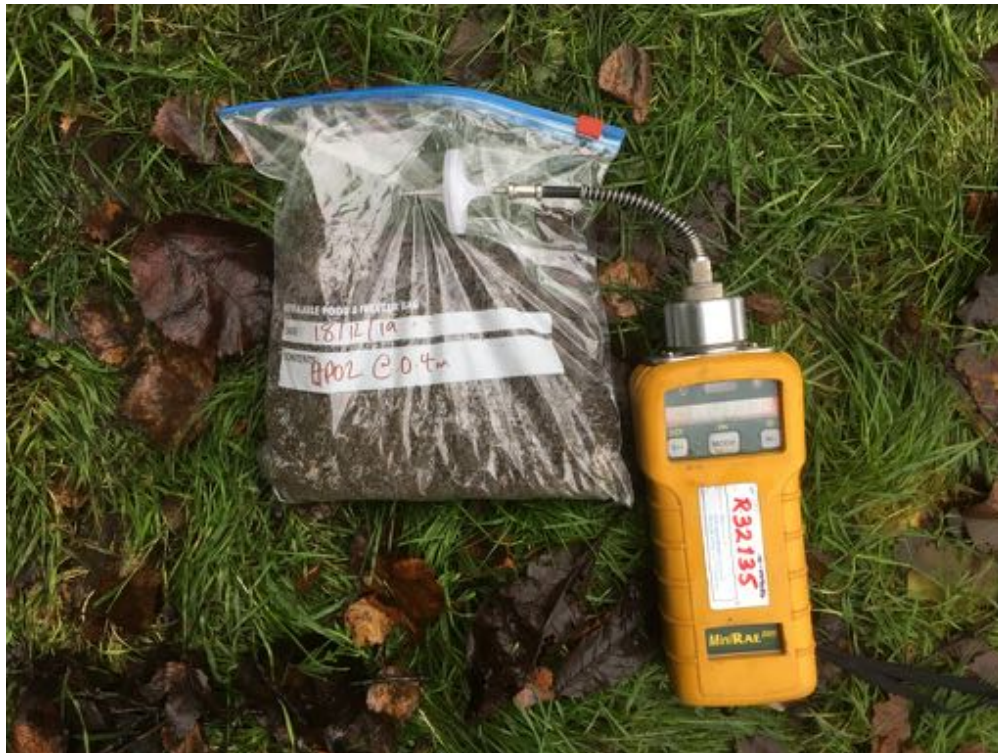
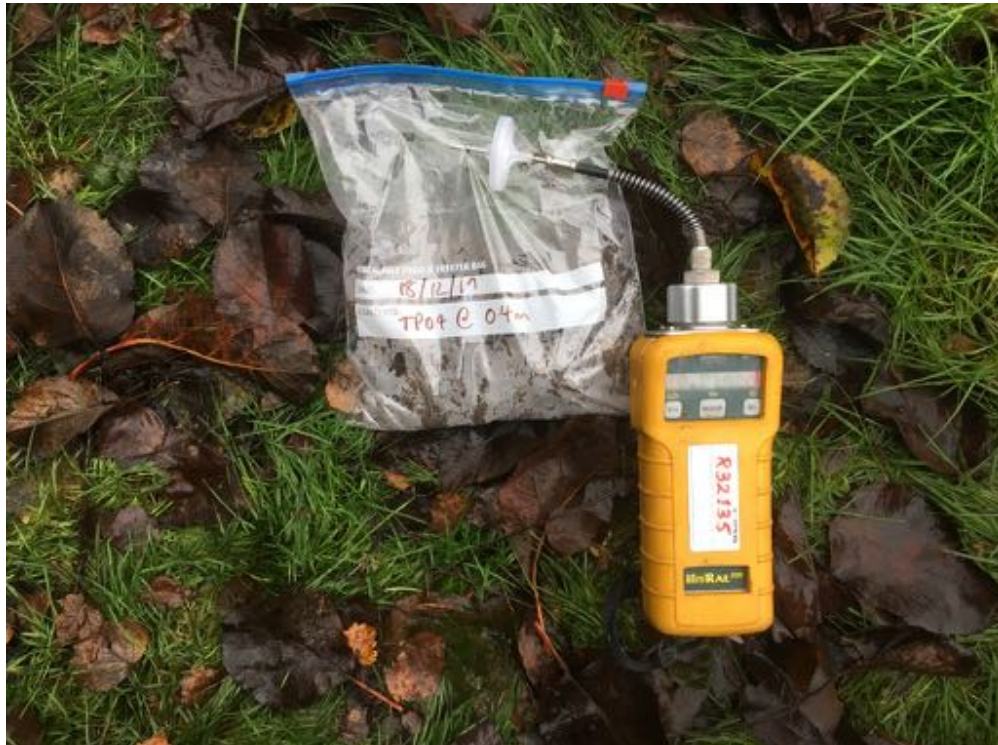
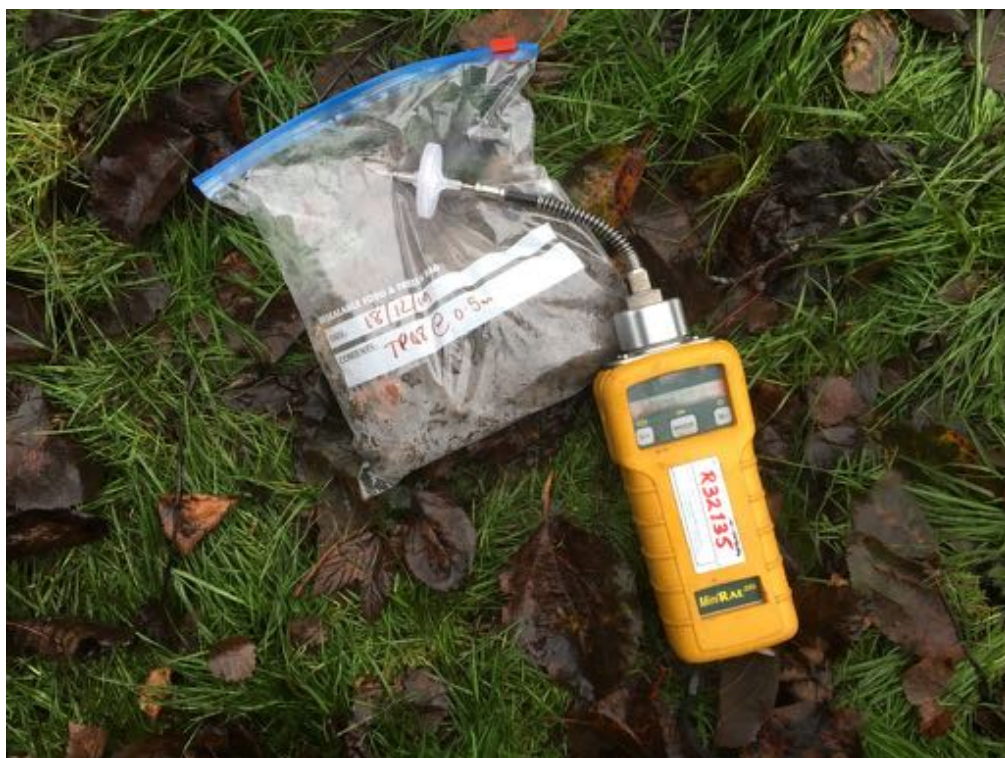
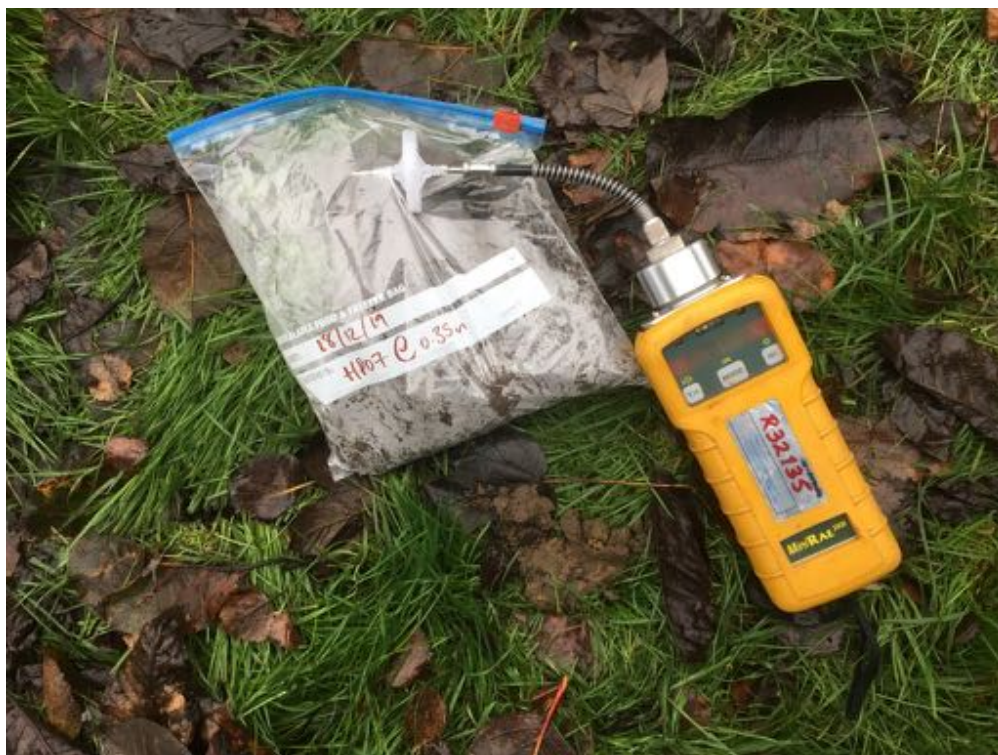
**Photograph 55**      **Description:** Example of soil sample PID headspace testing  
**Date:** 18/12/2019

**Photograph 56**      **Description:** Example of soil sample PID headspace testing  
**Date:** 18/12/2019

**Photograph 57**      **Description:** Example of soil sample PID headspace testing  
**Date:** 18/12/2019

**Photograph 58**      **Description:** Example of soil sample PID headspace testing  
**Date:** 18/12/2019
