## BEECH COTTAGE, MINERA

# PRELIMINARY BAT ROOST ASSESSMENT EMERGENCE SURVEY AND NESTING BIRD SURVEY

Report Ref EE.734.LB

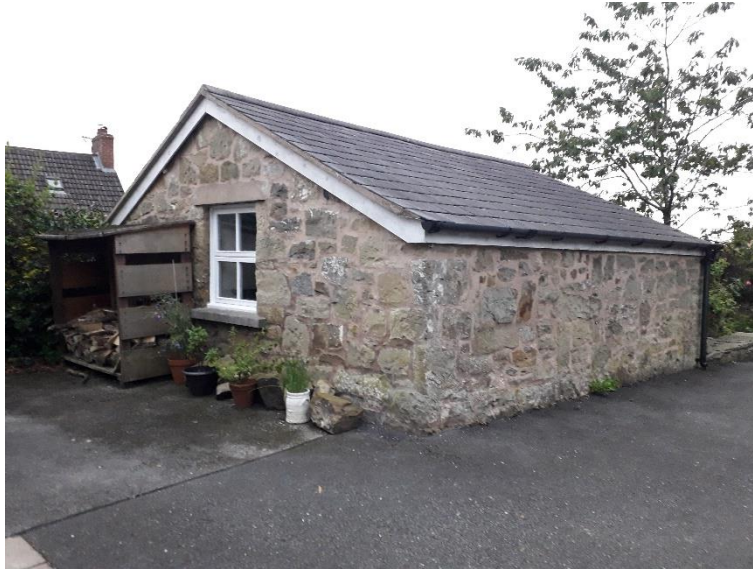
*PHOTO 4.1 NORTH WESTERN CORNER OF THE BUILDING*

- 4.1.1 The store comprised a single storey, stone built building, measuring approx. 6m x 6m (Photos 4.1 & 4.2). It was constructed of un-rendered stone, with a small window at both gable ends and a doorway on the southern gable end. The pitched roof was slated, with wooden fascias and bargeboards and no soffits.

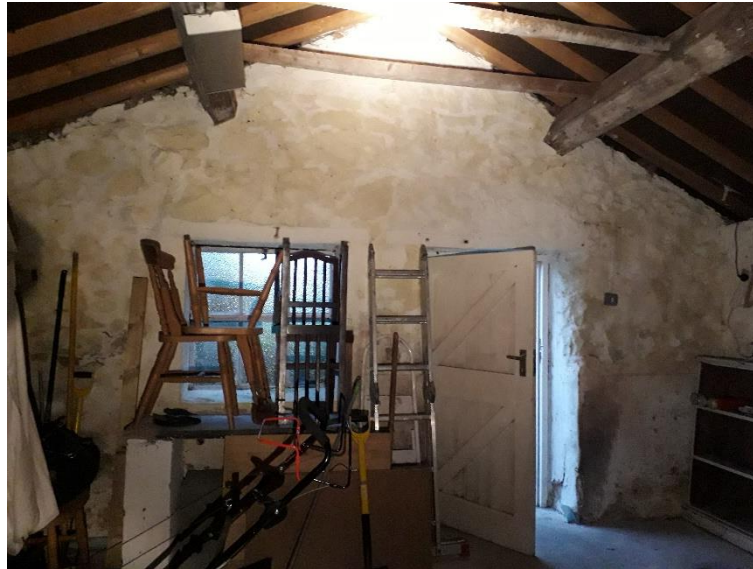
*PHOTO 4.3 SOUTHERN GABLE END*

- 4.2.1 Internally, the building comprised a single room, which was open to the roof (Photo 4.3). The stone walls were white washed and in good condition. The roof looked to be relatively new with an exposed ridge board, rafters and breathable membrane beneath the slates (Photo 4.4). The beams looked to pre-date the rest of the roof structure. The room was in use for storage.

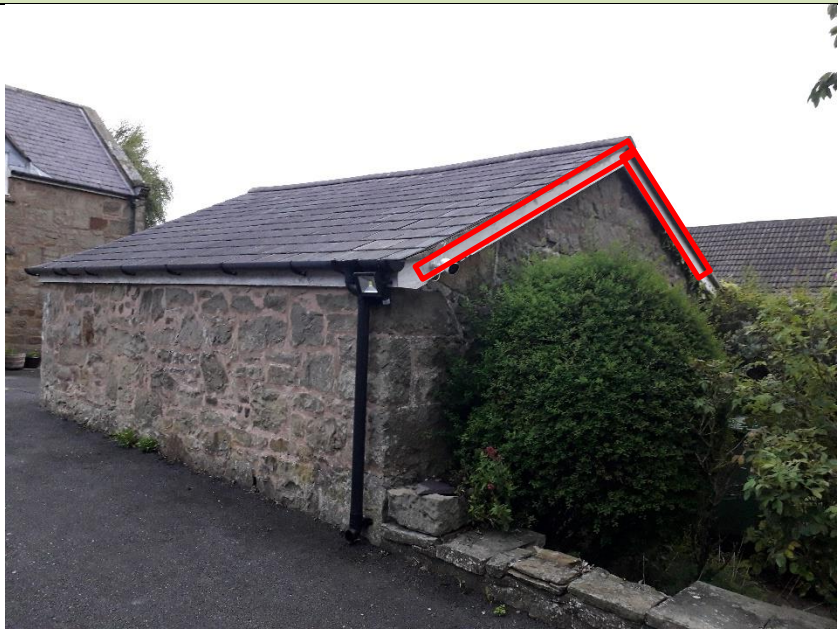
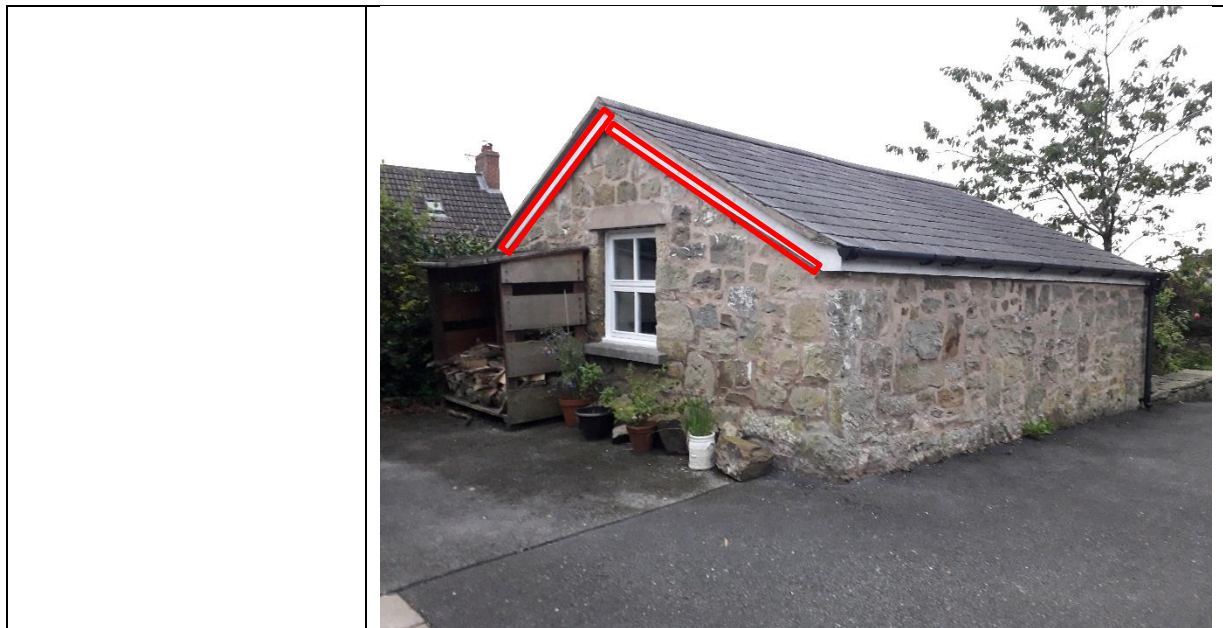
**TABLE 5.1 DESCRIPTION AND PHOTOS OF POTENTIAL ROOSTING FEATURES (SHOWN IN RED)**

- 5.1 The stone work was in very good condition with no gaps or cervices present and the roof was also in very good condition, with no missing, slipped or raised slates. The windows and door were intact and well-sealed and there were no gaps present at the eaves. Behind the bargeboards at both gable ends, there was a gap between the top of the gable wall and the

roof, which led through to the inside of the building. There was a fair amount of cobwebs present covering the majority of the gaps.

| Description of Potential Roosting Features | Photo |
|---|---|
| <p>Small gaps behind the bargeboards, between the roof and the top of the northern and southern gable walls, which led through to the inside of the building.</p> <p>There were a fair number of cobwebs covering the majority of the gaps.</p> | |

- 8.1 As the building is not used by bats to roost, no further surveys, specific mitigation or reasonable avoidance measures are required.
- 8.2 To prevent birds from using the gaps above the gable walls to nest, it is recommended that they are blocked up prior to the works and outside of bird nesting season (from March to September [inclusive]). If works were to be conducted within bird nesting season then a thorough search for any nesting birds should take place immediately prior to the commencement of works. If any active nest is recorded then all works to that section of the building would have to cease until the chicks have fledged. It is an offence to intentionally take, damage or destroy the nest of any wild bird whilst it is in use or being built with unlimited fines and/or imprisonment.
