## Template Method Statement to be used within a Bat Development Licence Application

| <b>Method Statement Title:</b> | Conversion of Former Public House and outbuilding into dwellings at Oak Tree Inn |
| <b>Site Address:</b> | Oak Tree Inn, Ruabon Road, Acton, Wrexham LL13 7PL |

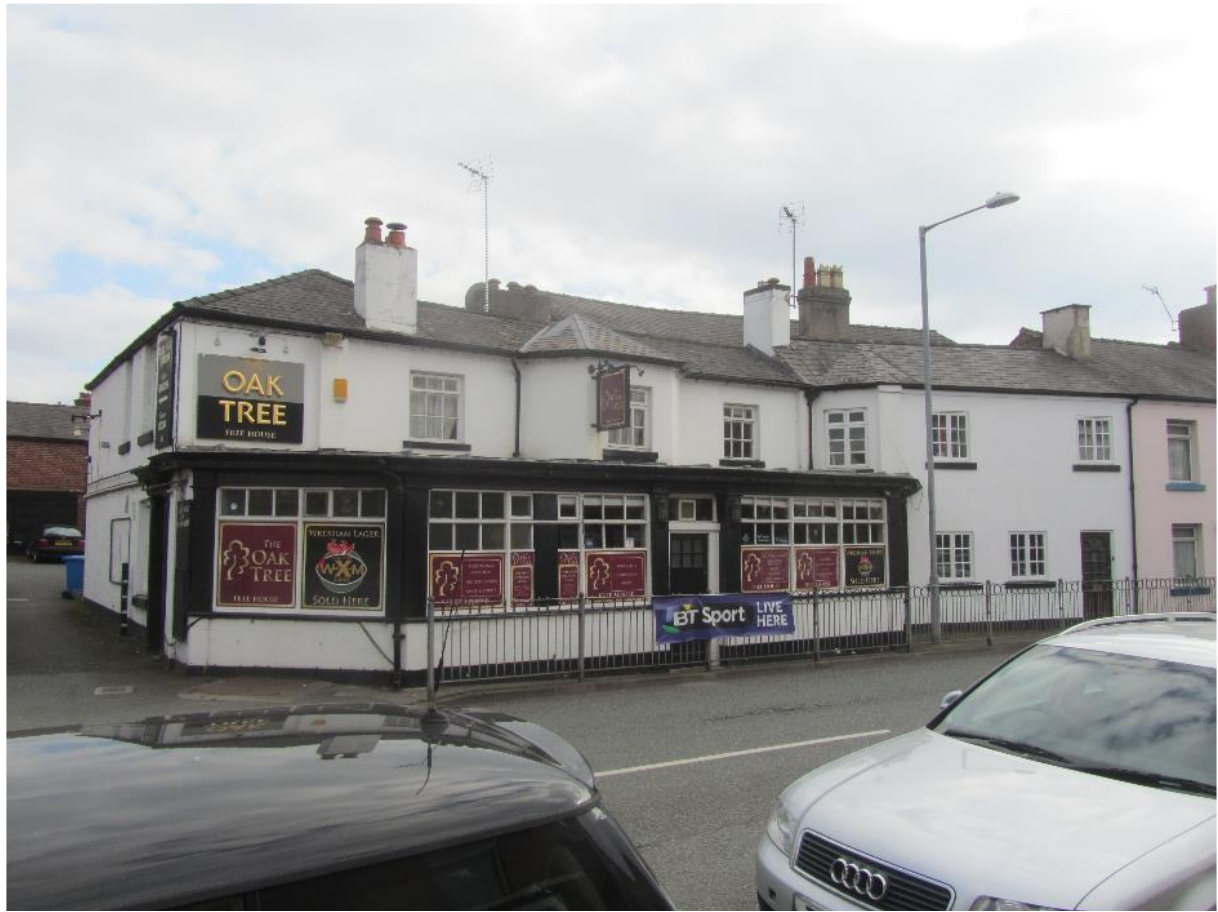
- B1 – The Oak Tree Inn – a public house (currently in use) adjoined to a dwelling, set upon hardstanding and constituting the northern portion of the site, at SJ 33116 49686

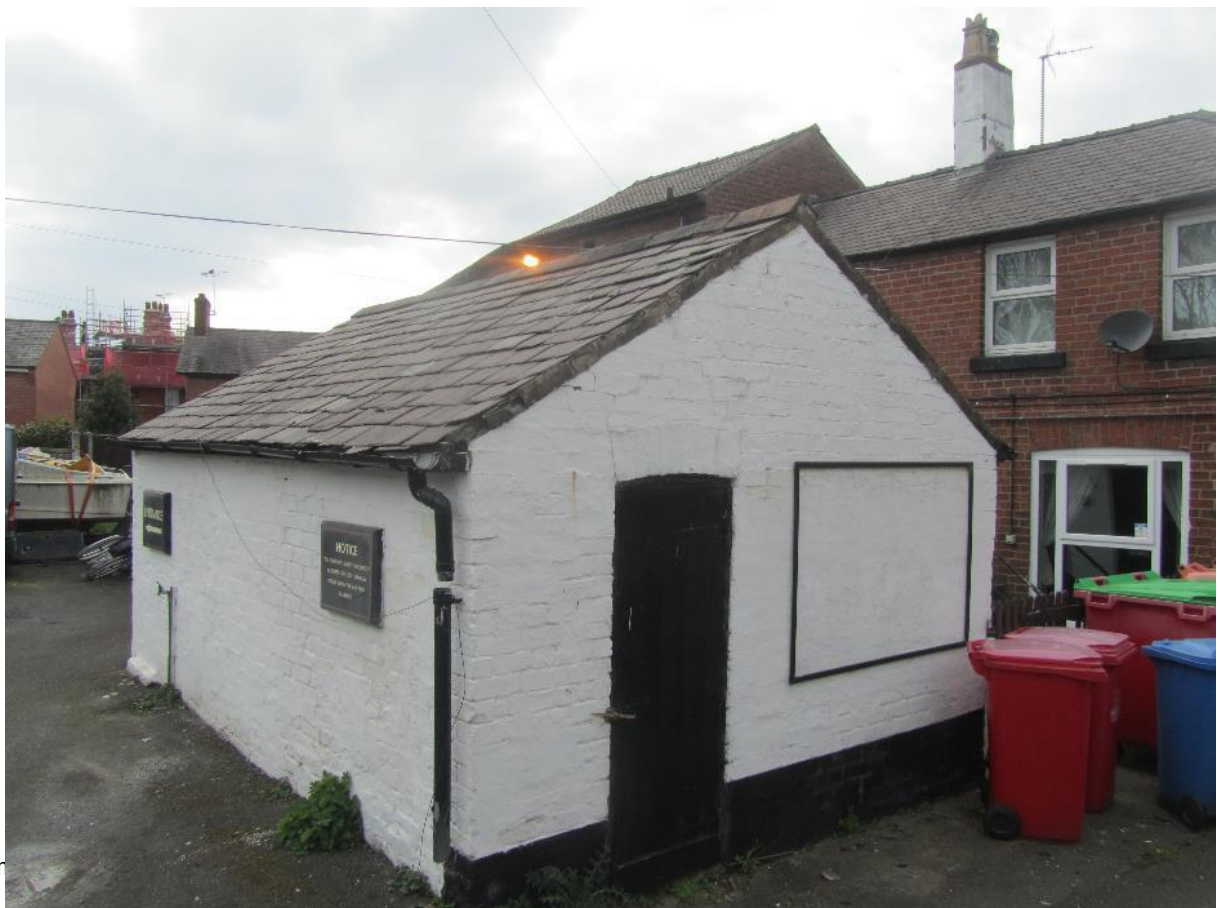
- B2 – A small outbuilding associated with B1, set upon hardstanding within the central portion of the site, at SJ 33128 49680

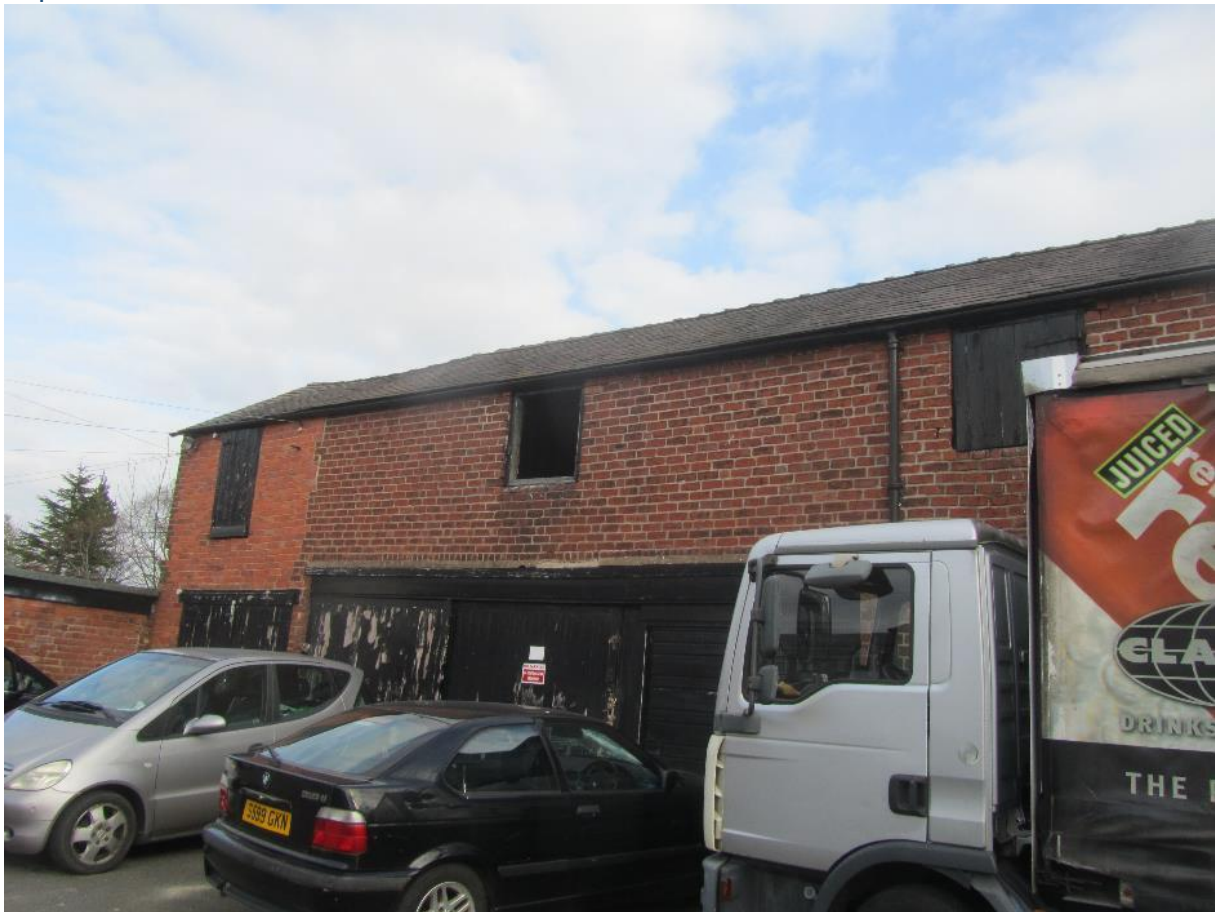
- B3 – A large outbuilding located to the rear of the existing carpark, set upon hardstanding in the southeast portion of the site, at SJ 33143 49670

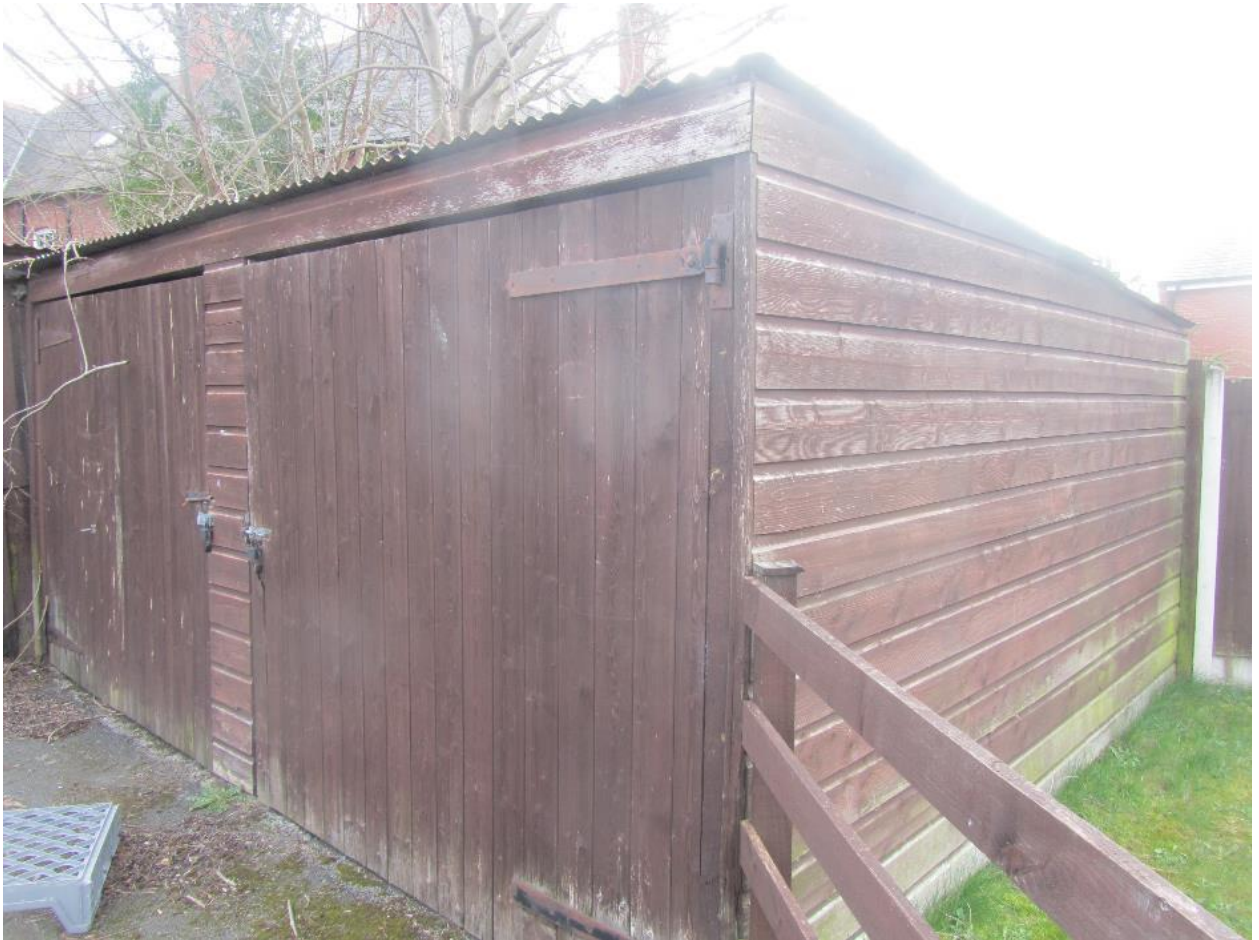
- B4 – A block of timber-built sheds set upon hardstanding along the western site boundary, at SJ 33121 49659

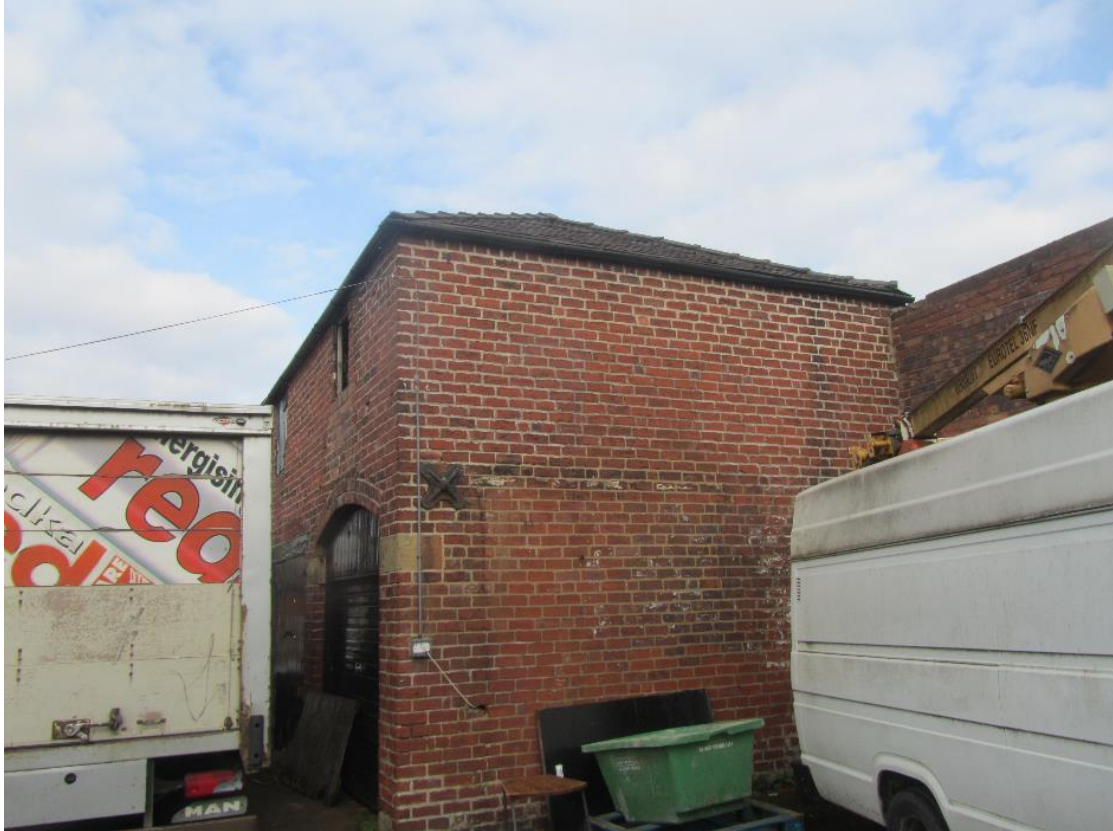
Image 3.25 Western elevation of B3

- B3 (SJ 33143 49670; Image 3.25; Image 3.26) is a large, two-storey outbuilding – possibly a former coach house. B3 is constructed from brick throughout, with a timber truss and a combined of a pitched/ hipped roof with slate tiles. A corrugated lean-to appears to adjoin to the southern aspect (off-site).

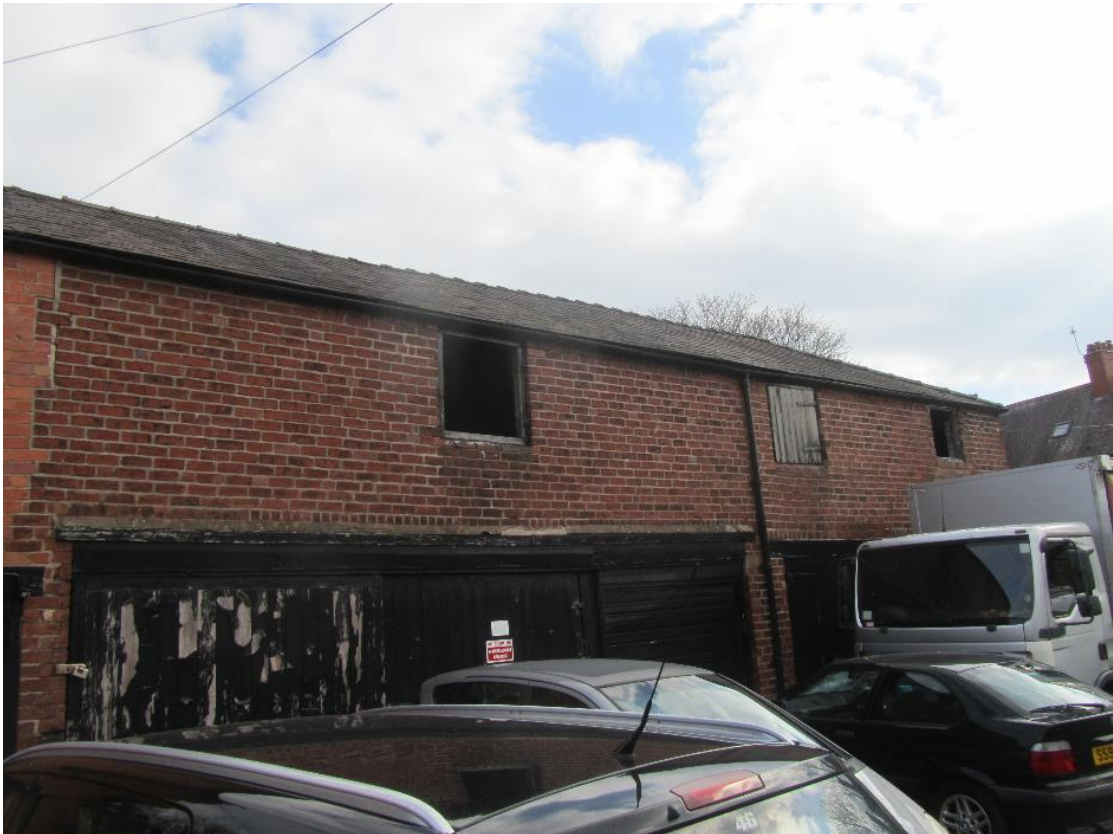
Image 3.26 Northern elevation of B3

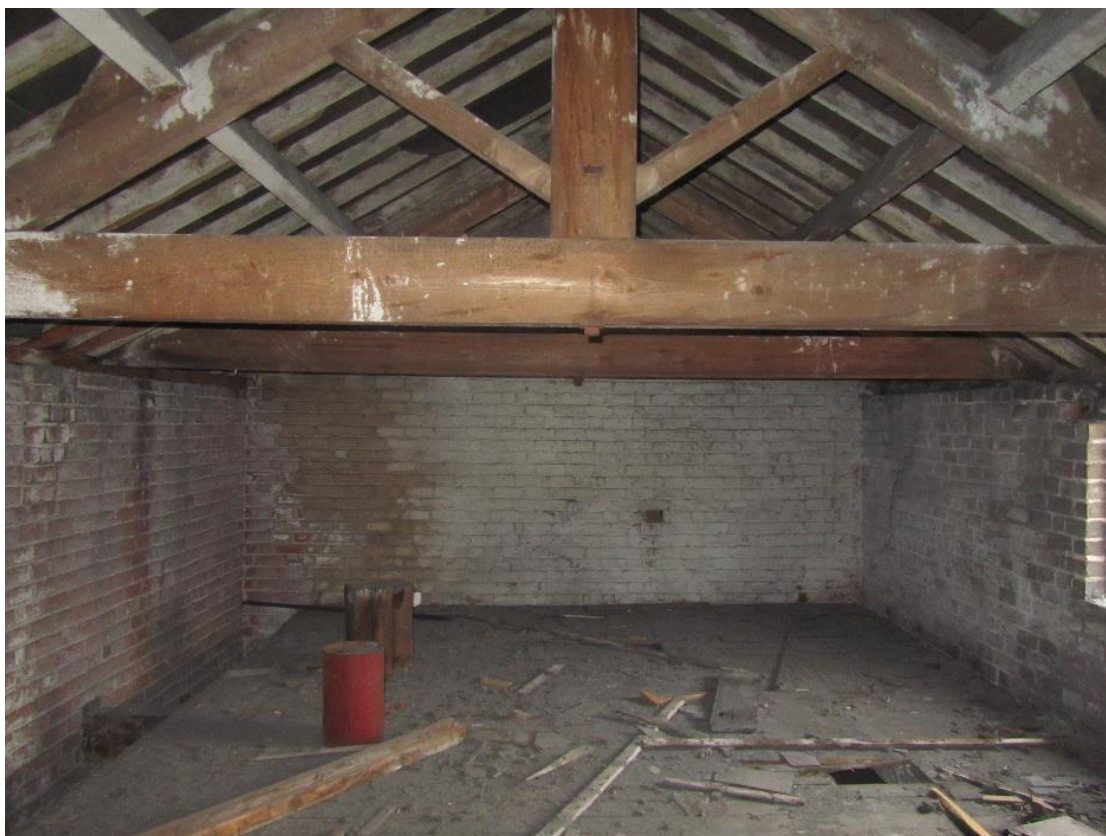
Image 3.27 A typical view within the first-floor level of B3

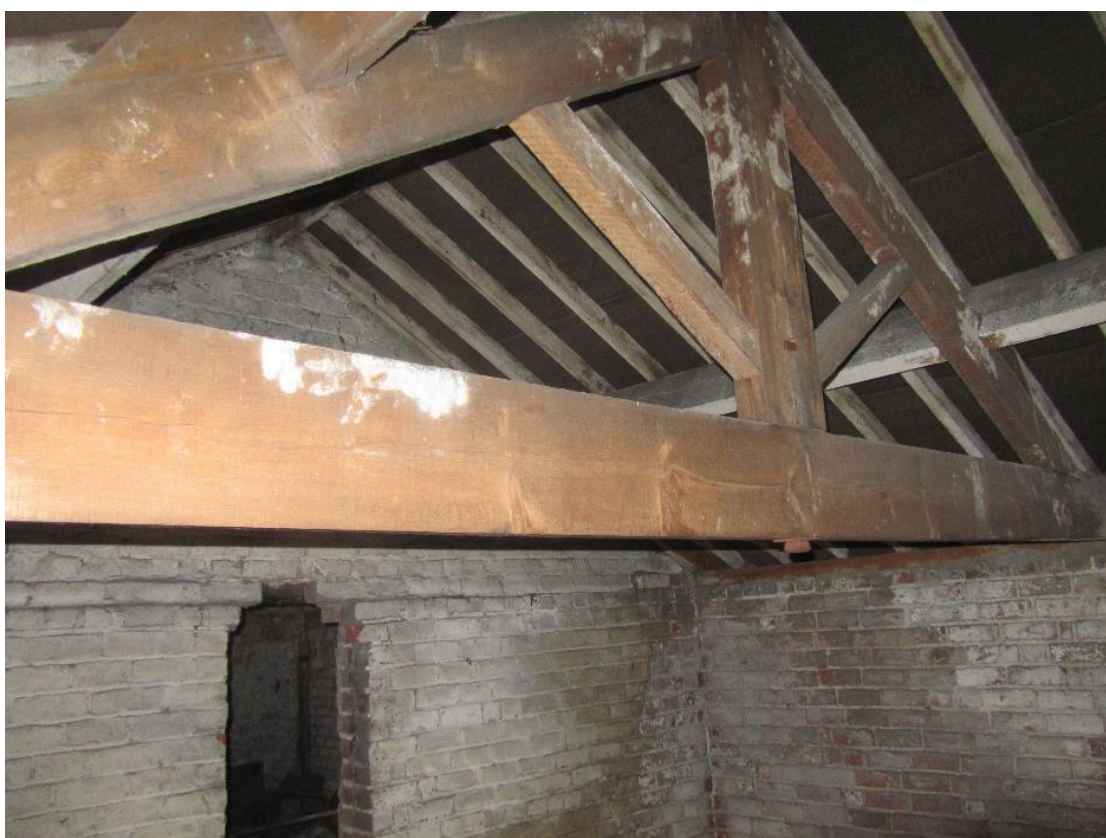
Image 3.28 A typical view within the first-floor level of B3 – showing partition wall with open gap

- Internally, B3 is in good condition overall. The first-floor level is split into four approximate sections via internal partition walls – open door/ window frames within two (2) of the partition walls potentially allows free movement between the two (2) eastern-most sections and between the two (2) western-most sections (Image 3.27; Image 3.28). The timber truss is in good condition and the roof is lined with bitumastic felt (Image 3.29). A small number of potential bat roost features and ingress/ egress points were noted within the interior of B1 during the PRA, and are evaluated below:

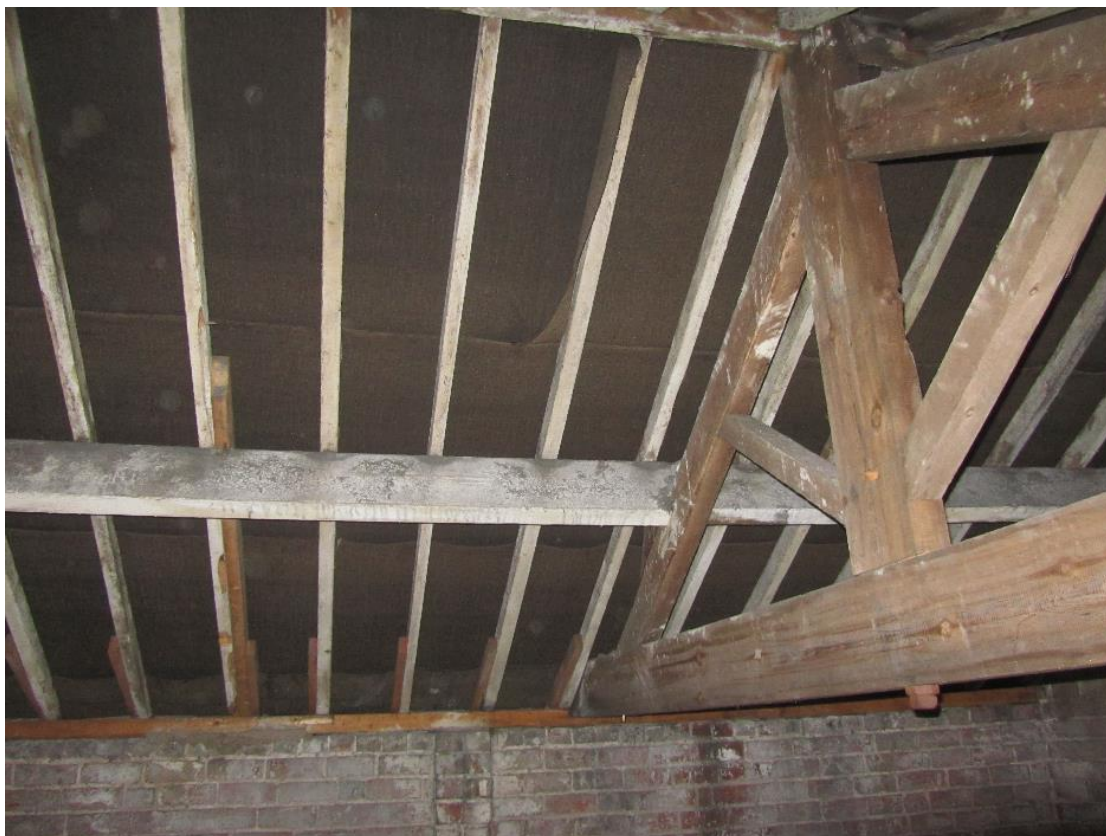
Image 3.29 Bitumastic felt roof lining within B3, with occasional sags noted

- Several sags within the bitumastic felt lining within the roof of B3;
  - Three (3) open window frames on the northern and southern elevations of B3 allow potential access into all sections of this building, along with a significant gap above a shutter (Image 3.30).

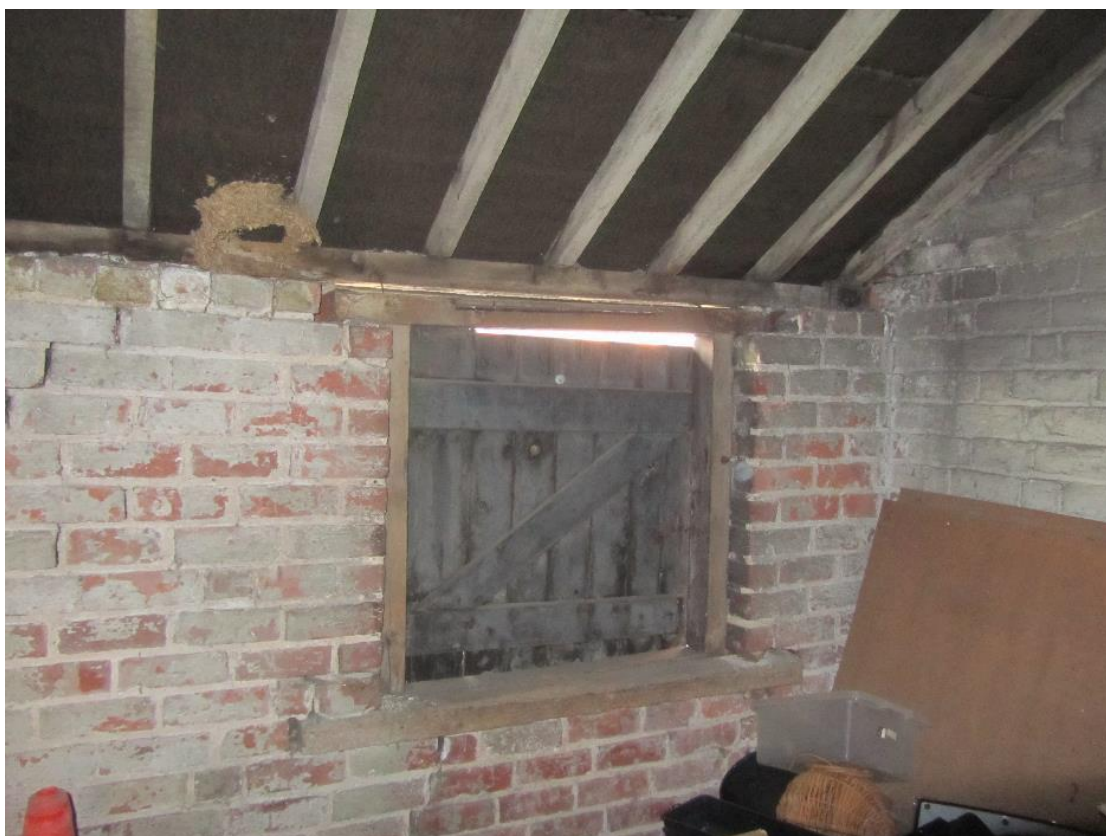
Image 3.30 Gap above a shutter on the first-floor level of B3 presenting a potential access opportunity

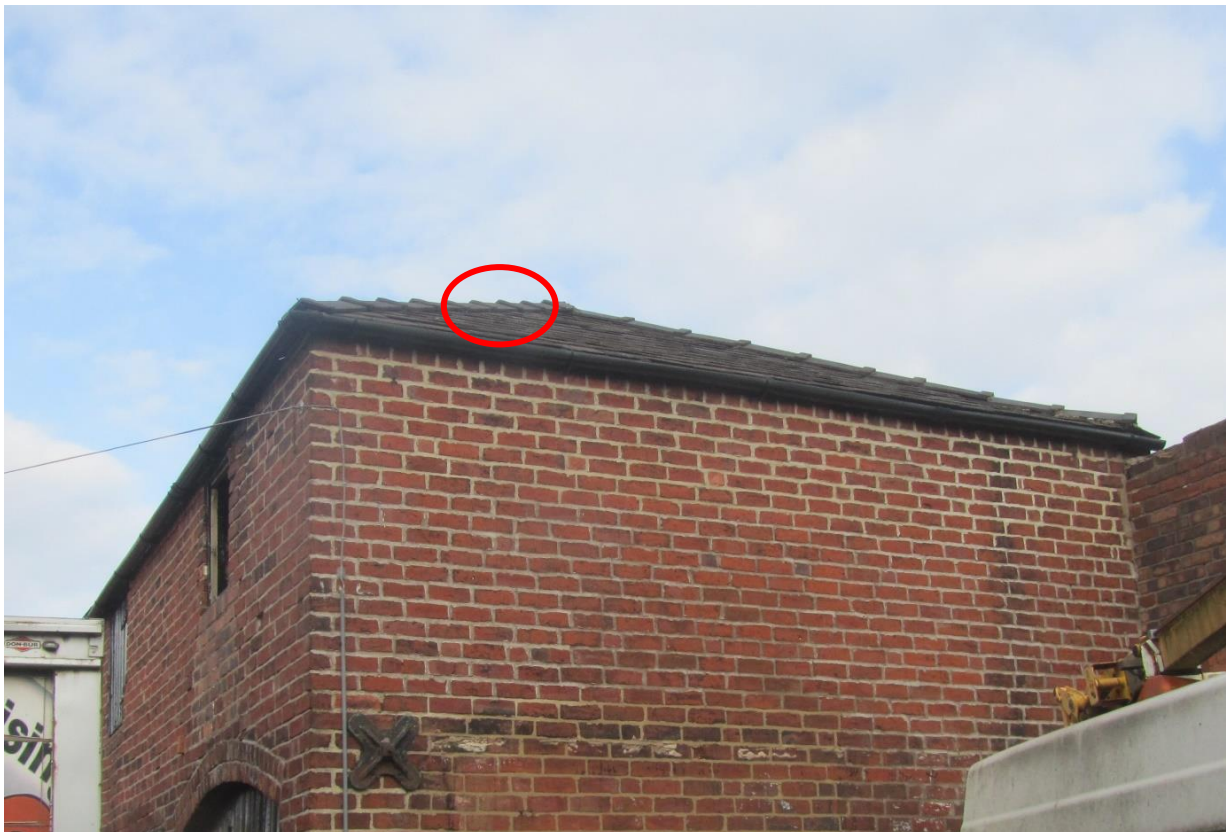
Image 3.32 Pipistrelle roosting location (indicated in red)

- One (1) common pipistrelle emerged from underneath a tile on the hipped roof on the western elevation of B3, where the hip joins the ridge, at 21:18 (Image 3.32). No further bat emergences were recorded.

The first bat pass was observed at 21:27 hrs (15 minutes after sunset); a common pipistrelle which emerged from underneath a tile on the hipped roof on the western elevation of B3 (Image 3.32).

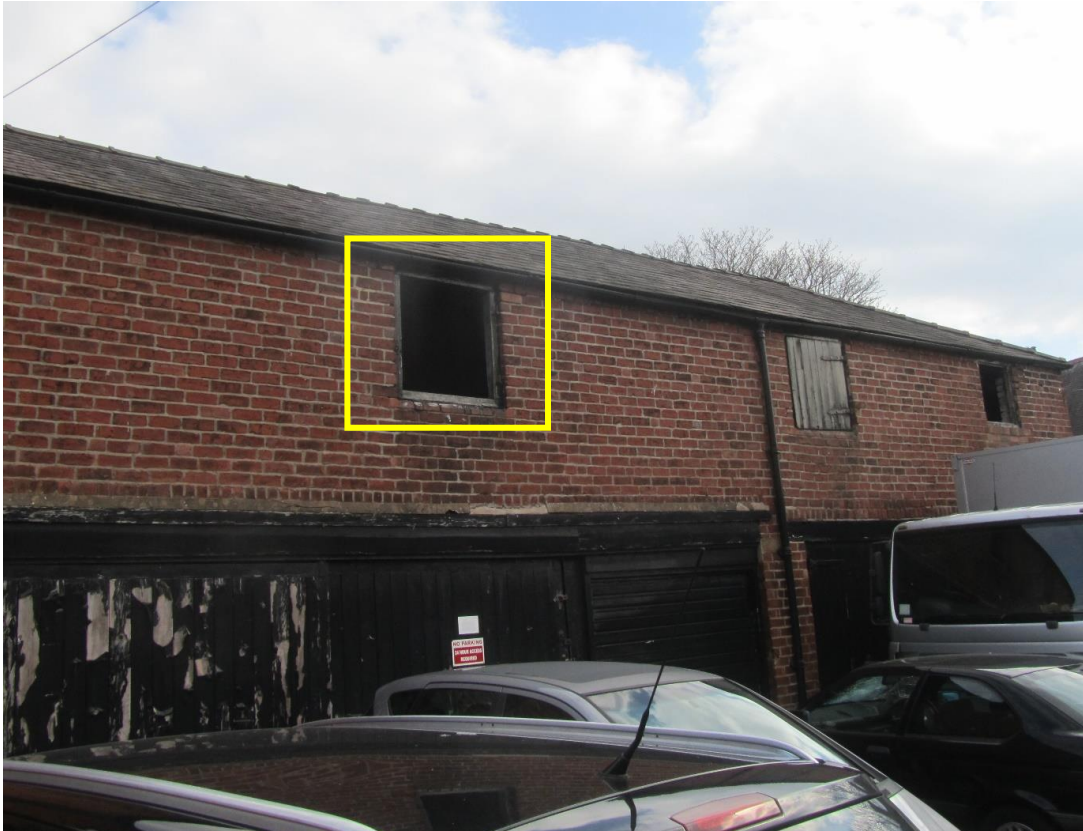
Image 3.33 Open window on the northern elevation of B3, from which a BLE emerged (indicated)

- A single brown long-eared bat (BLE) emerged from B3 at 21:42, which flew out of the eastern-most open window on the northern elevation – this individual flew back inside and then immediately flew out again before commuting to the west (Image 3.33).
