# GARAGE AND WORKSHOP AT MAYFIELD YARD, SUMMERHILL

## PRELIMINARY BAT ROOST ASSESSMENT

Report Ref EE.688.LB

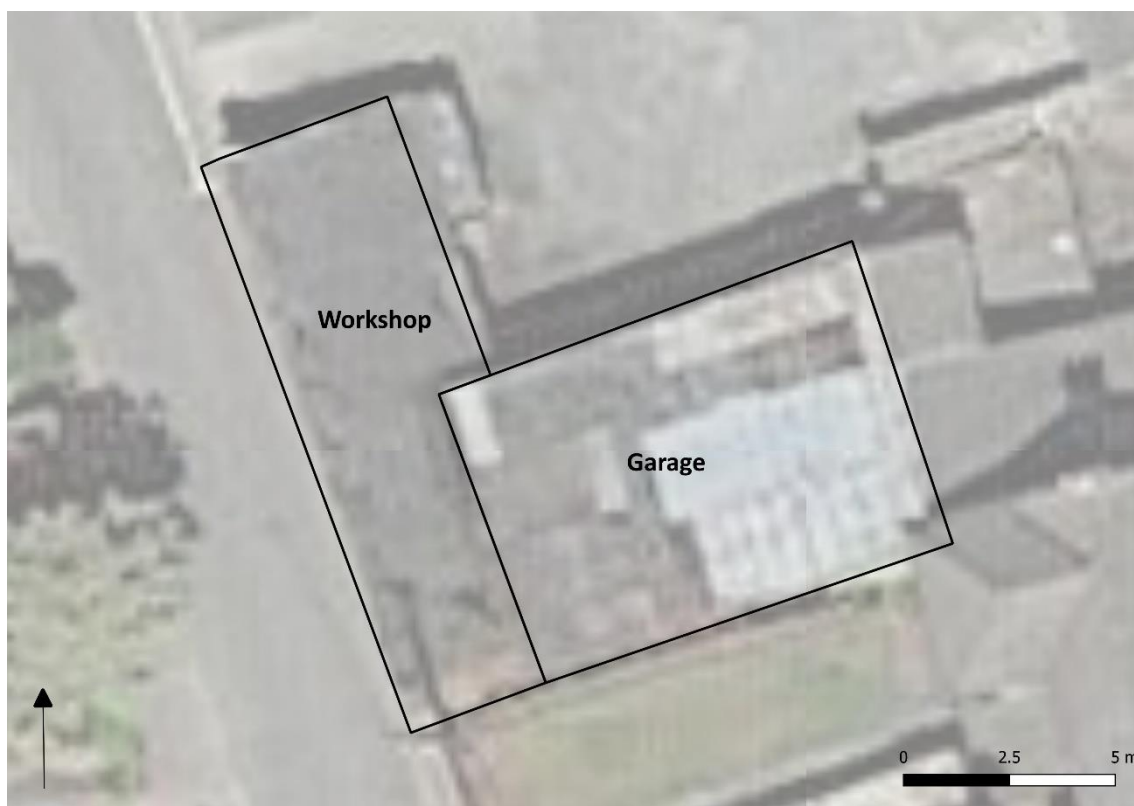
**FIGURE 4.1 SITE PLAN**

4.1 The site comprised a large open fronted garage with an adjoining workshop as shown in Figure 4.1.

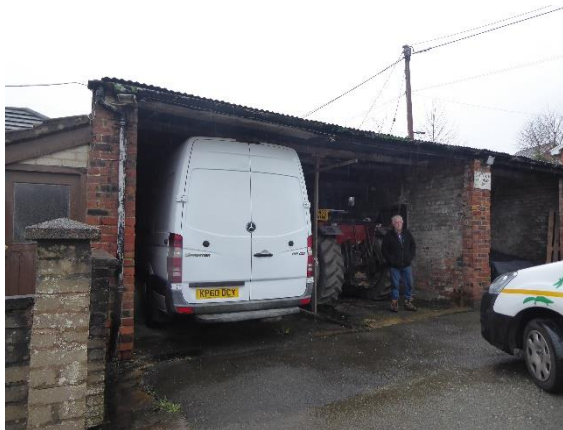
**PHOTO 4.1 GARAGE**

- 4.2.1 The garage comprised a large single storey brick-built building, which was open to the front and had a single skin corrugated metal roof (Photo 4.1). Internally the brick was bare and the space was used for vehicle storage.

| Building | Description of Potential Roosting Features | Photo |
|---|---|---|
| Garage | <p>As the northern elevation was open, the space inside was very exposed and the light levels and air flow were high. As the walls and roof were both a single layer, there were no potential roosting features present both externally or internally.</p> <p>No bats or evidence of bats were seen during the inspection.</p> <p>There were signs that a bird had nested on top of the back wall in the past.</p> | <b>No potential roosting features present</b> |

- 6.3 During the survey, no bats or evidence of bats was identified in either of the buildings.
- 6.4 No potential roosting features were identified in the garage and therefore was found to be of **negligible** suitability for bats (Collins, J., 2016).

- 7.1 As the garage was found to have negligible suitability for roosting bats (Collins, J., 2016), no further surveys are required.
- 7.2 As the workshop was found to have low suitability for roosting bats (Collins, J., 2016), a minimum of one emergence survey is required to assess if/how many/ what species of bats are using the building, **before** works can commence; these must be undertaken between May and August (inclusive).

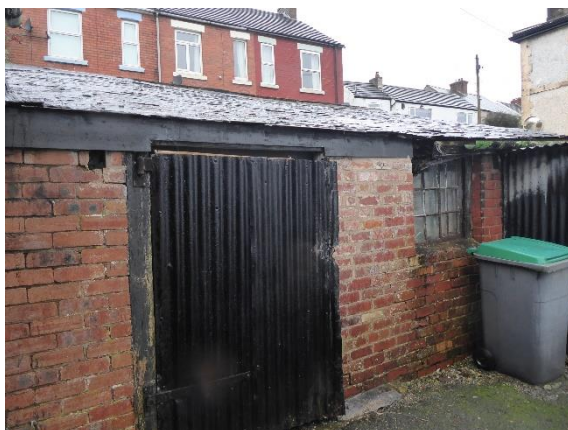
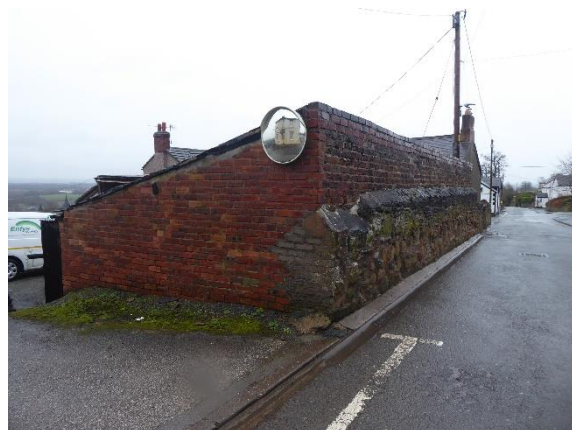
**PHOTOS 4.2 & 4.3 THE EASTERN SIDE AND NORTHERN GABLE END OF THE WORKSHOP**

- 4.3.1 To the west of the garage, running parallel with the main road, was a brick-built workshop (Photos 4.2 & 4.3). The roof was slated and had a wooden fascia along the eastern side. Internally, the workshop was split into two sections, with an internal brick wall. The southern end was the larger of the two sections and was used until recently as a workshop (Photo 4.4). The walls were bare brick and the slate roof was open with no cladding. The smaller section again had bare brick walls but the underside of the roof had been covered by a sheet of visqueen to protect a car, which was stored there (Photo 4.5).

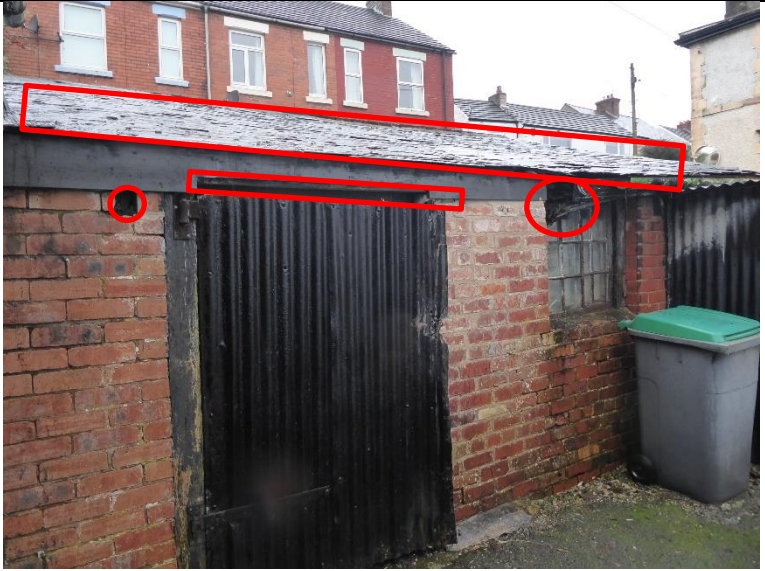
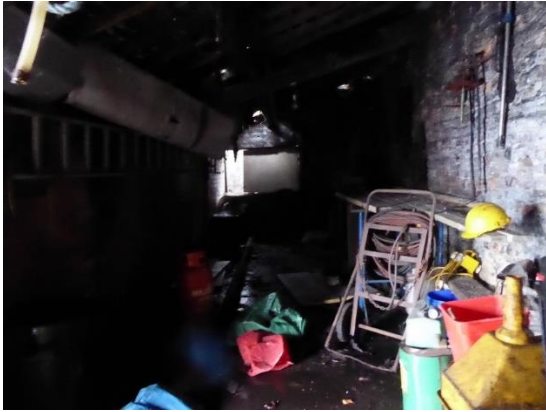
| Workshop | <p>There were a number of gaps and cracks that allowed access into the workshop. There was a small gap in the brick work and a gap above the window and doorway on the eastern side. In places, the roof was in a very poor condition, with multiple missing or slipped slates allowing access into the building. This is shown by multiple light gaps when stood inside.</p> <p>Internally, the light and air flow levels were low.</p> <p>No bats or evidence of bats were seen during the inspection.</p> | |

- 6.5 The workshop had a number of gaps allowing potential access into the building and internally the conditions were suitable for bats. Considering the potential roosting features identified and the surrounding habitat, the workshop is of **low** suitability for roosting bats (Collins, J., 2016).

- 7.3 If bats are found to be using the building, a licence for the works must be obtained from the species licensing body Natural Resources Wales (NRW) **before** any works can take place.
