## Template Method Statement to be used within a Bat Development Licence Application

| Method Statement Title: | Method statement for EPS licensed works at Pen-y-fron Farm |
| Site Address: | Pen-y-fron Farm, Gyfelia, Wrexham, LL13 0YH |

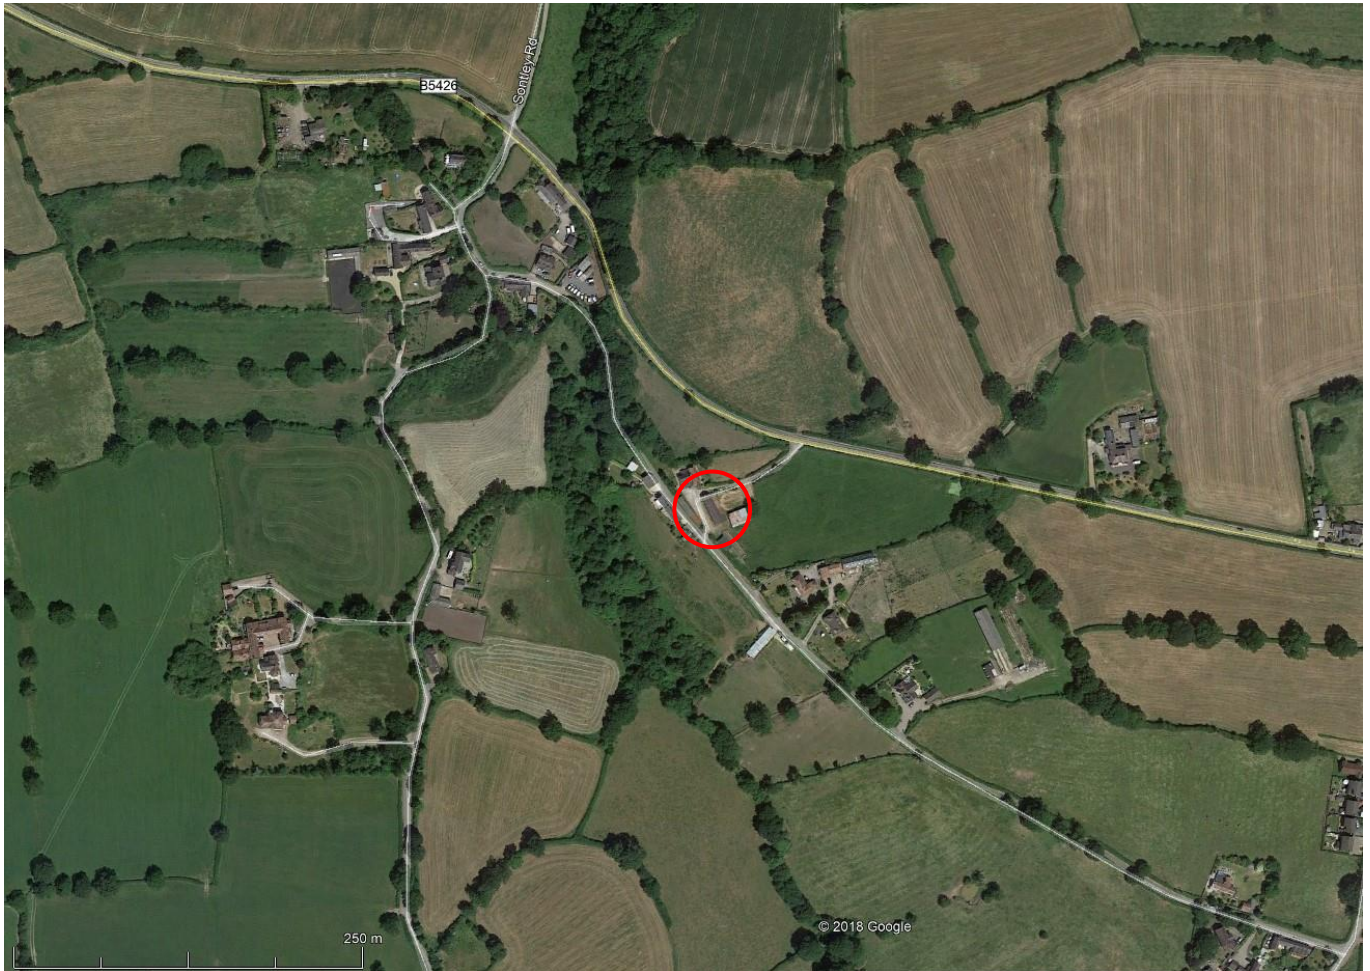
**Figure 4.** Aerial photograph showing the surrounding broad habitat types in the immediate vicinity of the site.  
(imagery dates from 2018, courtesy of Google Earth)

The buildings at Pen-y-Fron Farm are surrounded by pastoral and arable farmland (**Figure 4**), and the habitats in the immediate vicinity include grassland (either permanently grazed or temporarily shut up for silage) and semi-natural broadleaved woodland, with arable fields mostly to the north of the B5426. Approximately 100m to the west, the Gyfeiliau Brook runs northwards towards Sontley, and all of these habitats are linked by an intact network of hedgerows. Connectivity with the surrounding landscape is therefore good, and this mixture of habitats presents significant potential for commuting and foraging bats

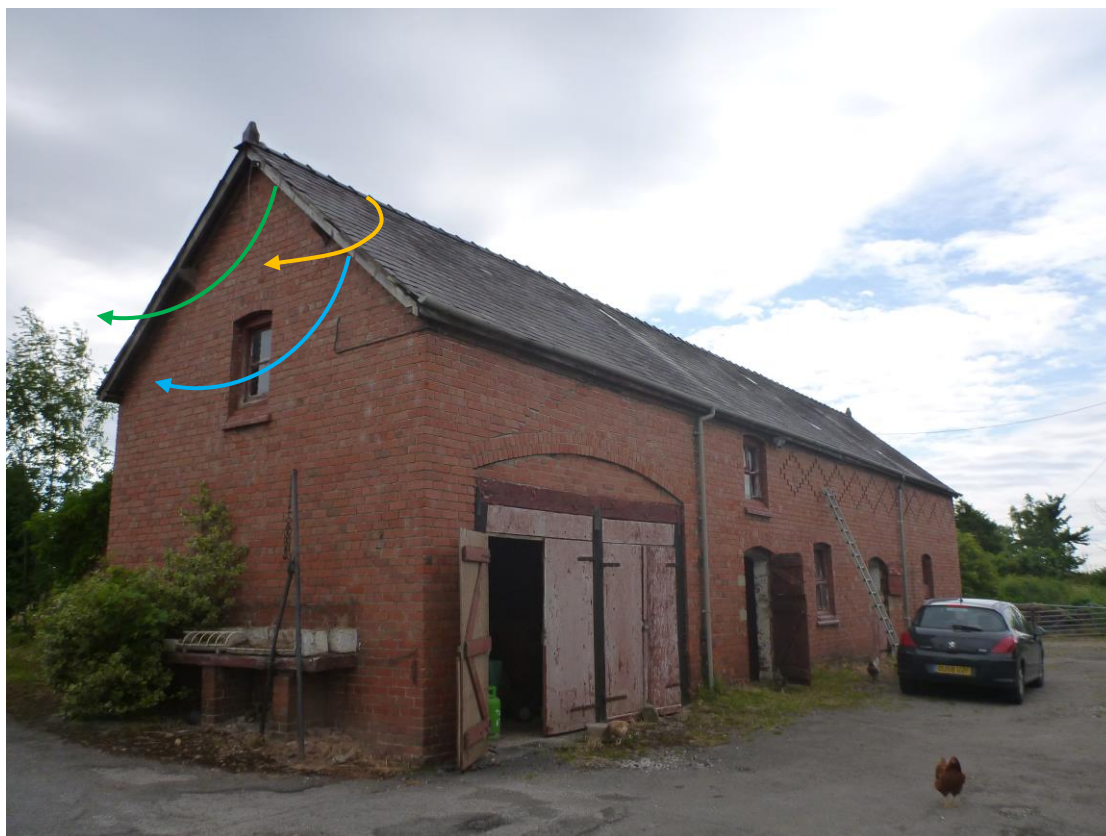
**Figure 9.** View from VP1 showing roost access points (one soprano pipistrelle, one indeterminate pipistrelle, and one whiskered bat).

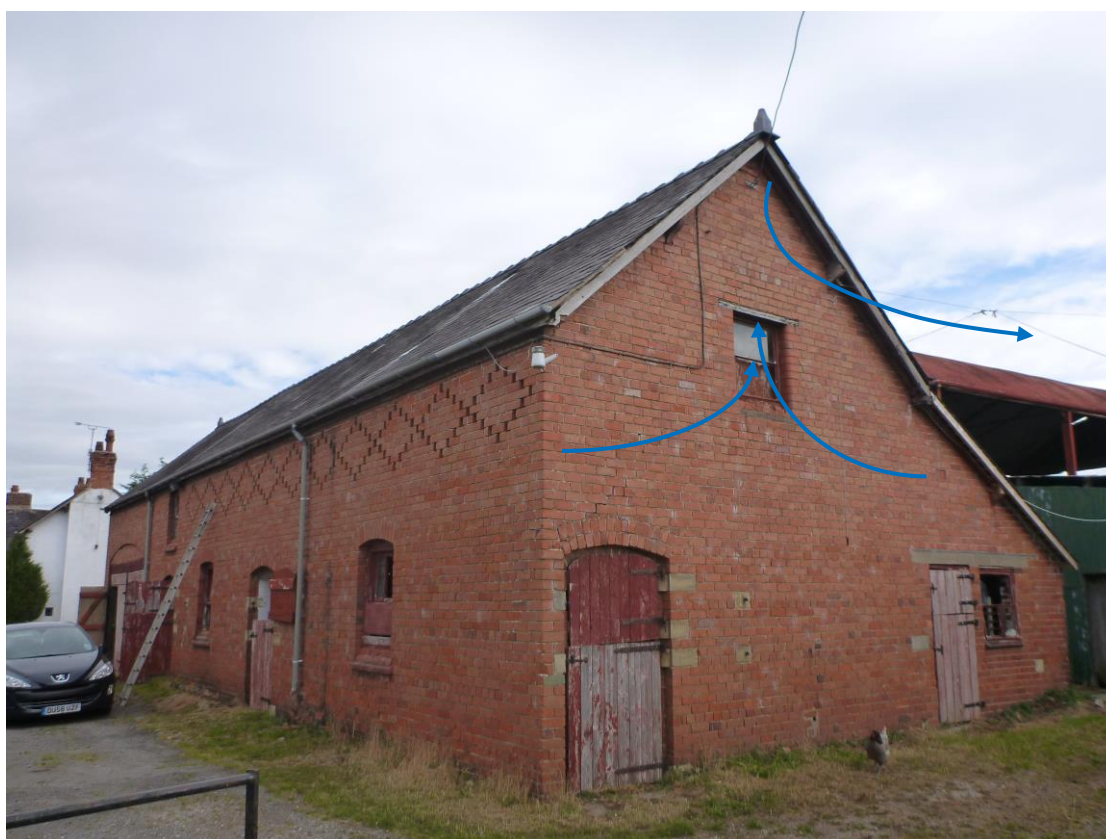
**Figure 10.** View from VP2 showing roost access points (three common pipistrelles).

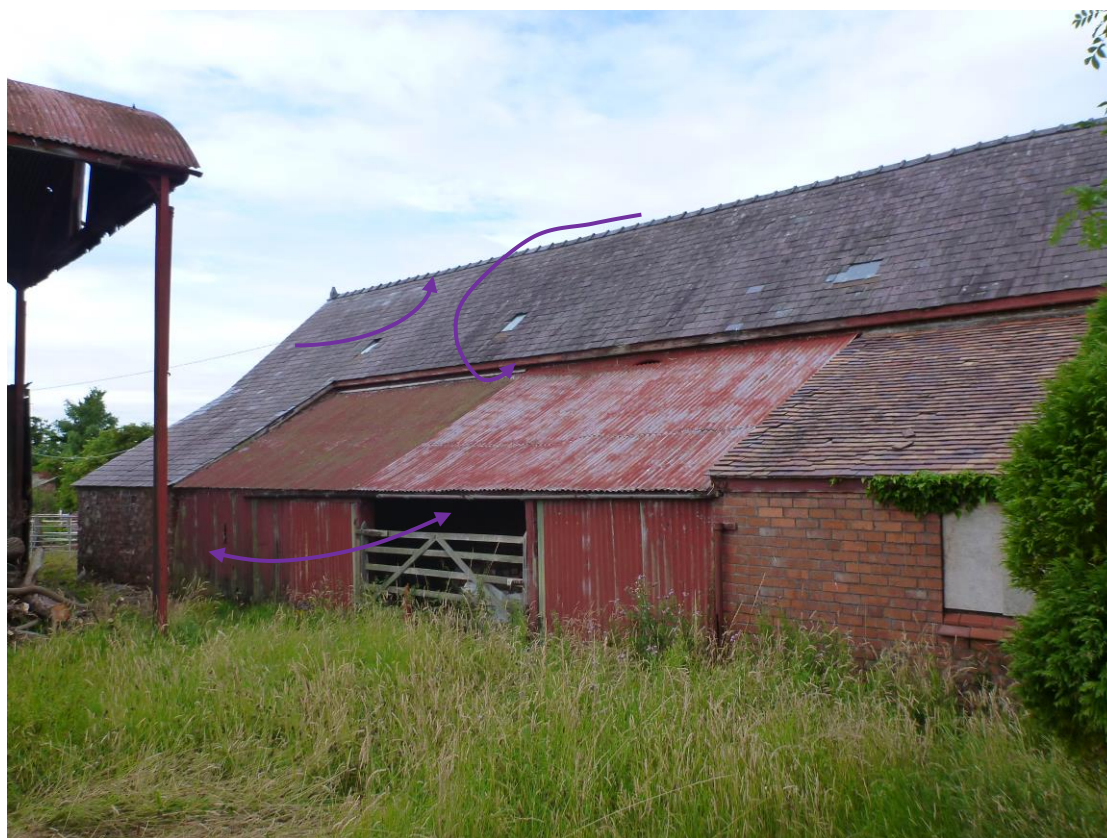
**Figure 11.** View from VP3 showing roost access points (five brown long-eared bats).
