Update of Land adjacent to Lay Hall Riverside Business Park Cefni-y-Bedd  
Wrexham. LL12 9YG  
TREE SURVEY BS5837:2012

GUY SMALLTHWAITE

TREESURE

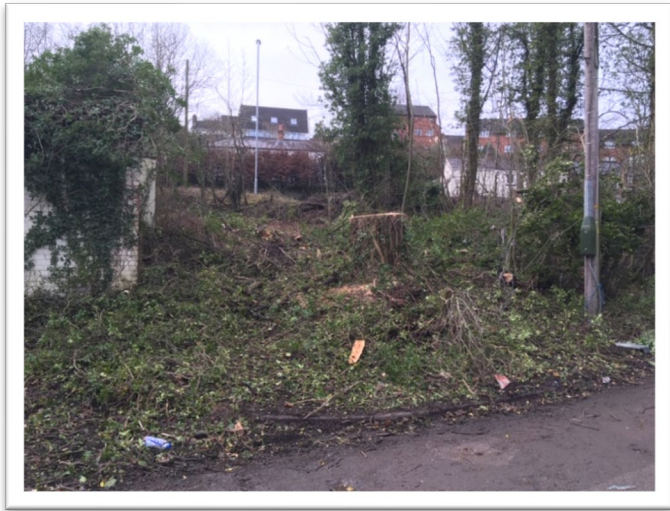
Plate 1. T4 has been removed. Electricity pole on left.

| SURVEY SCHEDULE COMPLIANT TO BRITISH STANDARD 5837: 2012 DATE 3/02/2020 | | | | | | | | | | | | | |
|---|---|---|---|---|---|---|---|---|---|---|---|---|---|
| T4 | Sycamore<br><i>Acer Pseudoplatanus</i><br><b>Now removed.</b> | 19m | 923mm | 8 | 8 | 8 | 8 | 5 (N) | 5m | M | 40+ | B2 | 1. A large, healthy example with no apparent defects.<br>2. It is clad in ivy and bifurcates at 3m.<br><b>Now removed.</b> |

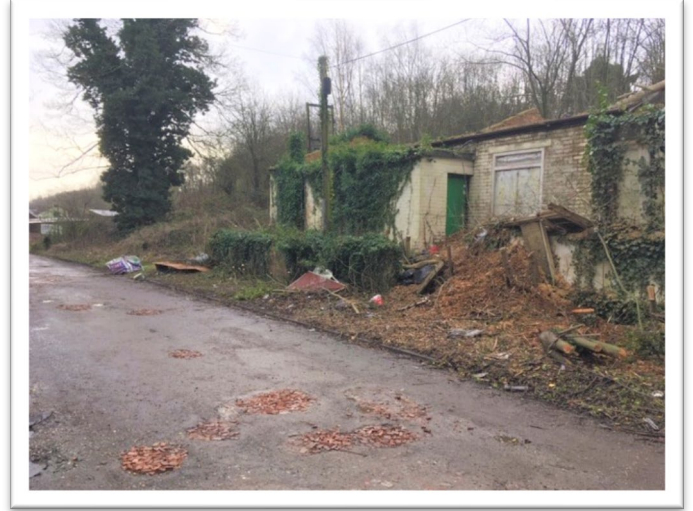
Plate 2. G1 – The saplings which were growing against building have now been removed.

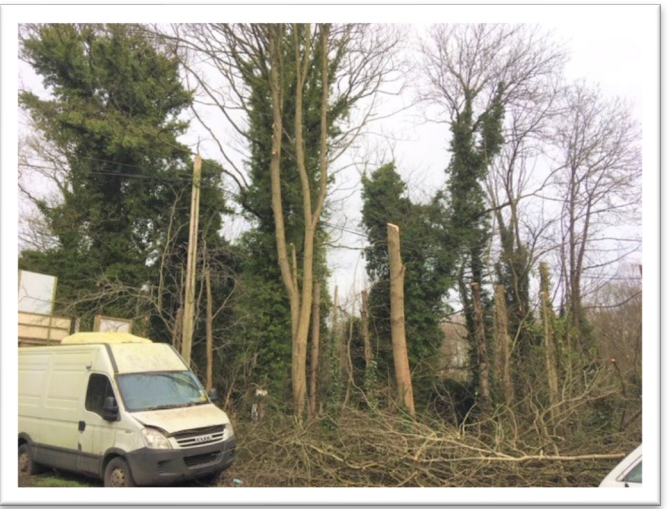
Plate 3. Trees on north east boundary. T7 has had lower branches removed and T8, T9 and G2 have been reduced to approx. 4 metres to clear power lines.

| SURVEY SCHEDULE COMPLIANT TO BRITISH STANDARD SURVEY SCHEDULE COMPLIANT TO BRITISH STANDARD 5837: 2012 DATE 03/02/2020 | | | | | | | | | | | | | |
|---|---|---|---|---|---|---|---|---|---|---|---|---|---|
| T7 | Sycamore<br><i>Acer pseudoplatanus</i><br>Canopy raised by 2m. | 11.5m | 381mm | 1 | 5 | 3 | 3 | 4(S) | 4m | S/M | 20+ | C2 | 1. Appears healthy with no apparent defects.<br>2. The tree bifurcates at 1.5m.<br>Canopy raised by 2m. |
| T9 | Cherry<br><i>Prunus avium</i><br>Reduced height to 4 metres. | 10m | 146mm | 0 | 4 | 2 | 2 | 3 (S) | 3m | M | 20+ | C2 | 1. Single-stemmed and leaning south.<br>2. Healthy foliage with no apparent defects.<br>Reduced height to 4 metres. |

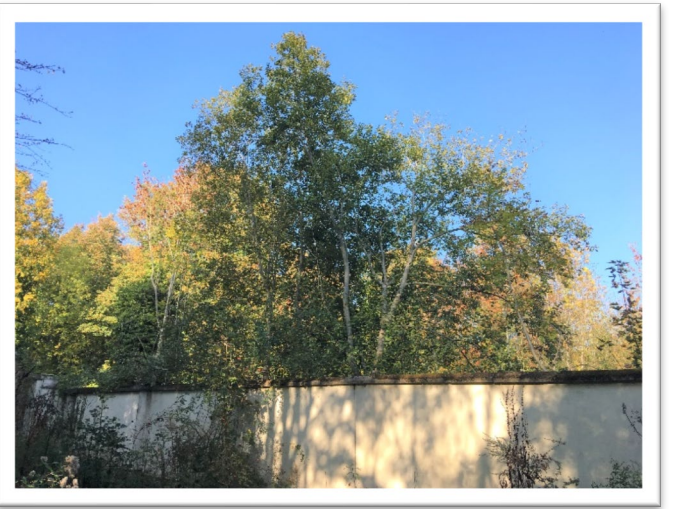
Plate 4. T22, T23 and T24 growing within the building.

| SURVEY SCHEDULE COMPLIANT TO BRITISH STANDARD SURVEY SCHEDULE COMPLIANT TO BRITISH STANDARD 5837: 2012 DATE 03/02/2020 | | | | | | | | | | | | | |
|---|---|---|---|---|---|---|---|---|---|---|---|---|---|
| T22 | Goat Willow<br><i>Salix caprea</i> | 8m | 230mm | 4 | 2 | 3 | 3 | 2 (N) | 3m | Y | 20+ | C2 | 1. Multi-stemmed example, appears healthy with no apparent defects.<br>2. Growing out of building. |
| T23 | Goat Willow<br><i>Salix caprea</i> | 8m | 380mm | 4 | 2 | 3 | 3 | 2 (W) | 3m | Y | 20+ | C2 | 1. Single-stemmed example, appears healthy with no apparent defects.<br>2. Growing out of building. |
| T24 | Ash<br><i>Fraxinus excelsior</i> | 12m | 170mm | 3 | 2 | 2 | 2 | 2 (N) | 2m | Y | 20+ | C2 | 1. Single-stemmed and leaning south.<br>2. Healthy foliage with no apparent defects. |

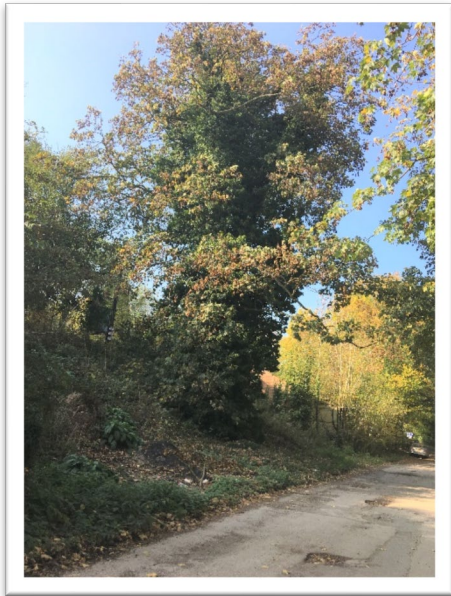
Plate 5. T15 – large Sycamore tree clad in ivy.

| SURVEY SCHEDULE COMPLIANT TO BRITISH STANDARD SURVEY SCHEDULE COMPLIANT TO BRITISH STANDARD 5837: 2012 DATE 13/10/2018 | | | | | | | | | | | | | |
|---|---|---|---|---|---|---|---|---|---|---|---|---|---|
| Ref No | Species | Height (m) | Stem diameter (mm) | N | S | E | W | First sig branch and direction (m) | Canopy height (m) | Life stage | Estimated remaining contribution (years) | Category grading | Observations and Management recommendations |
