## PHASE I GEO-ENVIRONMENTAL SITE ASSESSMENT

**Stansty Chain Road  
Wrexham  
LL11 4YH**

**Report Ref: 11-130-r1**  
**Date Issued: October 2017**

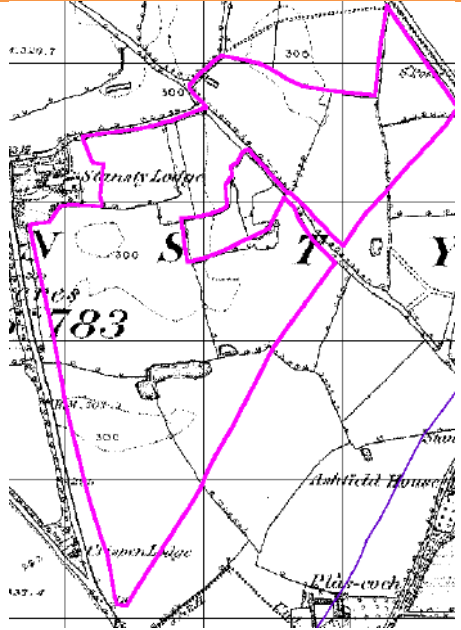
| MAP EDITION | HISTORICAL LAND USE | HISTORICAL MAP EXCERPT |
|---|---|---|
| <p><b>1848</b><br/><b>1:10,000</b></p> | <p>The site is shown to comprise undeveloped fields, containing boundaries and footpaths. There are also two ponds recorded in the south of the site.</p> | |

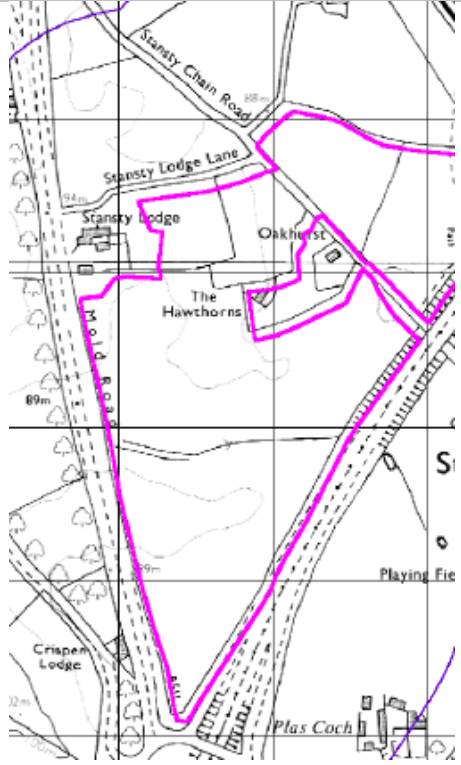
| MAP EDITION | HISTORICAL LAND USE | HISTORICAL MAP EXCERPT |
|---|---|---|
| <p><b>1874</b><br/><b>1:10,000</b></p> | <p>The site remains similar to present day. However, several trees within the site and bordering the site are no longer present after 1874.</p> | |

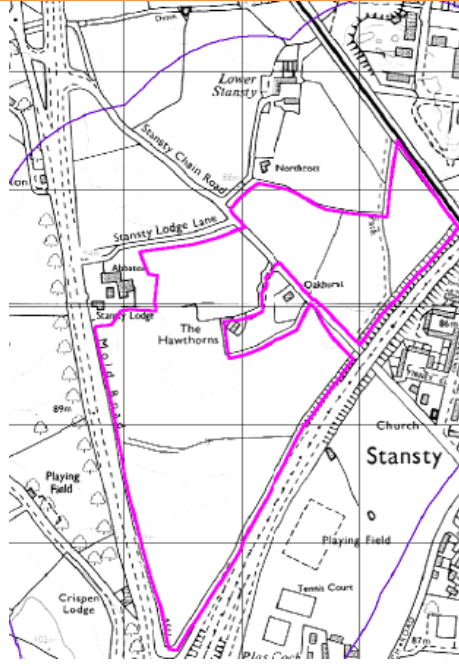
| MAP EDITION | HISTORICAL LAND USE | HISTORICAL MAP EXCERPT |
|---|---|---|
| <p><b>1992</b><br/><b>1:10,000</b></p> | <p>Little has changed since the previous map edition. However the two ponds within the northern sector of the site are long present.</p> | |

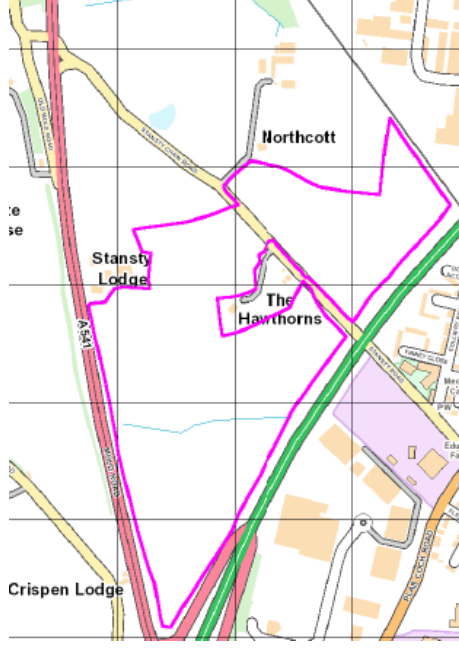
| MAP EDITION | HISTORICAL LAND USE | HISTORICAL MAP EXCERPT |
|---|---|---|
| <p><b>1874</b><br/><b>1:10,000</b></p> | <p>Little has changed since the previous map edition.</p> | |

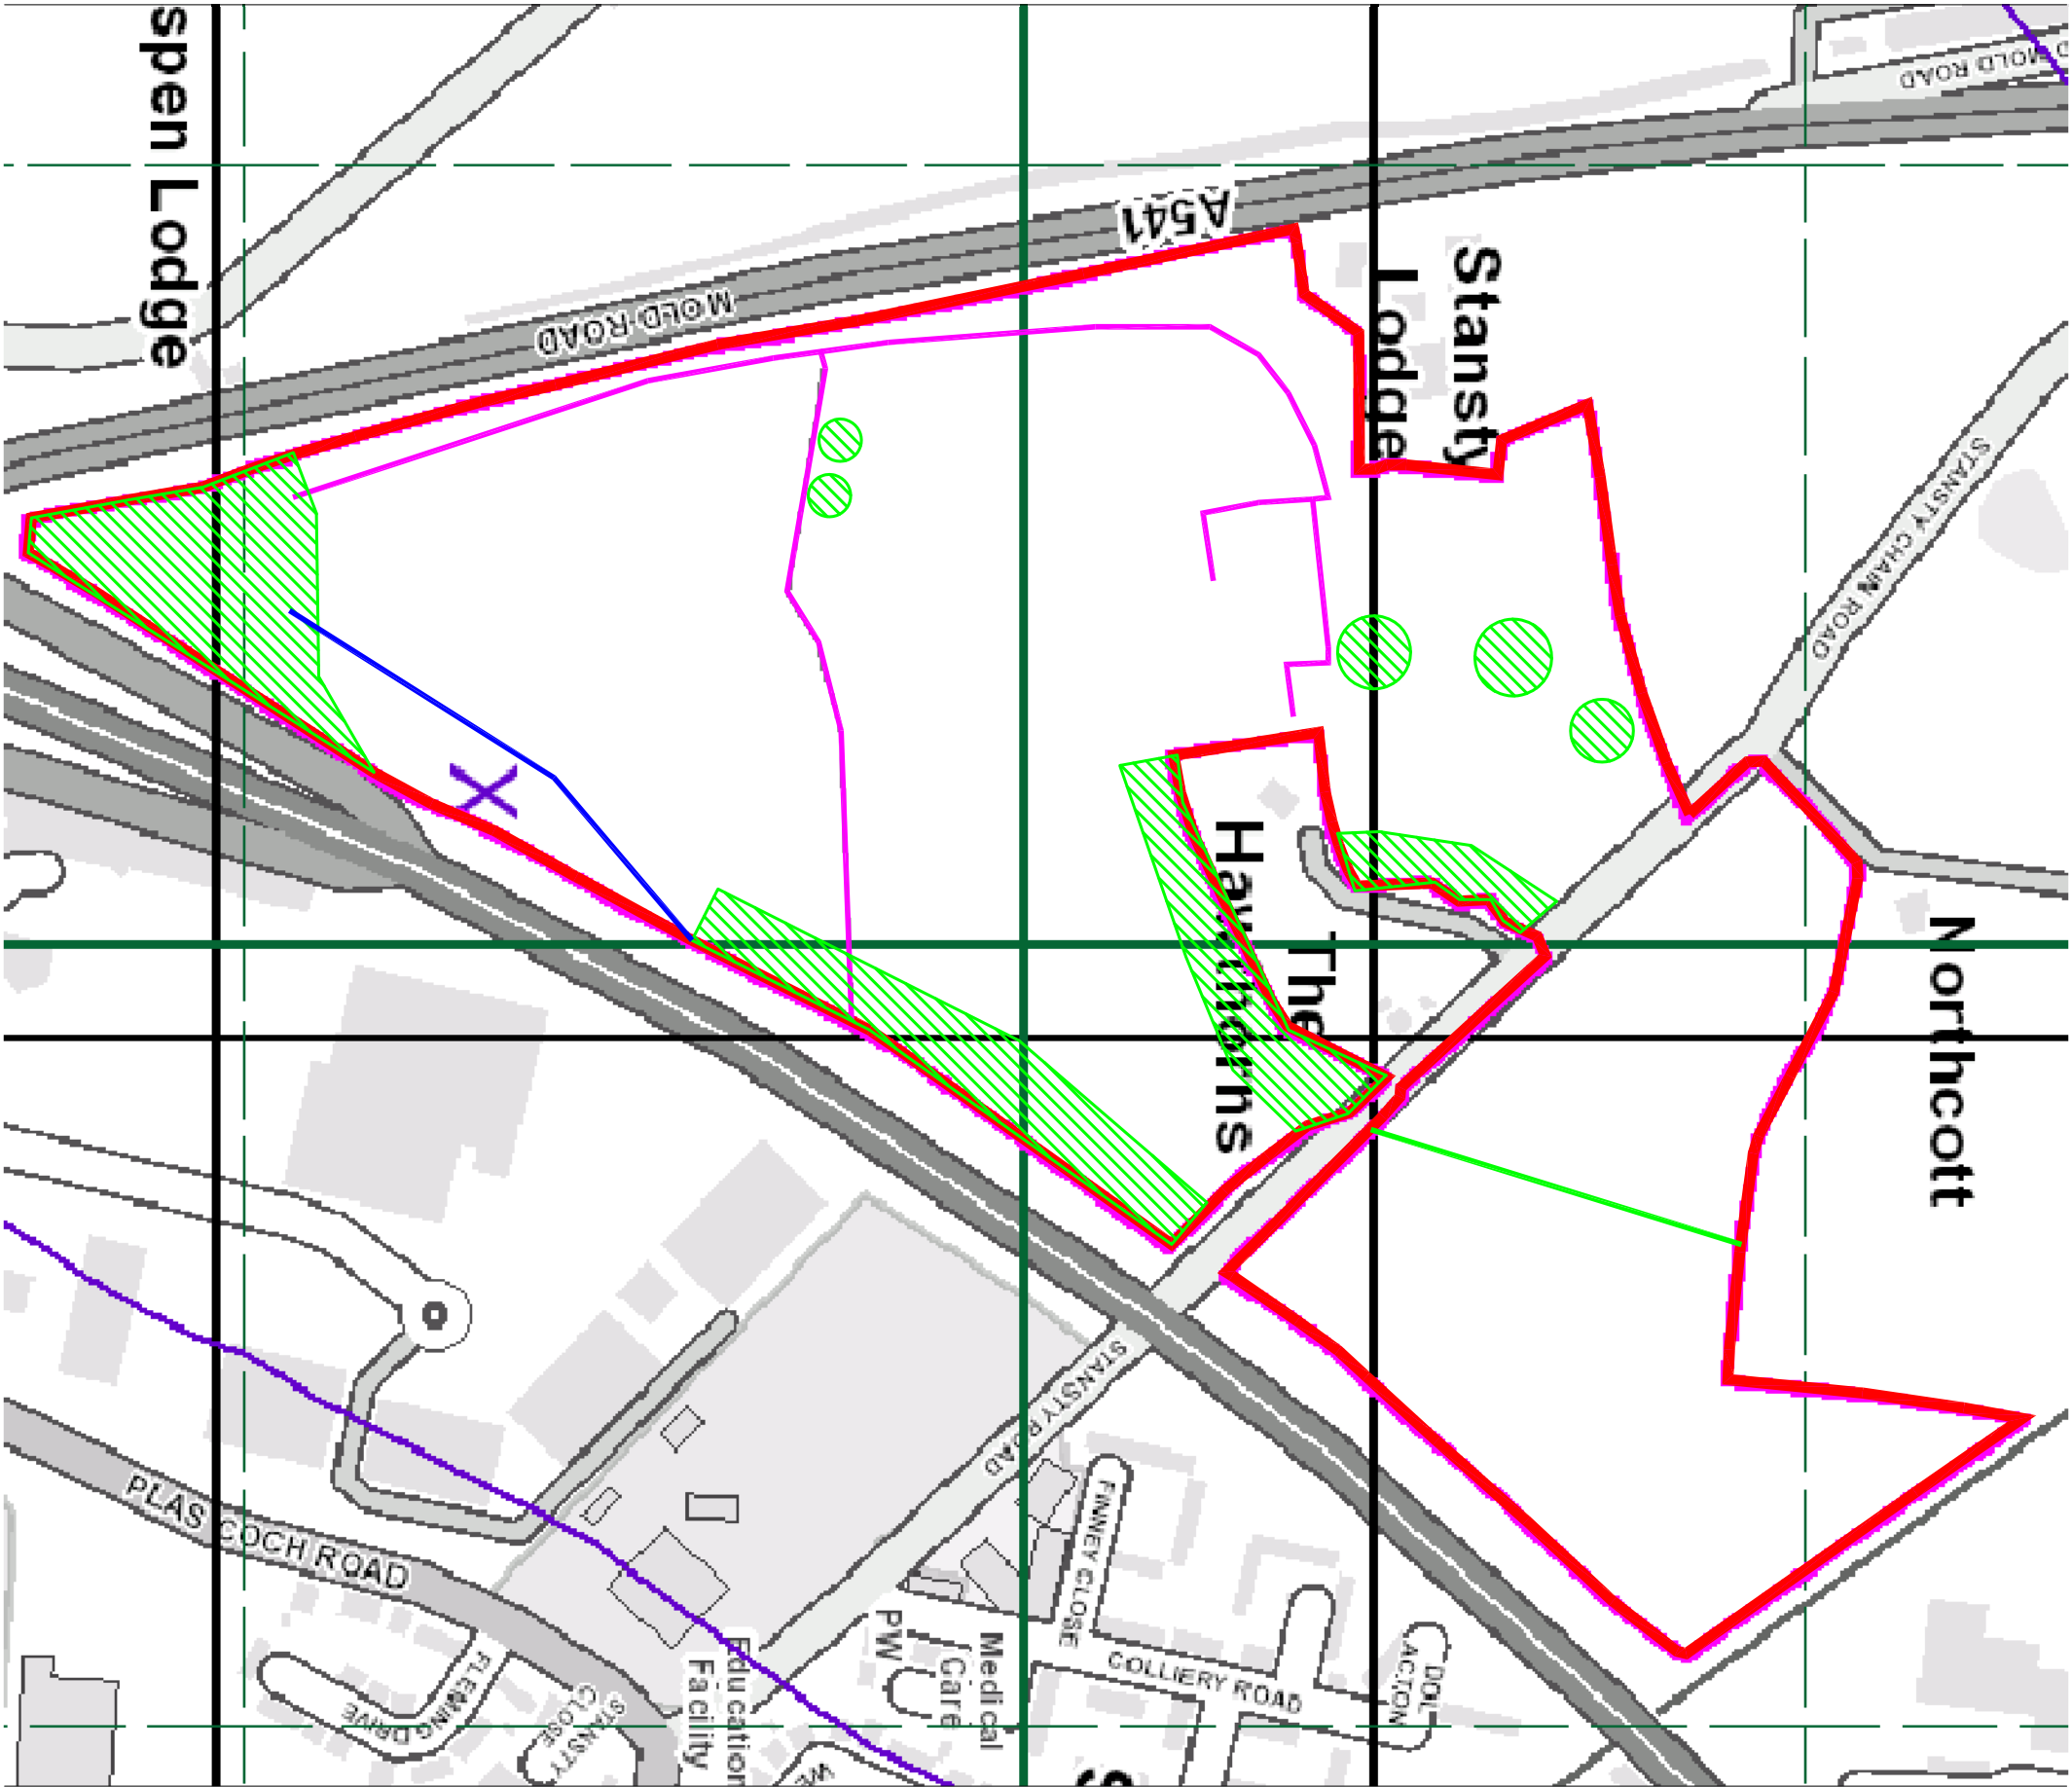
- Historical Features**
- Paths
  - Area of Trees and Hedges
  - Overhead Power Lines
