# Preliminary Bat Roost Assessment (PRA) Report

**Project:** Glenmore, Higher Penley, Penley, Wrexham, LL13 0NB

**Reference:** 110320.PRA

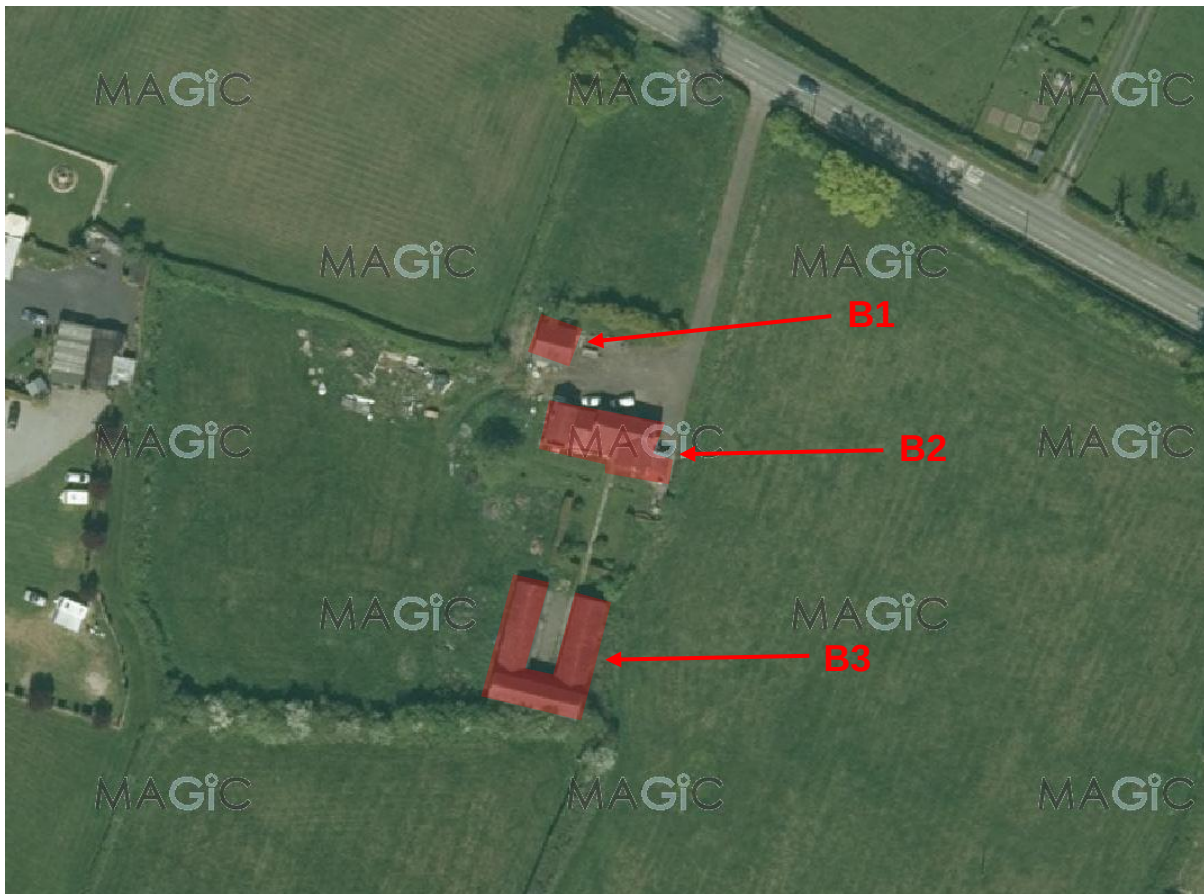
**Figure 3** Aerial image of the site/ survey area and immediate surrounds, showing buildings (B1 – B3)

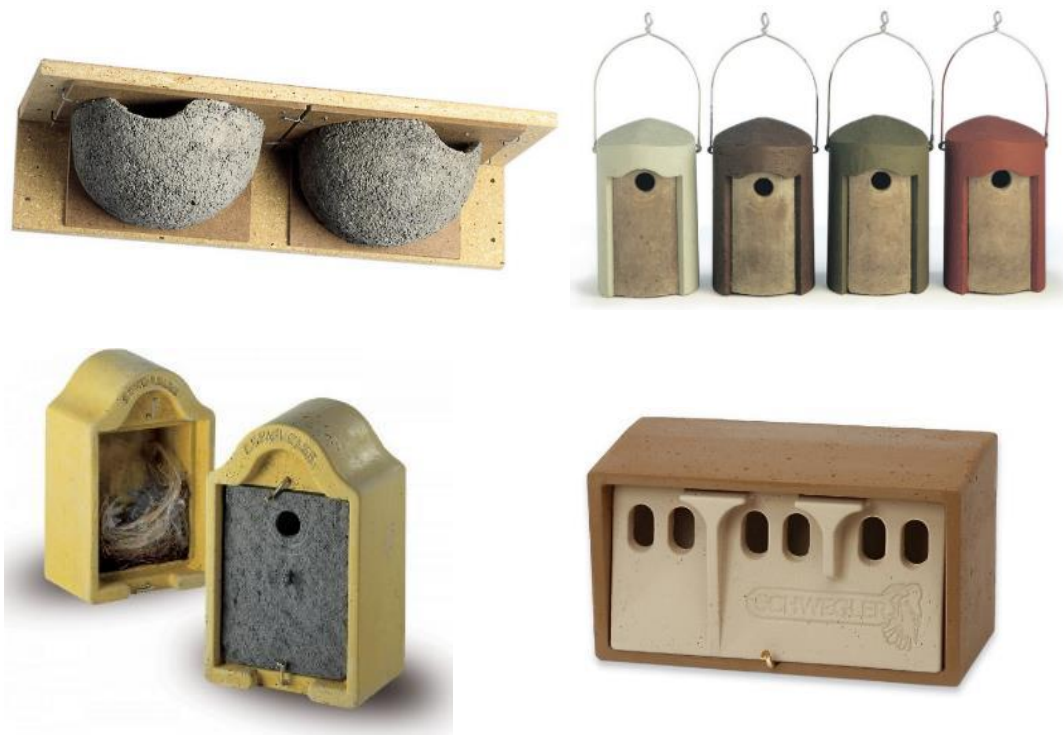
**Figure 4** Examples of Schwegler Double House Martin Nests (top left); Schwegler Woodcrete 1B nest boxes (top right); Schwegler Bird House boxes (bottom left); and a Schwegler 1SP Sparrow Terrace nesting box (bottom right)

5.3.14 The provision of a minimum of four (4) bird nesting boxes is recommended as an enhancement for biodiversity on the site and to ensure nesting opportunities remain on the site post-development. All bird boxes must be retained in perpetuity and their exact location/ specification may be discussed with a suitably-qualified ecologist, and alternative options can be considered. A selection of reliable options is detailed below, although suitable equivalents are acceptable (**Figure 4**):

- Schwegler Single & Double House Martin Nests. These should be installed in sheltered locations (such as under the eaves of a suitable building), installed at a minimum height of 2m and orientated in in southerly/ westerly direction.
- Schwegler Woodcrete 1B nest boxes (for trees) and/ or Schwegler Bird House nest boxes (for buildings). These should be installed upon a suitably-mature tree and/ or upon a suitable building, installed at a height no less than 2m and orientated in a southerly or westerly direction.
- Schwegler 1SP Sparrow Terrace nest boxes. These should be installed in a sheltered location upon a suitable building, at a height no less than 2m and orientated in a southerly or westerly direction.

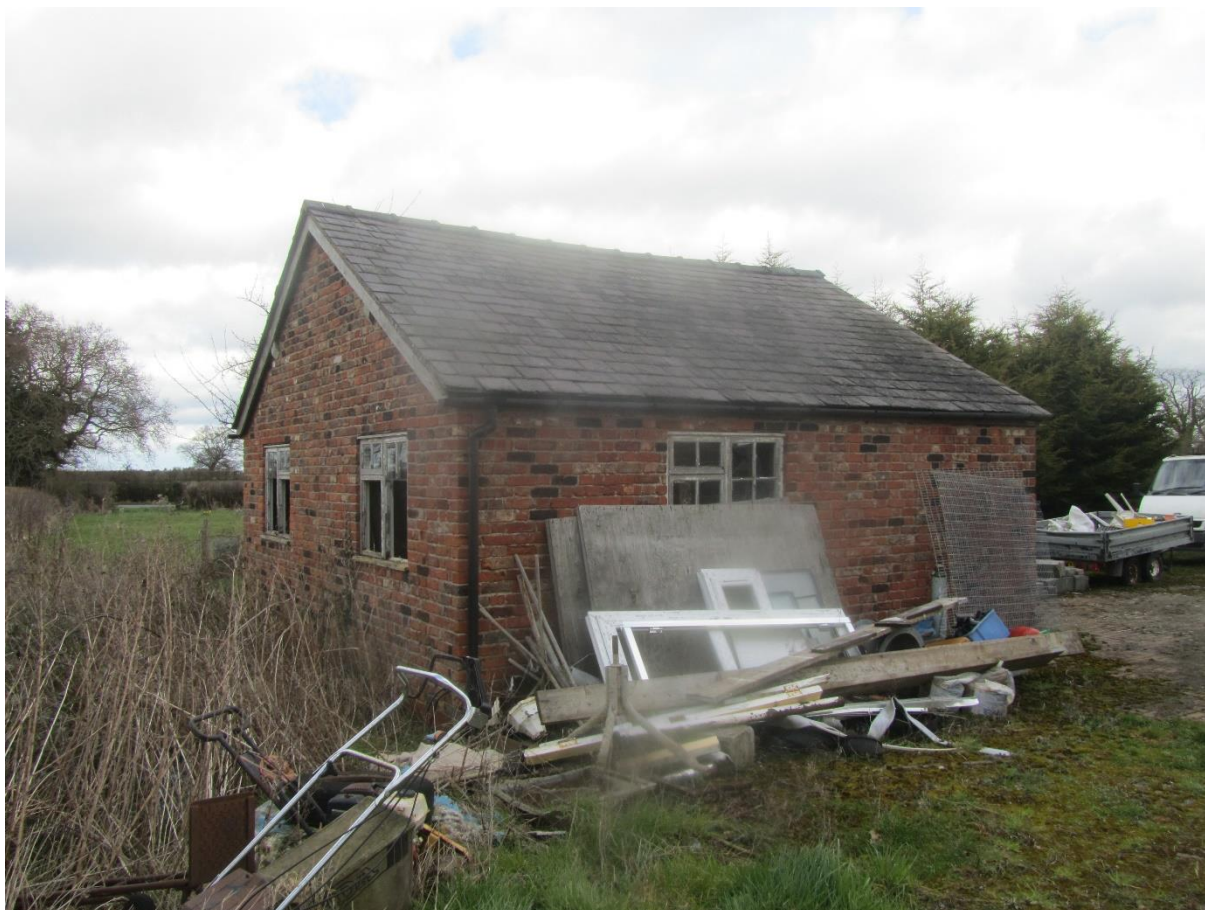
4.4.3 Externally, **B1** is considered to be in moderate condition overall. Potential bat roost features/ ingress points, noted on the exterior of **B1** during the PRA, are evaluated below:

**Image 1** Southern and western elevations of B1

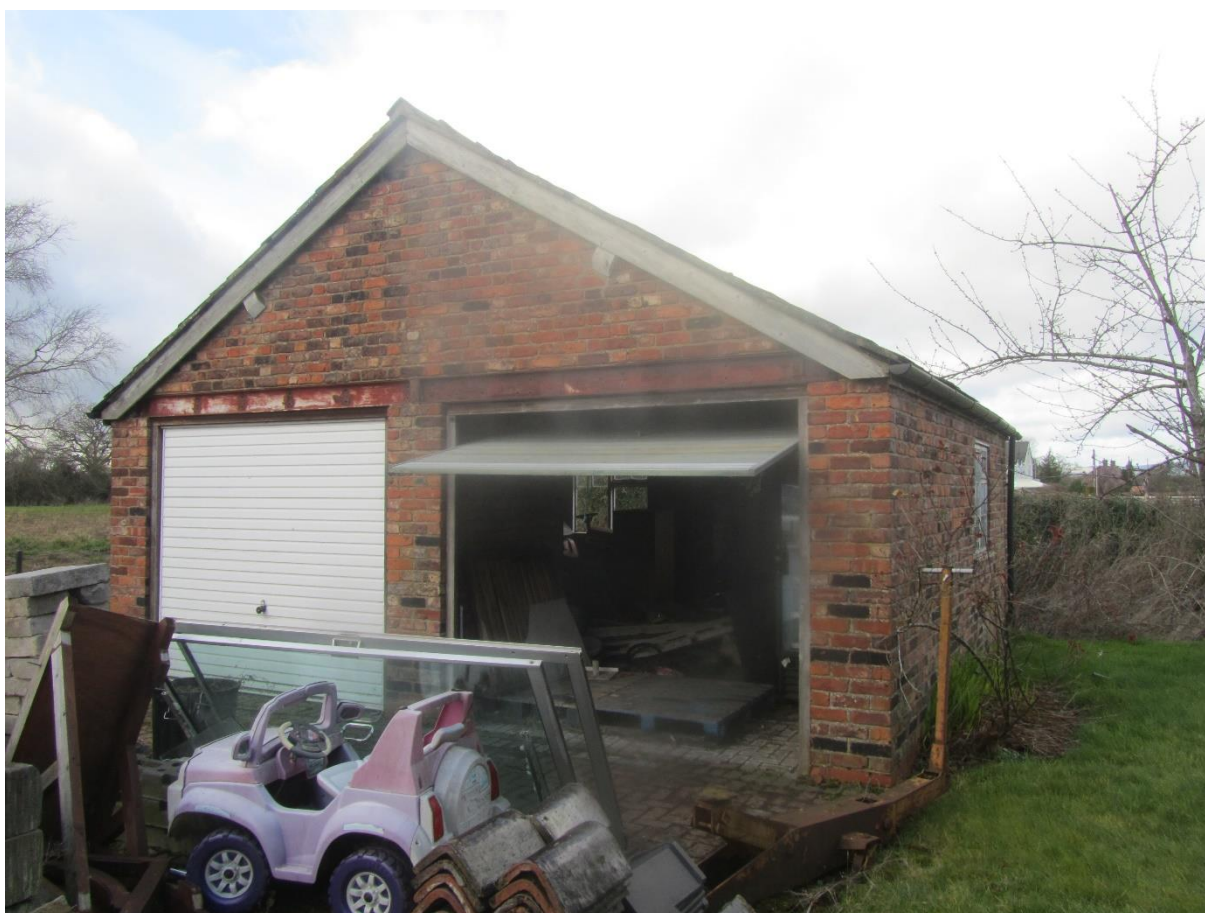
**Image 2** Northern and eastern elevations of B1

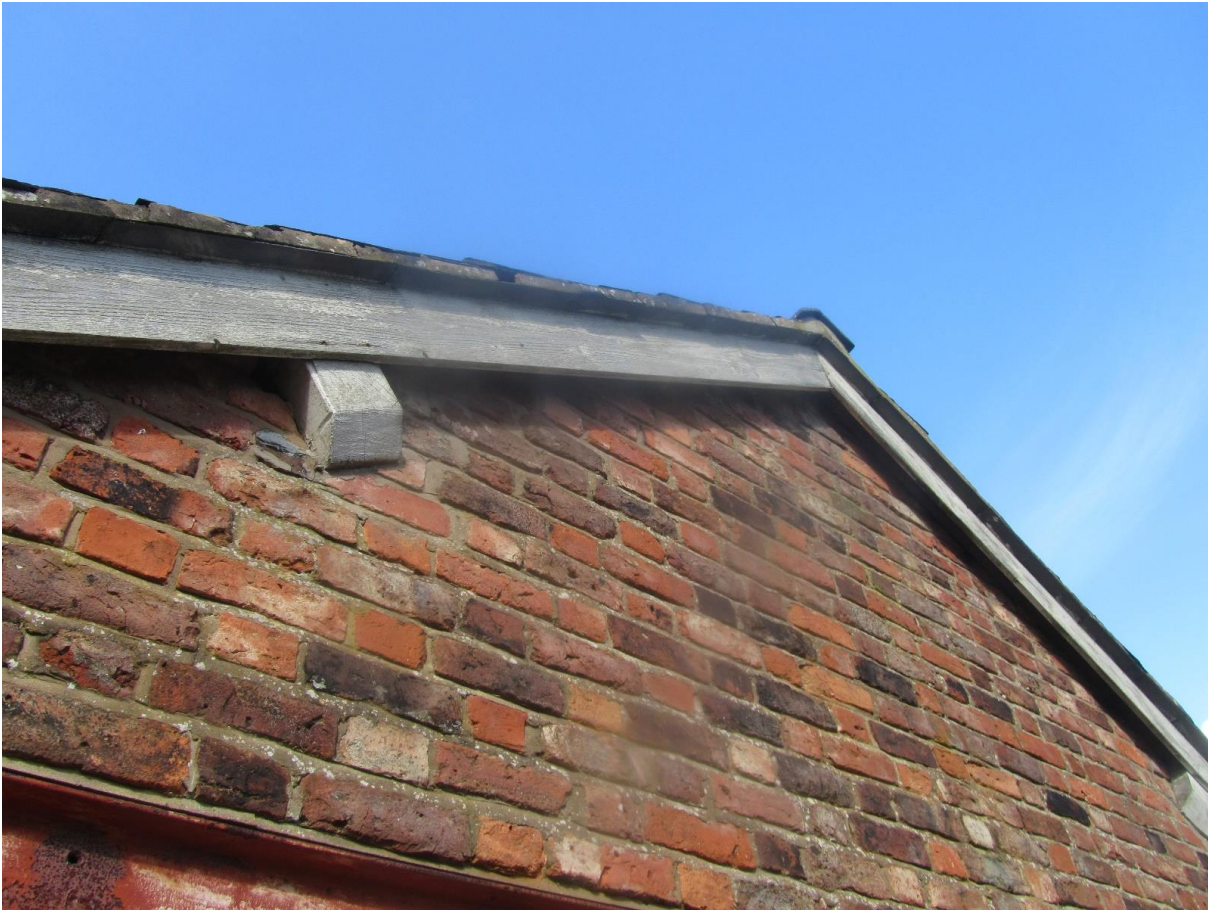
**Image 3** Eastern gable end of B1

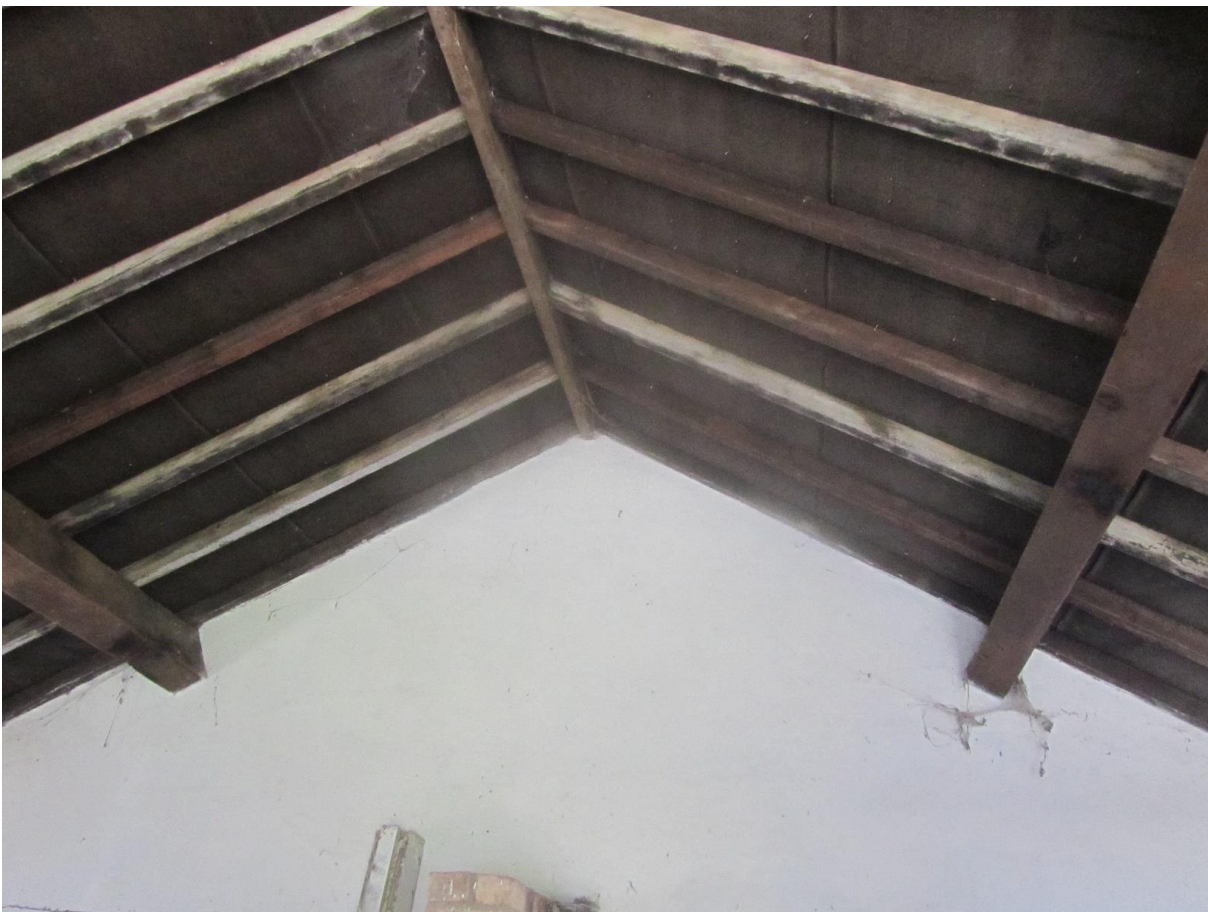
4.4.4 Internally, **B1** has an open, bitumen-lined roof throughout and a timber truss which is in good condition. Potential bat roost features/ ingress points, noted inside **B1** during the PRA, are evaluated below:

**Image 4** A typical view inside B1

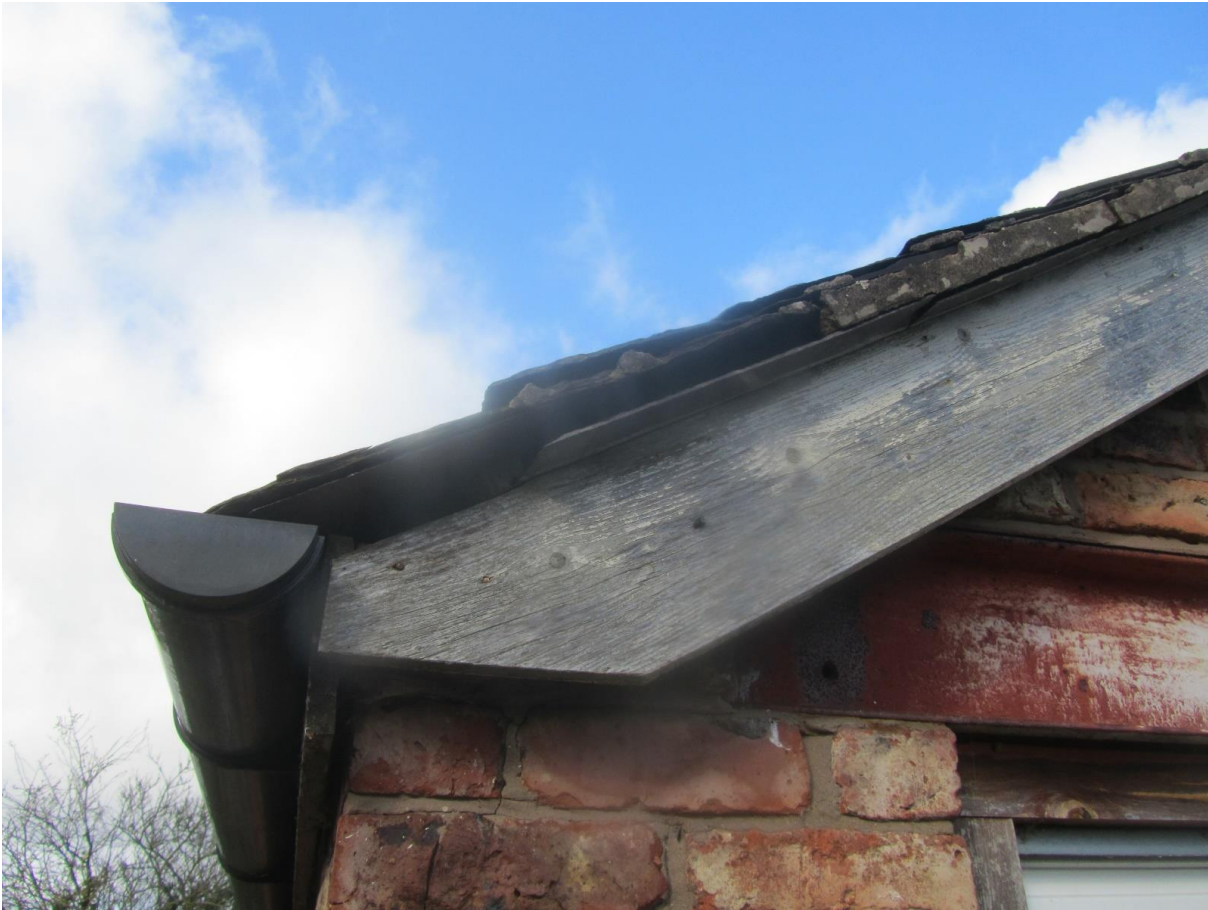
- Three (3) mortar gaps were identified on the eastern gable end of **B1** and two (2) mortar gaps were identified on the western gable end; these provide a degree of crevice-roosting potential.
- Several small gaps between the roof tiles were noted on the northern and southern elevations of **B1**; these may provide a potential ingress point into the small space between the roof tiles and the lining underneath.

**Image 5** Mortar gap on the eastern gable end of B1

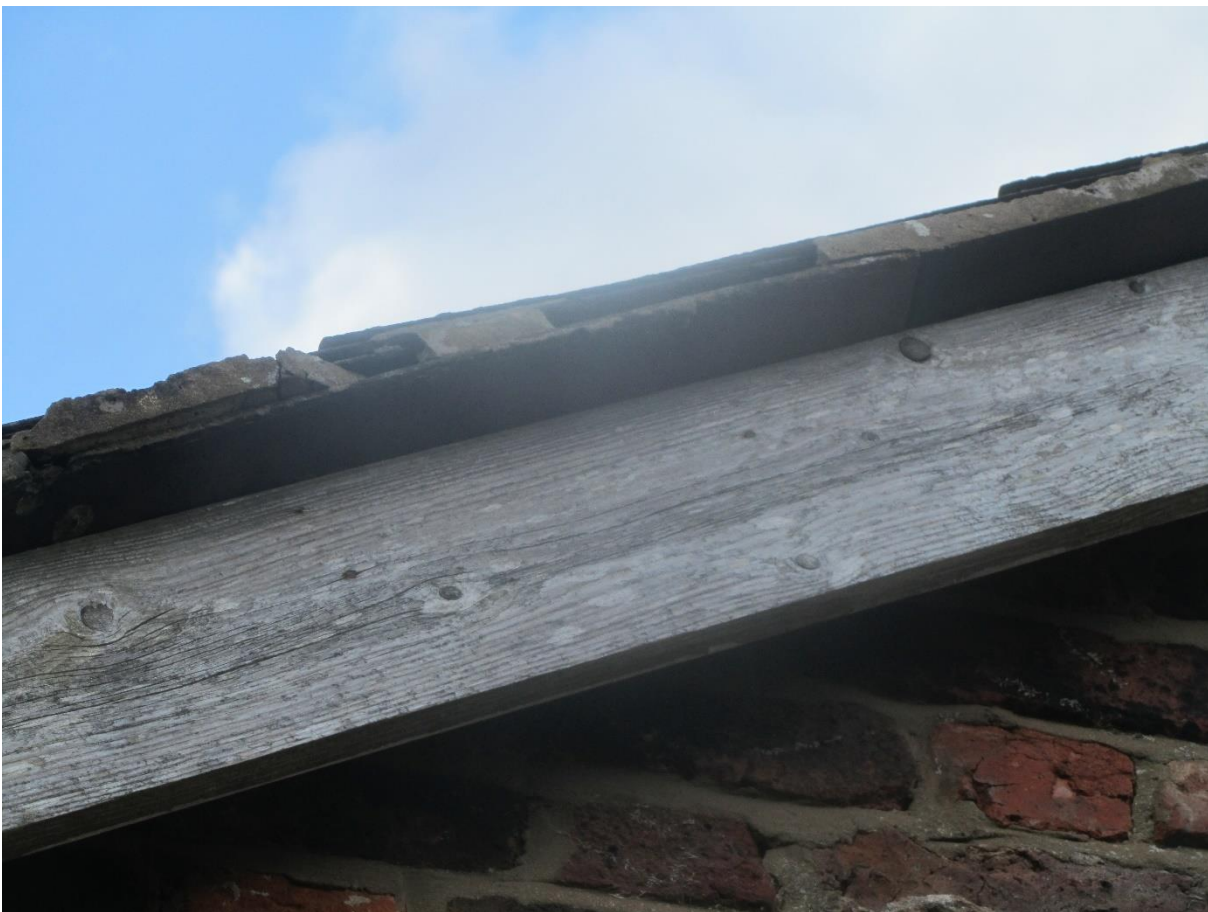
**Image 6** Mortar gaps on the western gable end of B1

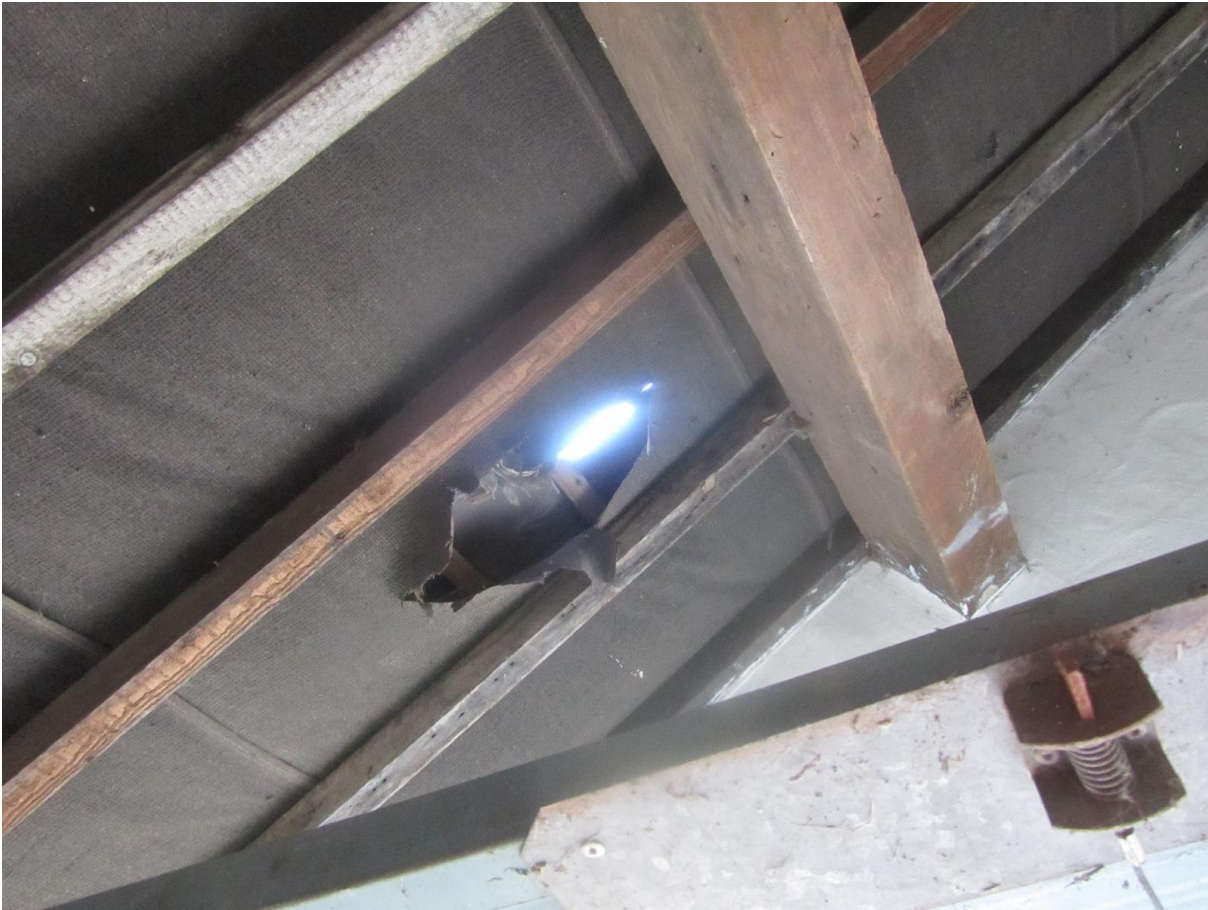
- Two (2) open windows are present on the western elevation of **B1**; these may provide potential bat ingress into the main internal space.
- At least three (3) tears were noted within the bitumen lining; these may provide a potential ingress point into the small space between this lining and the roof tiles.

**Image 7** Tear in the roof lining and tile gap, viewed from inside B1

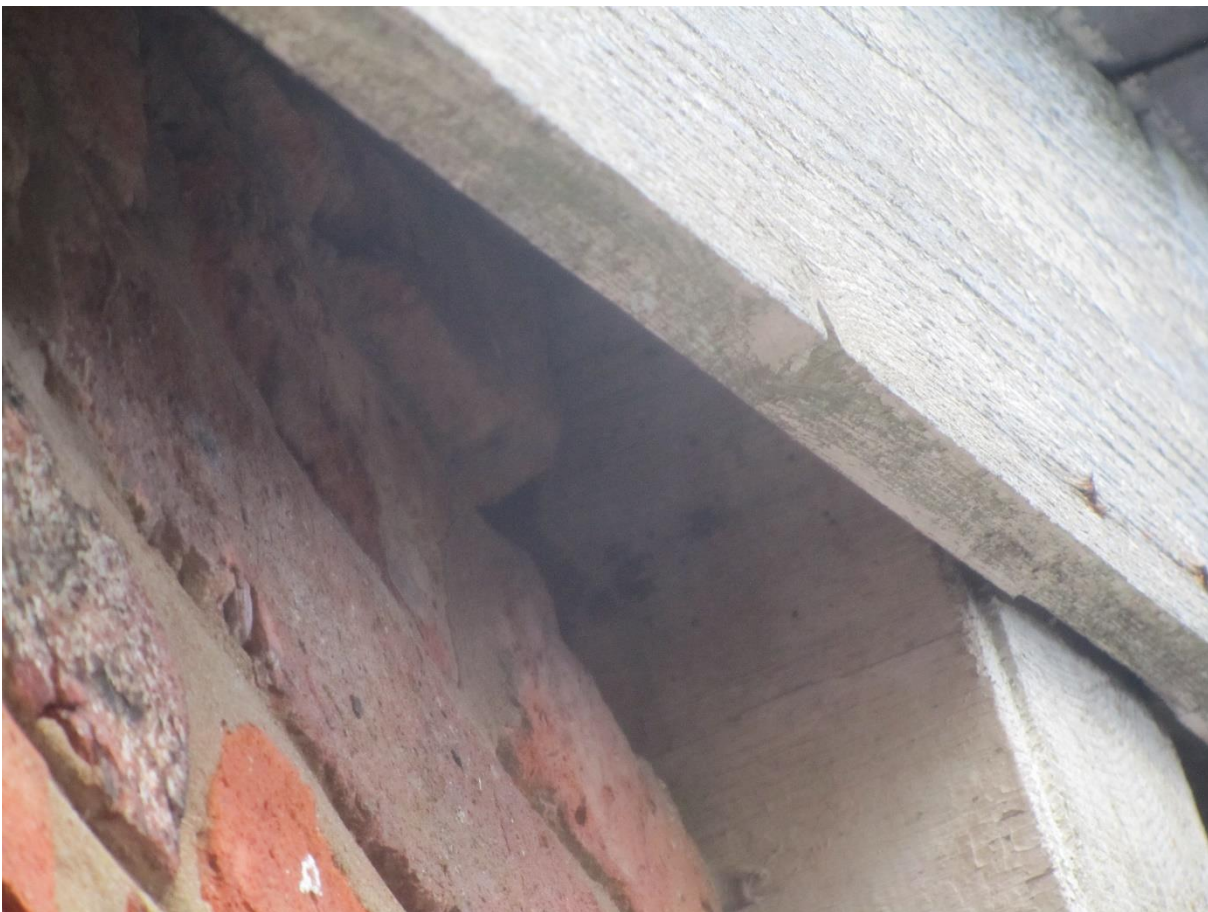
**Image 8** Small gap between the timbers and external wall on the eastern gable end of B1

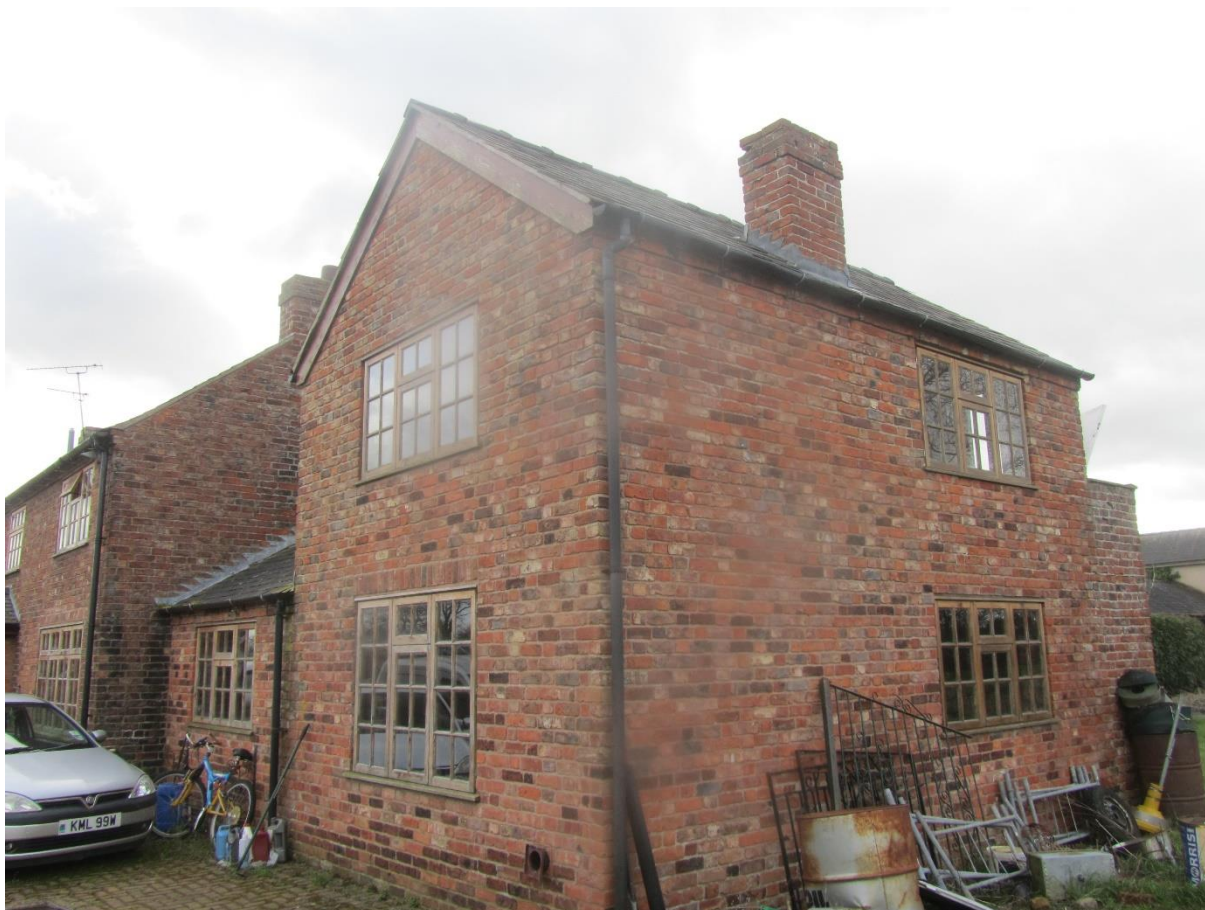
4.4.8 Externally, **B2** is considered to be in moderate condition overall. Potential bat roost features/ ingress points, noted on the exterior of **B2** during the PRA, are evaluated below:

**Image 9** Northern and western elevations of B2

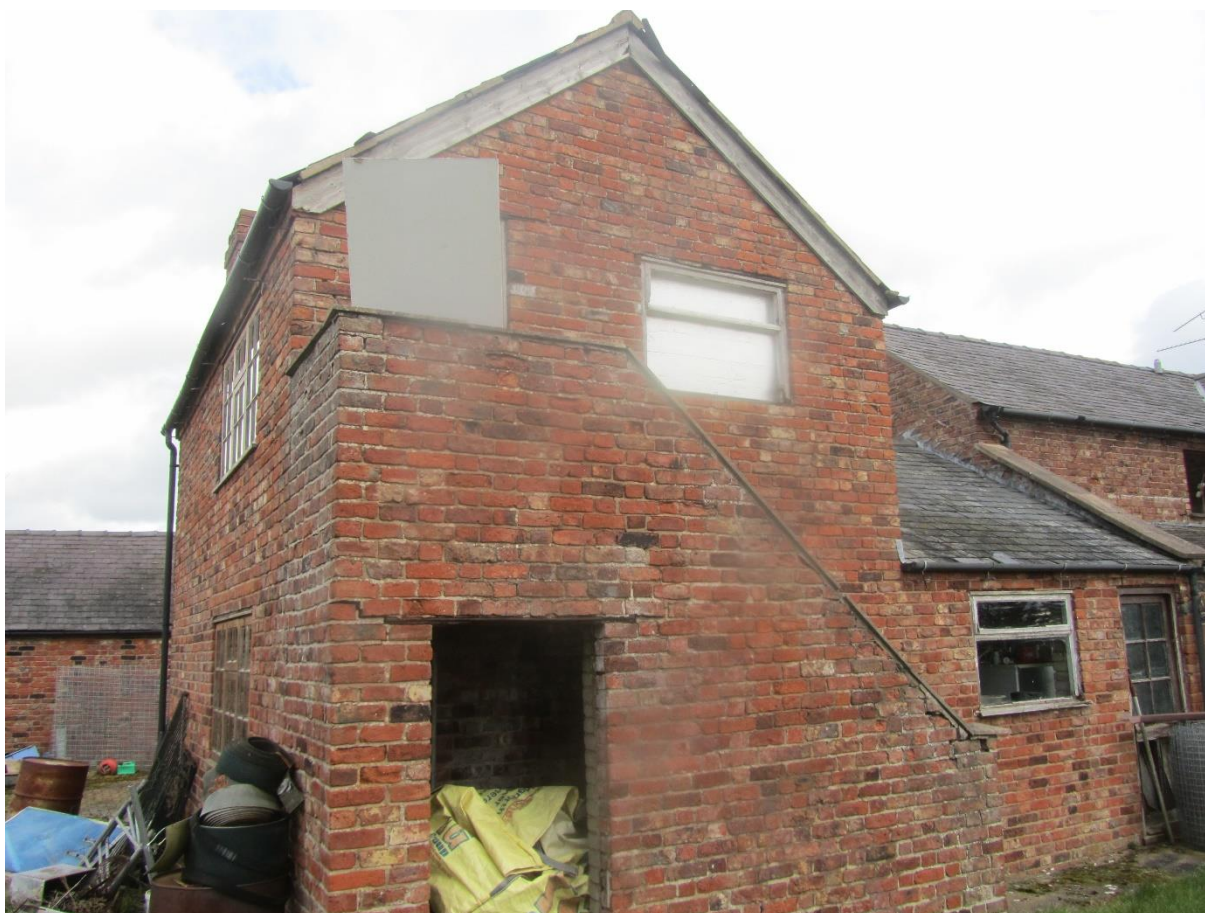
**Image 10** southern and western elevations of B2

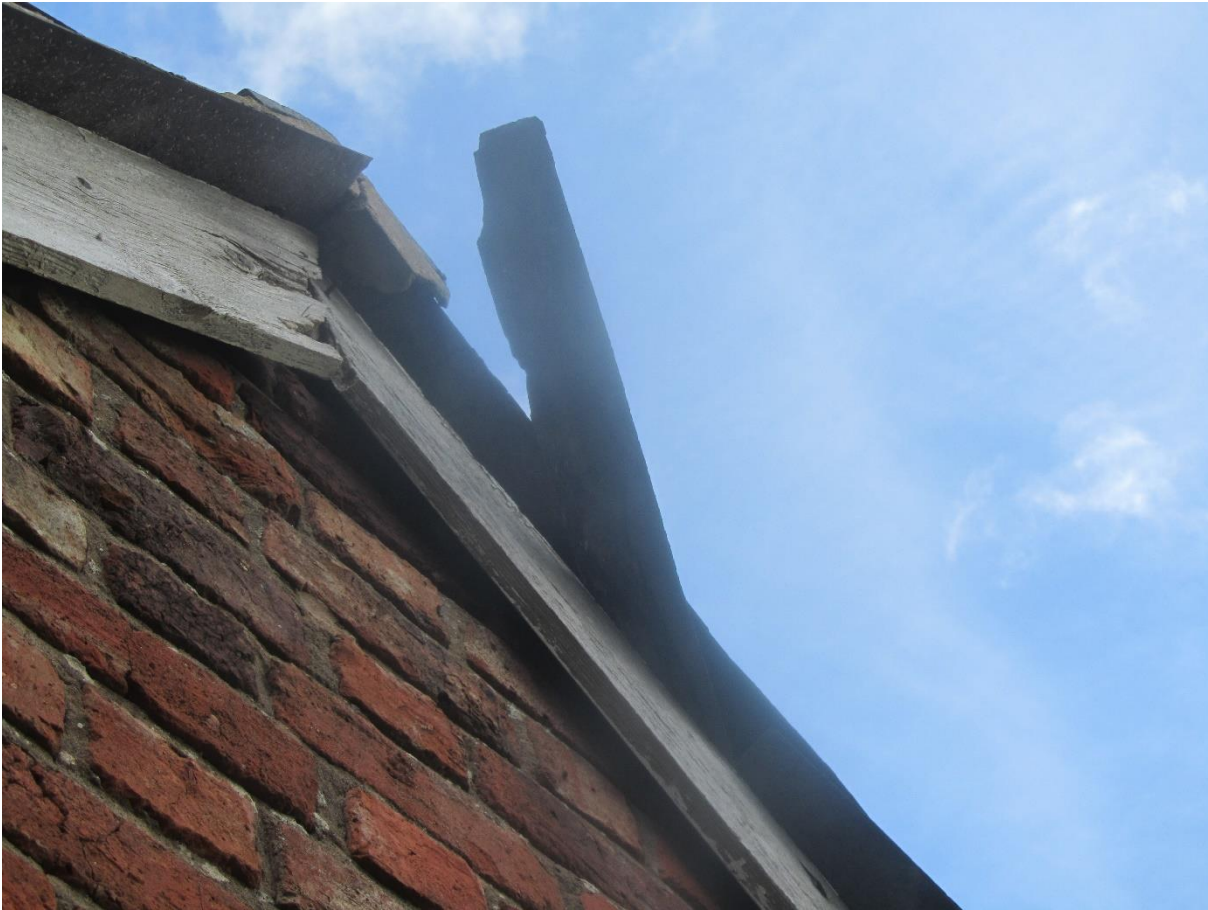
- Damage to the slate roof was noted on the southern gable end of **B2**; this may provide a potential ingress point into the loft void, as well as providing a degree of crevice-roosting potential in itself.
- Several other slipped tiles throughout the roof of **B2** provide a degree of crevice-roosting opportunity.

**Image 11** Damaged roof at the southern gable end of B2

- 5.3.8 A species data search from COFNOD will be obtained to supplement the findings of Phase 2 bat activity surveys.
- 5.3.9 No works (such as the blocking of any potential ingress/ egress points, repairs to the roofs etc.) are to be undertaken upon **B1** – **B3** until Phase 2 bat activity surveys have been completed and the appropriate mitigation put in place.

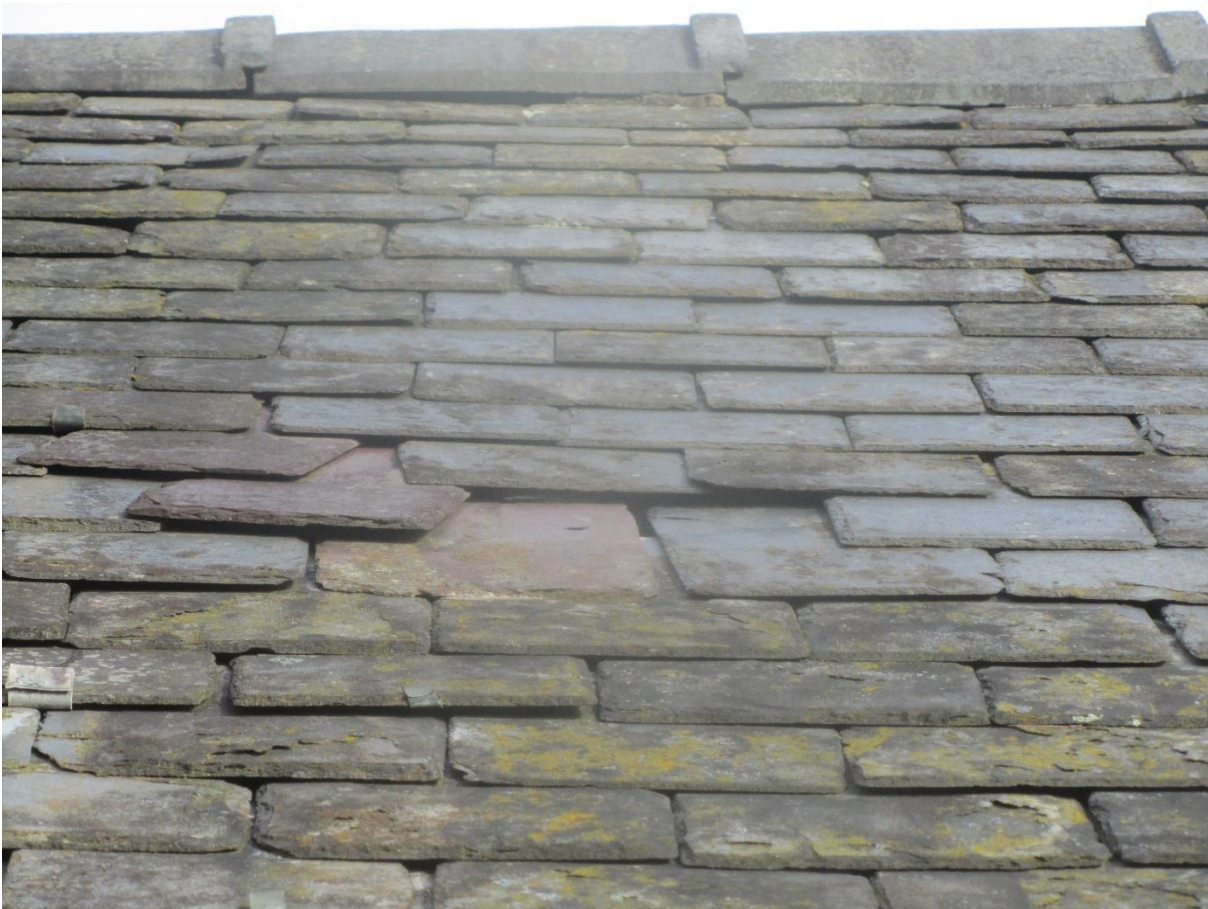
**Image 12** Slipped roof tiles on B2

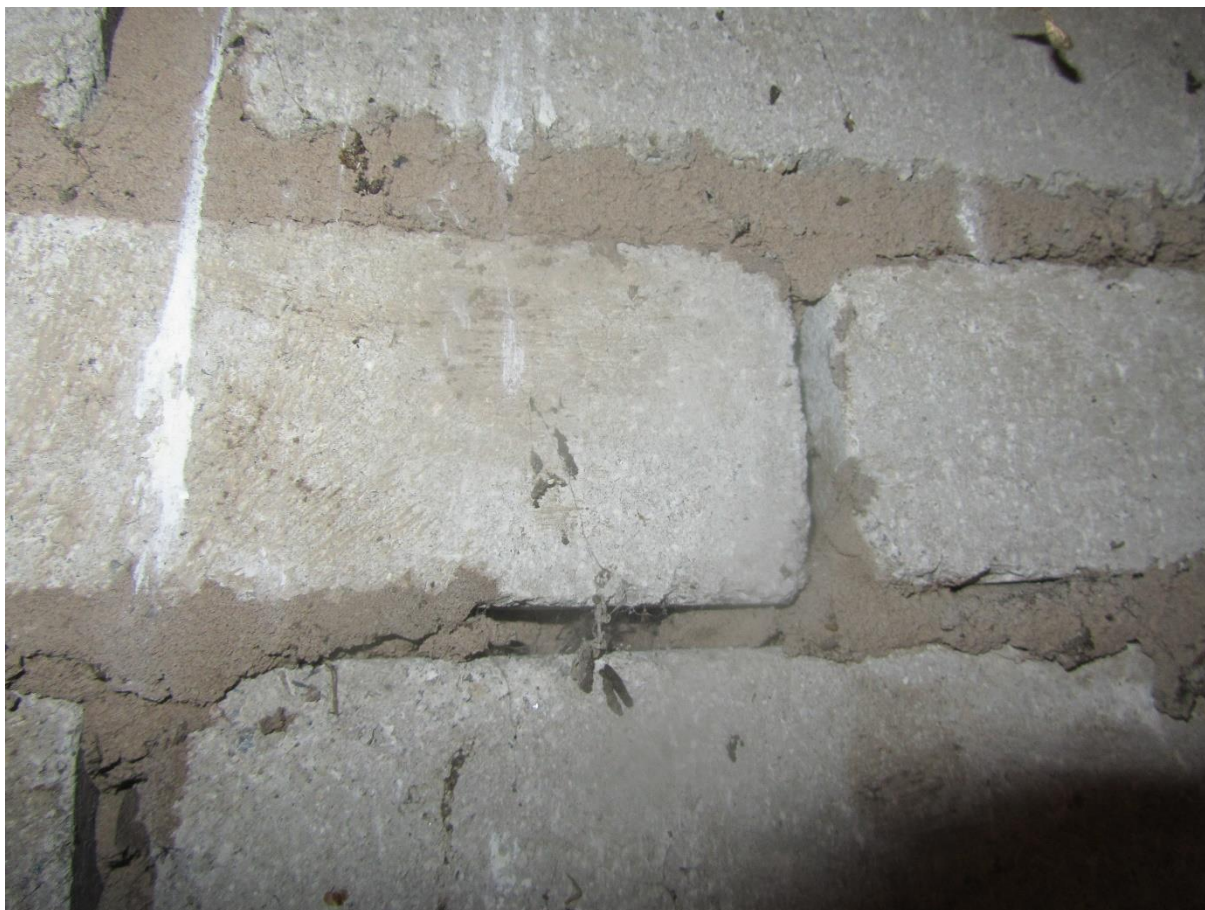
4.4.10 A small accumulation of at least 15 fresh bat droppings, commensurate with those of pipistrelle species, were found within **B2** near to the access hatch and on the northern gable wall.

**Image 13** Bat droppings stuck to the internal northern gable wall inside the loft void of B2 (also showing bird droppings)

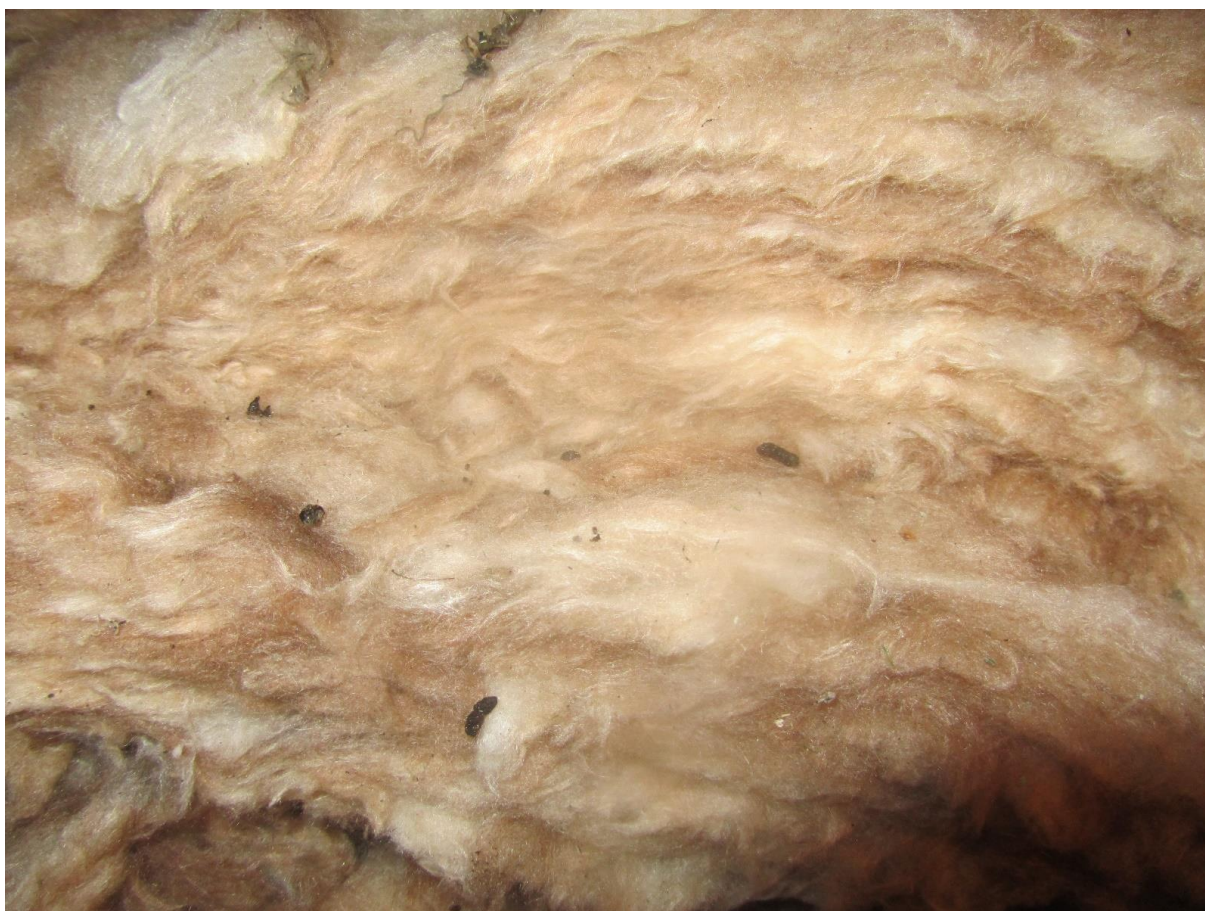
**Image 14** Bat droppings found on the floor near to the hatch within the loft void of B2

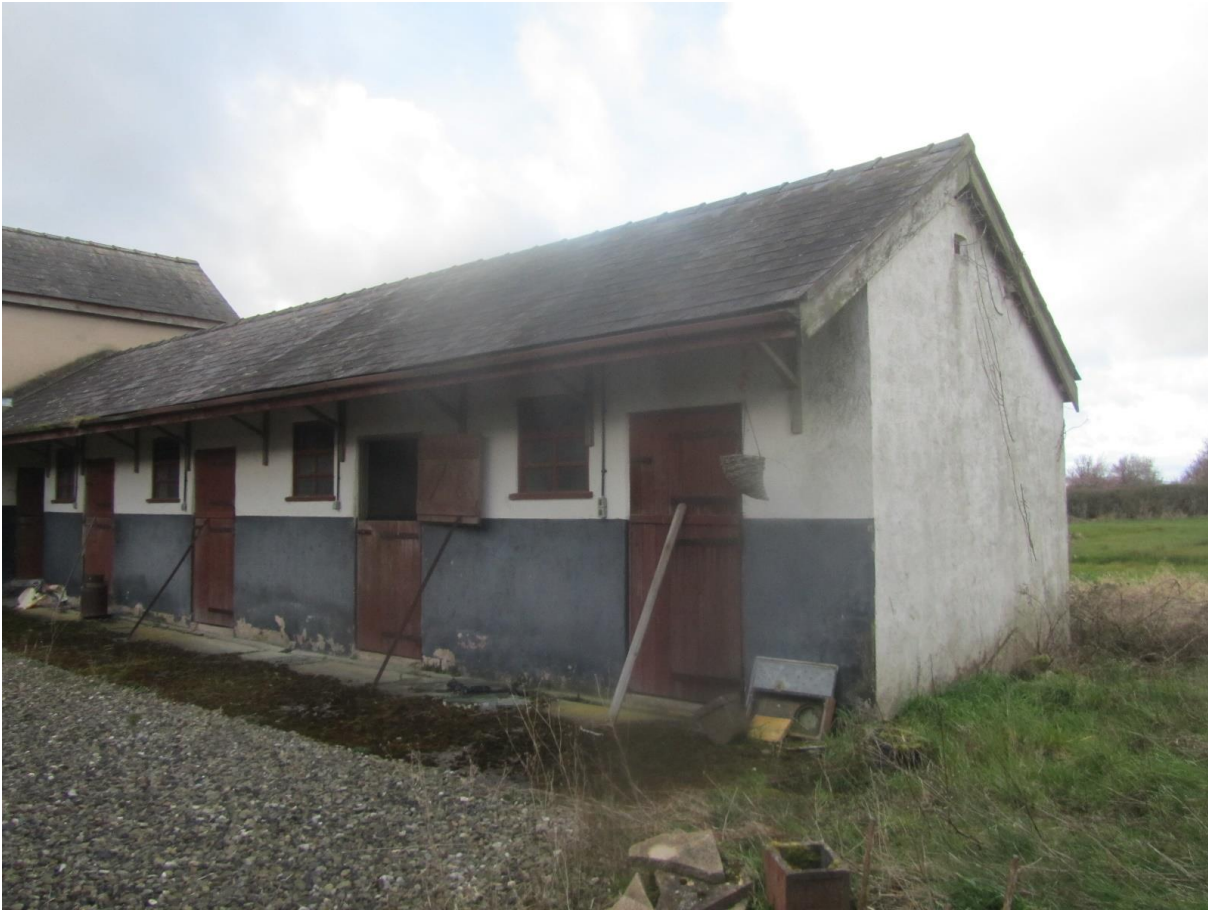
**Image 15** Western-most stable block section of B3

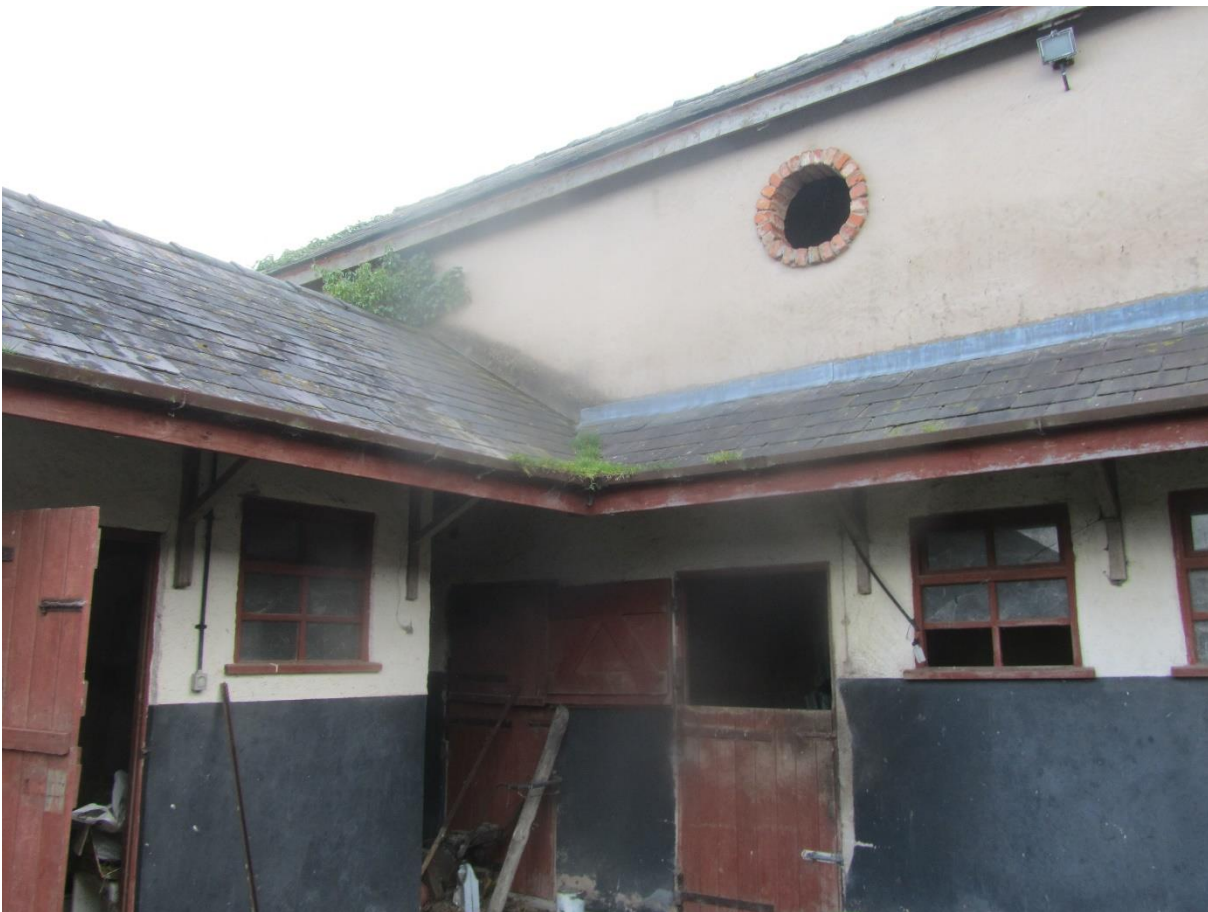
**Image 16** Join between the eastern-most stable block section and the barn of B3

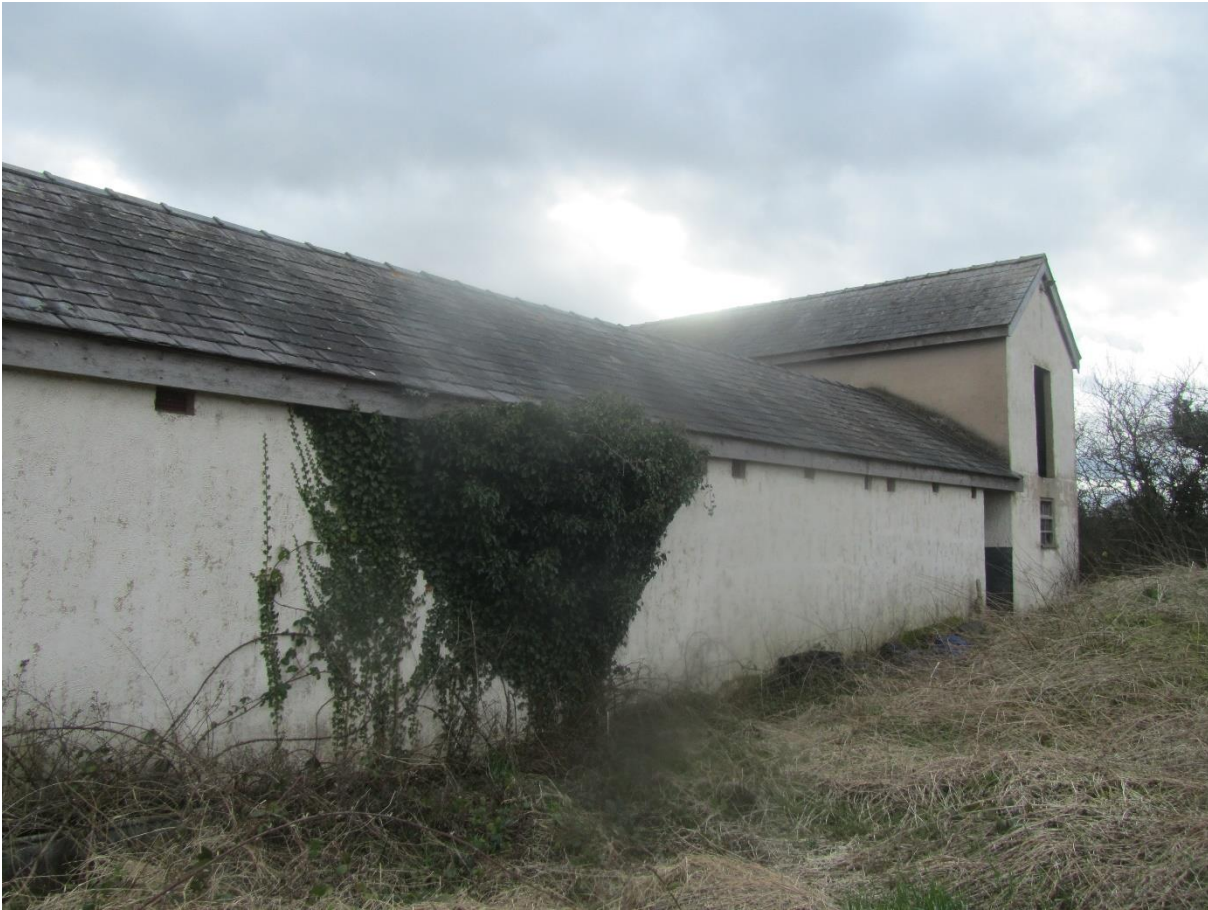
- The stable block sections of **B3** are open at the eaves and some upper stable doors are left open; this may provide potential ingress points into these portions of the building.
- The barn section of **B3** features a number of open window/ door spaces on the first-floor, allowing extensive ingress opportunities.
- A small number of minor tile gaps were noted throughout the roofs/ ridges of **B3**; these may provide a degree of crevice-roosting opportunity.

**Image 17** Western elevation of B3, showing barn and stable block
