# Preliminary Bat Roost Assessment (PRA) Report

**Project:** Glenmore, Higher Penley, Penley, Wrexham, LL13 0NB

**Reference:** 110320.PRA

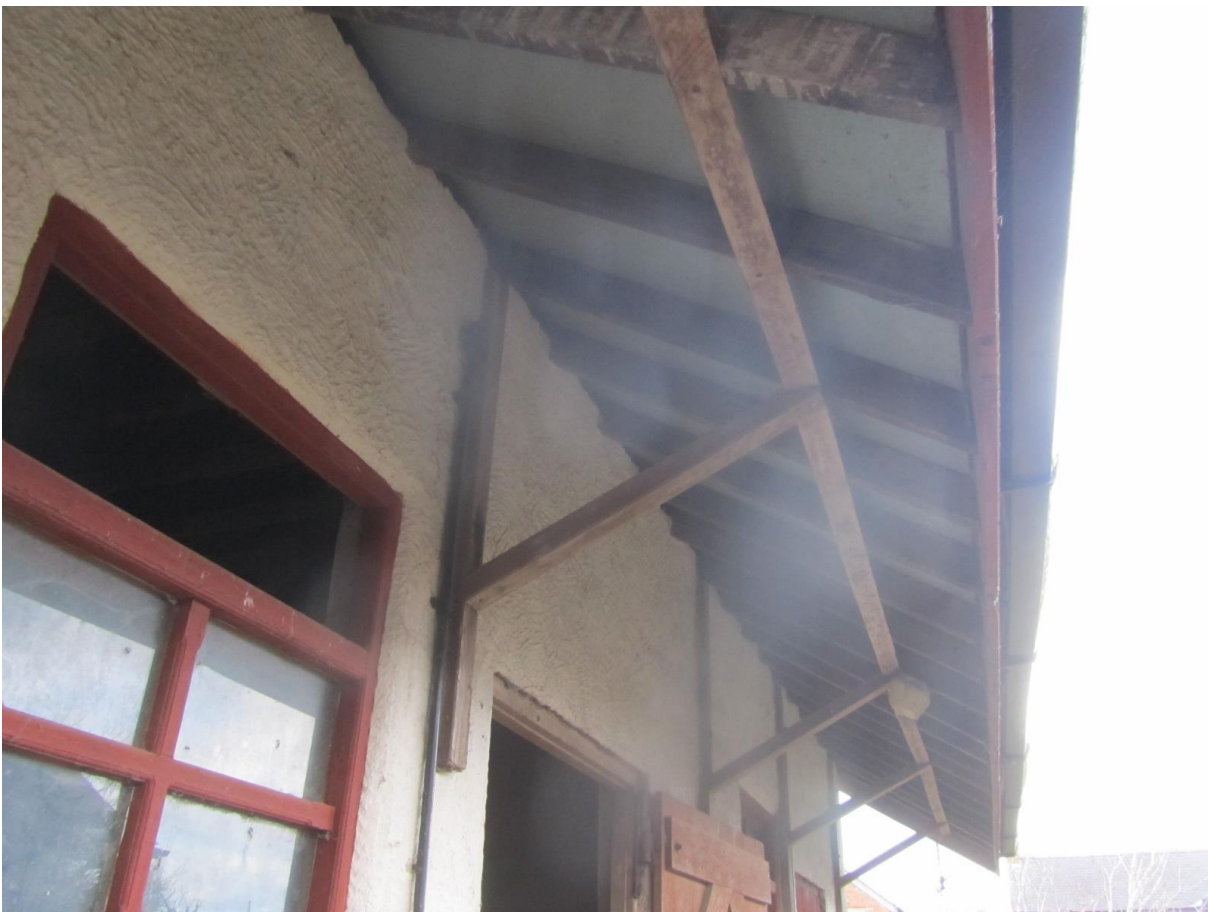
- The stable block sections of **B3** are open at the eaves and some upper stable doors are left open; this may provide potential ingress points into these portions of the building.
- The barn section of **B3** features a number of open window/ door spaces on the first-floor, allowing extensive ingress opportunities.
- A small number of minor tile gaps were noted throughout the roofs/ ridges of **B3**; these may provide a degree of crevice-roosting opportunity.

**Image 18** Open eaves in the stable block sections of B3

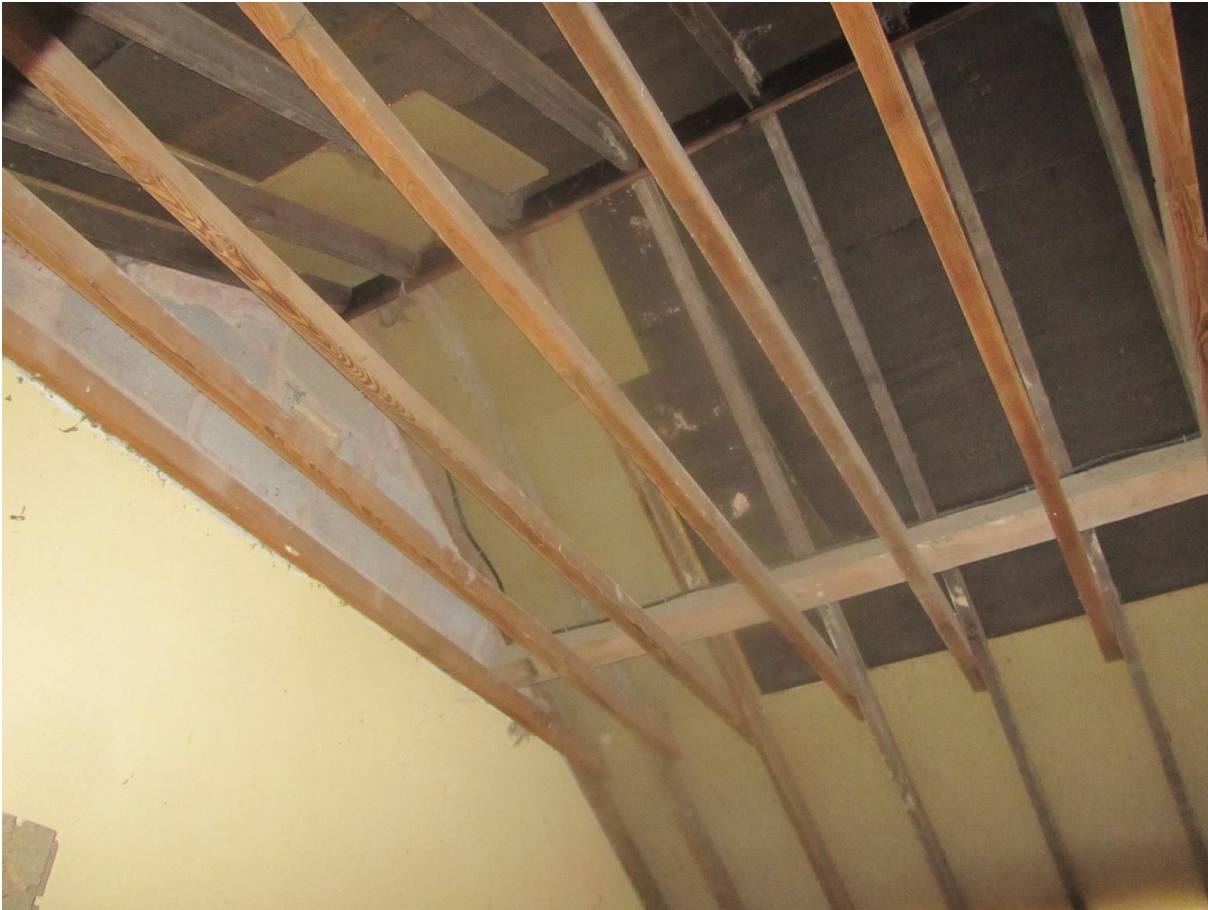
**Image 19** A typical view inside a stable block section of B3

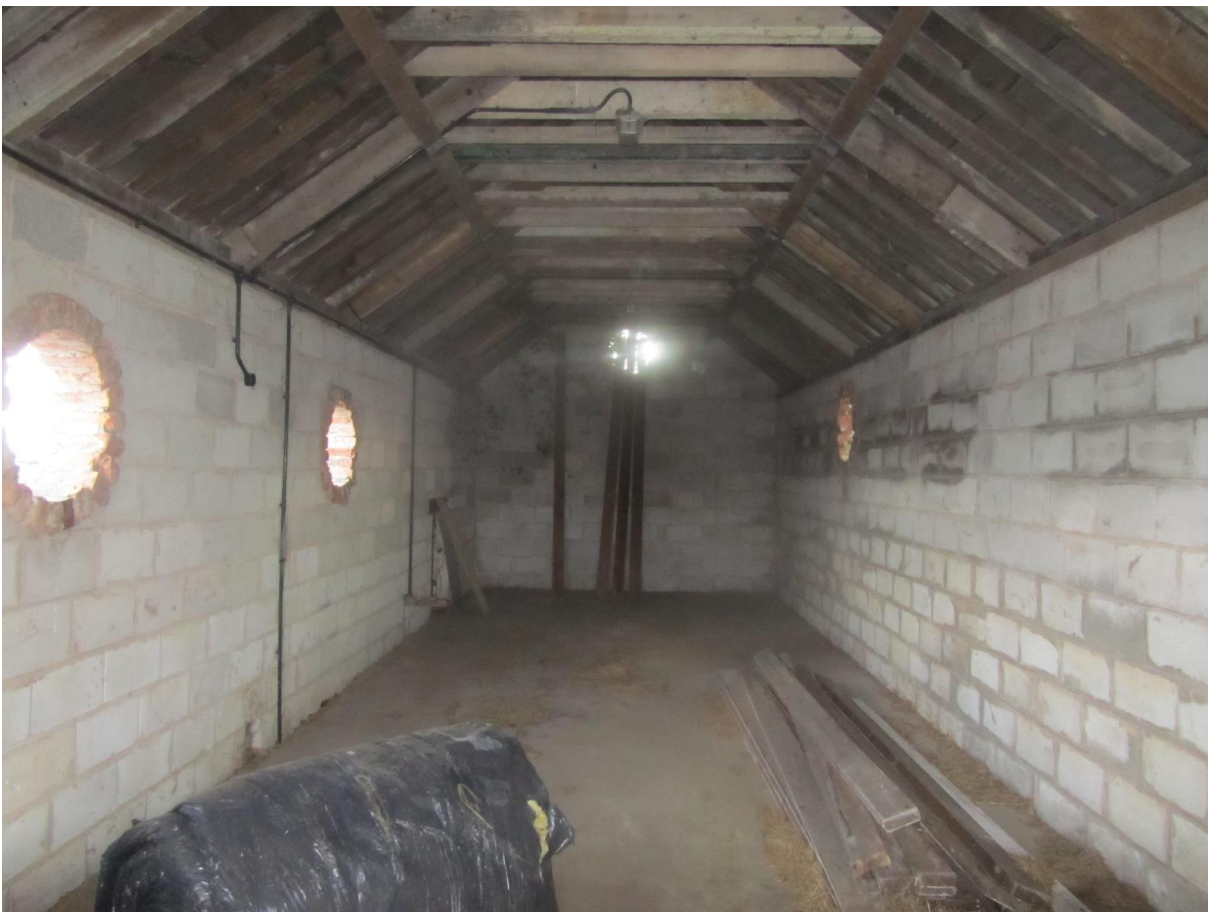
4.4.14 Internally, **B3** is open in structure throughout with no roof void(s) of any kind. The roof is bitumen-lined throughout and features timber trusses (some of which are reclaimed timbers) in moderate condition. No significant internal lighting was noted. Potential bat roost features/ ingress points, noted inside **B3** during the PRA, are evaluated below:

**Image 20** A typical view within the barn section of B3 (first-floor)

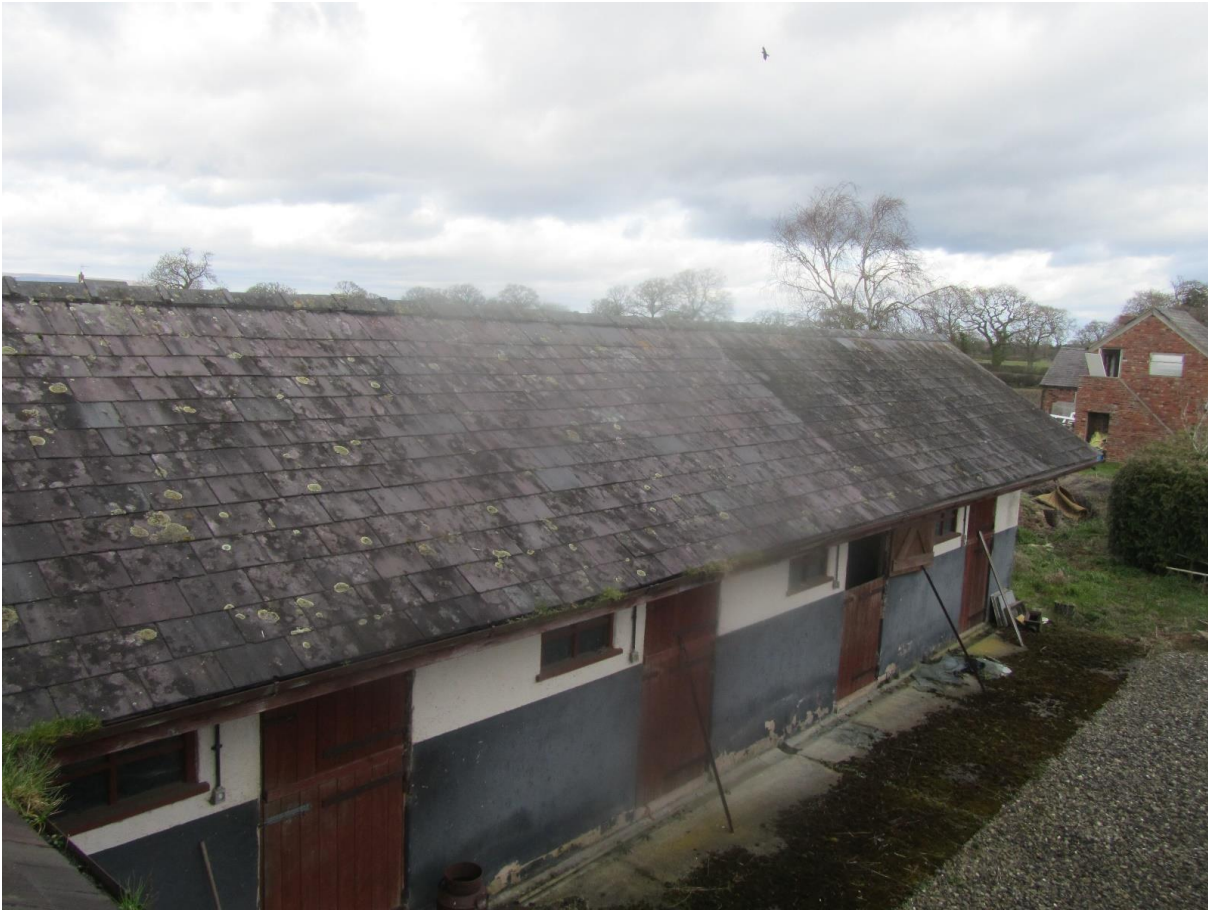
**Image 21** A typical view of the roof of B3 (western-most stable block section)

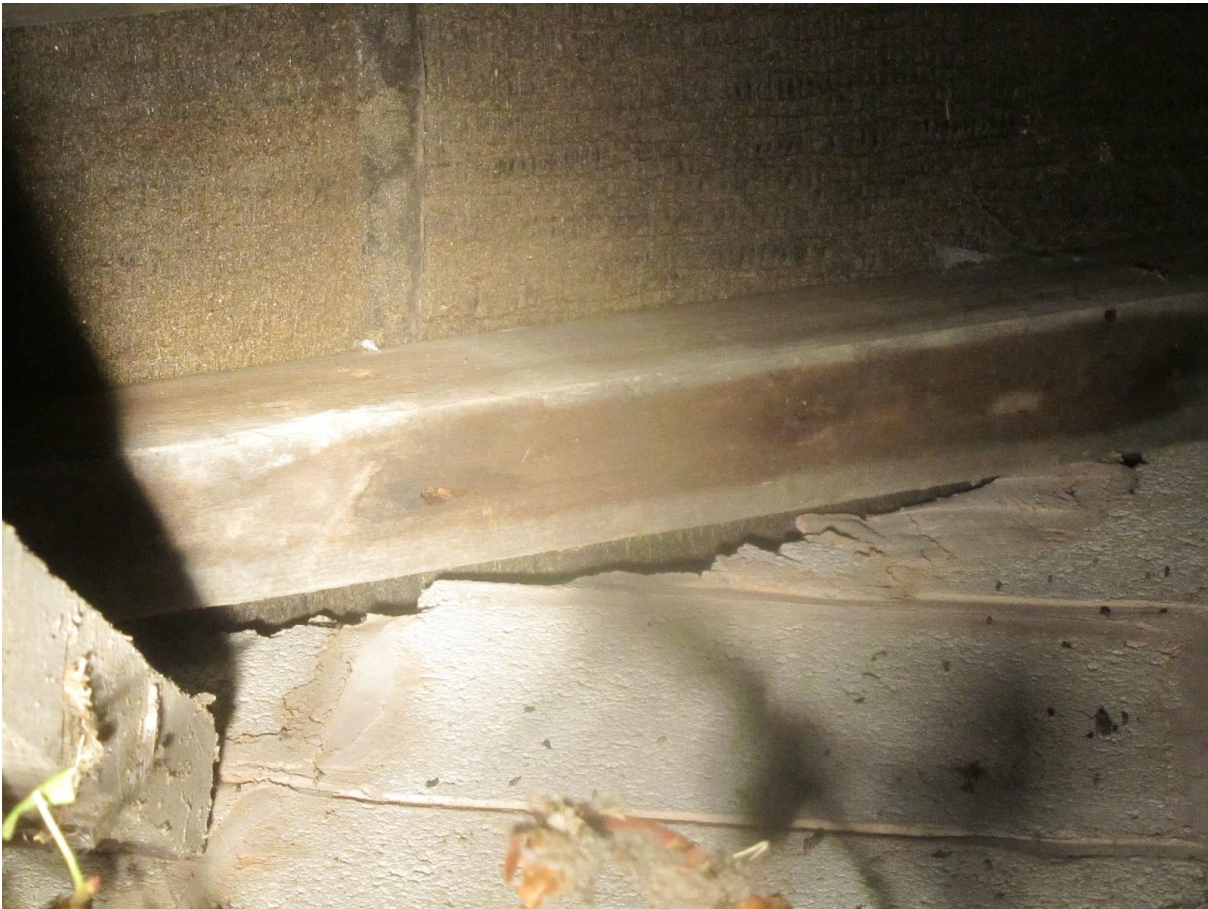
- Crevice roosting opportunities were noted between the roof timbers and internal eastern gable wall within the barn section of **B3**.

**Image 22** Crevices between the timbers and internal eastern gable wall inside the barn section of B3

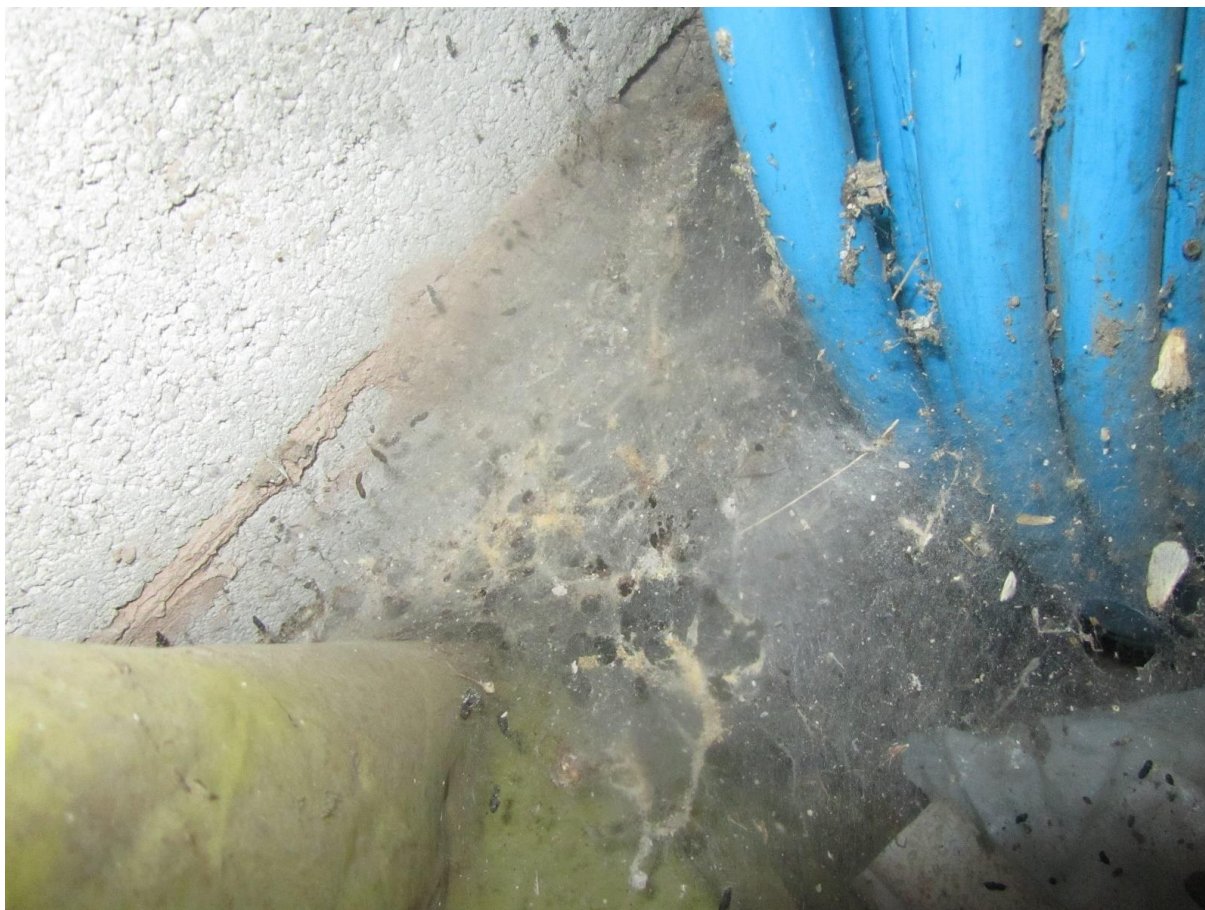
- No more than ten (<10) old bat droppings were found scattered throughout the stable blocks; this could be attributed to infrequent foraging behaviours.
- An accumulation of at least 40 droppings, approximately 1/2 seasons old, were found stuck to the wall and captured within cobwebs on the southern-most internal wall of the eastern-most stable block, in **B3**.
- An accumulation of at least ten (>10), estimated to be more than 2 seasons old, were found stuck to the wall below the cervices between the roof timbers and internal eastern gable wall, within the barn section of **B3**.

**Image 23** Accumulation of bat droppings found inside eastern-most table block section of B3, on the wall and stuck in cobwebs

- 5.3.8 A species data search from COFNOD will be obtained to supplement the findings of Phase 2 bat activity surveys.
- 5.3.9 No works (such as the blocking of any potential ingress/ egress points, repairs to the roofs etc.) are to be undertaken upon **B1** – **B3** until Phase 2 bat activity surveys have been completed and the appropriate mitigation put in place.

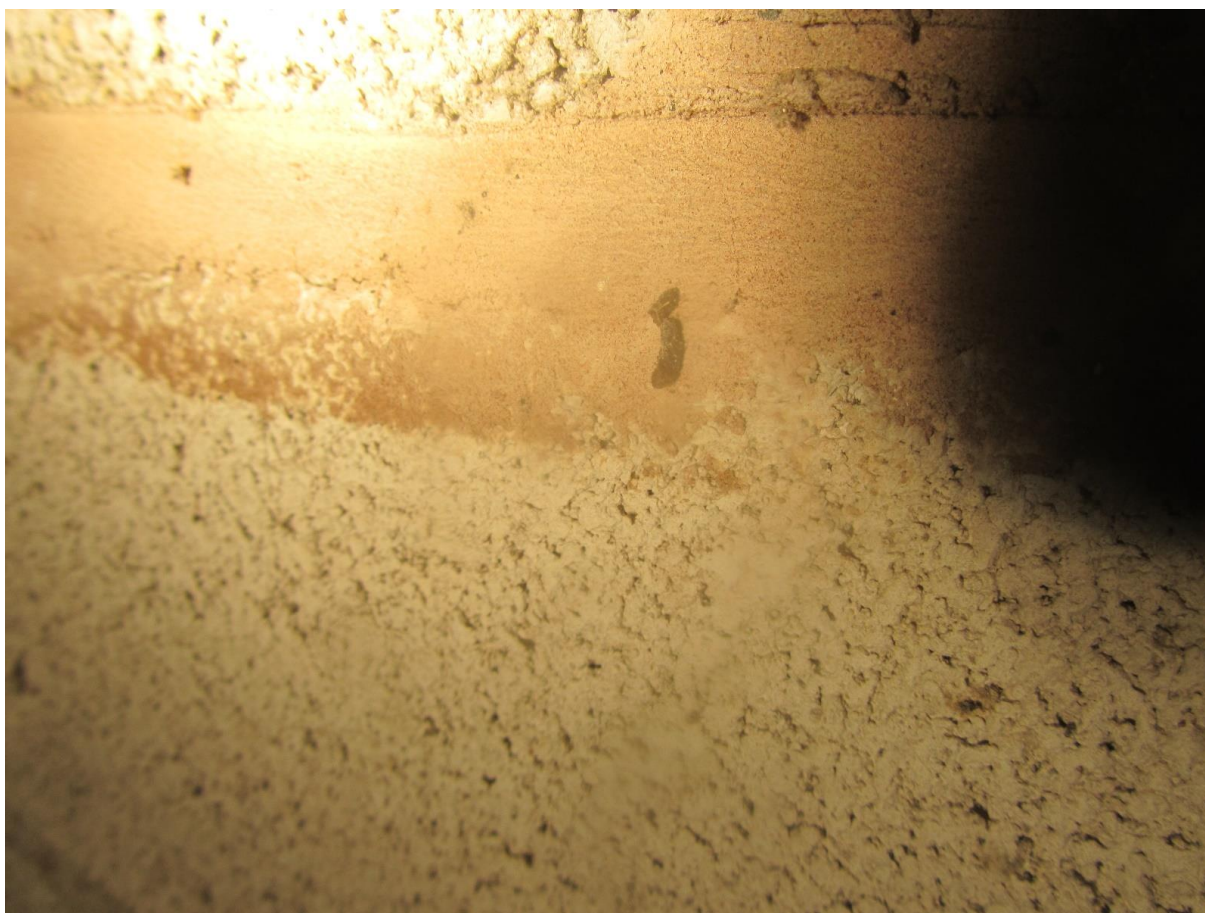
**Image 24** Bat droppings found on the wall below crevices between the timbers and internal eastern gable wall inside the barn section of B3

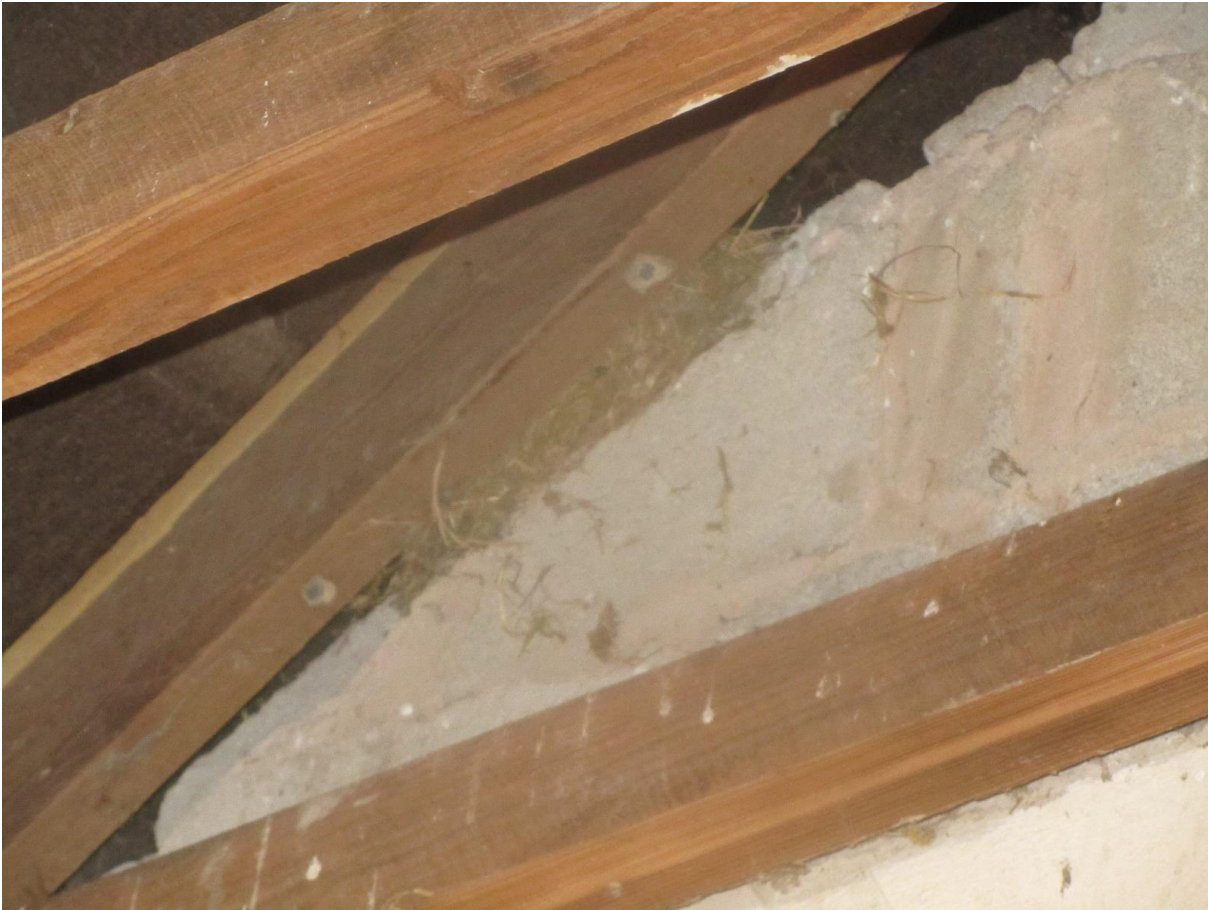
4.4.23 At least two (2) disused/ former bird nests, one (1) of which was commensurate with that of a swallow (*Hirundo rustica*), were identified within the stable block sections of **B3** during the nesting bird inspection and further evidence of nesting birds (droppings and the remains of a passerine bird) were also found. Extensive nesting opportunities are evident throughout this building, given its open structure and numerous potential ingress points.

**Image 25** Disused passerine bird nesting found inside a stable block section of B3

5.3.13 Any major works to **B1 – B3** must be timed to occur outside of the bird nesting season (this is February – August inclusive). In the event that works are required within this time period then inspections for nests should be undertaken by a competent person immediately prior to the start of any works. Should any active nest be found, works shall cease and a minimum 5m buffer, appropriate marked, is to be formed until subsequent checks by an ecologist prove the absence of nesting birds.
