### "ERWALLO UCHAF, DOLYWERN, PONTFADOG, WALES"

#### PHASE 2 BAT SURVEYS

#### STATEMENT REPORT

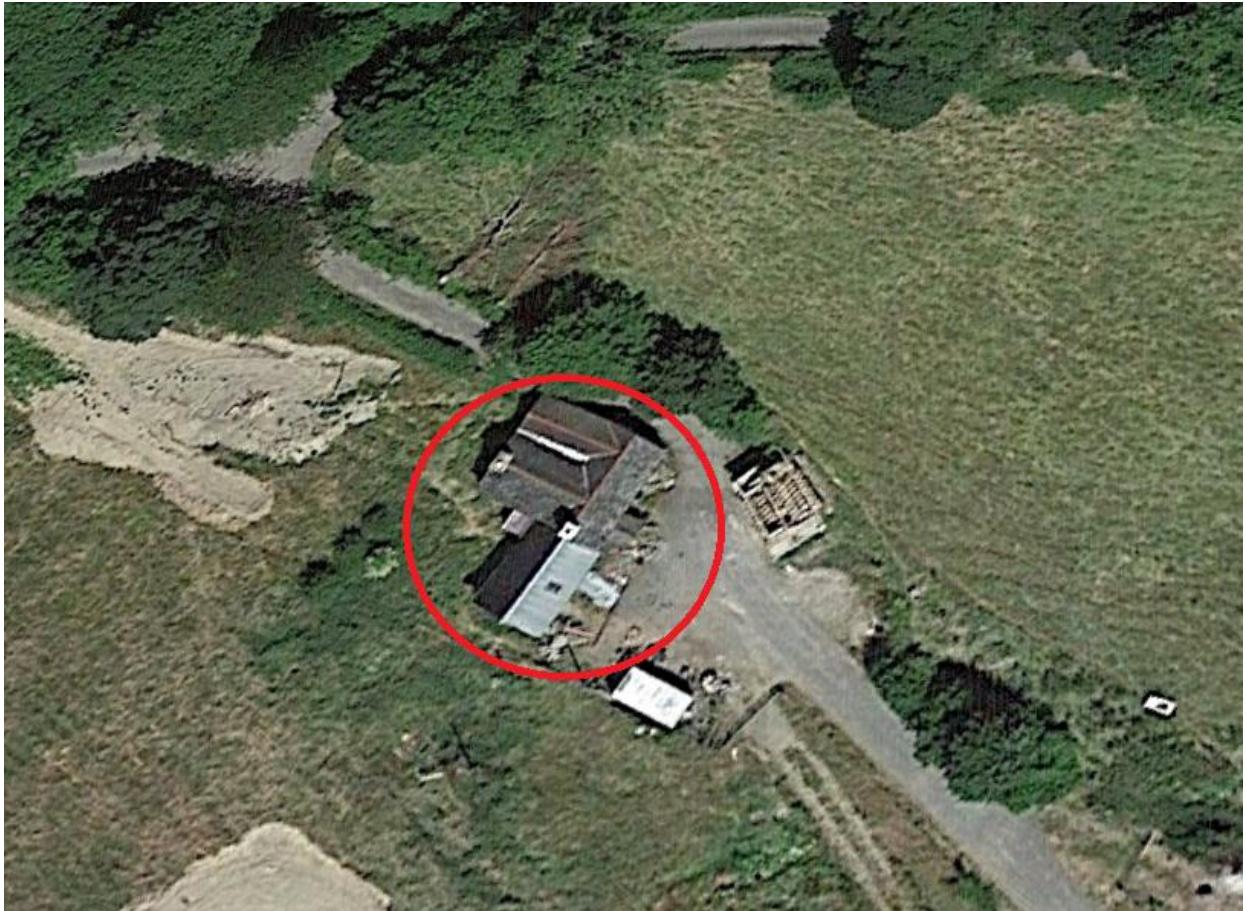
**Figure 1: Aerial view of Surveyed Building and surrounds.**

*Note: The target building is highlighted with a red ring. The main residential building can be seen to the northern end with the attached metal roofed barn structure to the south.*

The building occupies an isolated location on the side of a steep hill (**Figure 1**).

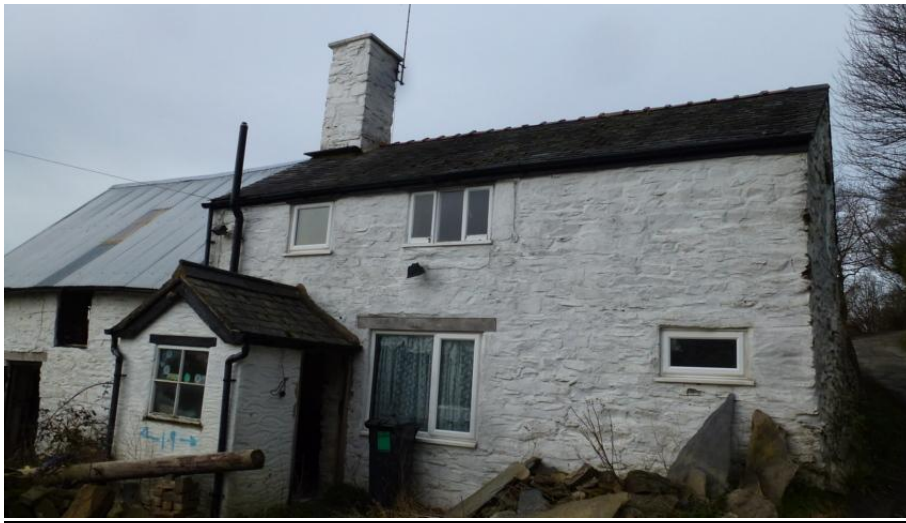
**Photograph A: General view of front (east facing) frontage to target building.**

The target building is a detached two storey property of stone construction with pitched slate covered roofing (**Photographs A, B & C**) with an attached former barn structure again of stone construction with pitched corrugated metal sheet roofing (**Photograph D**). The main residential building has been vacant for a number of years and has been stripped out internally in preparation for conversion work.

The structure is generally in good repair externally. The slate roofing is in good condition and well sealed. The ridge tiles are in good condition and well bedded down. The metal roofing on the extension barn is again in good condition and well sealed to stonework. Features such as chimney stacks are in good condition.

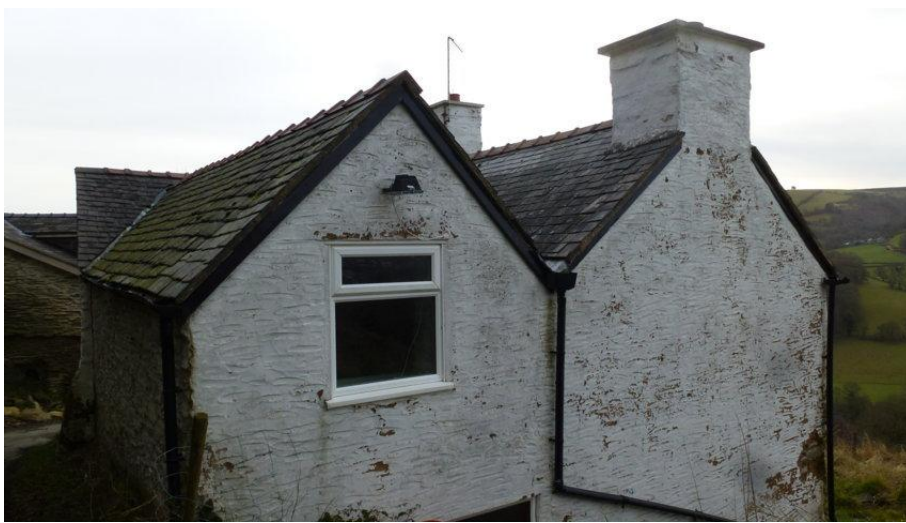
**Photograph B: General view of rear (west facing) frontage to target building.**

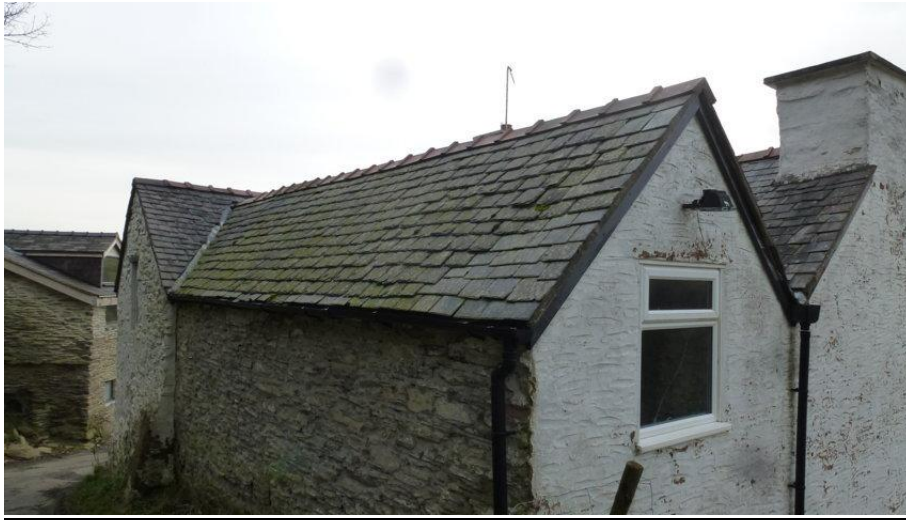
**Photograph C:** View of north facing frontage to target building.

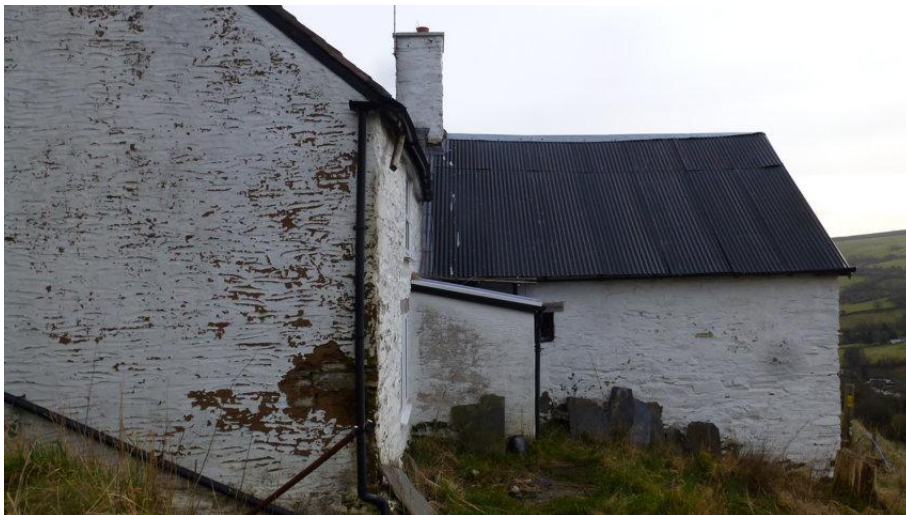
**Photograph D:** View of south facing frontage to building with corrugated metal roofing extension to rear.

The surveys detected evidence of two Common Pipistrelle bats day time roosting with the target building. The bats are roosting within the metal roofed barn structure (Photographs D & H) which is attached to the main residential building. The barn structure has currently two high level unglazed windows (Photographs G & H) which offer bat access/egress. This feature is in contrast to the main residential structure whose windows are glazed and sealed throughout.

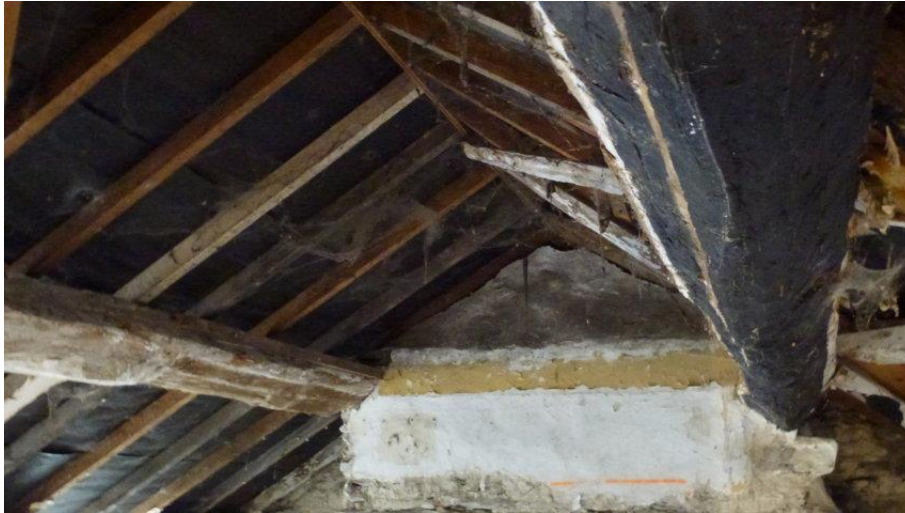
**Photograph E:** View of exposed felt backing to slate roofing covering main building.

*Note: The absence of an enclosed roof chamber, the exposed internal felt backing to the slates and the extensive hanging mats of accumulated spider's webs.*

Internally the main building slate roofing is backed with felt which is in good condition and well sealed (**Photograph E**); whilst the metal roofing is exposed internally within the barn extension (**Photograph F**).

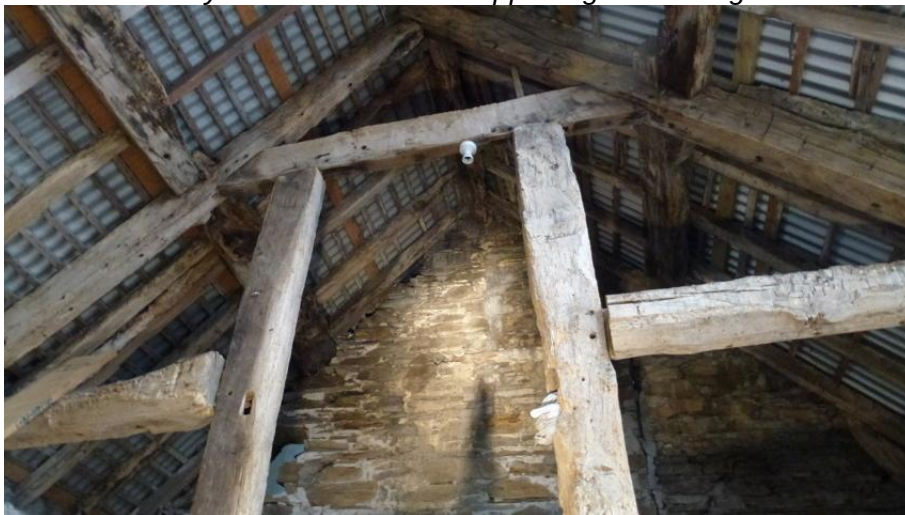
**Photograph F:** View of internally exposed corrugated metal roofing covering extension.

*Note: The heavy timber framework supporting the roofing.*

The barn has a metal panel roof which is exposed internally (Photograph I). Metal roofing is generally considered to represent a hostile and commonly avoided environment to roosting bats due to the wide temperature fluctuations associated with the material. Although the exact roosting location within the barn has not been identified there are suitable locations associated with timber frame and gable end stone work (Photographs F & I) to allow individual or small numbers of bats to roost.

The barn structure is isolated from the main residential building by a stone gable end (Photographs F & I). It is therefore concluded that continuing works on the residential building may proceed with negligible risk to bats, provided potential bat access points such as windows and doors remain sealed during nocturnal periods. Protection measures can therefore focus on the barn structure.

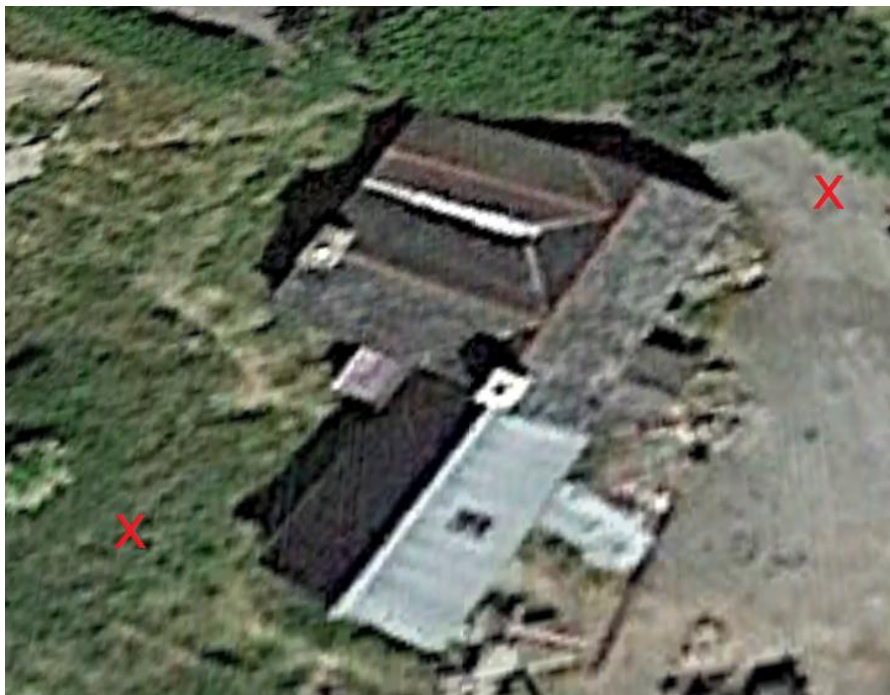
Figure 2: Aerial view of target building showing approximate location of the bat surveyors (red crosses).

Two experienced bat surveyors, led by Dr David Bell, Director, Sensible Ecological Survey Solutions, supported by Janet Bell, were able to position themselves to obtain good observation points to cover all the frontages and roofing of the building (Figure 2).

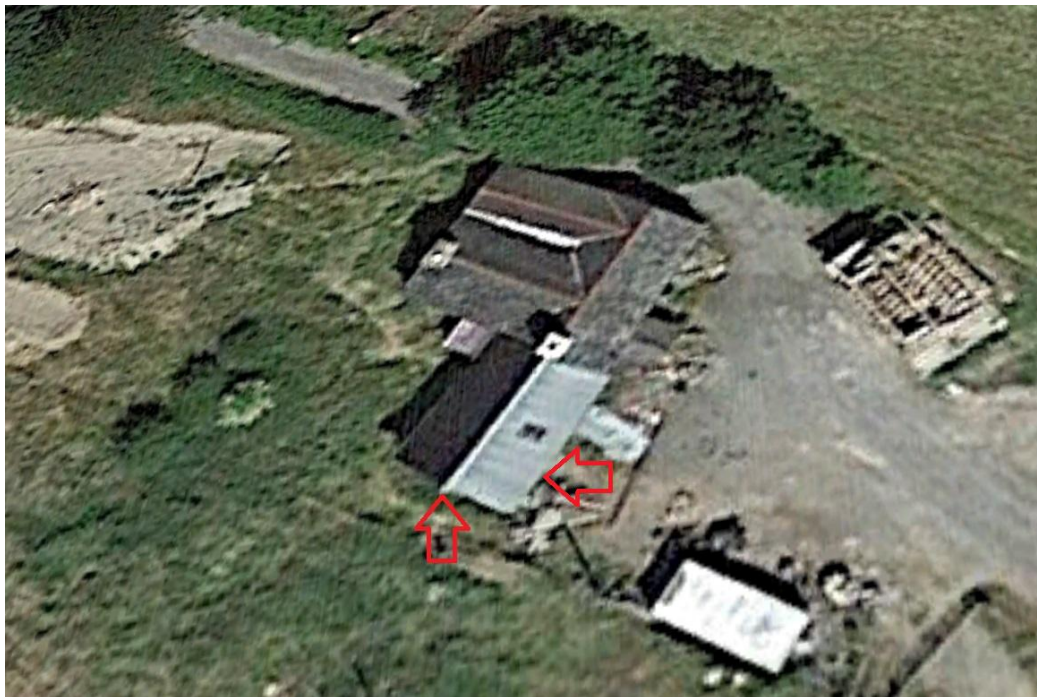
**Figure 3:** Aerial view of target building showing the bat egress locations from the barn structure building.

**SURVEY 1:** Two Common Pipistrelle bats were recorded egressing the target building via an unglazed high level window at the southern gable end of the barn extension structure (Figure 3; Photograph G).

**SURVEY 2:** Two Common Pipistrelle bats were recorded egressing the target building one via an unglazed high level window at the southern gable end of the barn extension structure (Figure 3; Photograph G), and the second via an unglazed window to the east facing frontage of the same barn structure (Figure 3: Photographs G & H).

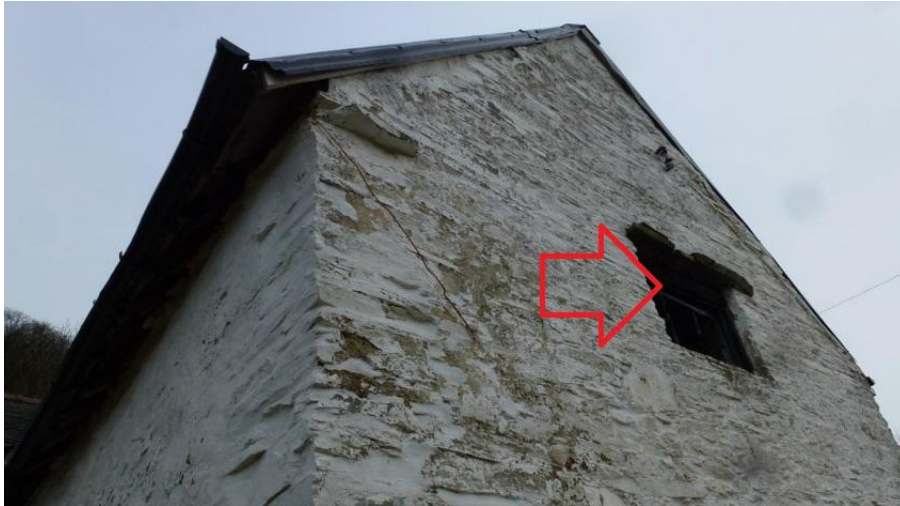
**Photograph G:** View of south facing gable end of barn structure with bat egress location via unglazed windows indicated.

Two CP bats recorded emerging from the target building, via south facing gable end high level window (glass missing) (Photograph G)

Two CP bats recorded emerging from the target building, one via south facing gable end high level unglazed window, and one via east facing unglazed window (Photographs G & H).

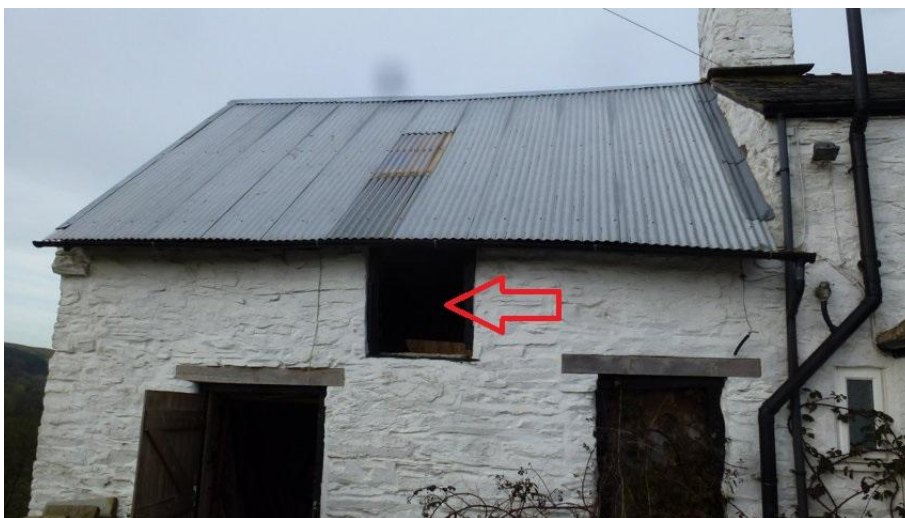
**Photograph H:** View of east facing frontage to barn structure with bat egress location via unglazed windows indicated.
