**Cinders Farm, Ruabon**

## **Infiltration Test Report**

**February 2020**

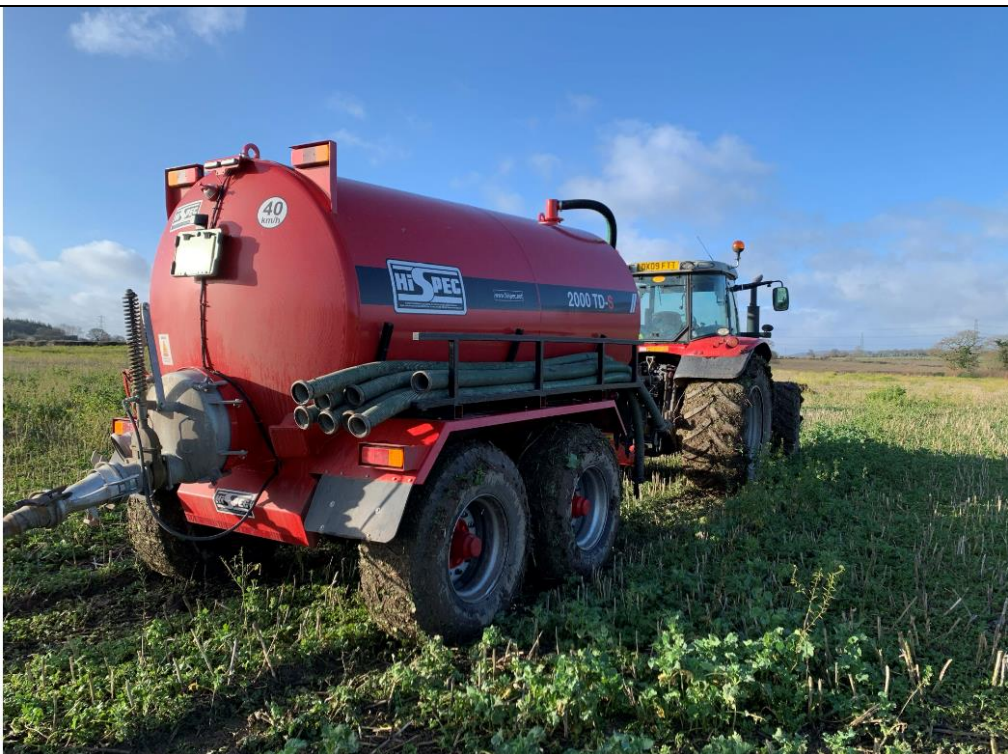
| <b>Photo No.1</b><br><b>Water Bowser</b> | <b>Job Reference &amp; Number: Cinders Farm, Ruabon-12443</b> | |

| <b>Description:</b><br><br>The water bowser used for the water supply to each trial pit. | | |

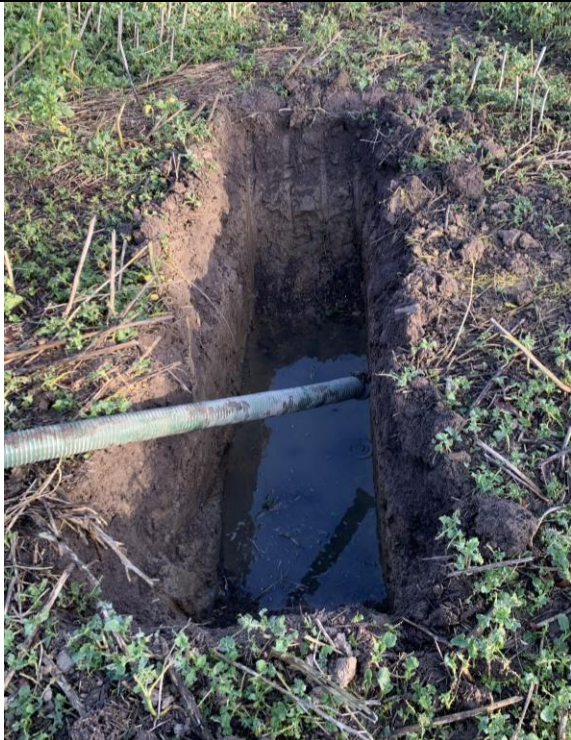
| <b>Photo No.2</b><br><b>Trial Pit 1</b> | <b>Job Reference &amp; Number: Cinders Farm, Ruabon-12443</b> | |

| Trial Pit | Description | Infiltration Rate (m <sup>3</sup> /s) |
|---|---|---|
| TP1 | Prior to adding water for infiltration purposes, groundwater was recorded at a depth of 0.80m.bgl. The water level fell by 110mm (from 0.017m.bgl to 0.028m.bgl) over a period of 331 minutes (5 hours and 31 minutes). Infiltration testing was abandoned. | N/A |

| <b>Description:</b><br><br>Trial pit 1 before any water was added. There was groundwater present at a depth of approximately 0.80m.bgl. | | |

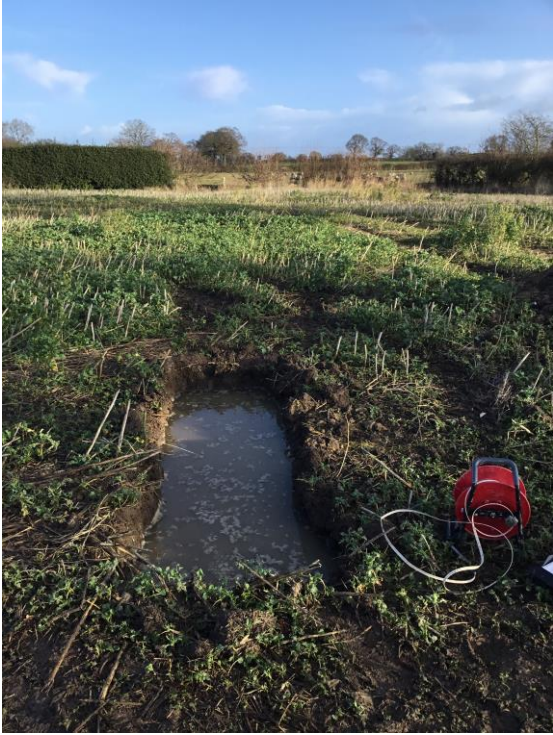
| Photo No.3<br>Trial Pit 1 | Job Reference & Number: Cinders Farm, Ruabon-12443 | |

| Photo No.3<br>Trial Pit 1 | Job Reference & Number: Cinders Farm, Ruabon-12443 | |
|---|---|---|
| <p><b>Description:</b></p> <p>Trial Pit 1 after the water was added.</p> | | |

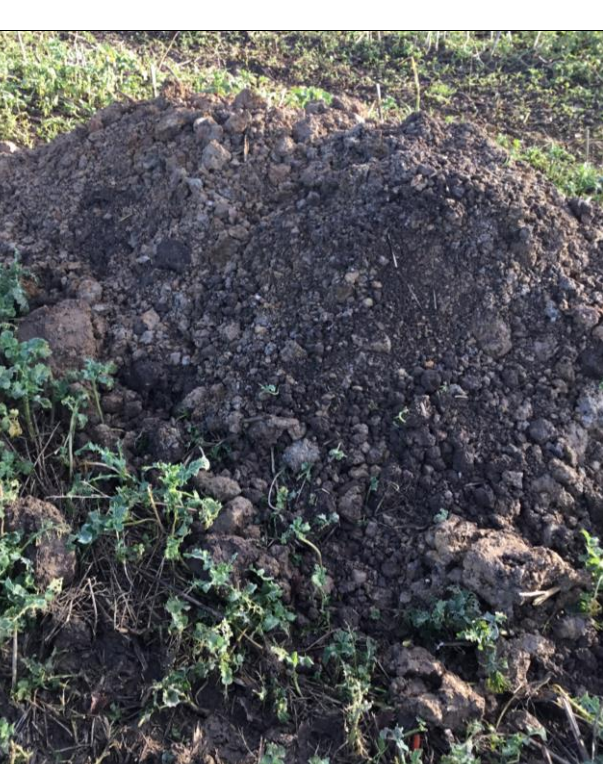
| Photo No. 4<br>Trial Pit 1 | Job Reference & Number: Cinders Farm, Ruabon-12443 | |

| Photo No. 4<br>Trial Pit 1 | Job Reference & Number: Cinders Farm, Ruabon-12443 | |
|---|---|---|
| <p><b>Description:</b></p> <p>Trial pit 1 arisings.</p> | | |

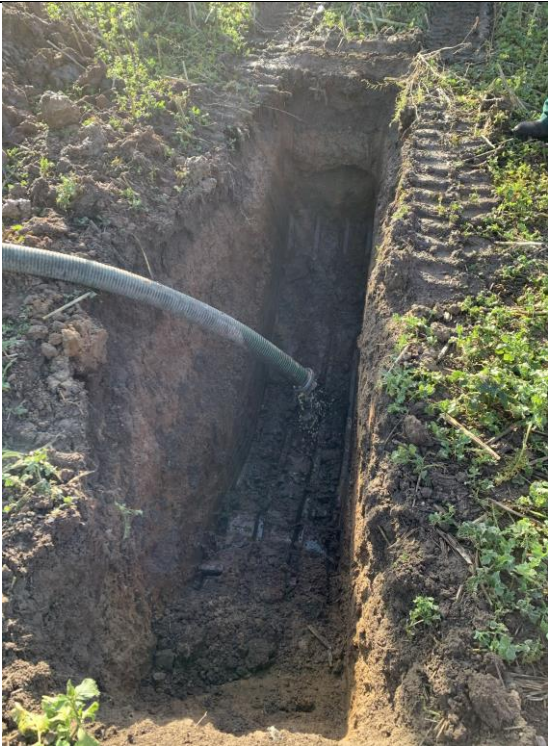
| <b>Photo No.5</b><br><b>Trial Pit 2</b> | <b>Job Reference &amp; Number: Cinders Farm, Ruabon-12443</b> | |

| Trial Pit | Description | Infiltration Rate (m <sup>3</sup> /s) |
|---|---|---|
| TP2 | The water level fell by 80mm (from 0.28m.bgl to 0.36m.bgl) over a period of 310 minutes (5 hours and 10 minutes). Infiltration testing was abandoned. | N/A |

| <b>Description:</b><br><br>Trial pit 2 before any water was added.<br>There was no groundwater present. | | |

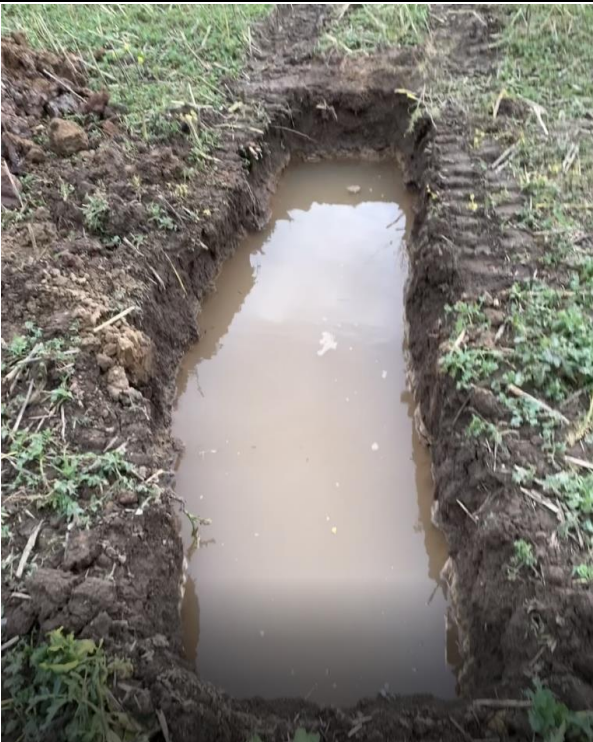
| <b>Photo No. 6</b><br><b>Trial Pit 2</b> | <b>Job Reference &amp; Number: Cinders Farm, Ruabon-12443</b> | |

| <b>Description:</b><br><br>Photograph showing trial pit 2 after the water was added. | | |

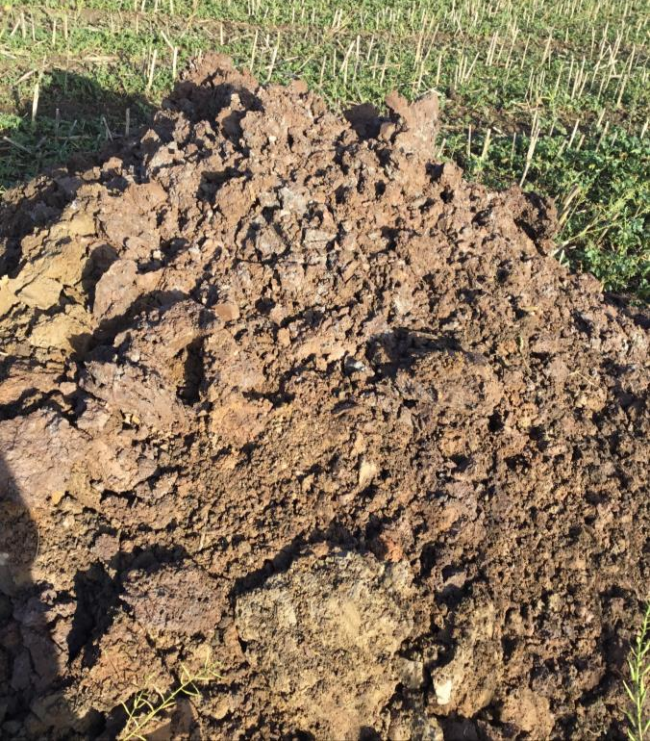
| <b>Photo No.7</b><br><b>Trial Pit 2</b> | <b>Job Reference &amp; Number: Cinders Farm, Ruabon-12443</b> | |

| <b>Description:</b><br><br>Trial pit 2 arisings. | | |

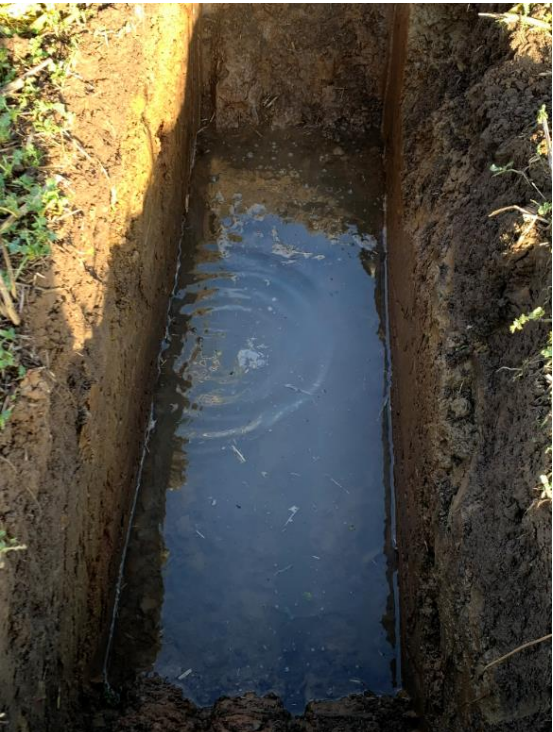
| <b>Photo No. 8</b><br><b>Trial Pit 3</b> | <b>Job Reference &amp; Number: Cinders Farm, Ruabon-12443</b> | |

| Trial Pit | Description | Infiltration Rate (m <sup>3</sup> /s) |
|---|---|---|
| TP3 | Prior to adding water for infiltration purposes, groundwater was recorded at a depth of 0.86m.bgl. During the infiltration testing the water level fell by 30mm (from 0.28m.bgl to 0.31m.bgl) over a period of 300 minutes (5 hours). Infiltration testing was abandoned. | N/A |

| <b>Description:</b><br><br>Photograph showing Trial pit 3 before any water was added. Groundwater was present at a depth approximately 0.86m.bgl. | | |

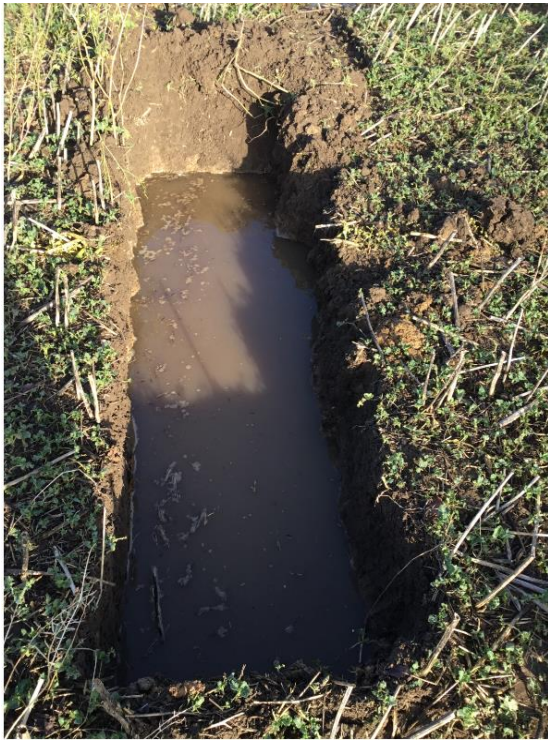
| <b>Photo No.9</b><br><b>Trial Pit 3</b> | <b>Job Reference &amp; Number: Cinders Farm, Ruabon-12443</b> | |

| <b>Description:</b><br><br>Trial Pit 3 after the water was added. | | |

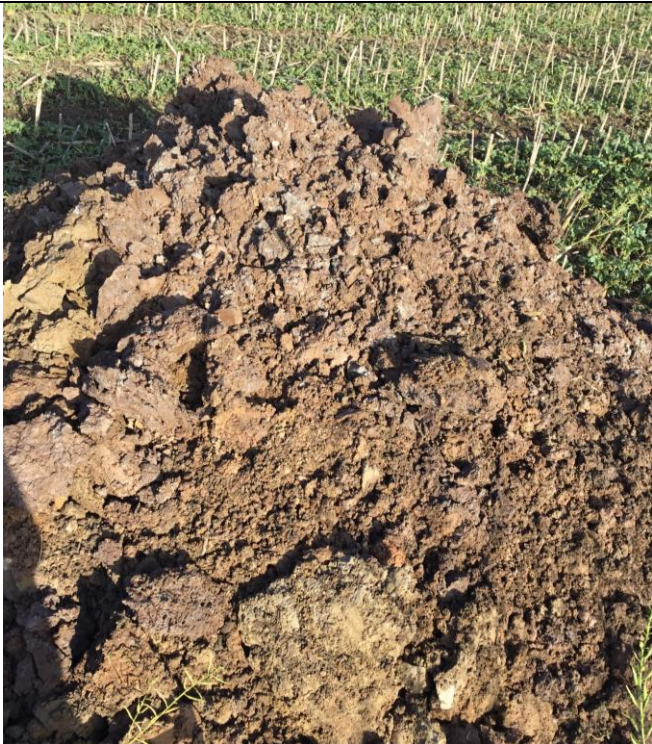
| <b>Photo No. 10</b><br><b>Trial Pit 3</b> | <b>Job Reference &amp; Number: Cinders Farm, Ruabon-12443</b> | |

| <b>Description:</b><br><br>Trial pit 3 arisings. | | |

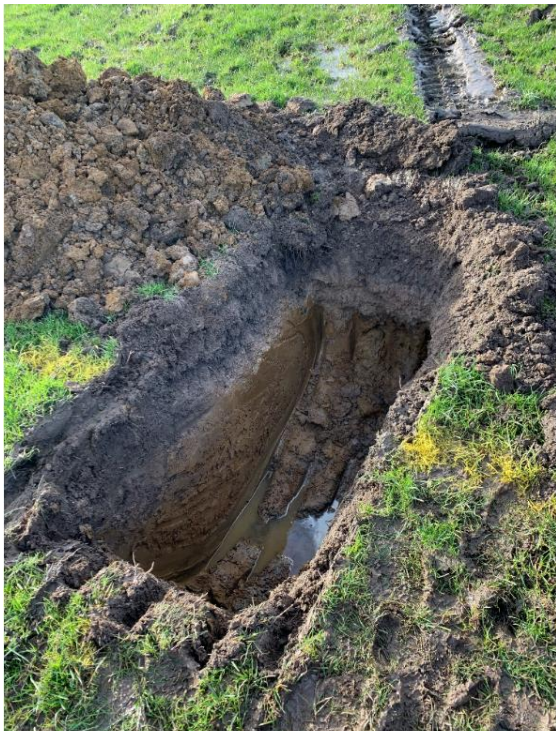
| <b>Photo No.11</b><br><b>Trial Pit 4</b> | <b>Job Reference &amp; Number: Cinders Farm, Ruabon-12443</b> | |

| Trial Pit | Description | Infiltration Rate (m <sup>3</sup> /s) |
|---|---|---|
| TP4 | Prior to adding water for infiltration purposes, groundwater was recorded at a depth of 1.05m.bgl. The water level did not fall over a period of 270 minutes (4 hours and 30 minutes). Infiltration testing was abandoned. | N/A |

| <b>Description:</b><br><br>Photograph showing Trial pit 4 after it was excavated. There was groundwater at a depth of approximately 1.05m.bgl. | | |

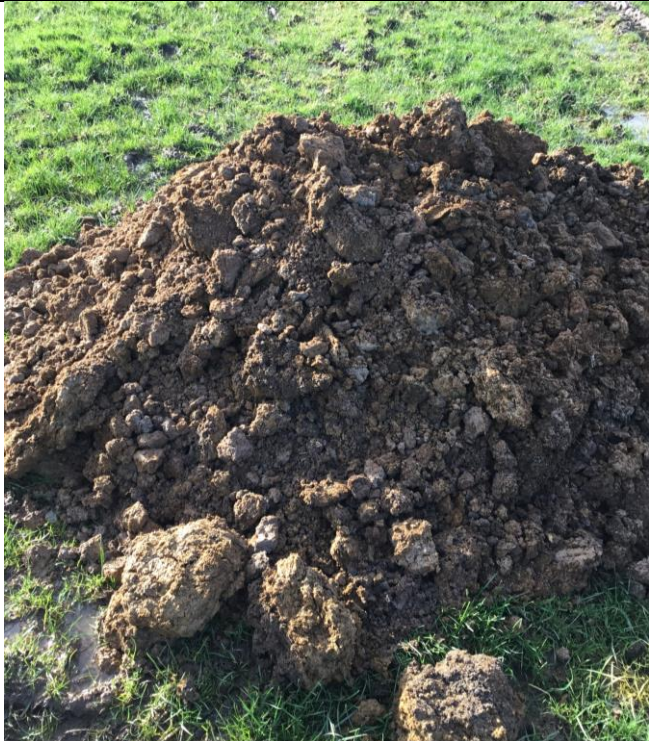
| <b>Photo No. 12</b><br><b>Trial Pit 4</b> | <b>Job Reference &amp; Number: Cinders Farm, Ruabon-12443</b> | | |

| <b>Description:</b><br><br>Trial pit 4 arisings. | | | |

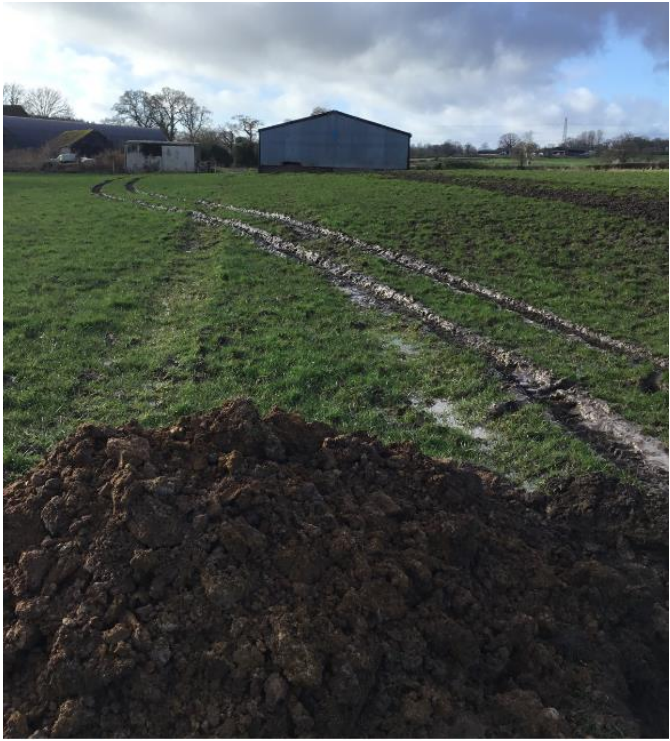
| <p><b>Photo No.13</b><br/><b>Trial Pit 4</b></p> | <p><b>Job Reference &amp; Number: Cinders Farm, Ruabon-12443</b></p> |

| <p><b>Description:</b><br/>Photograph of trial pit 4 arisings and the location of the trial pit.</p> | |

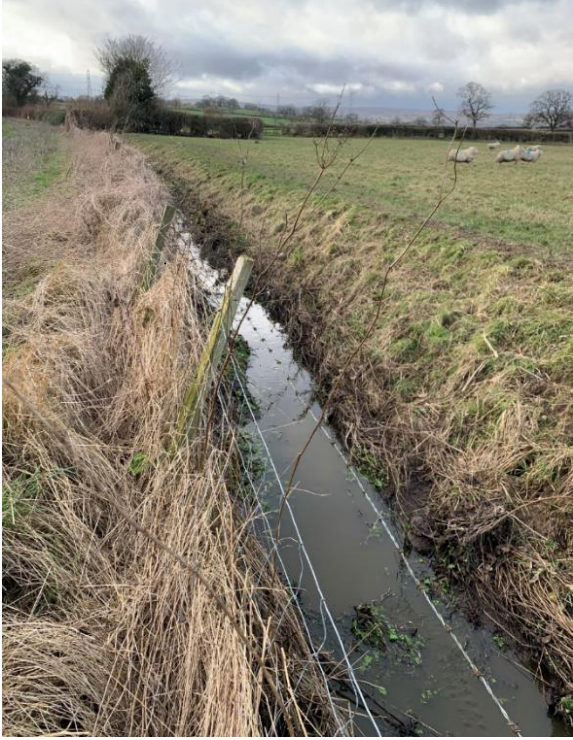
| <p><b>Photo No. 14</b></p> | <p><b>Job Reference &amp; Number: Cinders Farm, Ruabon-12443</b></p> |

| <p><b>Description:</b><br/>Photograph of the western side of the brook located to the north of the site.</p> | |

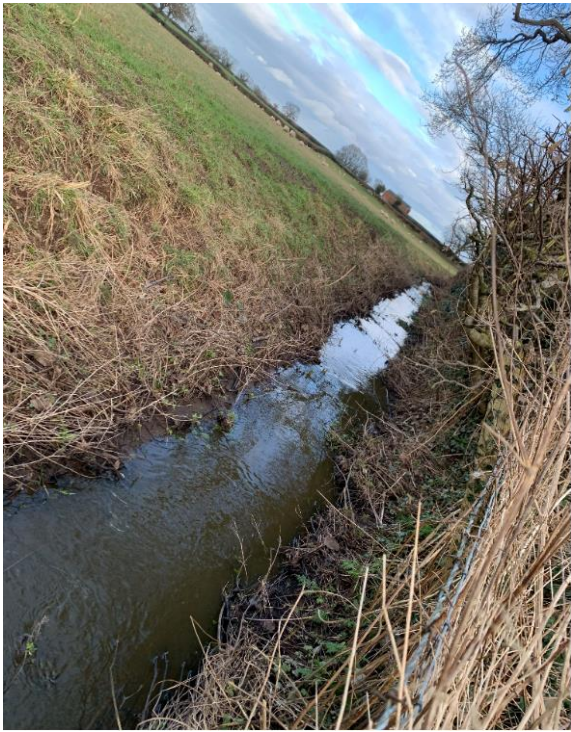
| <b>Photo No.15</b> | <b>Job Reference &amp; Number: Cinders Farm, Ruabon-12443</b> | |

| <b>Description:</b><br><br>Photograph of the eastern side of the brook located to the north of the site. | | |

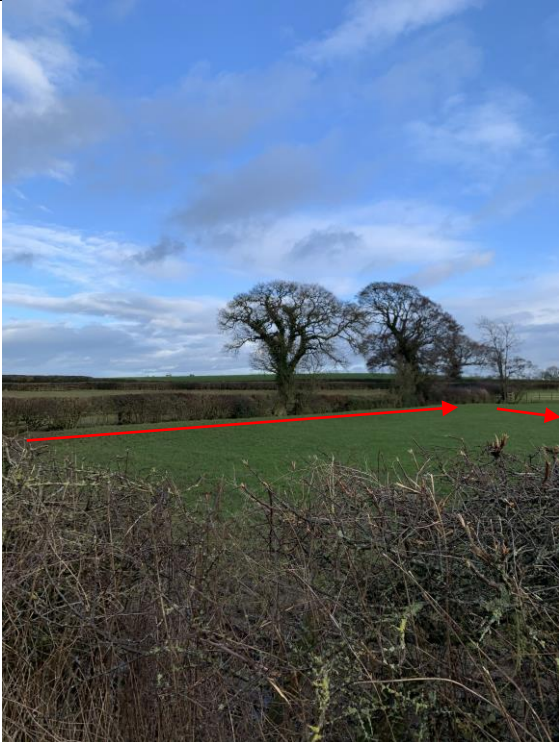
| <b>Photo No. 16</b> | <b>Job Reference &amp; Number: Cinders Farm, Ruabon-12443</b> | |

| <b>Description:</b><br><br>Photograph of the north-eastern extent of the site. Annotations have been made showing the direction of the brook. | | |
