# **Phase 2 land quality assessment: land at junction of Bryn Road and Harwd Road, Brymbo, Wrexham, LL11 5BW**

**Report reference:** 4145R1

**Date of reporting:** 17 June 2020

**Prepared by**  
**Ground First Ltd**

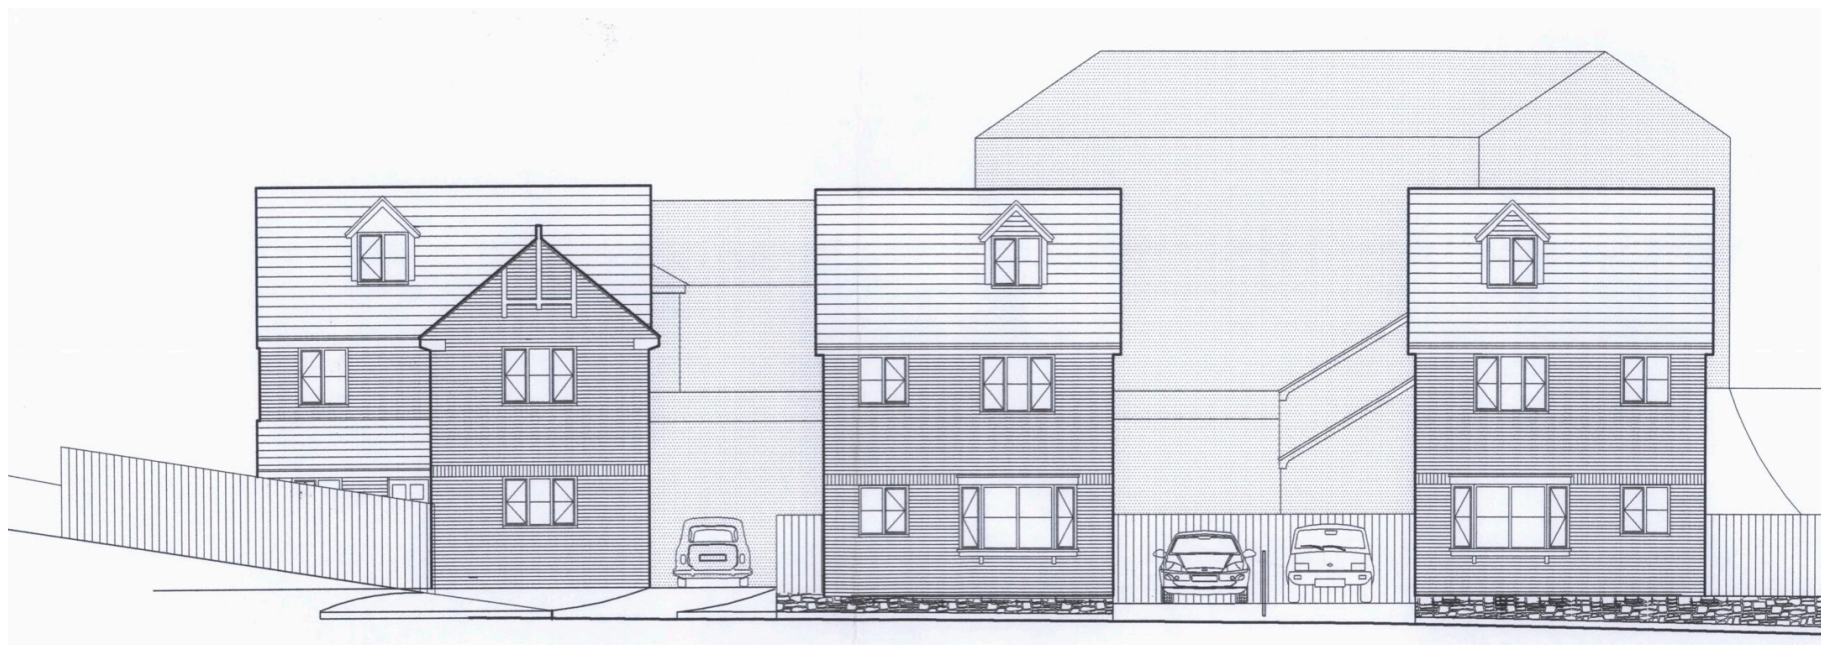
**Figure 1.3 Proposed development plan – building front elevations**

**Proposed development plan – view from Harwd Road****June 2020****Drawn: AJS****4145R1****Rev 1**

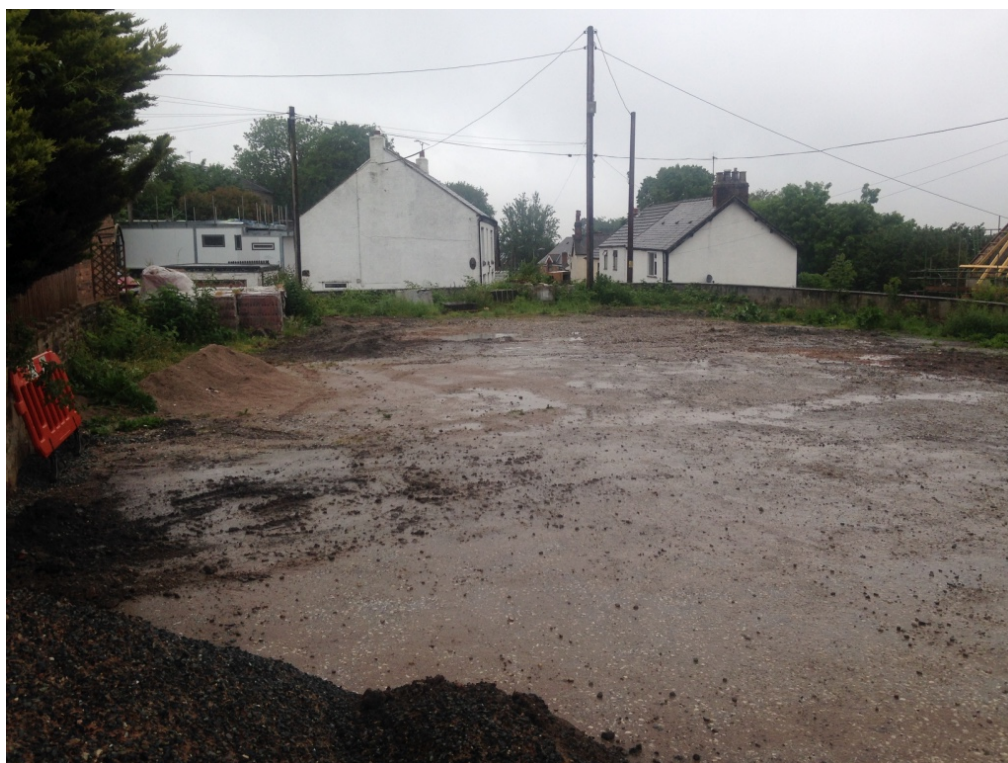
**Photograph 1**

- No evidence of any drainage infrastructure was observed on-Site.
- The Site topography across the open area across the north-east of the Site is relatively flat and level (see Photograph 1 in Appendix B). The ground elevation along the northern and north-eastern Site boundaries is c. 1.4 m higher than the adjacent road levels (see also annotations included on Figure 3.1). This suggests that the Site has previously been subject to infilling in order to create a level platform.

**Description:** Main development area (eastern part of the Site)

**Location:** View from mid-point on southern Site boundary – looking north

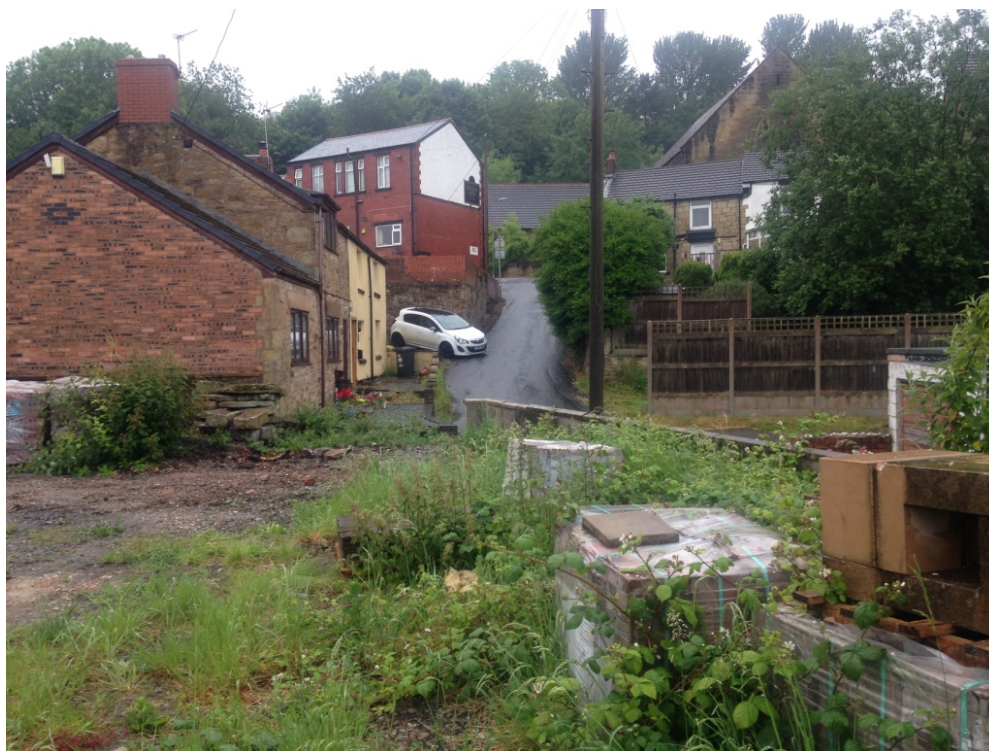
**Photograph 4**

- Modest quantities of building materials including some small aggregate / mineral stockpiles and several pallets of bricks and tiles were observed in the north-east of the Site (see Photographs 4 and 5 in Appendix B).

**Description:** Northern edge of the Site (showing localised storage of building materials and neighbouring properties - 3 and 4 Bryn Road)

**Location:** Northern Site boundary – looking to the west

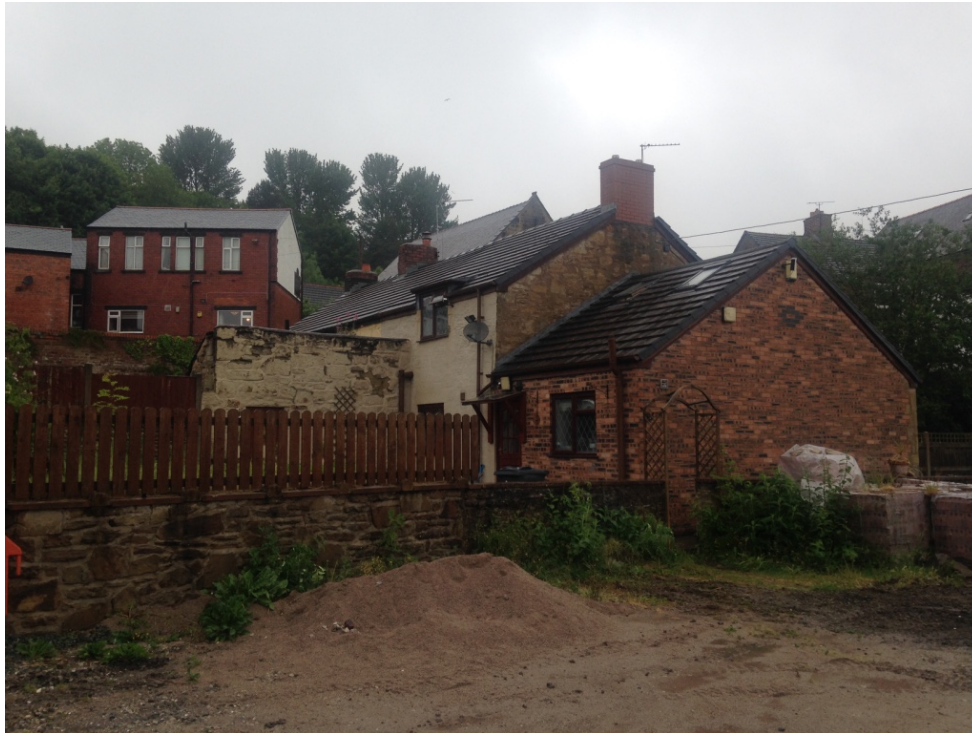
**Photograph 5**

**Description:** Localised storage of building aggregate plus neighbouring properties (3 and 4 Bryn Road)

**Location:** North-west corner of the Site – looking to the north-west

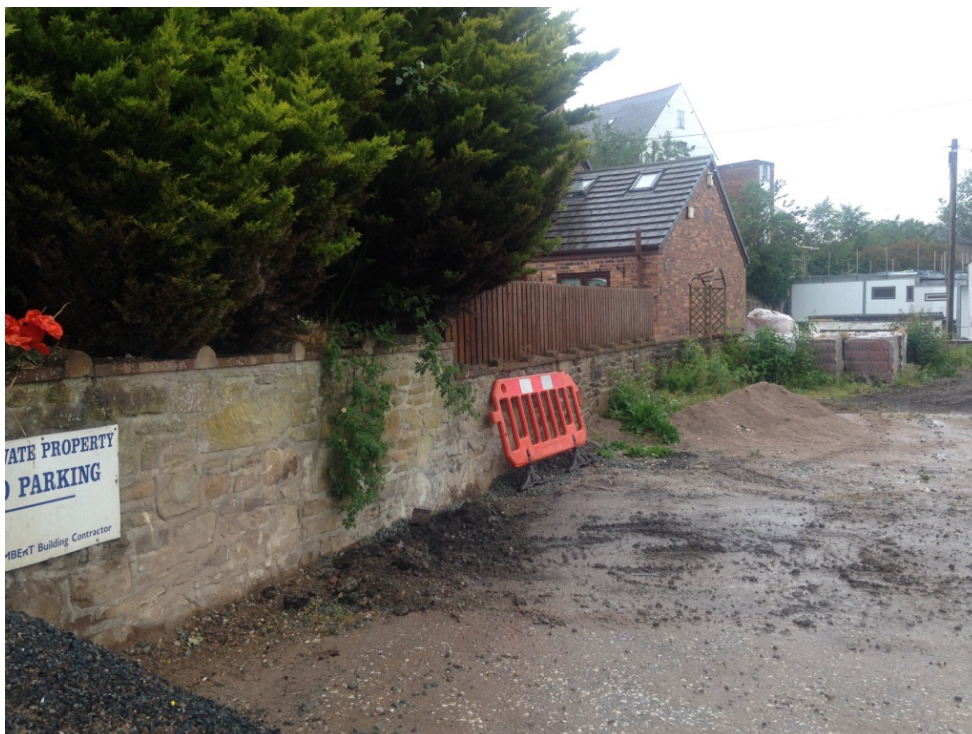
**Photograph 6**

**Description:** Current retaining wall along boundary of 4 Bryn Road

**Location:** Central area of the Site – looking to the north-west

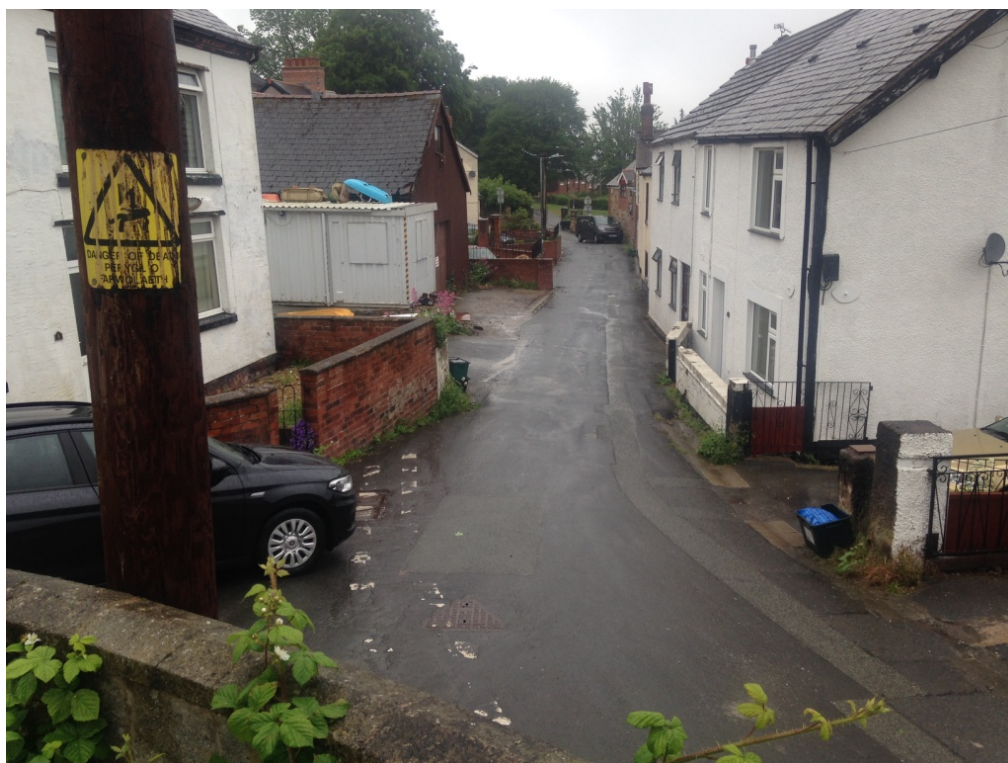
**Photograph 9**

**Description:** Retaining wall at edge of Site, maintaining Site elevation above adjacent Harwd Road
