Stansty Road, Wrexham (Total Fitness)

Proposed Housing

Urban Developments Ltd

Geo-environmental Report

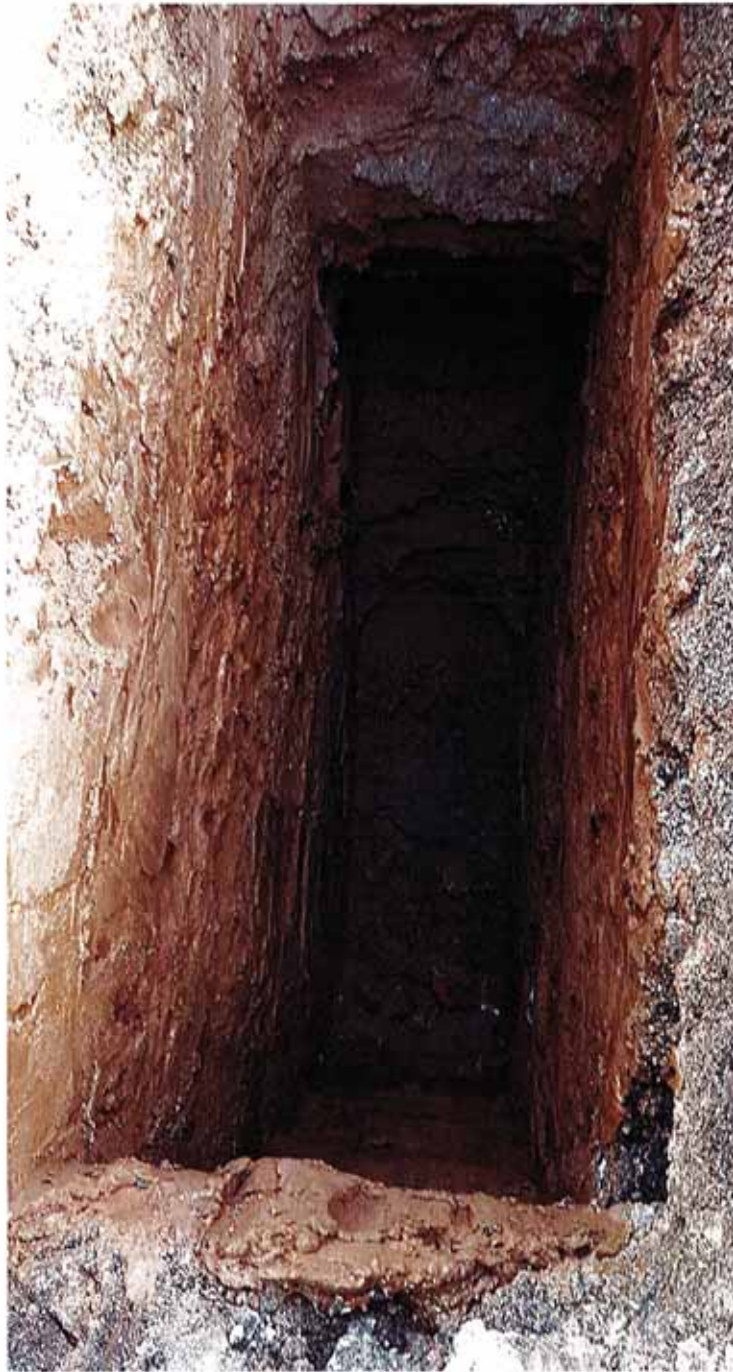
The property is not in an area where a notice has been given under section 41 of the Coal Industry Act 1994, cancelling the entitlement to withdraw support.

## 12 Withdrawal of support

In TP 1 excavated in the existing Total Fitness car park encountered similar made ground as those in the GSL 2015 investigation for the Gower Homes investigation. That is two layers of car park construction, one at surface constructed at the same time as Total Fitness, and a lower layer, which was the former GPO surface car park, which was encountered at a depth of 0.60m. Beneath the lower car park construction a concrete slab was encountered, which had to be broken out using a pneumatic breaker.

Beneath the tarmac and topsoil the made ground was generally a loose to medium dense, grey and dark grey, limestone, brick and concrete cobble and gravel in a silty sand matrix.

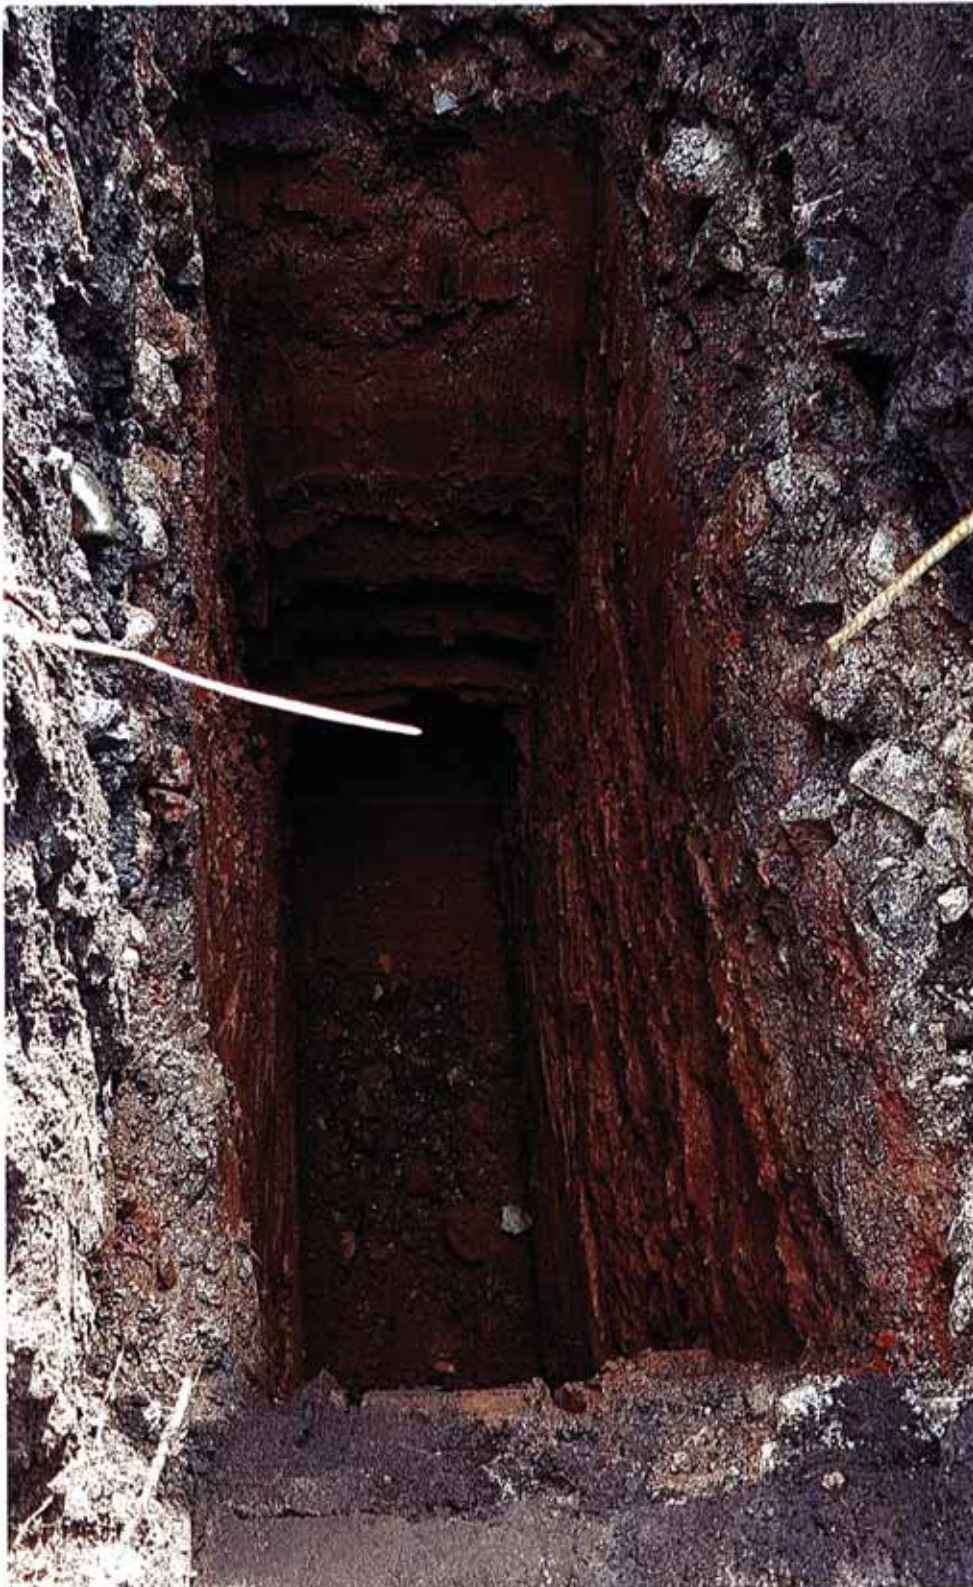
**mine entries** - collective name for shafts and adits

**future opencast coal mining** - a licence granted, or licence application received, by the Coal Authority to excavate coal from the surface

Topsoil/subsoil was only encountered in TP 2 and TP 3 in the eastern section of the site. In TP 2 it was encountered beneath a thin veneer of made ground, where it was described as, loose to medium dense, dark brown, slightly clayey, sandy, gravelly silt. Whilst in TP 3, it was described as, loose, black, sandy silt, with rootlets.
