# ARBORICULTURAL IMPLICATIONS ASSESSMENT AND METHOD STATEMENT

LAND OFF OAK ROAD  
WREXHAM INDUSTRIAL ESTATE  
WREXHAM

June 2019

PM/AIA/AMS/03/06/19

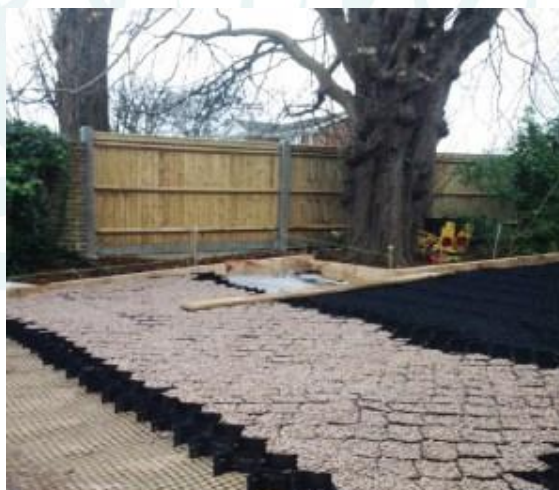
- 4.2.1 As shown above, the Implications Table identifies the potential for the proposed development to have an impact on T16 & T17 due to the proximity of the proposed footpath being within their RPA's as shown on the plan of Appendix Four.
- 4.2.2 Therefore, some special surfacing will be required in order to protect roots. Geotextile materials, such as 'Geoweb' and 'Cellweb' can be used to construct a permanent 'no dig' surfacing within the RPA's of trees. The below picture is an example of how the product can be used:

The following methodology supports the below drawing indicating the construction of the proposed 'no dig' surfaced area as mentioned in section 4.2.2 above with regard to T16 & T17. The methodology is prepared on the basis of the sequence of operations necessary to complete the construction of the hard surfaces with the minimum damage to the trees proposed for retention.

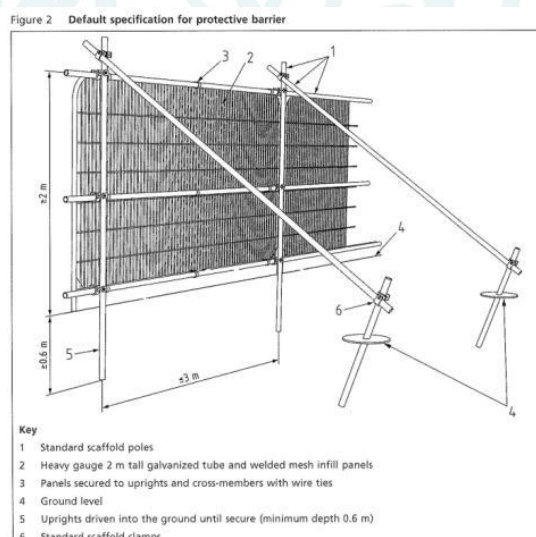
- 6.2.1 All fencing used on the site should fully comply with *BS 5837:2012 Trees in relation to design, demolition and construction – Recommendations*.
- 6.2.2 The fencing should be strong and suitable for local conditions. It should also take into account the degree of construction activity on the site.
- 6.2.3 In this circumstance the location for the protective fencing should be as shown on the Tree Protection Plan of Appendix Four and of the following specification:

- 6.2.6 The positioning of the protective fencing is also very important and should be erected in the proposed location identified on the site plan of Appendix Four. Once the fence has been erected it should never be crossed and particular care should be taken not to store any materials or soil within the protected area.

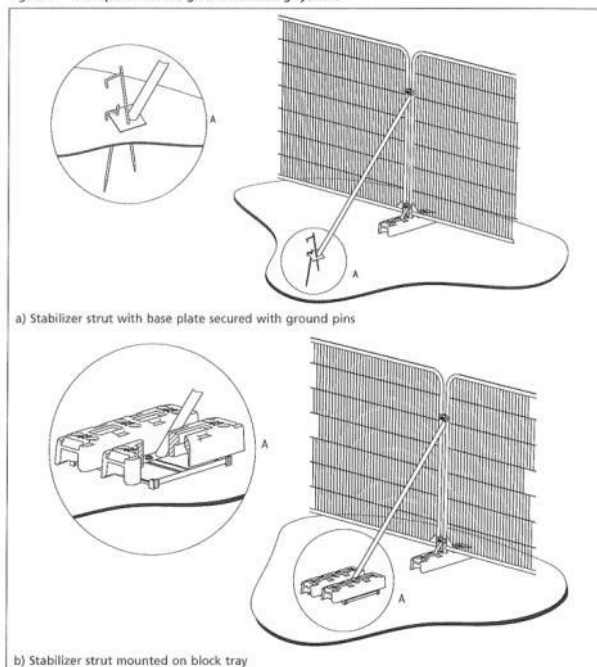
Figure 3 Examples of above-ground stabilizing systems

**Heras type temporary fencing can sometimes be acceptable with the bases pinned to the ground securely. This needs be checked with the Local Planning Authority.**

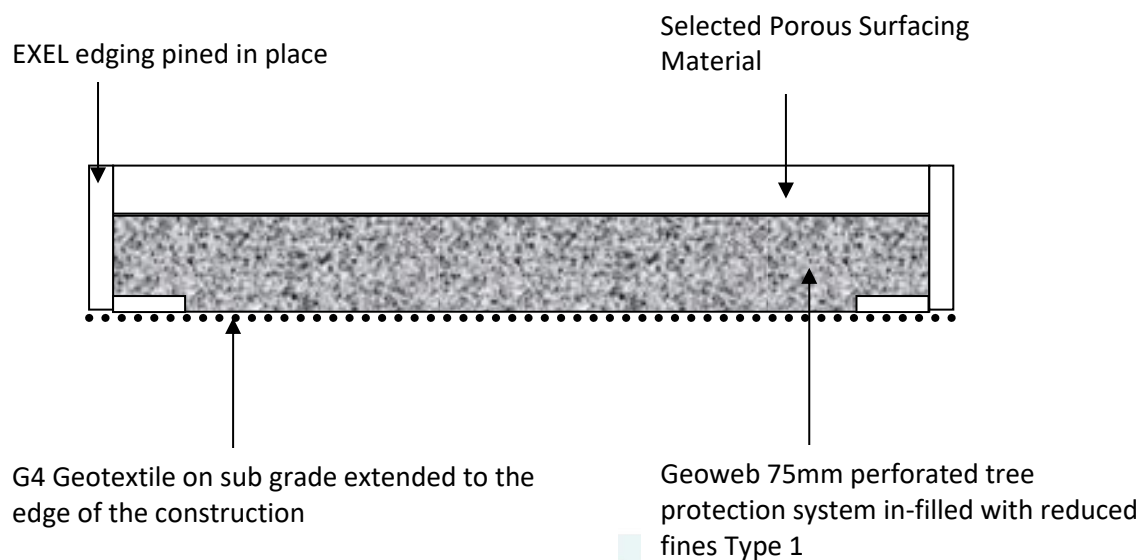
#### GEOWEB BASED SPECIAL SURFACE CONSTRUCTION – (INDICATIVE ONLY)

- Surface layer to be scrapped off by no more than 50-100mm. This can be done either by hand or by very small machinery but may not be needed at all in this instance.
- Spread a sub grade material over the areas to fill any small ruts.
- Lay G4 Geotextile over area to be surfaced.
- Position EXEL metal edging pinned in place.

- Extend the Geoweb 75mm perforated tree root protection system over the area to be surfaced.
- Fill the voids within the Geoweb with reduced fines Type 1 material working into the site over the top of the Geoweb.
- Surface over the Geoweb such that the construction binds itself together.

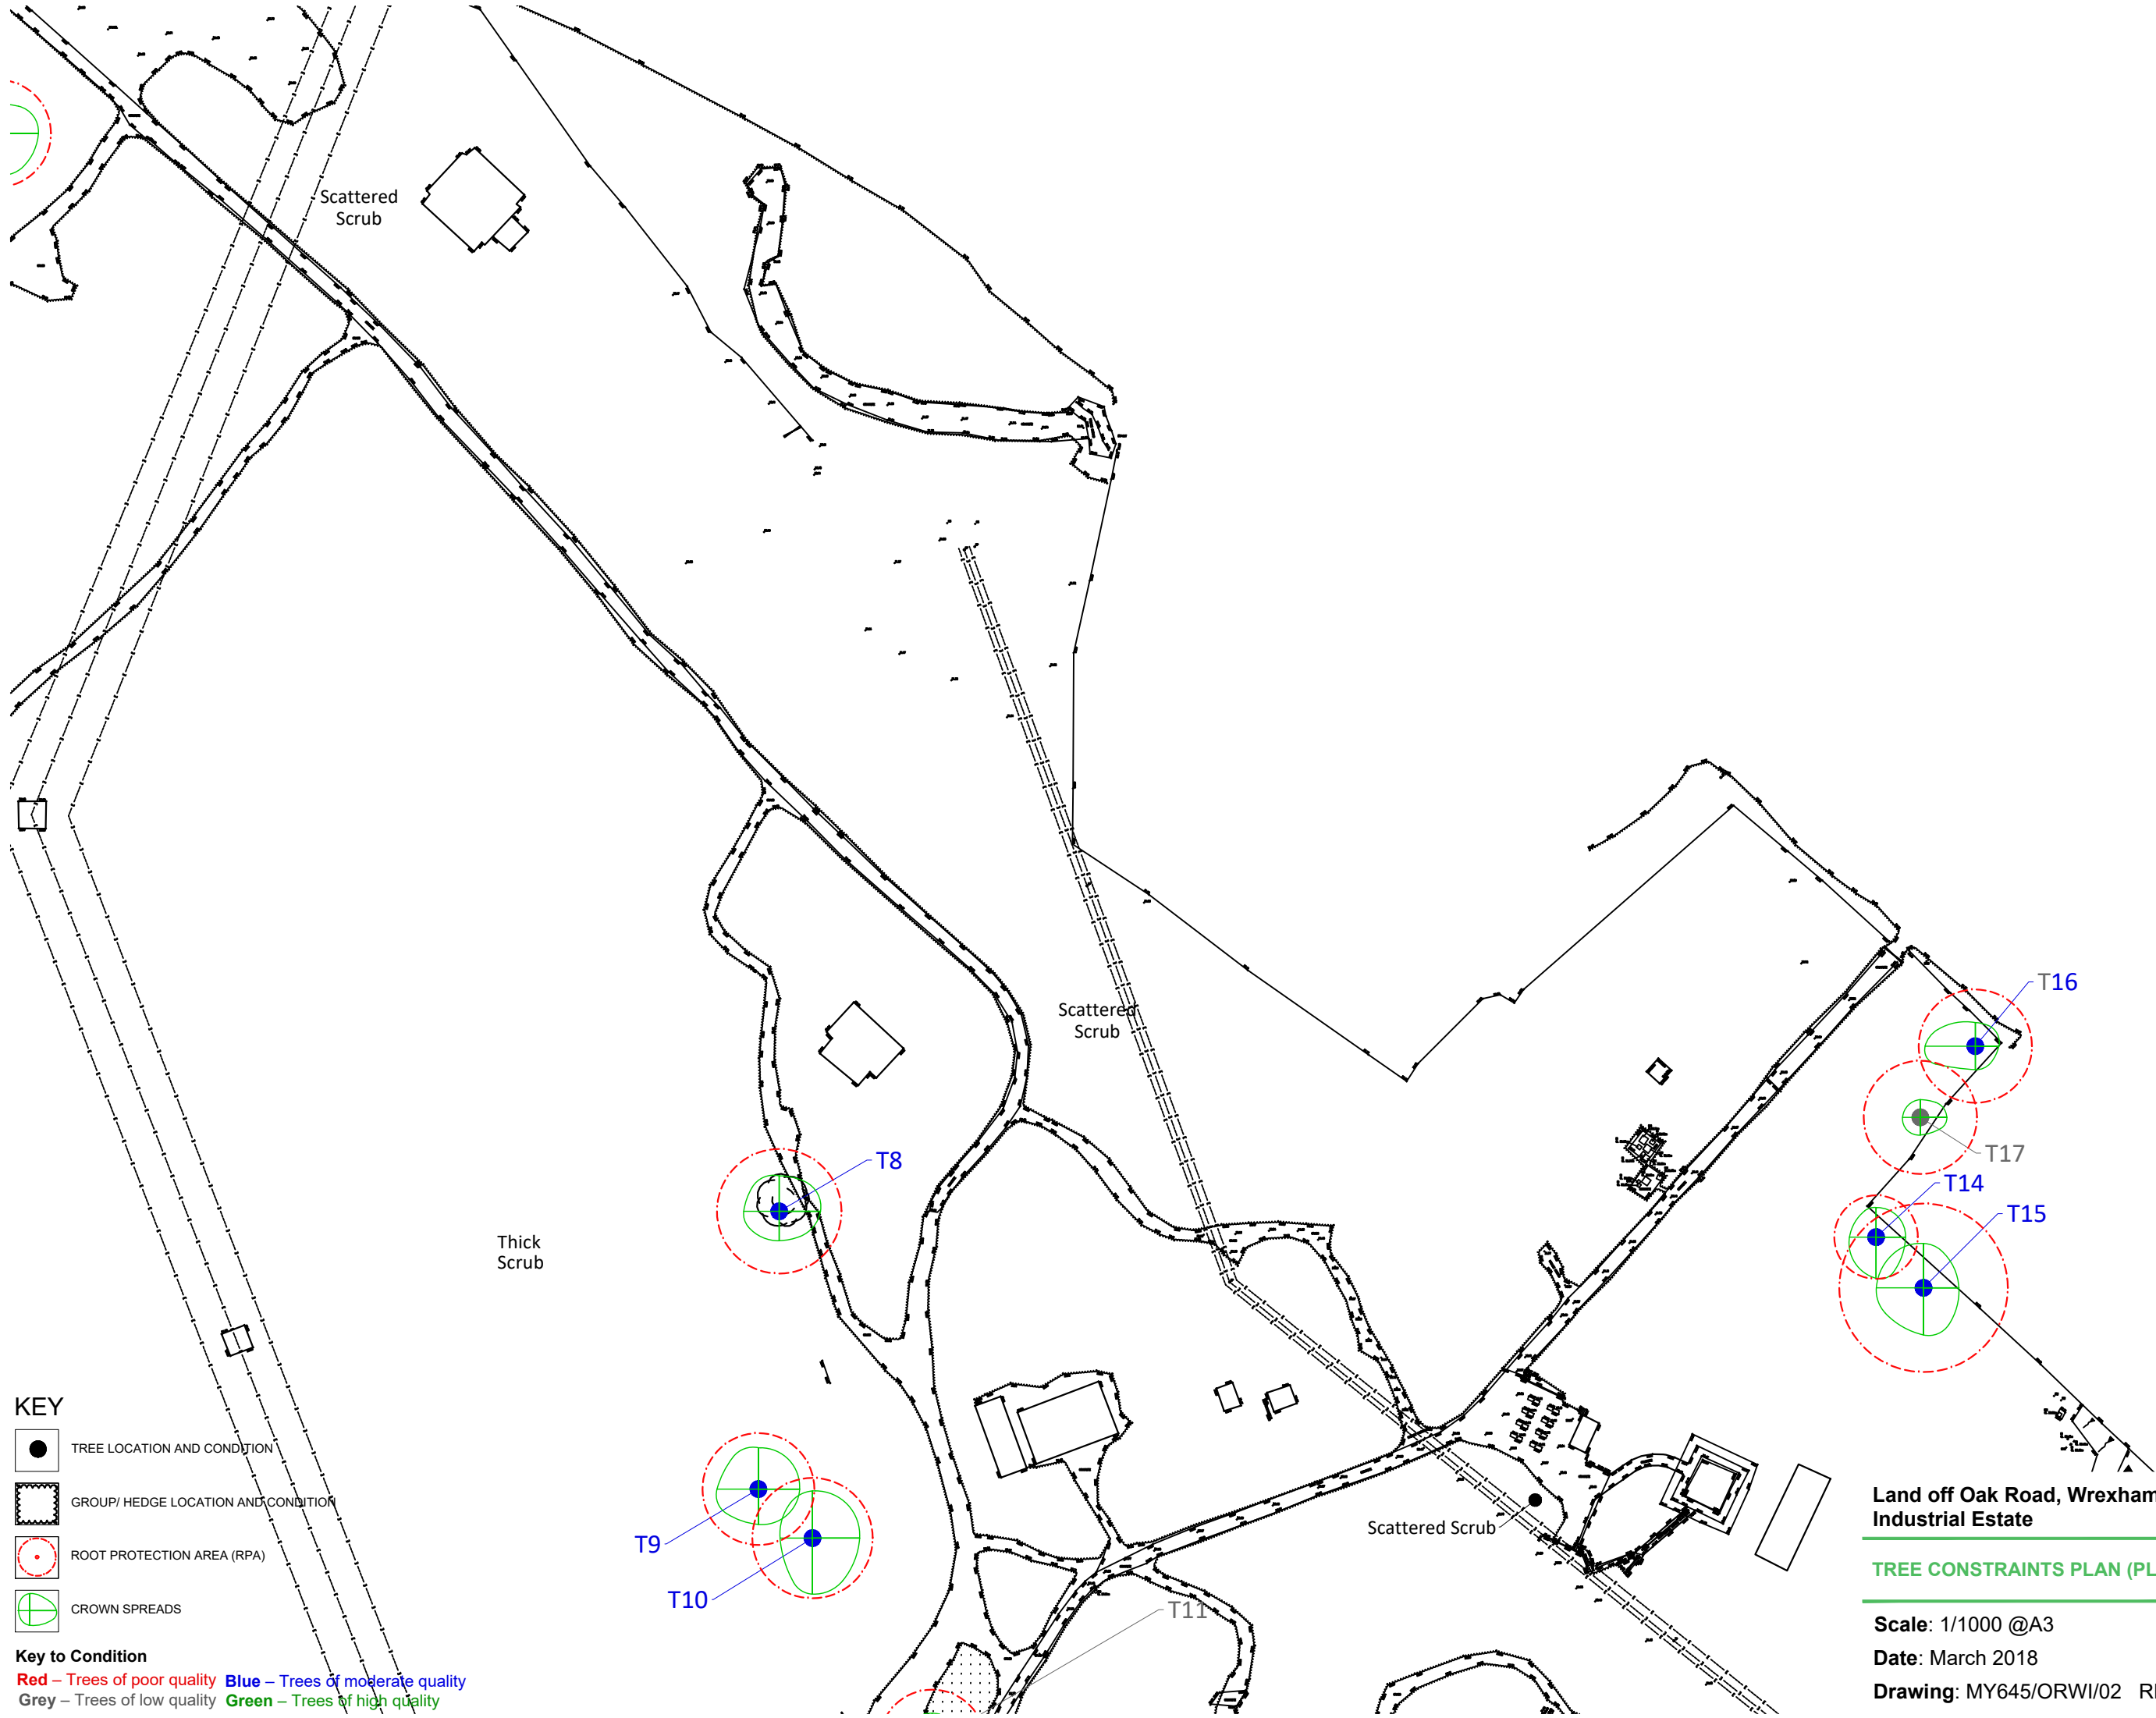
Drawing: MY645/ORWI/01   REV -

- TREE LOCATION AND CONDITION
- GROUP/ HEDGE LOCATION AND CONDITION
- ROOT PROTECTION AREA (RPA)
- CROWN SPREADS
