**DAVID KELLY LEGACY CAR DISMANTLERS /  
SCRAP YARD,  
ESCLUSHAM MILL,  
LLWYNEINION**

**Stage 1 and 2 Supplementary Contamination  
Investigation and  
Assessment**

**For: The Paletta Pension Scheme**

**R2499-R01-v1**

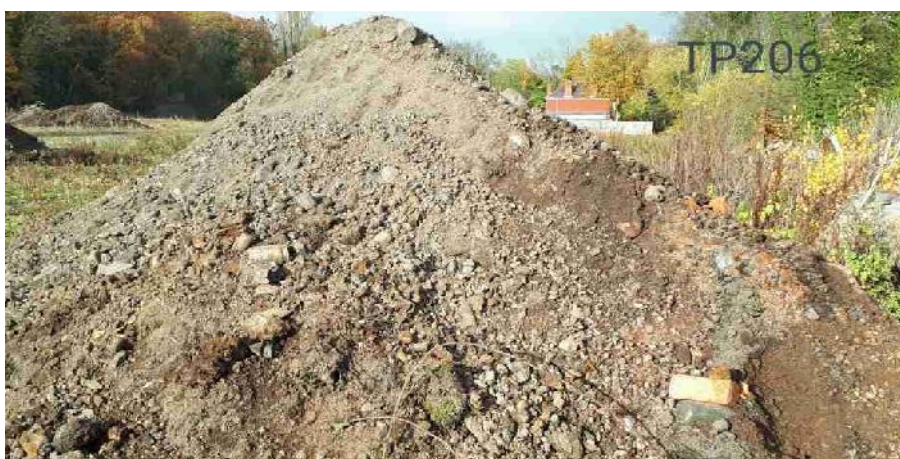
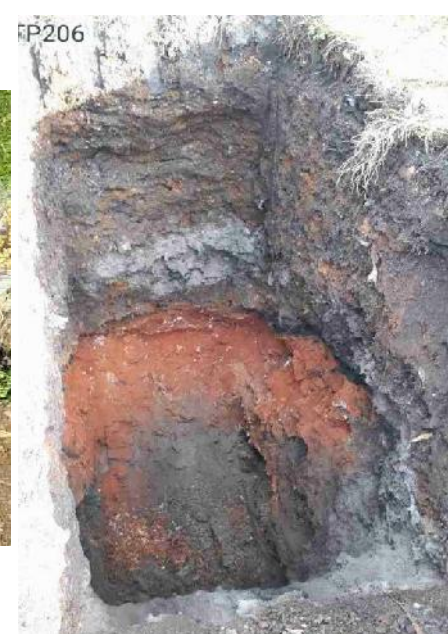
TP206

- 7.1.10. Ash and clinker were observed additionally in TP206, TP207, TP208 and TP211.
- 7.1.11. Mix of clay and shale gravel fill was observed typically to the south-western portion of the site in proximity of dismantled railway.
